**FINAL  
ANNUAL MONITORING REPORT  
CHARLES CREEK PARK**

**WETLAND RESTORATION  
PASQUOTANK COUNTY, NORTH CAROLINA  
(EEP Project Number 79)**

Monitoring Year 5 of 5 (2011)

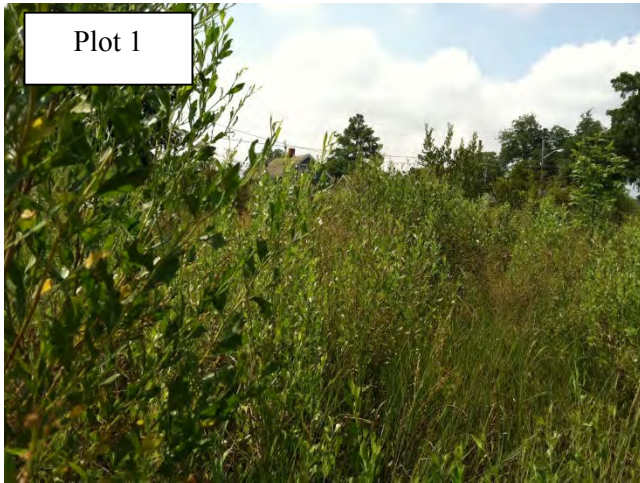
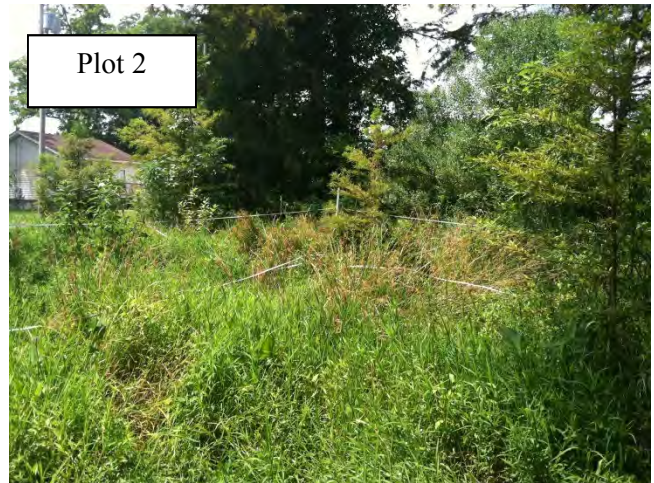
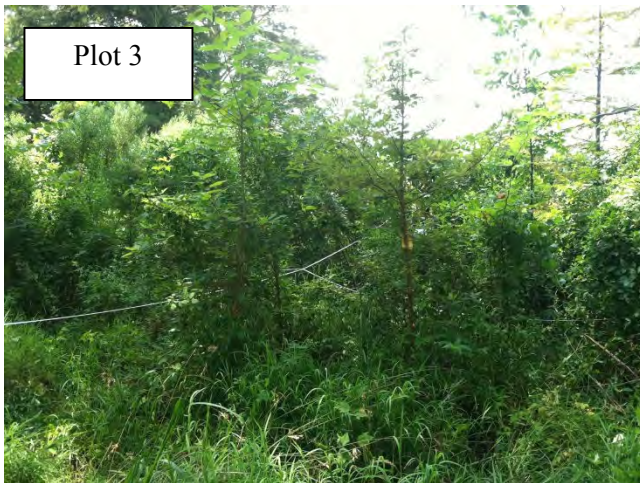
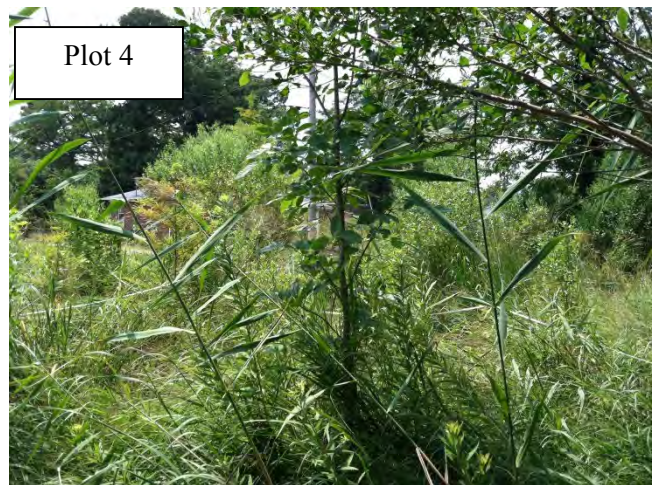
**Charles Creek Park  
Vegetation Monitoring Photographs  
Taken July 2011**

Vegetation success criteria dictate that an average density of 320 stems per acre must be surviving in the first three monitoring years. Subsequently, 290 stems per acre must be surviving in year 4 and 260 stems per acre in year 5. Stem counts will be based on an average of the evaluated vegetation plots. Based on the number of stems counted, average densities were measured at 607 stems per acre surviving in year 5 (2011). The dominant species identified at the Site were planted stems of bald cypress (*Taxodium distichum*), swamp blackgum (*Nyssa aquatica*), and buttonbush (*Cephalanthus occidentalis*). In addition, each individual vegetation plot met success criteria. Common reed (*Phragmites australis*) and kudzu (*Pueraria lobata*), invasive species previously located in the Site were treated chemically in early summer 2011. No new growth of common reed or kudzu was observed during the year 5 (2011) monitoring period. Growth of planted stems in the vicinity of vegetation plot 1 and the rain gauge has been slow most likely as the result of soil infertility from earth moving during construction; vigor of these stems is generally fair to good.
