**CLAYHILL FARMS MITIGATION SITE
JONES COUNTY, NORTH CAROLINA
TIP No. R-2105 WM
(EEP Project Number .00018)
2006 Annual Monitoring Report (Year 1 of 5)**

Submitted to:
North Carolina Department of Environment and Natural Resources
Ecosystem Enhancement Program
Raleigh, North Carolina

Prepared by:
Axiom Environmental, Inc.
2126 Rowland Pond Drive
Willow Spring, North Carolina 27592

Design Firm:
Office of Natural Environment & Roadside Environmental Unit
North Carolina Department of Transportation
Raleigh, North Carolina

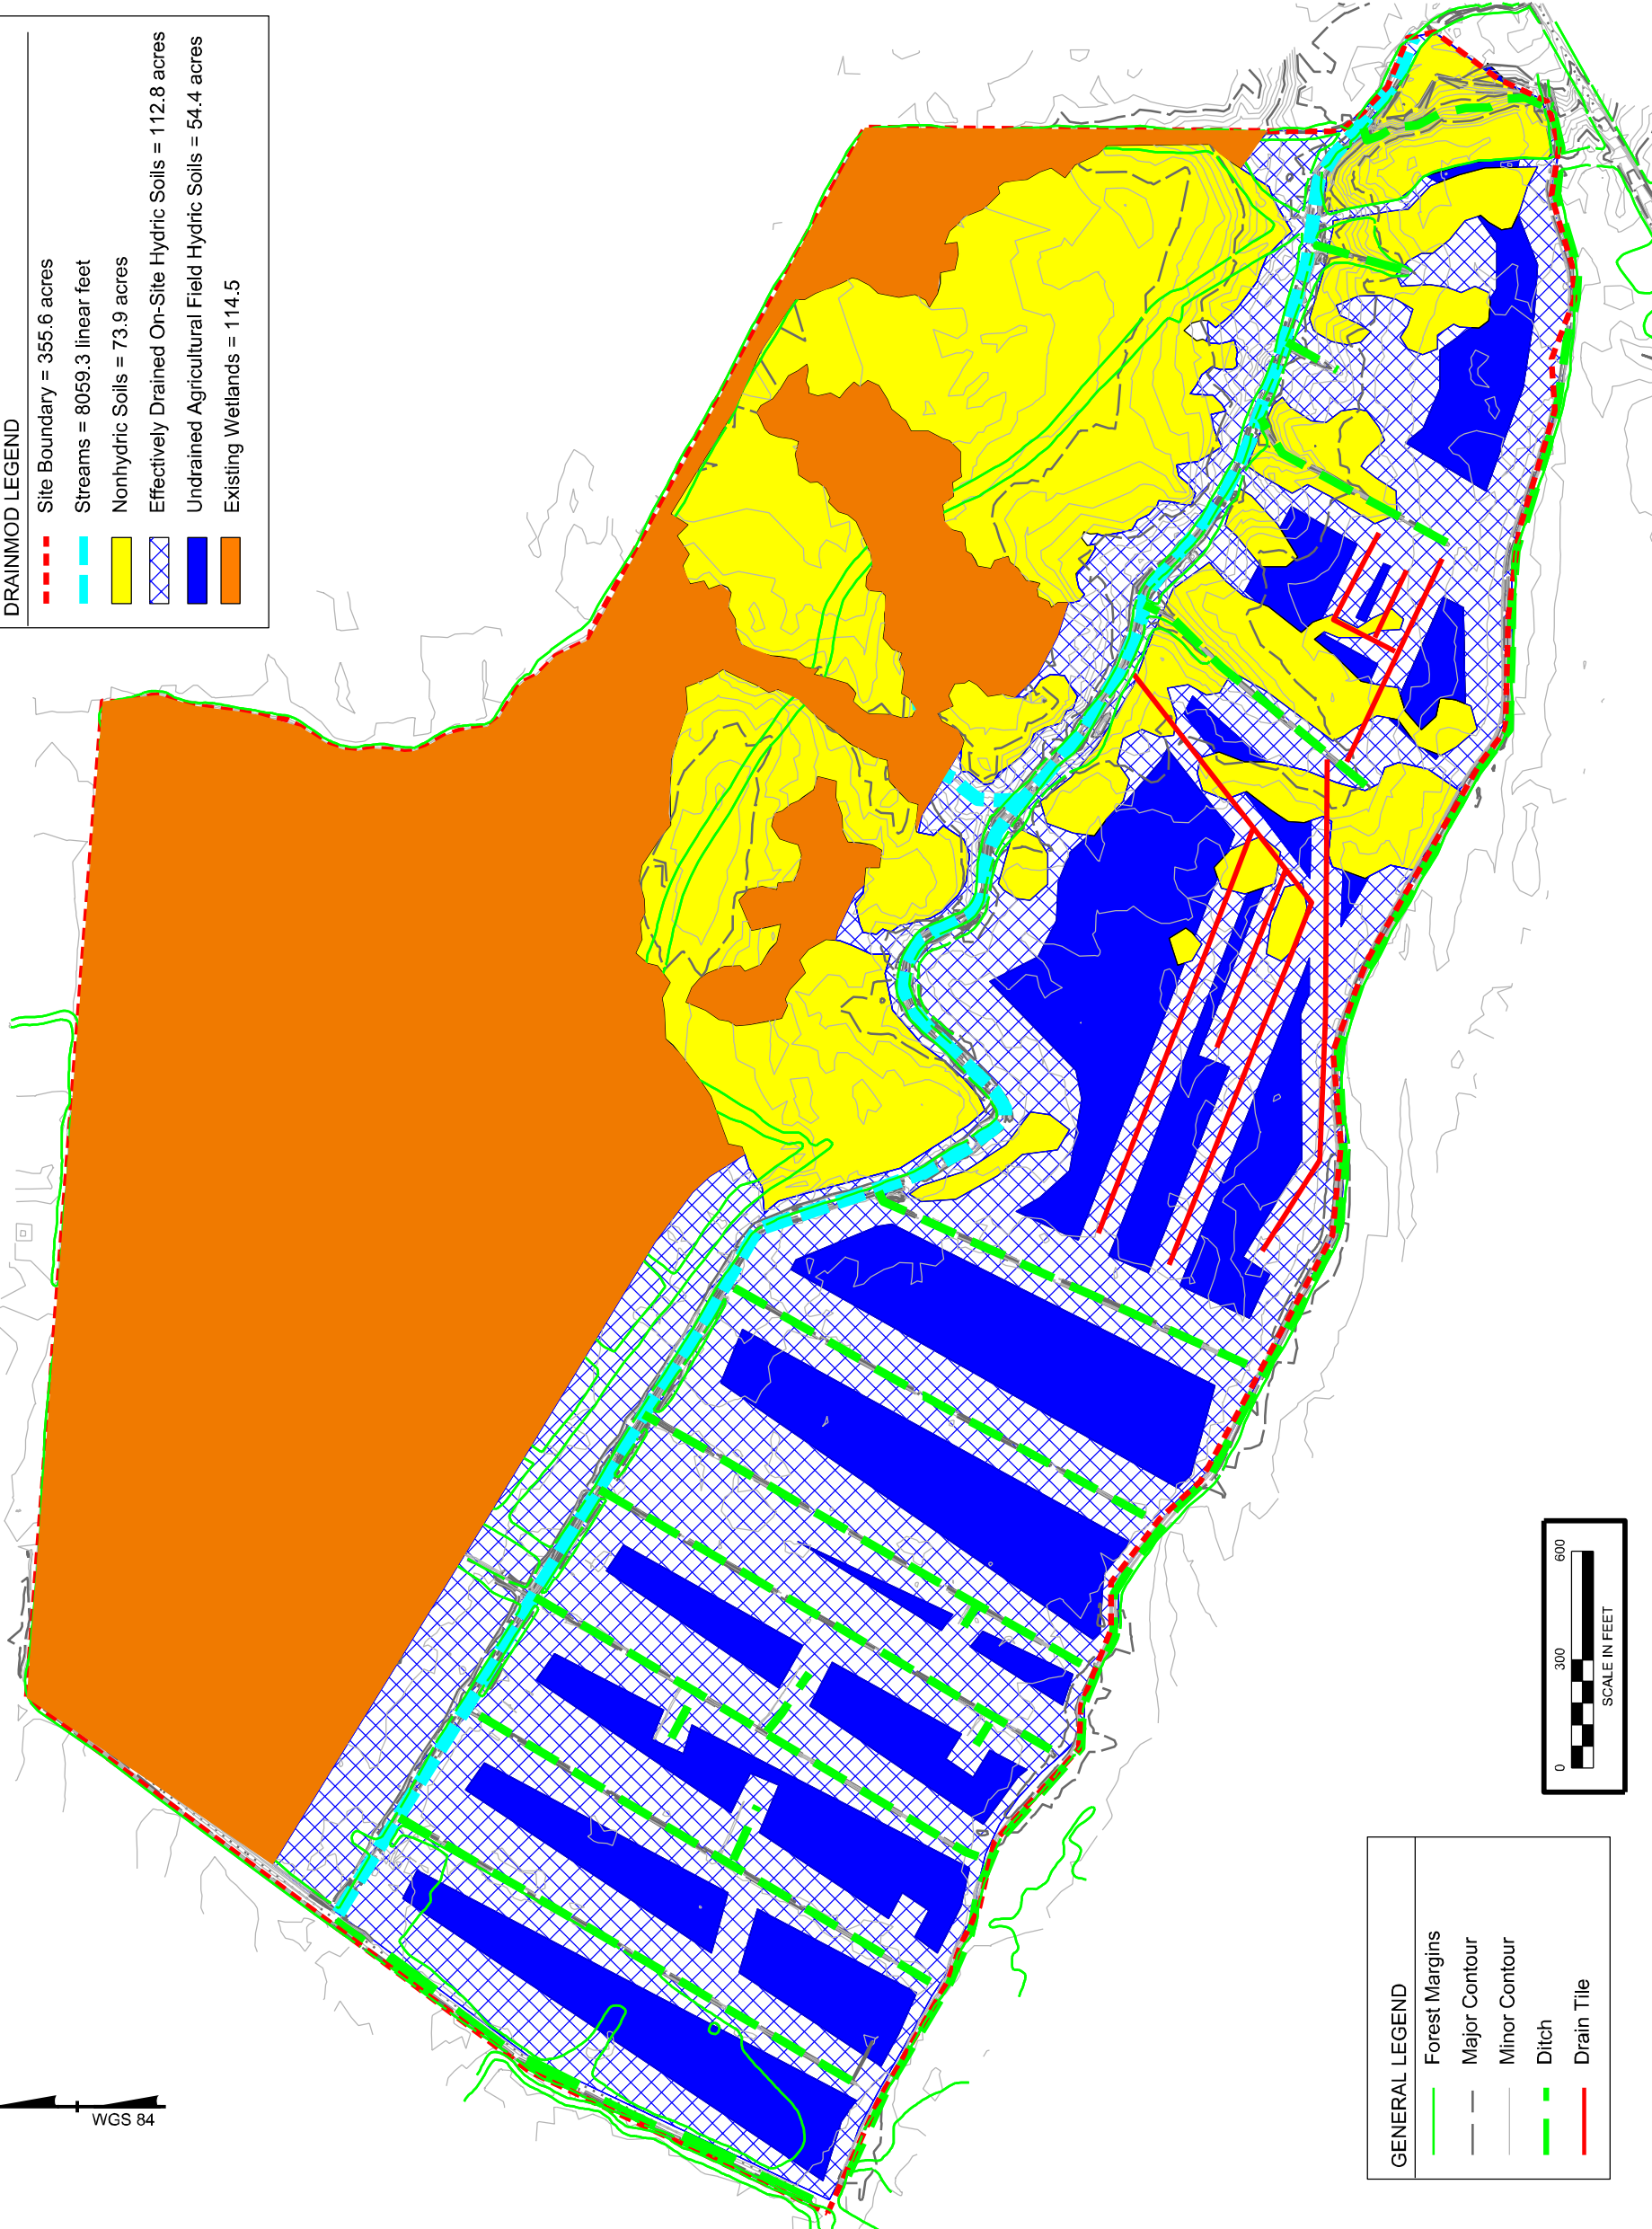
DRAINMOD Preconstruction Conditions

Site Boundary = 355.6 acres
-

Streams = 8059.3 linear feet
-

Nonhydic Soils = 73.9 acres
-

Effectively Drained On-Site Hydric Soils = 112.8 acres
-

Undrained Agricultural Field Hydric Soils = 54.4 acres
-

Existing Wetlands = 114.5

In the early 1970s the Site was logged and portions of the Site were converted to agricultural land. At that time, perimeter and interior drainage ditches were excavated and Site streams were channelized in support of land uses. Figure 2 depicts preconstruction conditions at the Site.

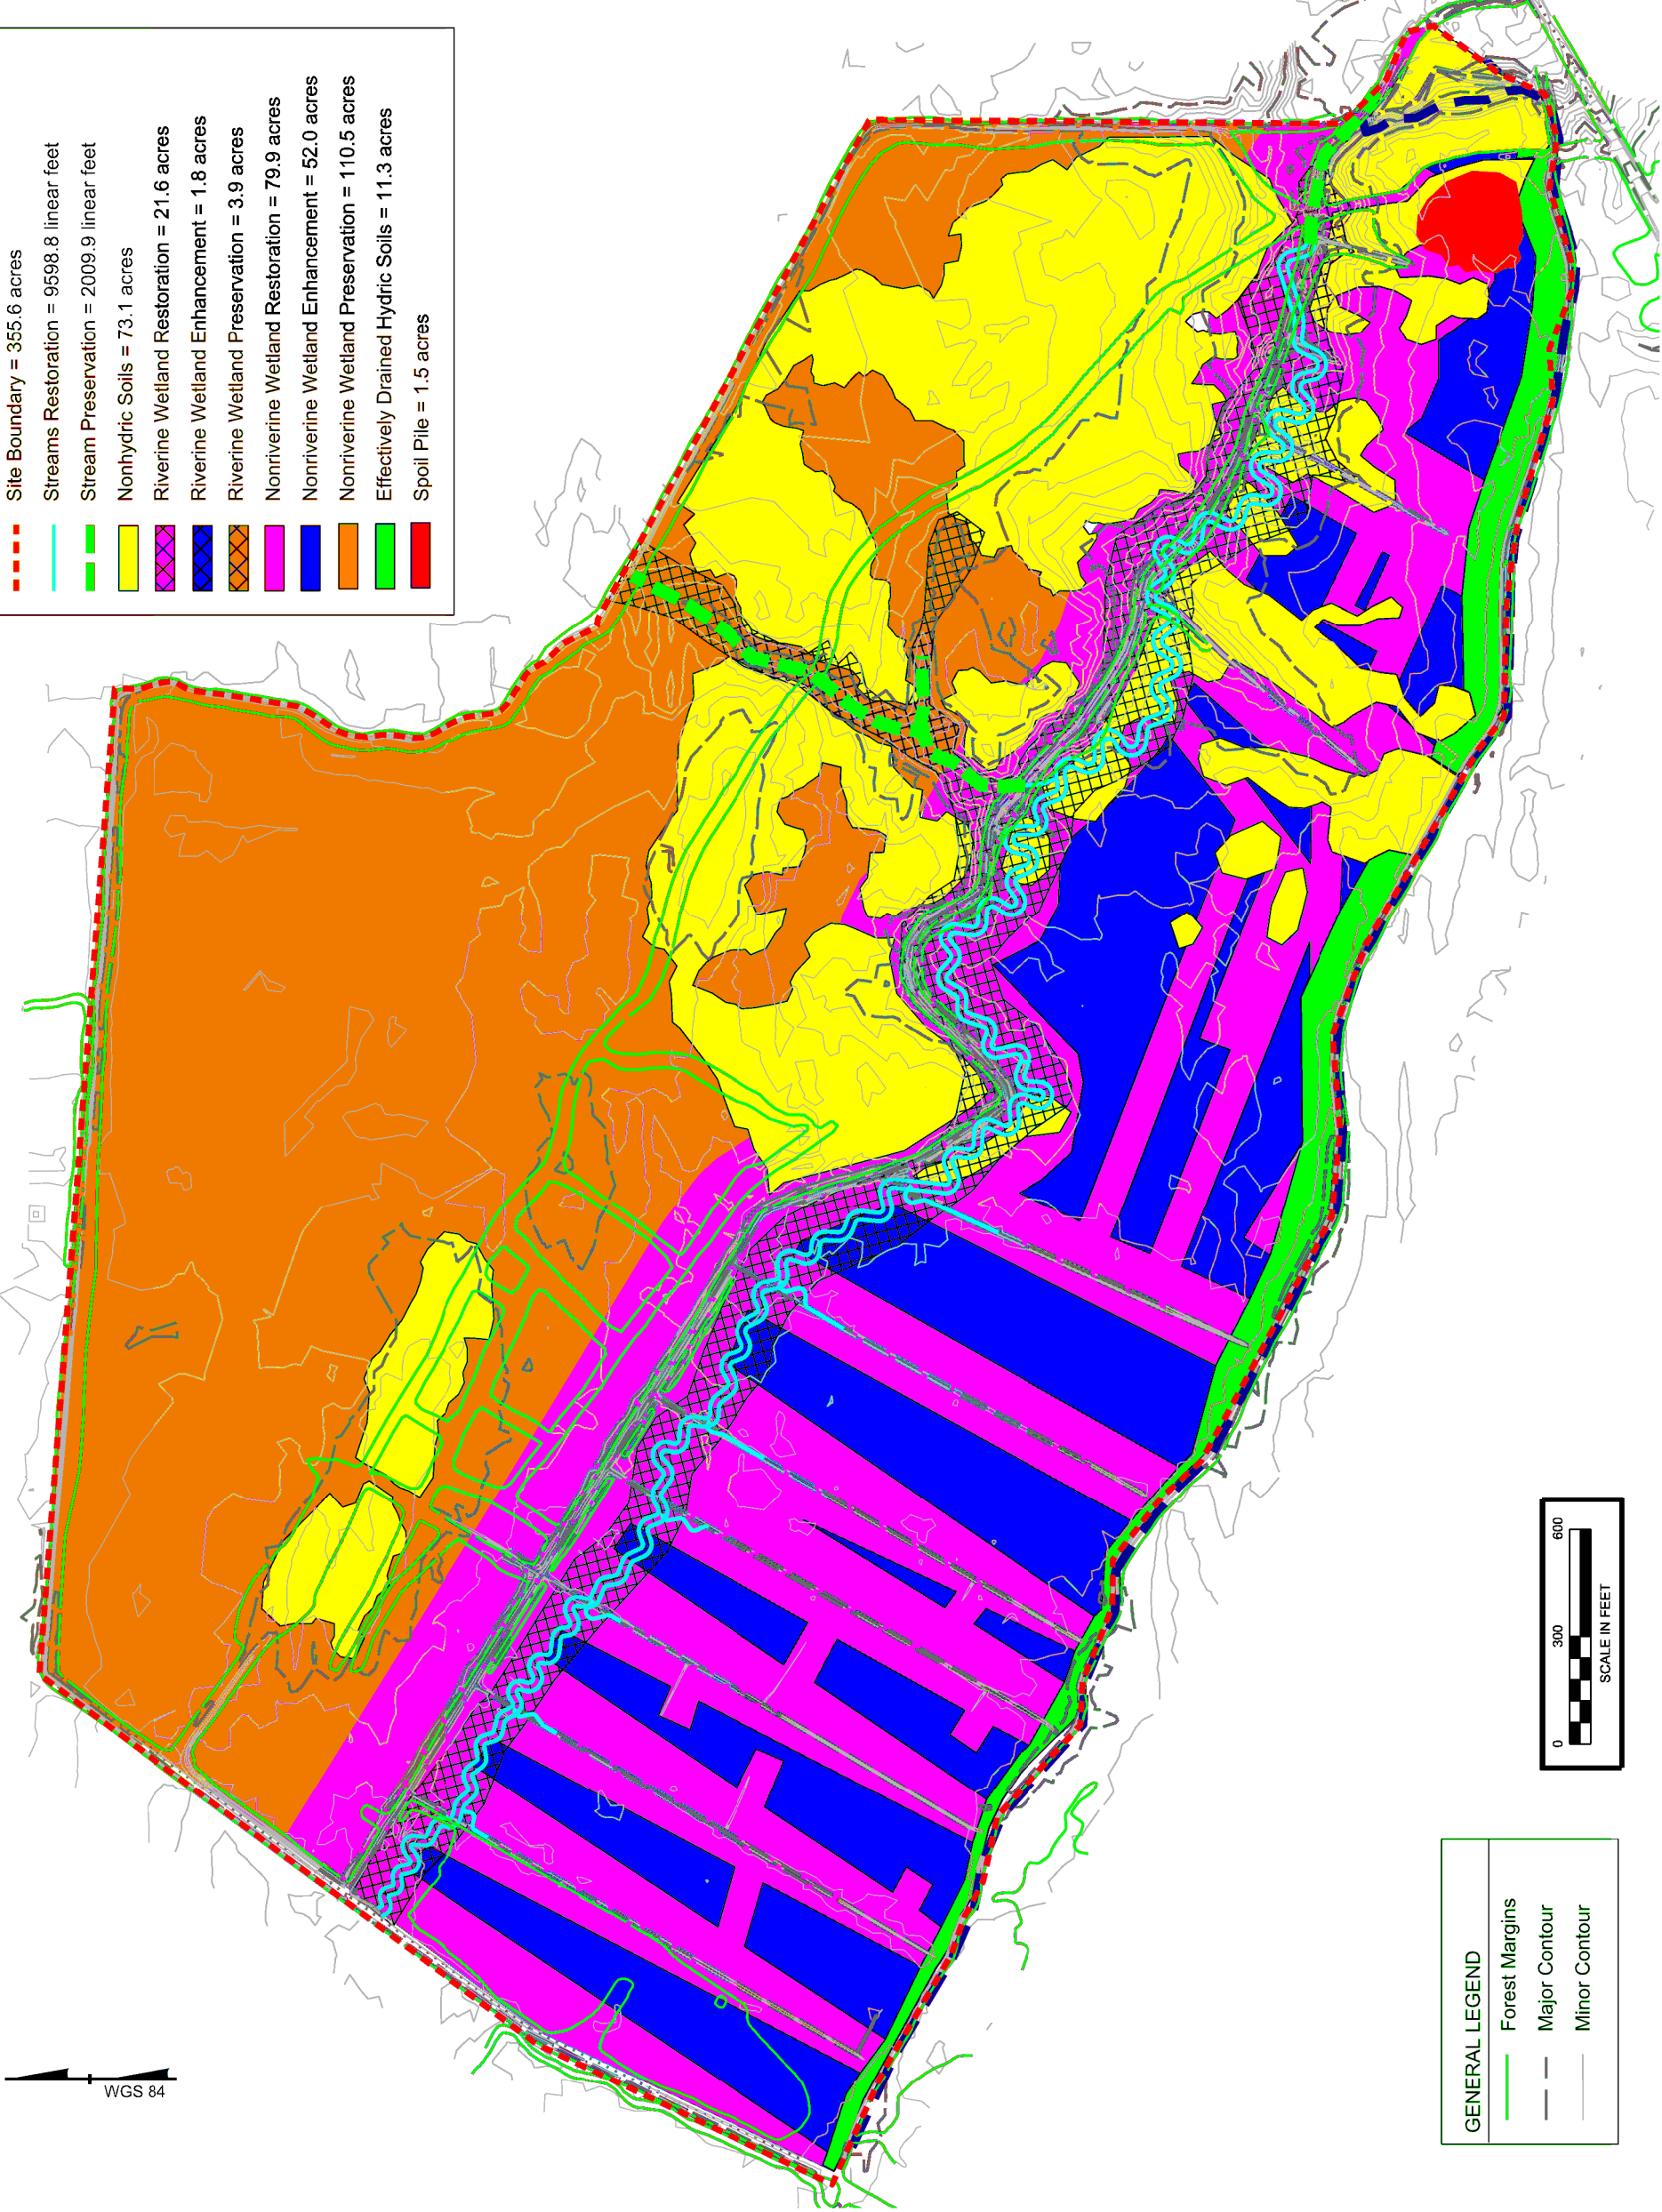
DRAINMOD Post Construction Conditions

- Site Boundary = 355.6 acres
- Streams Restoration = 9598.8 linear feet
- Stream Preservation = 2009.9 linear feet
- Nonhydric Soils = 73.1 acres
- Riverine Wetland Restoration = 21.6 acres
- Riverine Wetland Enhancement = 1.8 acres
- Riverine Wetland Preservation = 3.9 acres
- Nonriverine Wetland Restoration = 79.9 acres
- Nonriverine Wetland Enhancement = 52.0 acres
- Nonriverine Wetland Preservation = 110.5 acres
- Effectively Drained Hydric Soils = 11.3 acres
- Spoil Pile = 1.5 acres

The primary mitigation activities at the Site are outlined in Figure 3 and included

- restoration of 7931 linear feet of Billy's Branch through excavation of a new channel within a floodplain bench;
- restoration of 1667.8 linear feet of eight secondary tributaries,
- preservation of 2009.9 linear feet of forested secondary tributaries and the downstream forested reach of Billy's Branch;
- restoration of 21.6 acres of riverine wetlands by filling ditches, removing field crowns, and planting agricultural fields;
- enhancement of 1.8 acres of riverine wetlands by planting within agricultural fields;
- preservation of 3.9 acres of forested riverine wetlands;
- restoration of 79.9 acres of nonriverine wetlands by filling ditches, removing field crowns, and planting agricultural fields;
- enhancement of 52.0 acres of nonriverine wetlands by planting within agricultural fields;
- preservation of 110.5 acres of forested nonriverine wetlands.

Restoration activities at the Site entailed 1) plugging and filling of feeder ditches, 2) removal of crowning within fields, 3) clearing and grading to prepare for creation of the new stream alignment, 4) construction of a stable channel, 5) filling of the abandoned stream channel with onsite materials excavated from the floodplain and other upland areas, 6) installation of a grade control structure at the downstream end of the restoration reach, 7) removal of the bridge crossing of Billy's Branch within the southeast portion of the Site, and 8) ripping/scarifying soils to prepare for planting.

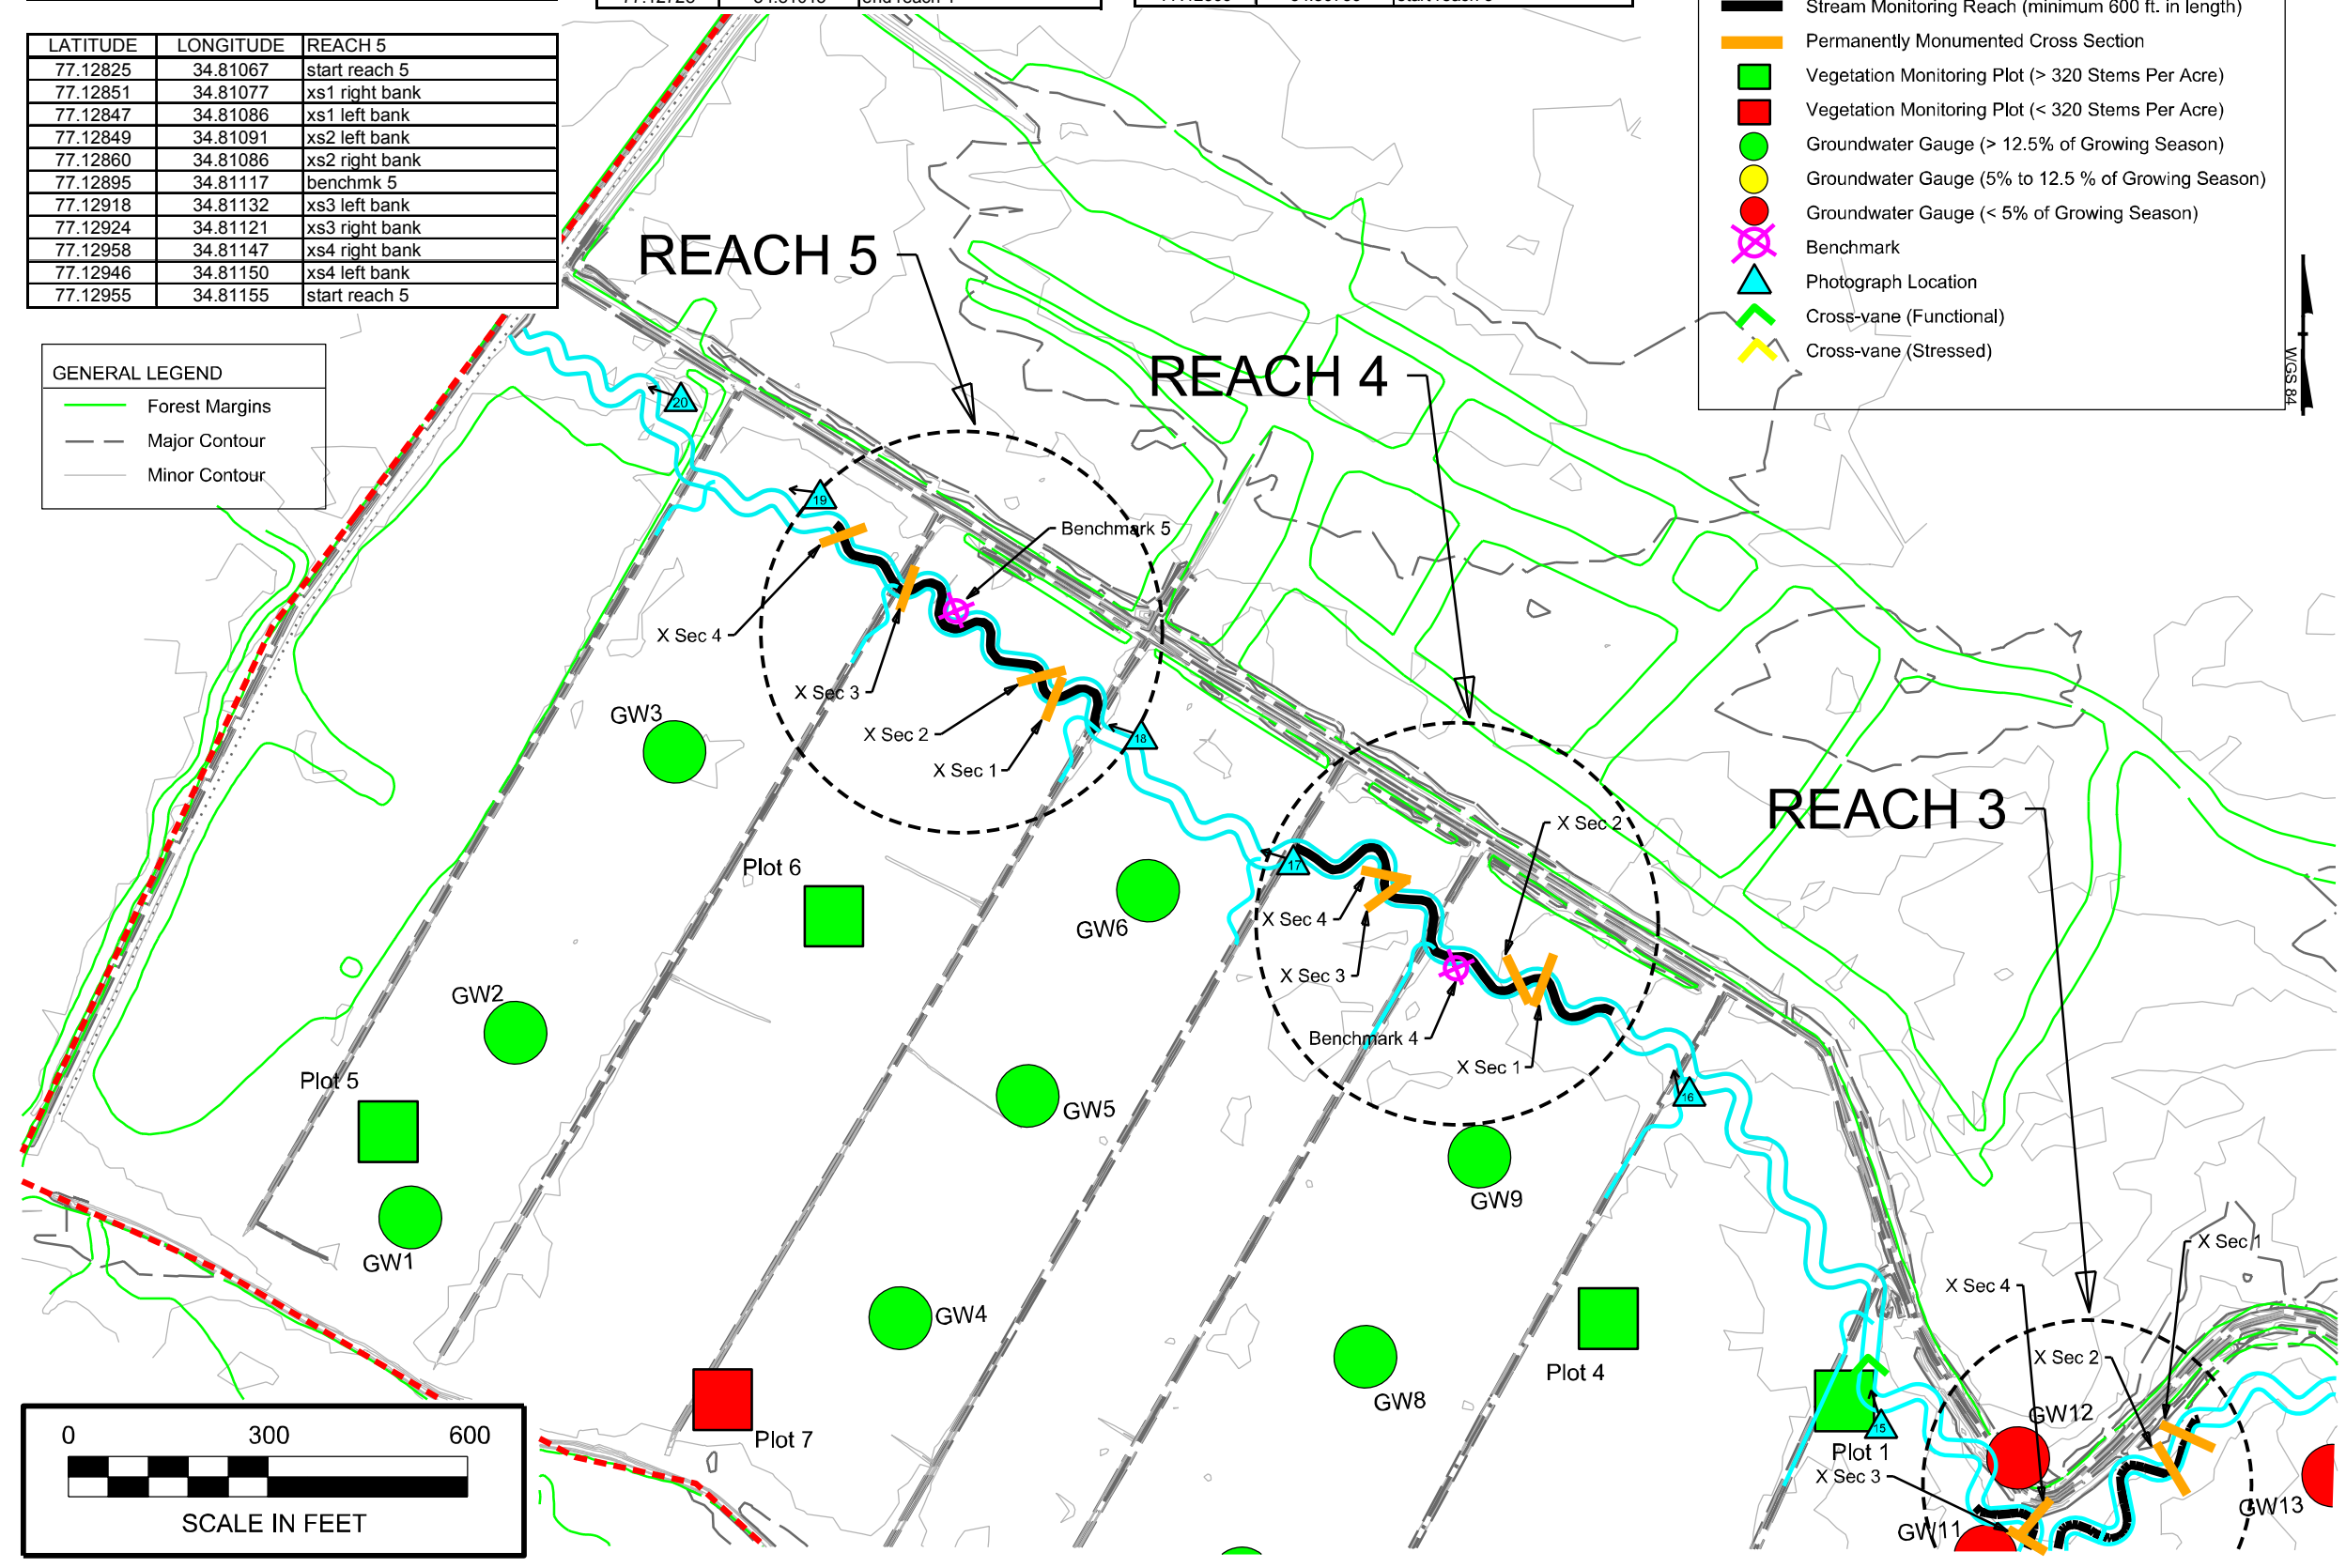
Title:
Monitoring Plan

DRAINMOD LEGEND	
	Site Boundary = 355.6 acres
	Streams Restoration = 9598.8 linear feet
	Stream Monitoring Reach (minimum 600 ft. in length)
	Permanently Monumented Cross Section
	Vegetation Monitoring Plot (> 320 Stems Per Acre)
	Vegetation Monitoring Plot (< 320 Stems Per Acre)
	Groundwater Gauge (> 12.5% of Growing Season)
	Groundwater Gauge (5% to 12.5% of Growing Season)
	Groundwater Gauge (< 5% of Growing Season)
	Benchmark
	Photograph Location
	Cross-vane (Functional)
	Cross-vane (Stressed)

Vegetation and hydrology will be monitored at the Site for five years or until success criteria have been achieved. The monitoring plan is outlined in Figures 4A-4B.

Twenty groundwater monitoring gauges and a rain gauge will be maintained and monitored throughout the growing season for each monitoring year.

Ten 10-meter by 10-meter vegetation monitoring plots will be sampled each year using the EEP/CVS methods for vegetation sampling (Lee et al. 2006). In addition, photographs will be taken at each of the plots to provide a visual record of vegetation development over the monitoring period.

Twenty permanent cross-sections will be measured each year surveying points at all breaks in slope including top of bank, bankfull, and thalweg. Riffle cross-sections will be classified using the Rosgen stream classification system. Longitudinal profiles will be measured each year along five 600-foot reaches. Longitudinal profile measurements will include thalweg, water surface, bankfull, and top of low bank; each taken at the head of facets (i.e. riffle, run, pool, and glide) and the maximum pool depth. The surveys will also be used to calculate sinuosity. In addition, channel substrate is not expected to coarsen over time and will not be monitored for success at this Site. Stream photographs will be taken each year to document stream changes.

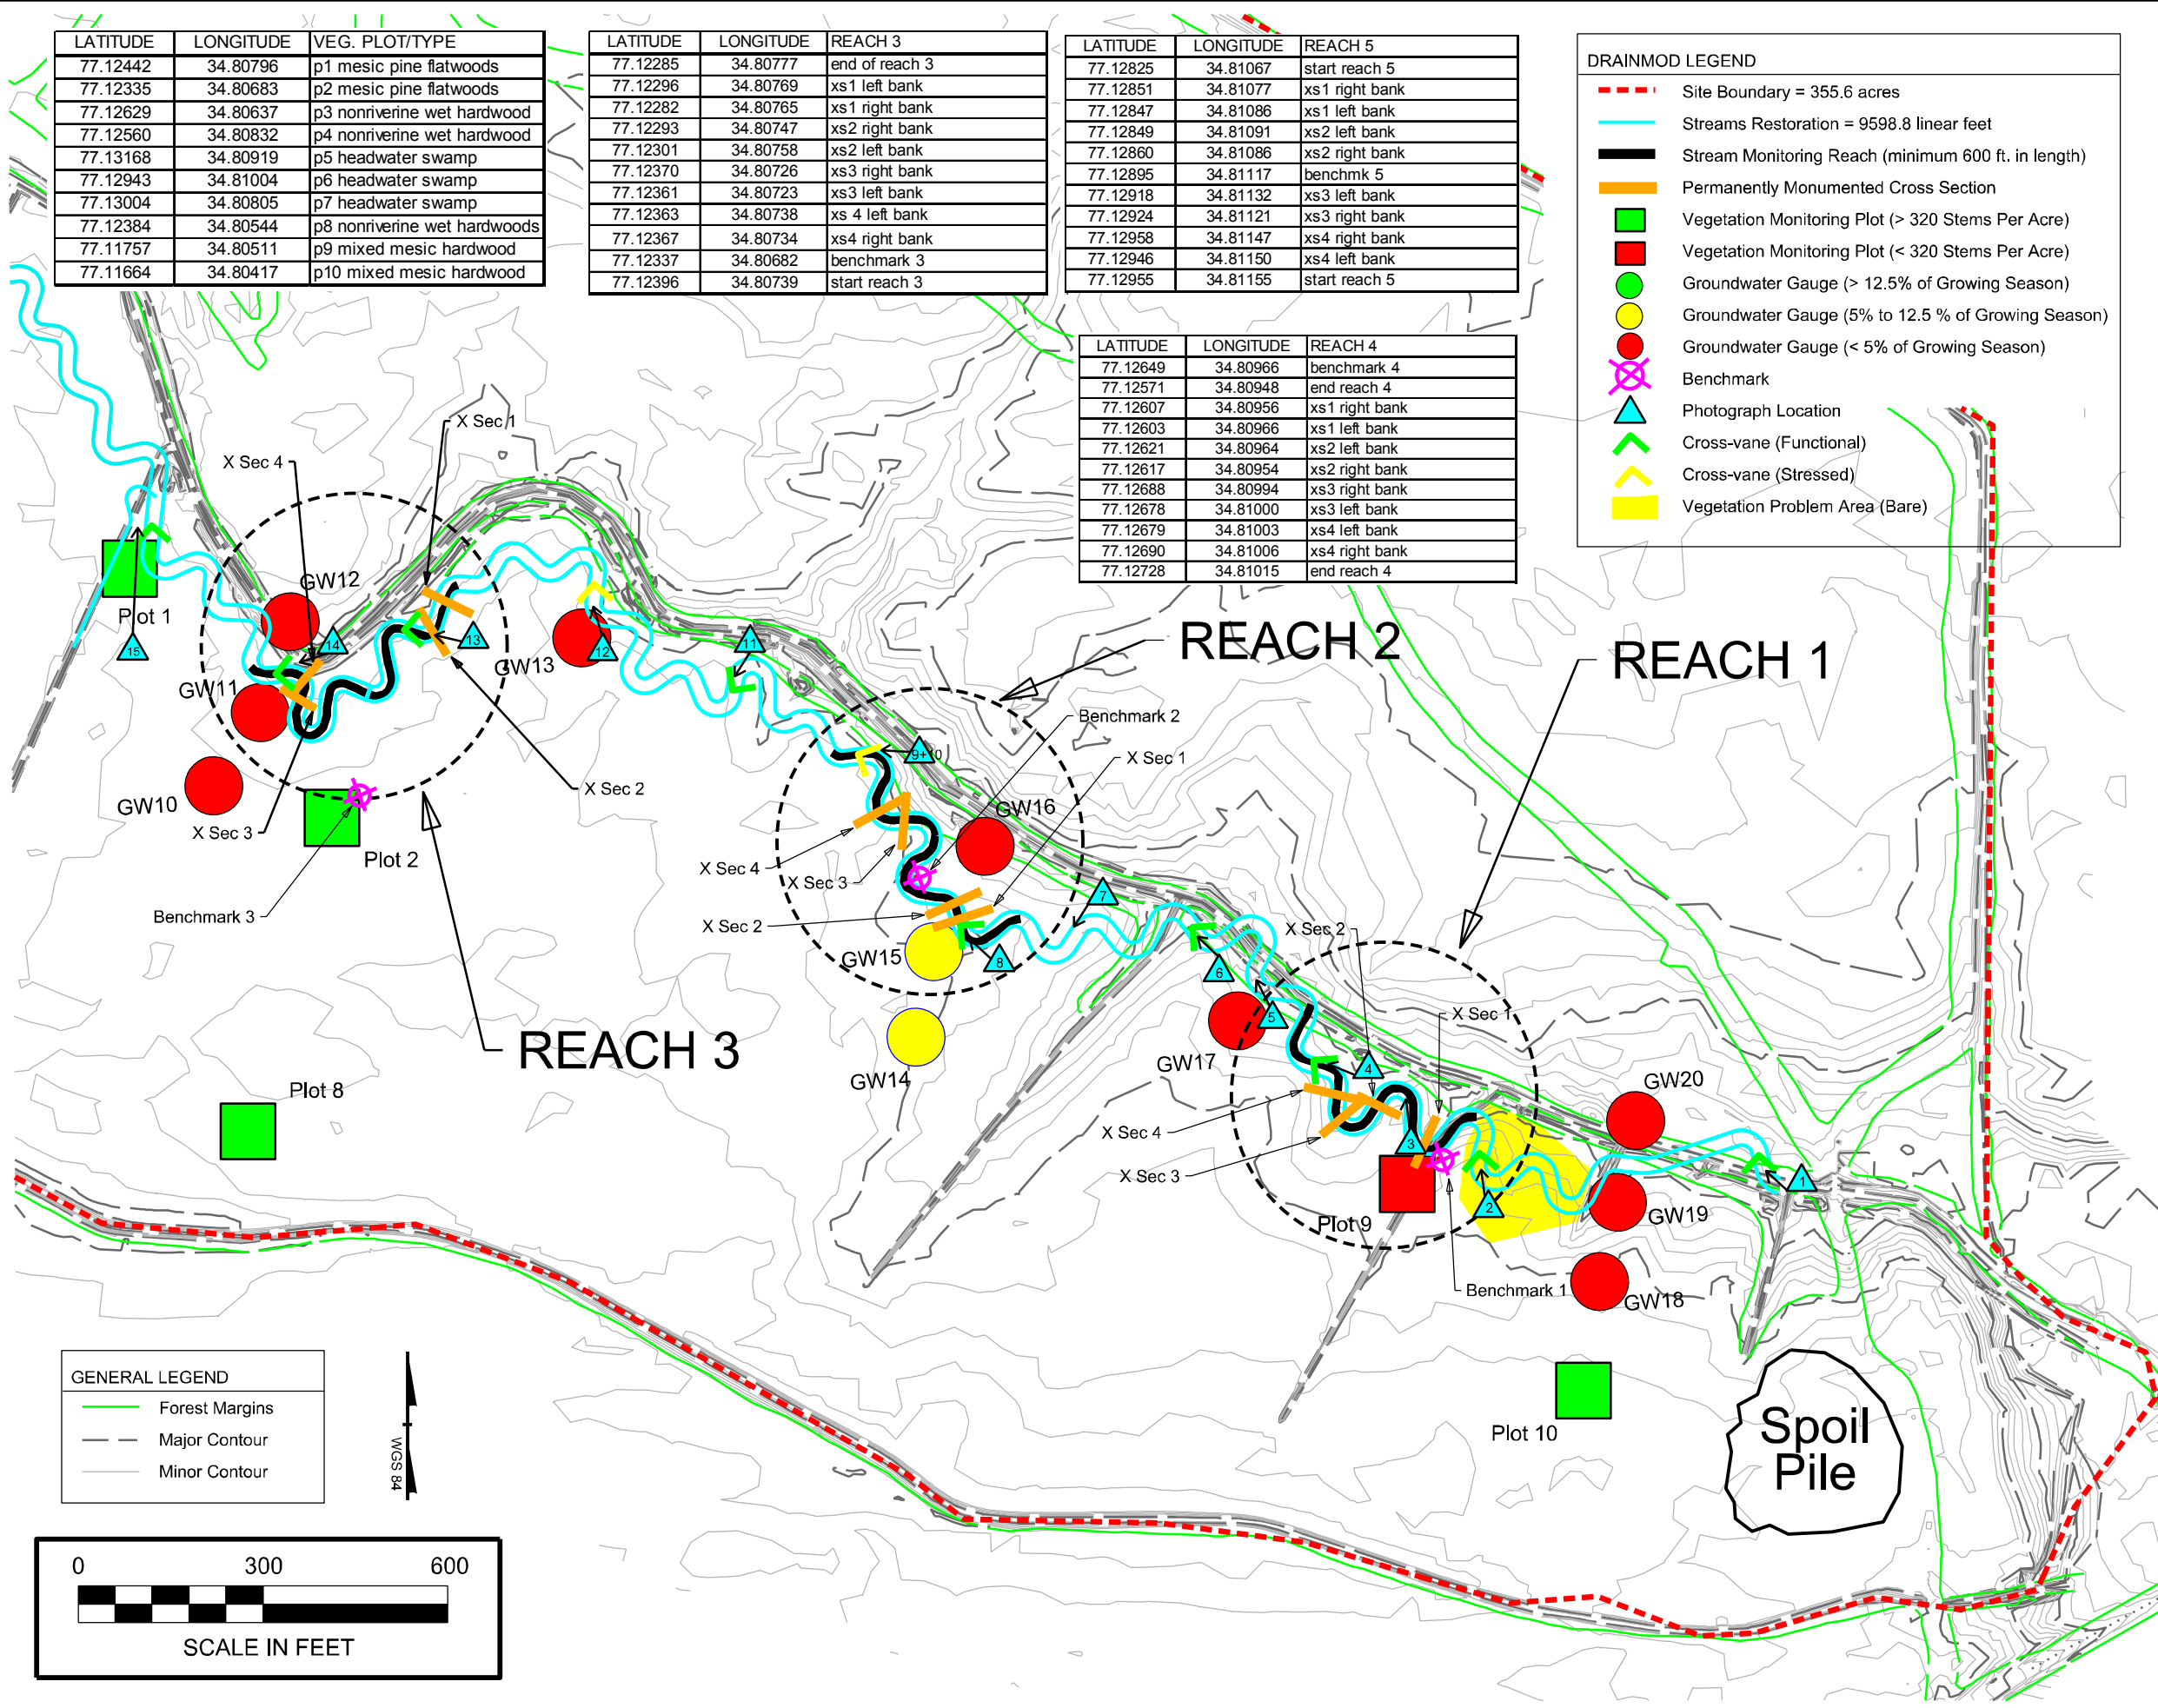
Title:
Monitoring Plan

- Site Boundary = 355.6 acres
- Streams Restoration = 9598.8 linear feet
- Stream Monitoring Reach (minimum 600 ft. in length)
- Permanently Monumented Cross Section
- Vegetation Monitoring Plot (> 320 Stems Per Acre)
- Vegetation Monitoring Plot (< 320 Stems Per Acre)
- Groundwater Gauge (> 12.5% of Growing Season)
- Groundwater Gauge (5% to 12.5 % of Growing Season)
- Groundwater Gauge (< 5% of Growing Season)
- Benchmark
- Photograph Location
- Cross-vane (Functional)
- Cross-vane (Stressed)
- Vegetation Problem Area (Bare)
