FINAL MITIGATION PLAN

**Cochran Branch
Macon County, North Carolina
Project No. 95720
Contract # 004370
RFP: 16-004370**

**Little Tennessee River Basin
Cataloging Unit 06010202040020**

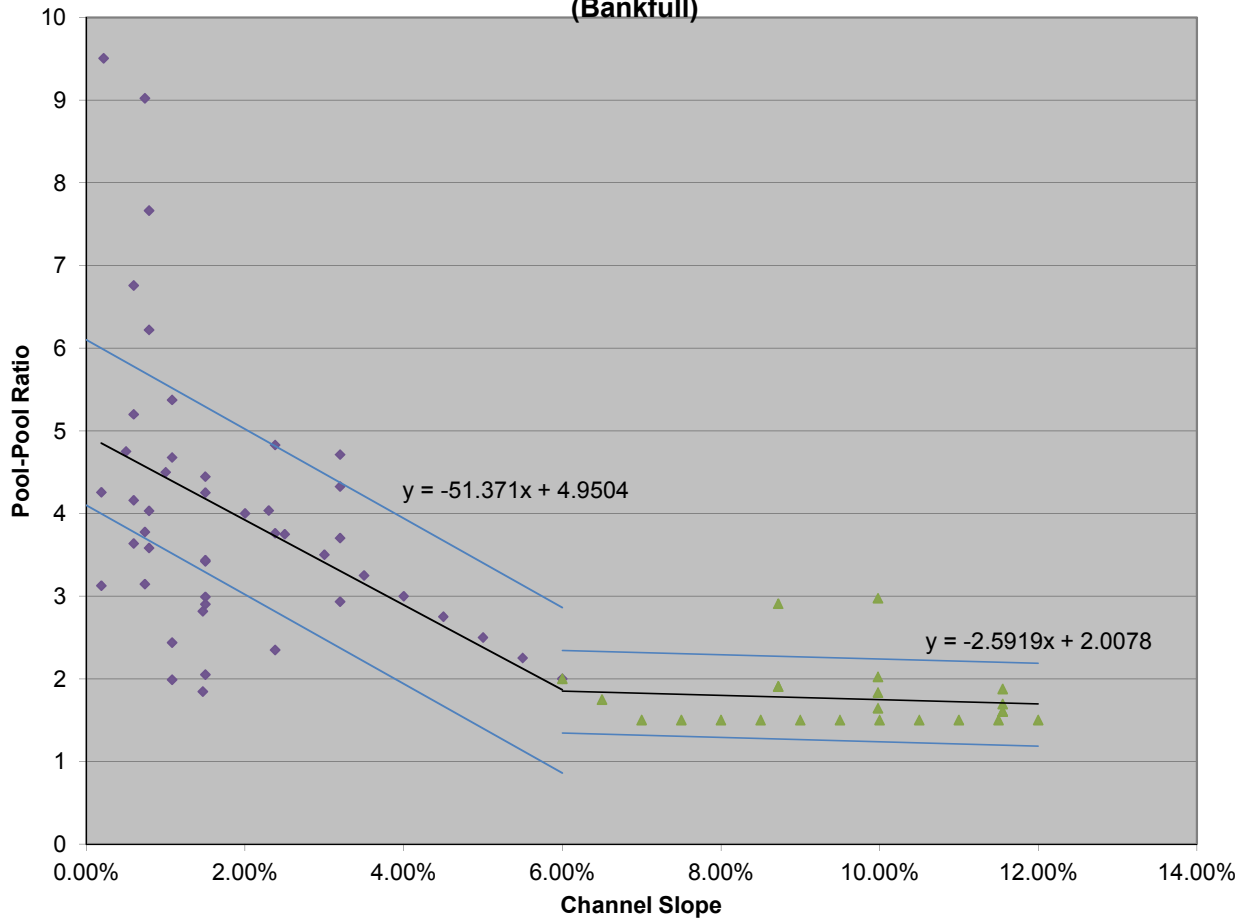
**Type B Channels
Pool Spacing Ratio vs. Channel Slope
(Bankfull)**

Y-int	Slope
Trendline Coefficients	5.1	-54.0
Design Range (+/-)	1.0	
Upper Boundary Line	6.1	-54.0
Lower Boundary Line	4.1	-54.0
