**Coddle Creek Tributary
(Indian Run) Stream Restoration
EEP Project # 94
DENR Contract # 5360**

**Annual Monitoring Report Year 5 of 5
Cabarrus County, North Carolina**

**Construction Completed: March 27, 2011
Data Collected: October and December 2016
Report Submission: January 2017**

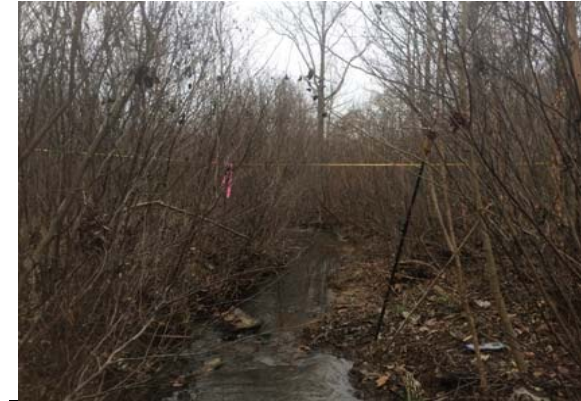
Sta. 18+40 Looking Downstream

| SUMMARY DATA | |
|--|---|
| Entrenchment Ratio | 4.95 |
| Bank Height Ratio | 1.03 |

Stream Type C4

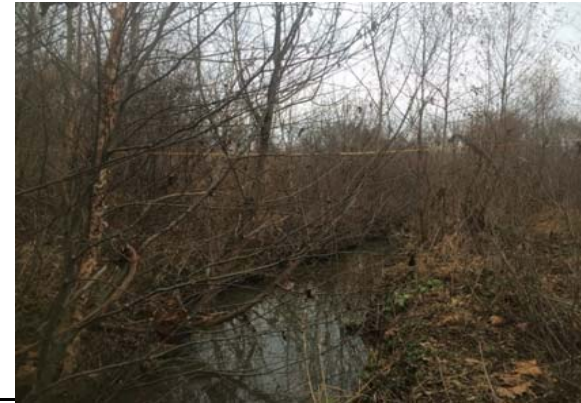
| SUMMARY DATA | |
|--|---|
| Entrenchment Ratio | 2.45 |
| Bank Height Ratio | 0.68 |

Stream Type C4 Sta. 20+62 Looking Downstream

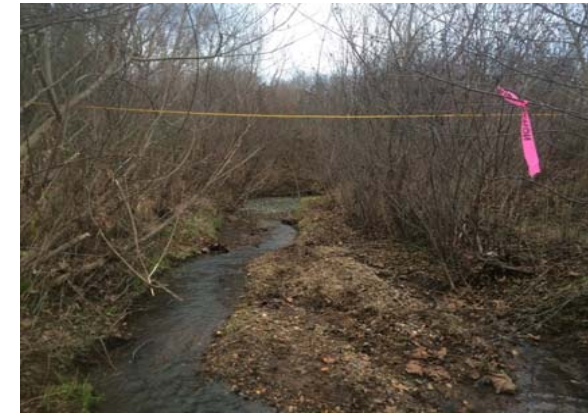
Sta. 25+40 Looking Downstream

| SUMMARY DATA | |
|--|---|
| Entrenchment Ratio | 1.47 |
| Bank Height Ratio | 0.99 |

Stream Type C4

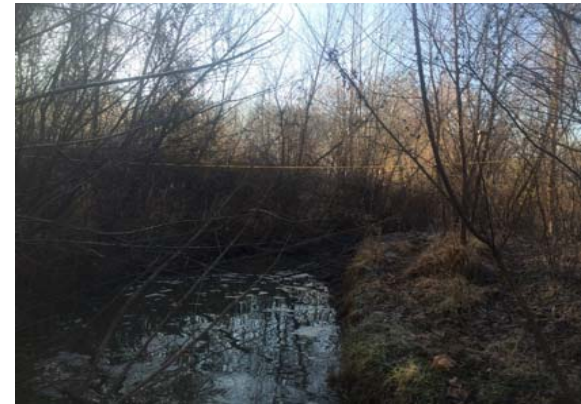
Sta. 25+92 Looking Downstream

| SUMMARY DATA | |
|--|---|
| Entrenchment Ratio | 1.50 |
| Bank Height Ratio | 0.77 |

Stream Type C4

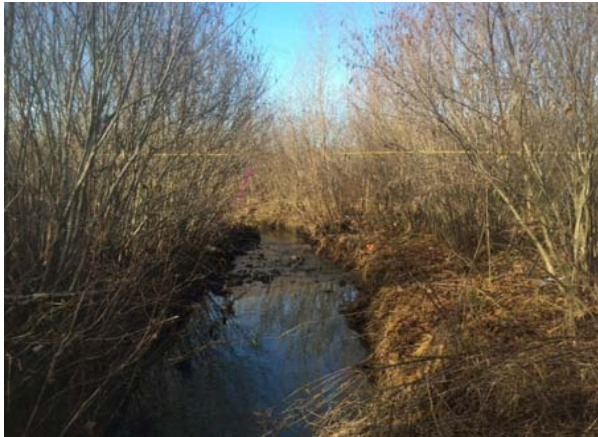
Sta. 11+15 Looking Downstream

| SUMMARY DATA | |
|--|---|
| Entrenchment Ratio | 6.72 |
| Bank Height Ratio | 0.62 |

Stream Type C4

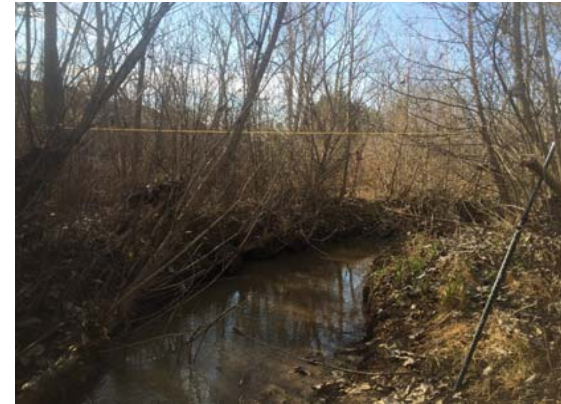
Sta. 13+10 Looking Downstream

| SUMMARY DATA | |
|--|---|
| Entrenchment Ratio | 4.65 |
| Bank Height Ratio | 0.64 |

Stream Type C4

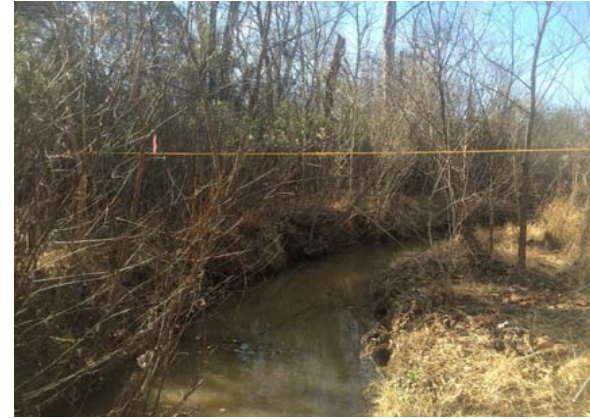
Sta. 15+89 Looking Downstream

| SUMMARY DATA | |
|--|---|
| Entrenchment Ratio | 3.00 |
| Bank Height Ratio | 1.02 |

Stream Type C4

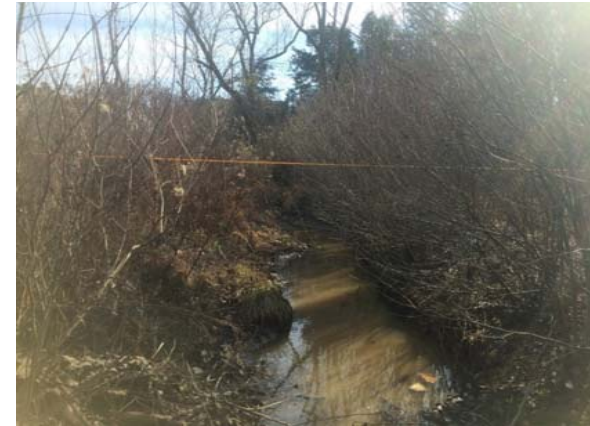
Sta. 16+50 Looking Upstream

| SUMMARY DATA | | |
|--|--|---|
| Entrenchment Ratio | | 3.22 |
| Bank Height Ratio | | 0.96 |

Stream Type C4

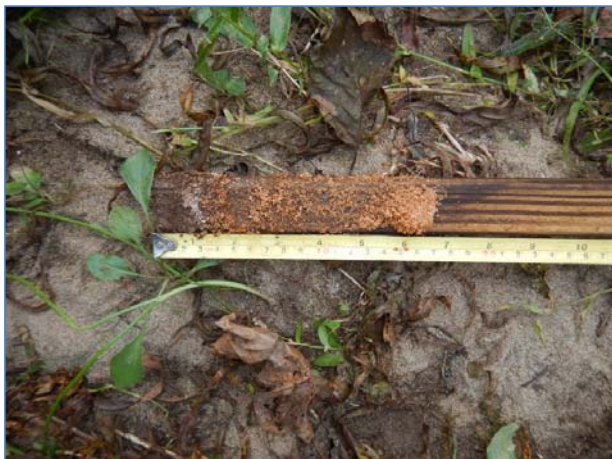
| Table 12. Verification of Bankfull Events | | | |
|---|---|---|---|
| 10/19/2016 and 12/14/16 | Between 6/23/2016 - 12/14/2016 | Visual observation of wrack lines; stream gauge reading at 6.5" above bankfull | Photos below |

Photo 1. Stream gauge 6.5" above bankfull 10/19/16.
