# **Collins Creek Restoration Plan**

Orange County, North Carolina

State Contract No. D05011

**Prepared for:  
North Carolina Ecosystem Enhancement Program**

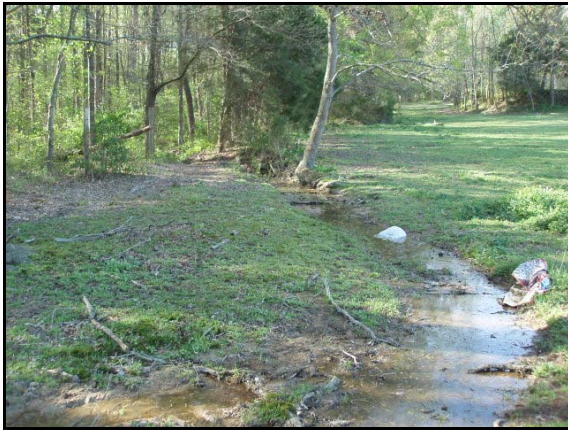
Looking upstream at the start of Tributary 1A as it leaves the woods and enters the project easement.

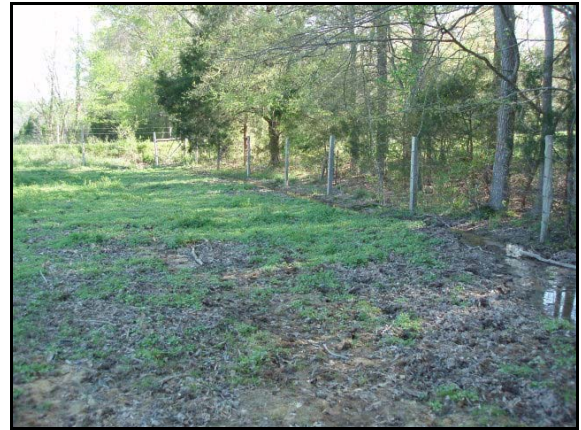
A downstream view of Tributary 1A, which shows undefined banks caused by grazing horses.

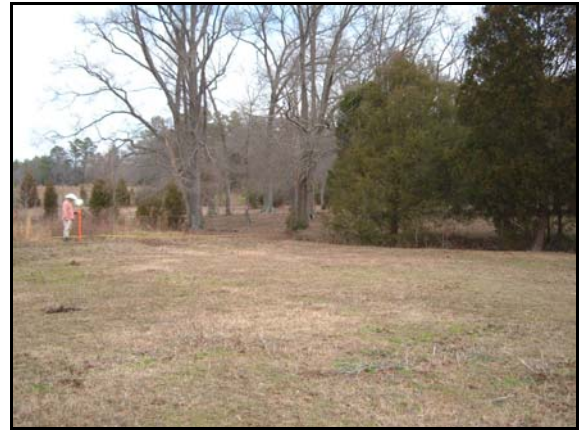
An overview of Tributary 1A looking downstream (cedars are at the channel).

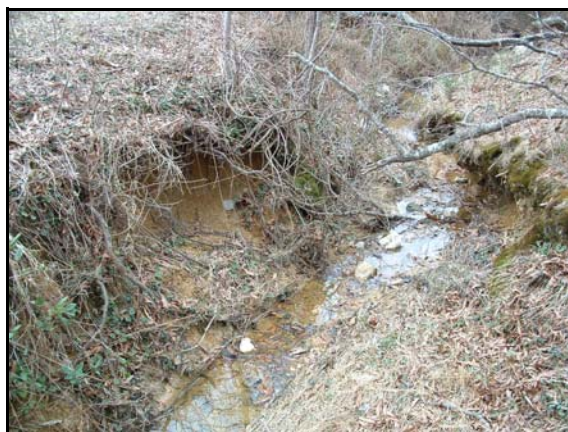
A section of Tributary 1A that shows the incision that the channel is experiencing.

The project streams have become degraded primarily through poor grazing management and vegetation removal. The streams have all experienced bank erosion, which has led to excessive sediment. Bed degradation and aggradation are also evident throughout the different project reaches. All of the reaches exhibit areas of incision and vertical instability. There are few stable riffle and pool sequences to provide bed diversity. As a result, the ecological diversity and water quality values of the site have been affected adversely.

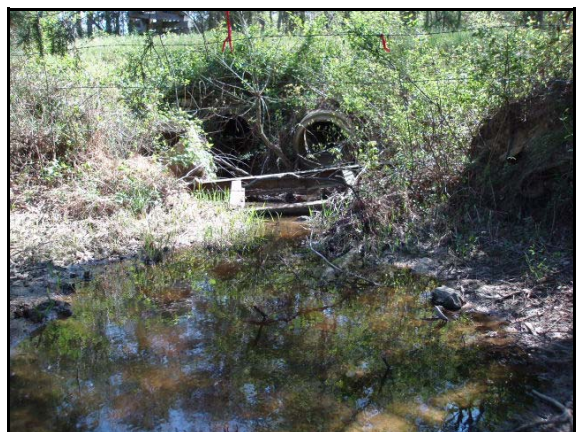
The beginning of Tributary 1B as it comes under Dodsons Crossroads through two culverts.

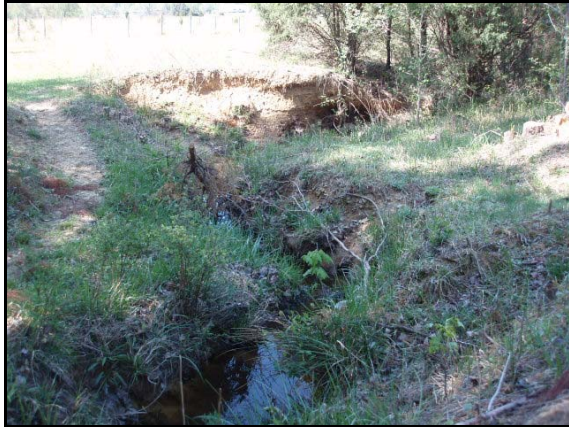
Tributary 1B just downstream of Dodsons Crossroads where the banks have become unstable.

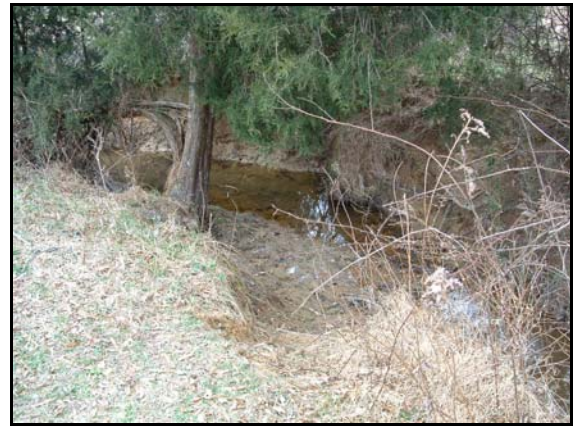
Tributary 1B as it enters a channelized section of stream.

The project streams at the CCS were reviewed in historic aerial photographs from 1938 to 2003 and the site showed impacts from clearing and grazing as far back as 1938. One of the project reaches (T1B) had been ditched by this time and a majority of the riparian buffers on the site were already cleared of vegetation. Currently, the property surrounding the project streams is used as active pasture for livestock grazing. A small number of residential and farm buildings exist throughout the site.

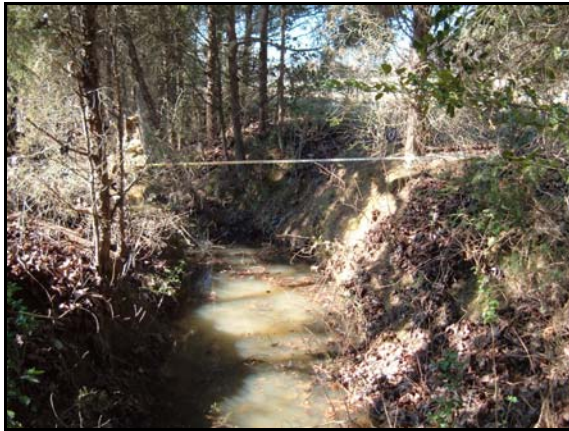
Looking upstream along Tributary 1B within the channelized reach.

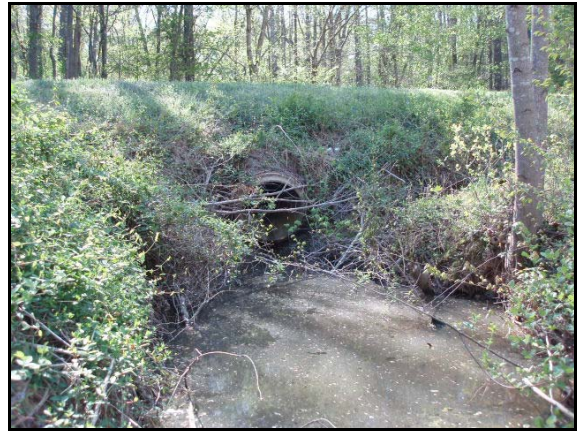
The beginning of Tributary 1 as it exits a culvert under Dodsons Crossroads.

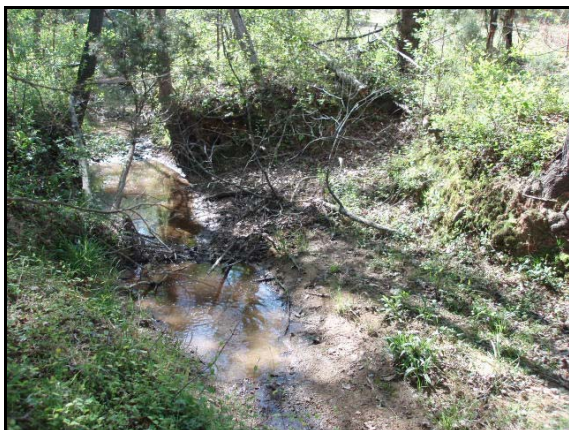
Looking downstream of the culvert where the channel of Tributary 1 has become too wide.

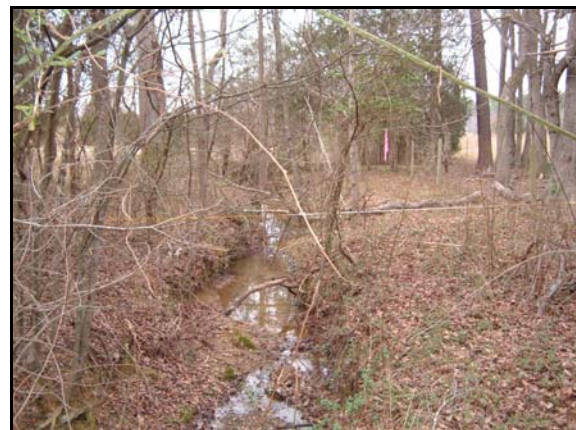
A view downstream of Tributary 1 approximately 100 feet below the culvert.

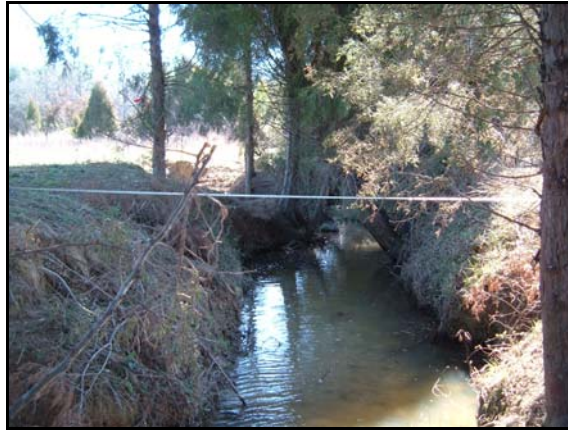
Looking upstream on Tributary 1 just below the confluence with Tributary 1A.

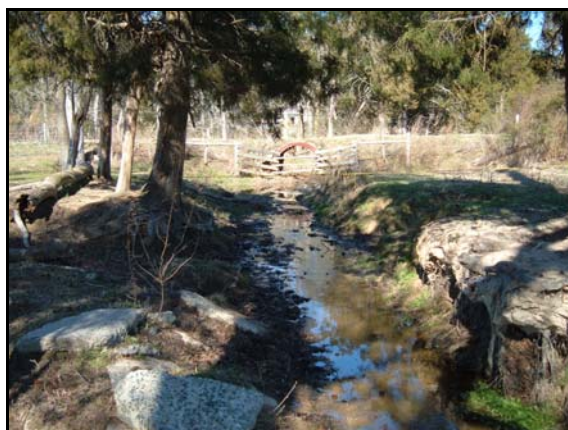
Looking downstream on Tributary 1 at the existing crossing of a private road. This area is used heavily by cattle.

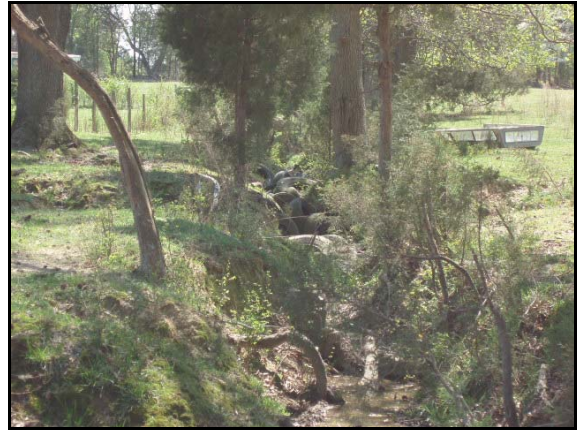
An upstream look at Tributary 2 near its beginning. Tires have been placed in the stream and cattle and horses have open access.

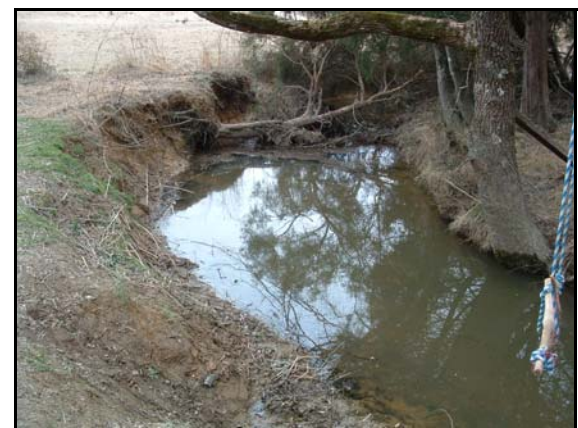
Eroding banks on the UT to Collins Creek when looking downstream.

UTCC exhibits the typical characteristics of an unstable stream channel. Most notably, the channel shows evidence of bank degradation and widening. Poor grazing management is the primary cause of disturbance, but the past removal of riparian vegetation has exacerbated bank erosion by eliminating rooting strength and cover protection. Few defined features were found along UTCC. The majority of UTCC has banks that have been trampled by cattle and the stream lacks stable stream dimensions. One of the culverts on UTCC has become blocked with debris and created a ponded, overwidened section of channel. In other sections, the banks are vertical and have little riparian vegetation.

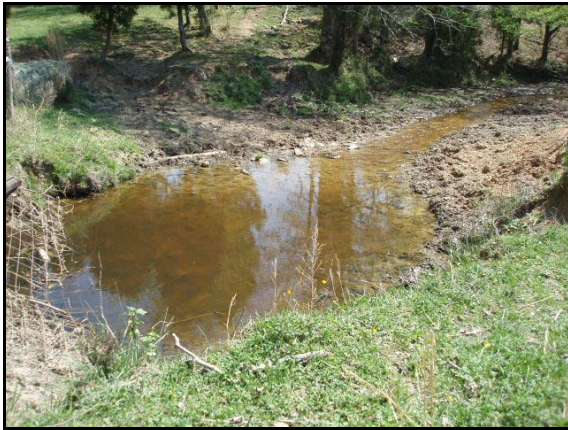
Looking downstream on UT to Collins Creek below the crossing where it is experiencing bank erosion and widening.

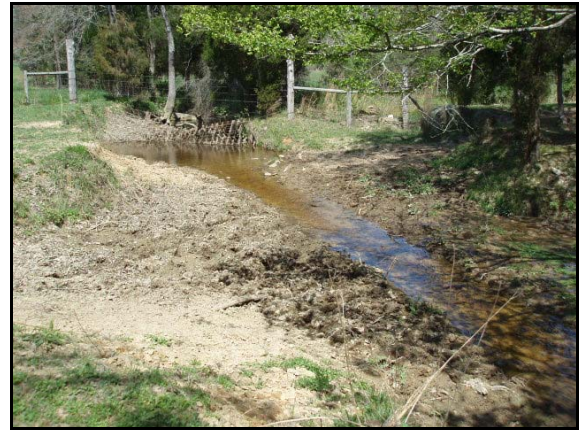
A look upstream on UT to Collins Creek at the same section that has become too wide.

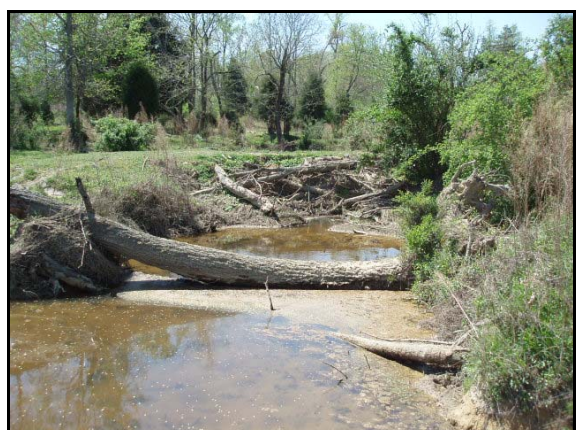
A look at the upstream side of a culvert on UT to Collins Creek that has become jammed with debris.

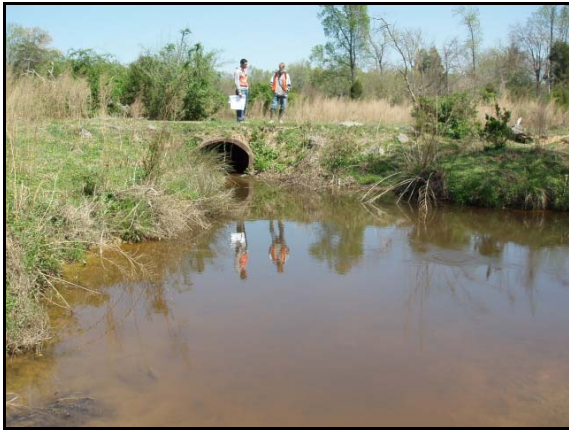
The downstream view of the jammed culvert along UT to Collins Creek. Water is currently working its way over the top of the crossing during bankfull events.

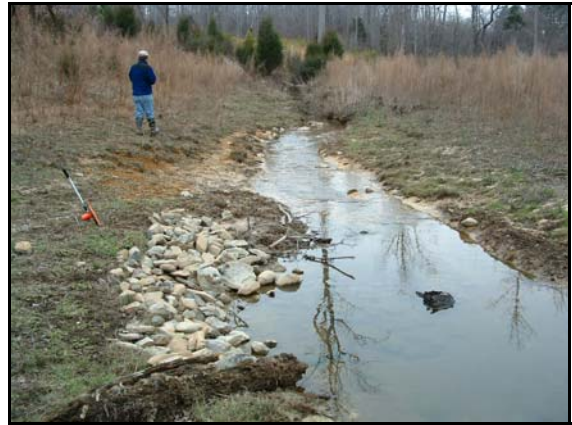
Looking downstream along UT to Collins Creek near the end of the project reach. The stream narrows in this section, which was likely caused by a temporary ford crossing.

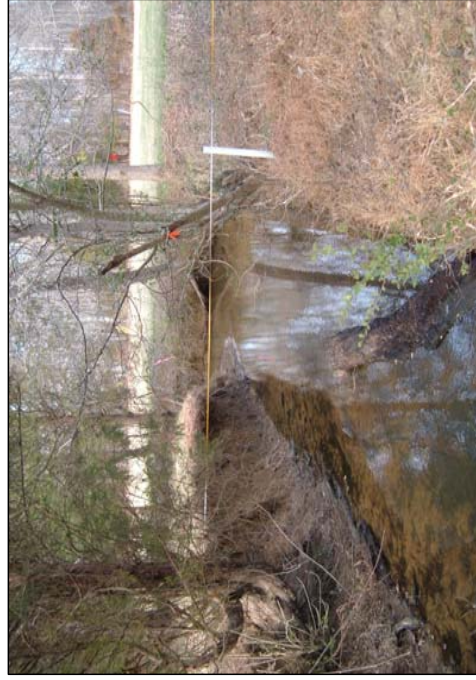
Cape Fear River Basin, UTCC, XS UTCC-1 Riffle

<b>River Basin:</b>	Cape Fear
<b>Watershed:</b>	UTCC
<b>XS ID</b>	XS UTCC-1 Riffle
<b>Drainage Area (sq mi):</b>	2.5
<b>Date:</b>	February 2006
<b>Field Crew:</b>	Mryncza, Helms, Hayes, Spiller, French

Stream Type: E4

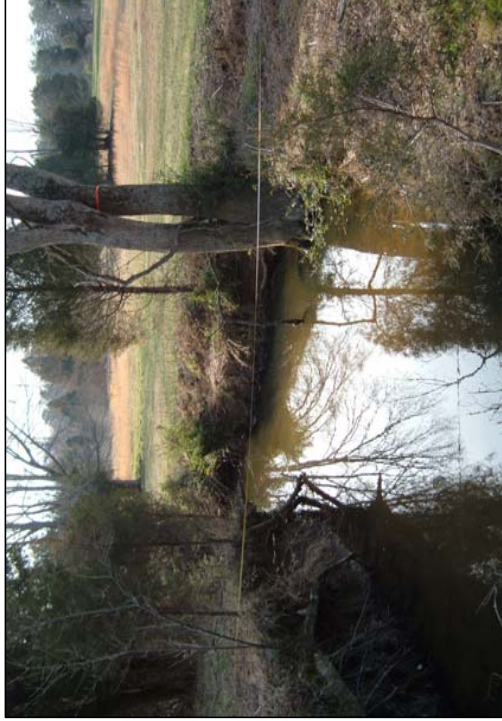
**Cape Fear River Basin, UTCC, XS UTCC-2 Pool**

<b>River Basin:</b>	Cape Fear
<b>Watershed:</b>	UTCC
<b>XS ID</b>	XS UTCC-2 Pool
<b>Drainage Area (sq mi):</b>	2.5
<b>Date:</b>	February 2006
<b>Field Crew:</b>	Mryncza, Helms, Hayes, Spiller, French

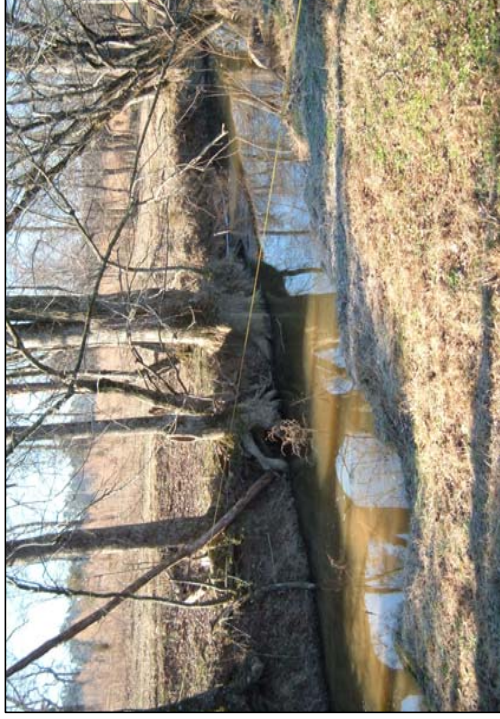
**Cape Fear River Basin, UTCC, XS UTCC-3 Riffle**

<b>River Basin:</b>	Cape Fear
<b>Watershed:</b>	UTCC
<b>XS ID</b>	XS UTCC-3 Riffle
<b>Drainage Area (sq mi):</b>	2.5
<b>Date:</b>	February 2006
<b>Field Crew:</b>	Mryncaza, Helms, Hayes, Spiller, French

**Stream Type:** E4

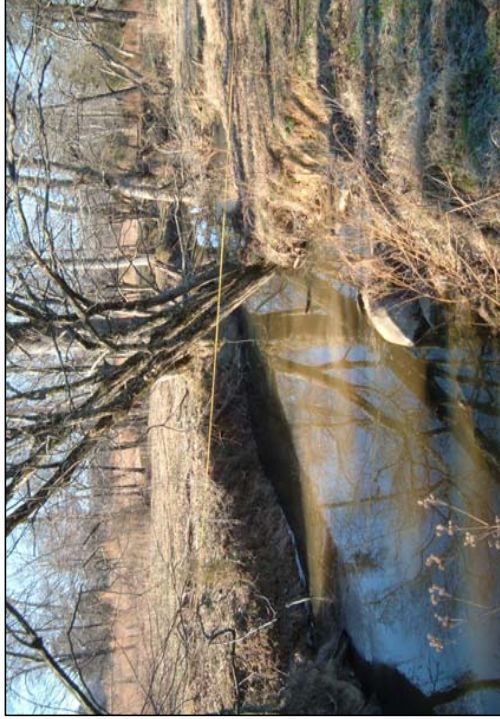
**Cape Fear River Basin, UTCC, XS UTCC-4 Pool**

<b>River Basin:</b>	Cape Fear
<b>Watershed:</b>	UTCC
<b>XS ID</b>	XS UTCC-4 Pool
<b>Drainage Area (sq mi):</b>	2.5
<b>Date:</b>	February 2006
<b>Field Crew:</b>	Mryncaza, Helms, Hayes, Spiller, French

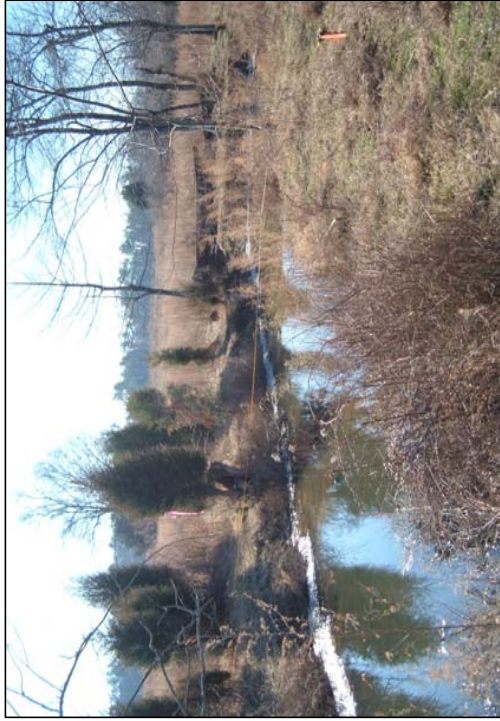
<b>River Basin:</b>	Cape Fear
<b>Watershed:</b>	UTCC
<b>XS ID</b>	XS UTCC-5 Riffle
<b>Drainage Area (sq mi):</b>	2.6
<b>Date:</b>	February 2006
<b>Field Crew:</b>	Mryncaza, Helms, Hayes, Spiller, French

**Stream Type:** C4

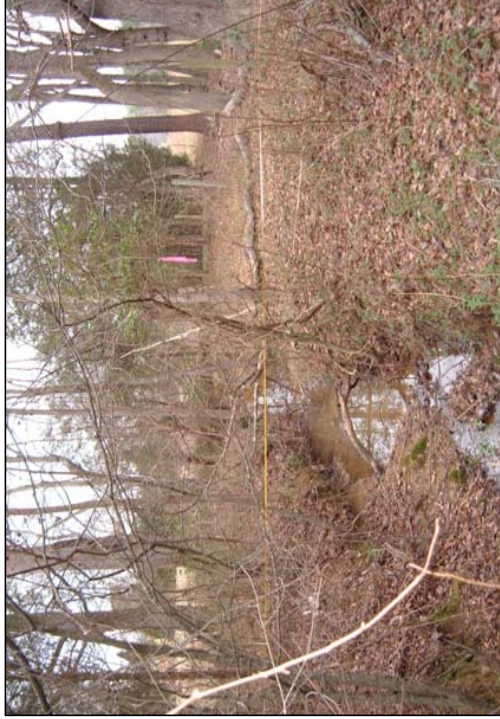
**Cape Fear River Basin, UTCC, XS T1-1 Riffle**

<b>River Basin:</b>	Cape Fear
<b>Watershed:</b>	UTCC
<b>XS ID</b>	XS T1-1 Riffle
<b>Drainage Area (sq mi):</b>	0.12
<b>Date:</b>	February 2006
<b>Field Crew:</b>	Mryncza, Helms, Hayes, Spiller, French

**Stream Type:** C4c

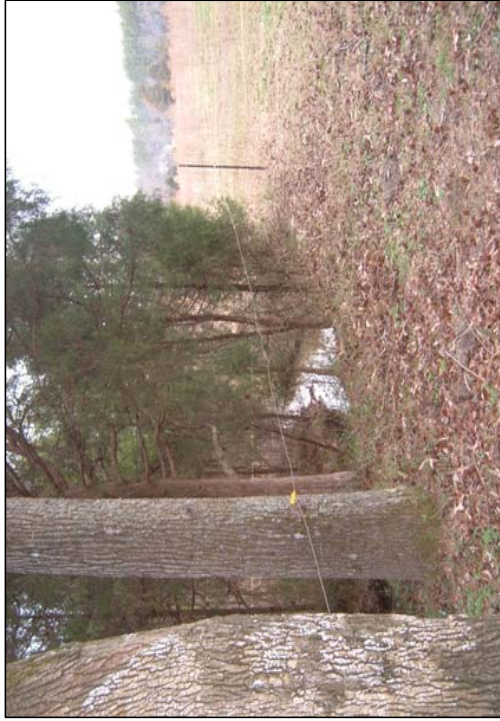
<b>River Basin:</b>	Cape Fear
<b>Watershed:</b>	UTCC
<b>XS ID</b>	XS T1-2 Riffle
<b>Drainage Area (sq mi):</b>	0.12
<b>Date:</b>	February 2006
<b>Field Crew:</b>	Mryncza, Helms, Hayes, Spiller, French

**Stream Type:** E4

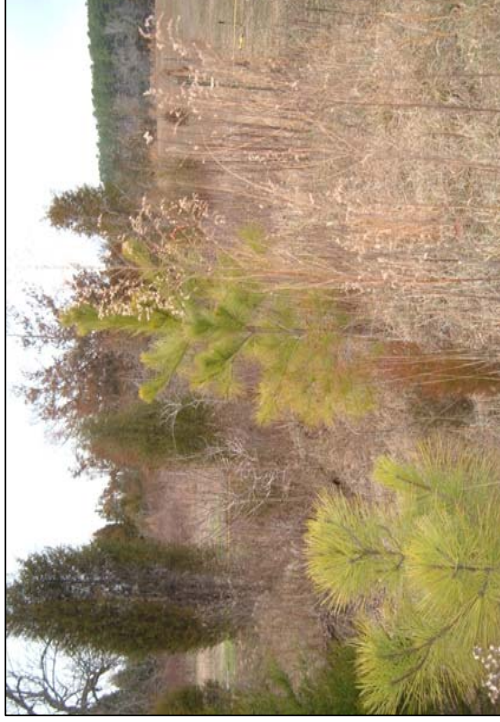
<b>River Basin:</b>	Cape Fear
<b>Watershed:</b>	UTCC
<b>XS ID</b>	XS T1-3 Riffle
<b>Drainage Area (sq mi):</b>	0.12
<b>Date:</b>	February 2006
<b>Field Crew:</b>	Mryncza, Helms, Hayes, Spiller, French

**Stream Type:** G4c

SUMMARY DATA	
<b>Bankfull Elevation:</b>	524.7
<b>Bankfull Cross-Sectional Area:</b>	8.8
<b>Bankfull Width:</b>	10.8
<b>Flood Prone Area Elevation:</b>	526.7
<b>Flood Prone Width:</b>	17.6
<b>Max Depth at Bankfull:</b>	2.0
<b>Mean Depth at Bankfull:</b>	0.8
<b>W / D Ratio:</b>	13.3
<b>Entrenchment Ratio:</b>	1.6
<b>Bank Height Ratio:</b>	2.4
<b>Slope (ft/ft):</b>	0.007
<b>Discharge (cfs)</b>	30

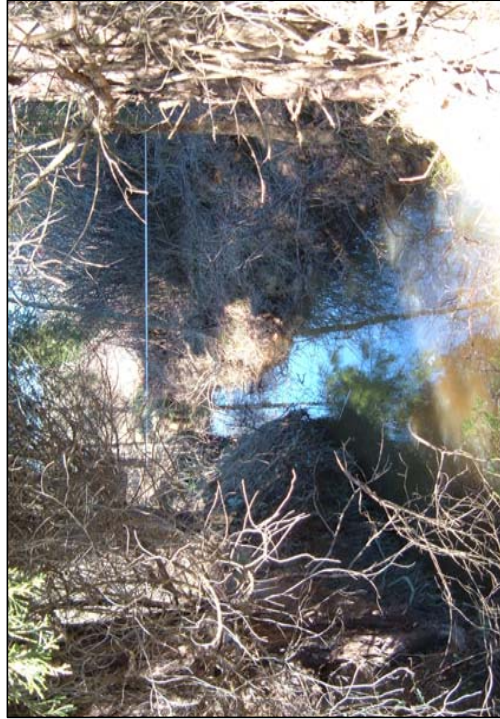
<b>River Basin:</b>	Cape Fear
<b>Watershed:</b>	UTCC
<b>XS ID</b>	XS T1-4 Riffle
<b>Drainage Area (sq mi):</b>	0.12
<b>Date:</b>	February 2006
<b>Field Crew:</b>	Mryncza, Helms, Hayes, Spiller, French

**Stream Type:** E4b/G4

SUMMARY DATA	
<b>Bankfull Elevation:</b>	522.0
<b>Bankfull Cross-Sectional Area:</b>	8.8
<b>Bankfull Width:</b>	5.8
<b>Flood Prone Area Elevation:</b>	524.1
<b>Flood Prone Width:</b>	10.8
<b>Max Depth at Bankfull:</b>	2.0
<b>Mean Depth at Bankfull:</b>	1.5
<b>W / D Ratio:</b>	3.8
<b>Entrenchment Ratio:</b>	1.9
<b>Bank Height Ratio:</b>	2.3
<b>Slope (ft/ft):</b>	0.007
<b>Discharge (cfs)</b>	40

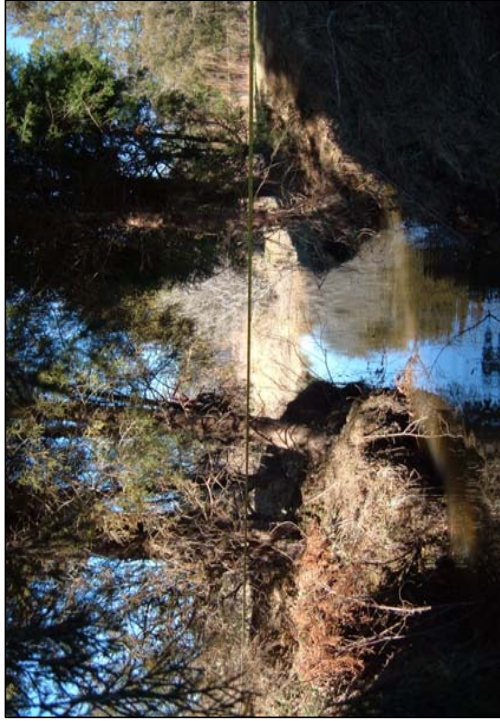
<b>River Basin:</b>	Cape Fear
<b>Watershed:</b>	UTCC
<b>XS ID</b>	XS T1-5 Riffle
<b>Drainage Area (sq mi):</b>	0.18
<b>Date:</b>	February 2006
<b>Field Crew:</b>	Mryncaza, Helms, Hayes, Spiller, French

**Stream Type:** E4

SUMMARY DATA	
<b>Bankfull Elevation:</b>	520.7
<b>Bankfull Cross-Sectional Area:</b>	8.2
<b>Bankfull Width:</b>	5.7
<b>Flood Prone Area Elevation:</b>	522.5
<b>Flood Prone Width:</b>	11.1
<b>Max Depth at Bankfull:</b>	1.8
<b>Mean Depth at Bankfull:</b>	1.4
<b>W / D Ratio:</b>	3.9
<b>Entrenchment Ratio:</b>	2.0
<b>Bank Height Ratio:</b>	2.1
<b>Slope (ft/ft):</b>	0.008
<b>Discharge (cfs)</b>	36

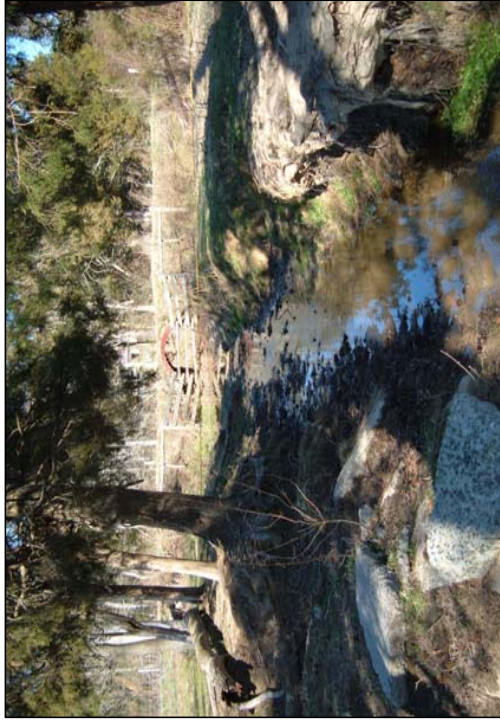
<b>River Basin:</b>	Cape Fear
<b>Watershed:</b>	UTCC
<b>XS ID</b>	XS T1-6 Riffle
<b>Drainage Area (sq mi):</b>	0.18
<b>Date:</b>	February 2006
<b>Field Crew:</b>	Mryncza, Helms, Hayes, Spiller, French

**Stream Type:** E4/G4c

SUMMARY DATA	
<b>Bankfull Elevation:</b>	518.1
<b>Bankfull Cross-Sectional Area:</b>	10.8
<b>Bankfull Width:</b>	10.1
<b>Flood Prone Area Elevation:</b>	519.5
<b>Flood Prone Width:</b>	16.0
<b>Max Depth at Bankfull:</b>	1.4
<b>Mean Depth at Bankfull:</b>	1.1
<b>W / D Ratio:</b>	9.5
<b>Entrenchment Ratio:</b>	1.6
<b>Bank Height Ratio:</b>	2.0
<b>Slope (ft/ft):</b>	0.008
<b>Discharge (cfs)</b>	46

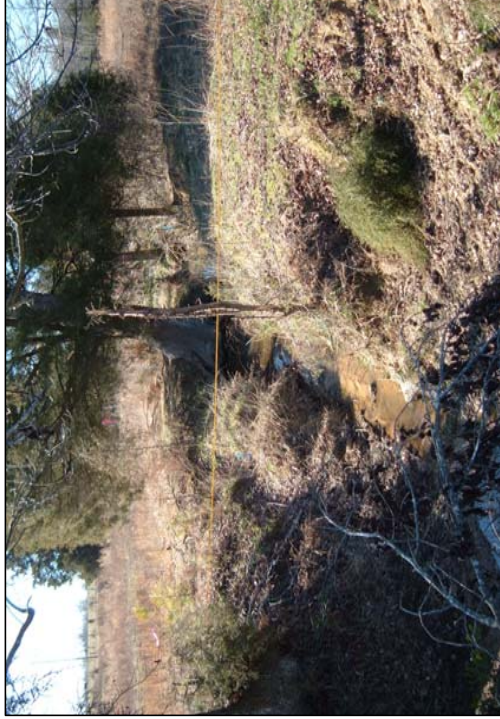
<b>River Basin:</b>	Cape Fear
<b>Watershed:</b>	UTCC
<b>XS ID</b>	XS T1-7 Riffle
<b>Drainage Area (sq mi):</b>	0.49
<b>Date:</b>	February 2006
<b>Field Crew:</b>	Mryncaza, Helms, Hayes, Spiller, French

**Stream Type:** E4

SUMMARY DATA	
<b>Bankfull Elevation:</b>	514.9
<b>Bankfull Cross-Sectional Area:</b>	15.1
<b>Bankfull Width:</b>	11.9
<b>Flood Prone Area Elevation:</b>	517.6
<b>Flood Prone Width:</b>	>70
<b>Max Depth at Bankfull:</b>	2.7
<b>Mean Depth at Bankfull:</b>	1.3
<b>W / D Ratio:</b>	9.4
<b>Entrenchment Ratio:</b>	>5.9
<b>Bank Height Ratio:</b>	1.2
<b>Slope (ft/ft):</b>	0.005
<b>Discharge (cfs)</b>	62

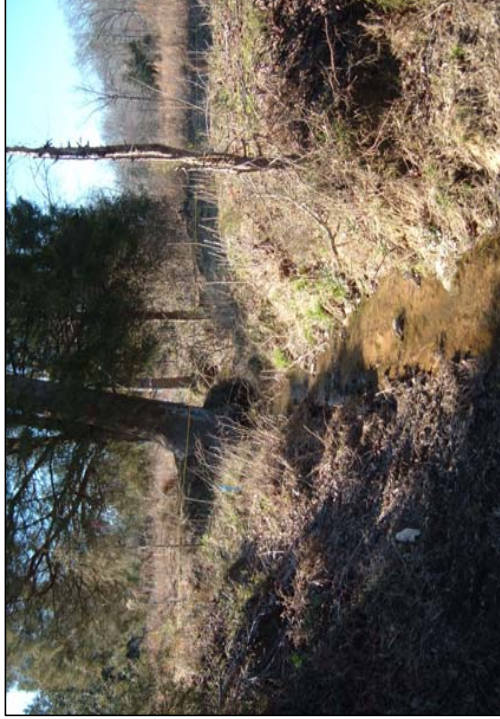
<b>River Basin:</b>	Cape Fear
<b>Watershed:</b>	UTCC
<b>XS ID</b>	XS T1-8 Pool
<b>Drainage Area (sq mi):</b>	0.49
<b>Date:</b>	February 2006
<b>Field Crew:</b>	Mryncaza, Helms, Hayes, Spiller, French

SUMMARY DATA	
<b>Bankfull Elevation:</b>	514.0
<b>Bankfull Cross-Sectional Area:</b>	20.1
<b>Bankfull Width:</b>	9.4
<b>Flood Prone Area Elevation:</b>	-
<b>Flood Prone Width:</b>	-
<b>Max Depth at Bankfull:</b>	3.1
<b>Mean Depth at Bankfull:</b>	2.1
<b>W / D Ratio:</b>	4.4
<b>Entrenchment Ratio:</b>	-
<b>Bank Height Ratio:</b>	1.4
<b>Slope (ft/ft):</b>	0.003
<b>Discharge (cfs)</b>	-

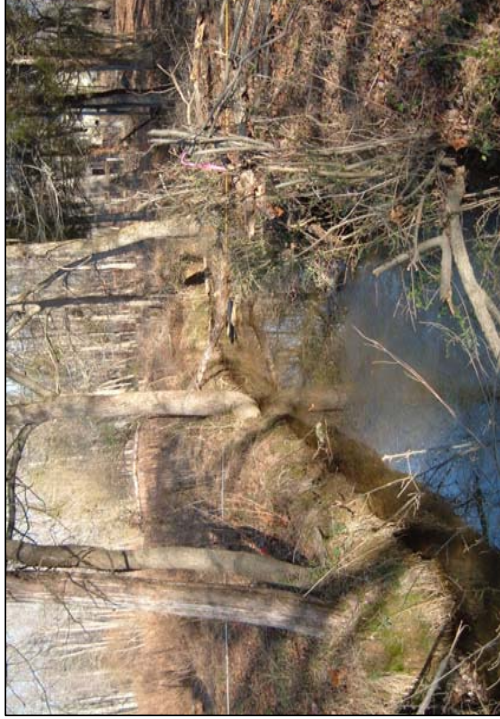
<b>River Basin:</b>	Cape Fear
<b>Watershed:</b>	UTCC
<b>XS ID</b>	XS T1-9 Riffle
<b>Drainage Area (sq mi):</b>	0.49
<b>Date:</b>	February 2006
<b>Field Crew:</b>	Mryncza, Helms, Hayes, Spiller, French

**Stream Type:** E4

SUMMARY DATA	
<b>Bankfull Elevation:</b>	511.1
<b>Bankfull Cross-Sectional Area:</b>	15.5
<b>Bankfull Width:</b>	7.7
<b>Flood Prone Area Elevation:</b>	513.6
<b>Flood Prone Width:</b>	>63
<b>Max Depth at Bankfull:</b>	2.5
<b>Mean Depth at Bankfull:</b>	2.0
<b>W / D Ratio:</b>	3.8
<b>Entrenchment Ratio:</b>	>8.2
<b>Bank Height Ratio:</b>	1.2
<b>Slope (ft/ft):</b>	0.005
<b>Discharge (cfs)</b>	70

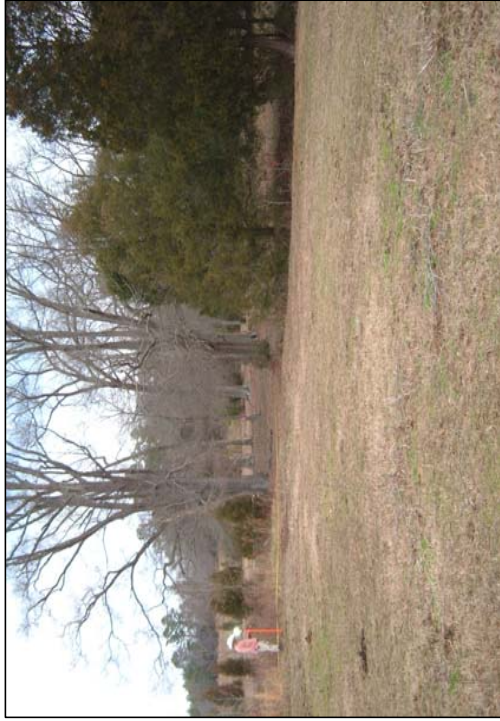
<b>River Basin:</b>	Cape Fear
<b>Watershed:</b>	UTCC
<b>XS ID</b>	XS T1A-1 Riffle
<b>Drainage Area (sq mi):</b>	0.045
<b>Date:</b>	February 2006
<b>Field Crew:</b>	Mryncza, Helms, Hayes, Spiller, French

**Stream Type:** G4

SUMMARY DATA	
<b>Bankfull Elevation:</b>	528.6
<b>Bankfull Cross-Sectional Area:</b>	5.5
<b>Bankfull Width:</b>	4.5
<b>Flood Prone Area Elevation:</b>	530.2
<b>Flood Prone Width:</b>	6.7
<b>Max Depth at Bankfull:</b>	1.6
<b>Mean Depth at Bankfull:</b>	1.2
<b>W / D Ratio:</b>	3.6
<b>Entrenchment Ratio:</b>	1.5
<b>Bank Height Ratio:</b>	2.3
<b>Slope (ft/ft):</b>	0.021
<b>Discharge (cfs)</b>	36

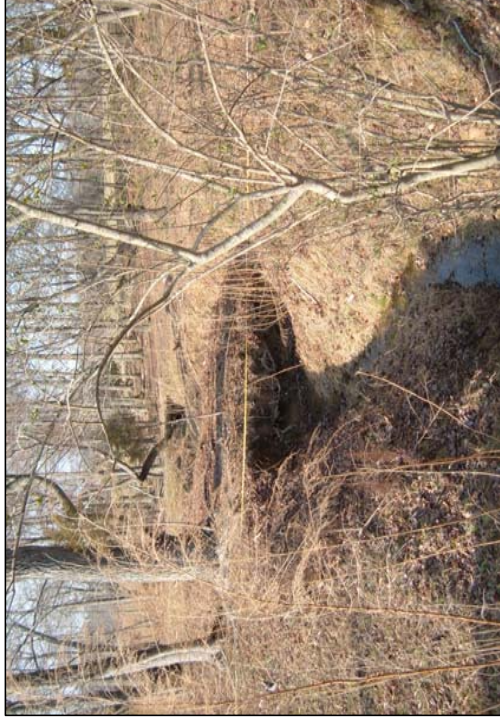
<b>River Basin:</b>	Cape Fear
<b>Watershed:</b>	UTCC
<b>XS ID</b>	XS T2-1 Pool
<b>Drainage Area (sq mi):</b>	0.07
<b>Date:</b>	February 2006
<b>Field Crew:</b>	Mryncza, Helms, Hayes, Spiller, French

SUMMARY DATA	
<b>Bankfull Elevation:</b>	525.2
<b>Bankfull Cross-Sectional Area:</b>	4.3
<b>Bankfull Width:</b>	5.3
<b>Flood Prone Area Elevation:</b>	-
<b>Flood Prone Width:</b>	-
<b>Max Depth at Bankfull:</b>	1.3
<b>Mean Depth at Bankfull:</b>	0.8
<b>W / D Ratio:</b>	6.6
<b>Entrenchment Ratio:</b>	-
<b>Bank Height Ratio:</b>	2.7
<b>Slope (ft/ft):</b>	0.006
<b>Discharge (cfs)</b>	-

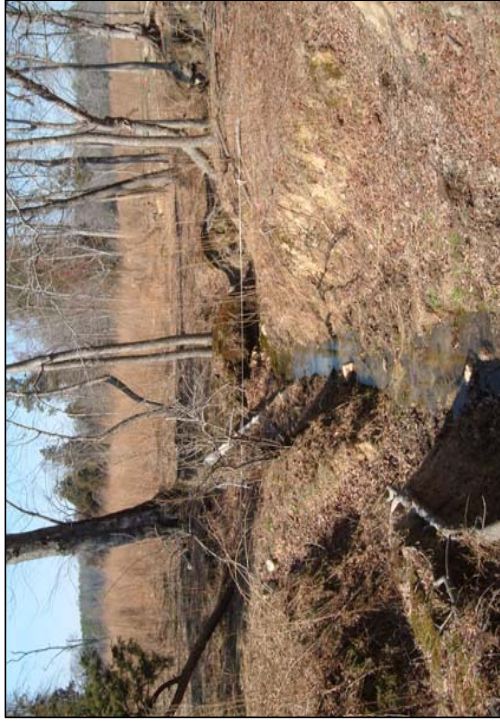
<b>River Basin:</b>	Cape Fear
<b>Watershed:</b>	UTCC
<b>XS ID</b>	XS T2-2 Riffle
<b>Drainage Area (sq mi):</b>	0.07
<b>Date:</b>	February 2006
<b>Field Crew:</b>	Mryncaza, Helms, Hayes, Spiller, French

**Stream Type:** G4c

SUMMARY DATA	
<b>Bankfull Elevation:</b>	520.9
<b>Bankfull Cross-Sectional Area:</b>	4.0
<b>Bankfull Width:</b>	4.6
<b>Flood Prone Area Elevation:</b>	522.3
<b>Flood Prone Width:</b>	7.5
<b>Max Depth at Bankfull:</b>	1.4
<b>Mean Depth at Bankfull:</b>	0.9
<b>W / D Ratio:</b>	5.2
<b>Entrenchment Ratio:</b>	1.6
<b>Bank Height Ratio:</b>	2.4
<b>Slope (ft/ft):</b>	0.018
<b>Discharge (cfs)</b>	18

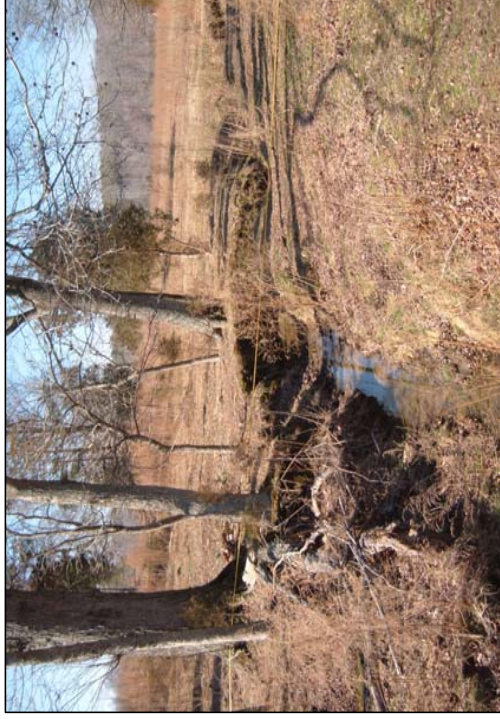
<b>River Basin:</b>	Cape Fear
<b>Watershed:</b>	UTCC
<b>XS ID</b>	XS T2-4 Riffle
<b>Drainage Area (sq mi):</b>	0.07
<b>Date:</b>	February 2006
<b>Field Crew:</b>	Mryncza, Helms, Hayes, Spiller, French

**Stream Type:** E4

SUMMARY DATA	
<b>Bankfull Elevation:</b>	514.0
<b>Bankfull Cross-Sectional Area:</b>	6.2
<b>Bankfull Width:</b>	6.1
<b>Flood Prone Area Elevation:</b>	515.5
<b>Flood Prone Width:</b>	28.1
<b>Max Depth at Bankfull:</b>	1.5
<b>Mean Depth at Bankfull:</b>	1.0
<b>W / D Ratio:</b>	6.0
<b>Entrenchment Ratio:</b>	4.6
<b>Bank Height Ratio:</b>	1.3
<b>Slope (ft/ft):</b>	0.013
<b>Discharge (cfs)</b>	27

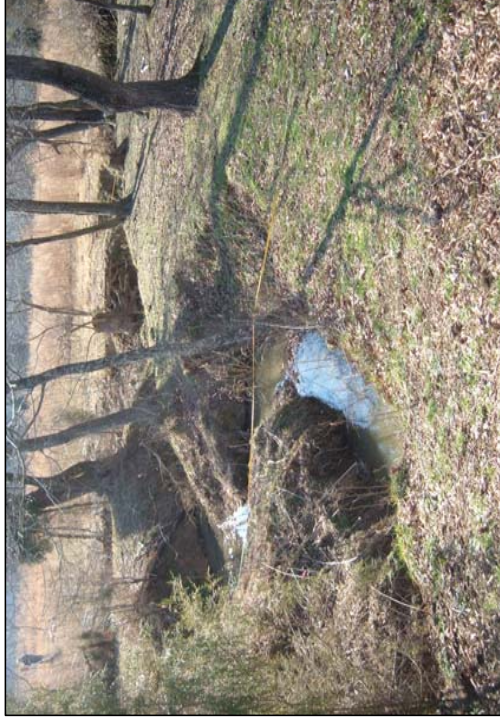
<b>River Basin:</b>	Cape Fear
<b>Watershed:</b>	UTCC
<b>XS ID</b>	XS T2-5 Pool
<b>Drainage Area (sq mi):</b>	0.07
<b>Date:</b>	February 2006
<b>Field Crew:</b>	Mryncaza, Helms, Hayes, Spiller, French

**Stream Type:** -

SUMMARY DATA	
<b>Bankfull Elevation:</b>	505.4
<b>Bankfull Cross-Sectional Area:</b>	7.7
<b>Bankfull Width:</b>	4.9
<b>Flood Prone Area Elevation:</b>	-
<b>Flood Prone Width:</b>	-
<b>Max Depth at Bankfull:</b>	2.0
<b>Mean Depth at Bankfull:</b>	1.6
<b>W / D Ratio:</b>	3.1
<b>Entrenchment Ratio:</b>	-
<b>Bank Height Ratio:</b>	2.0
<b>Slope (ft/ft):</b>	0.014
<b>Discharge (cfs)</b>	-

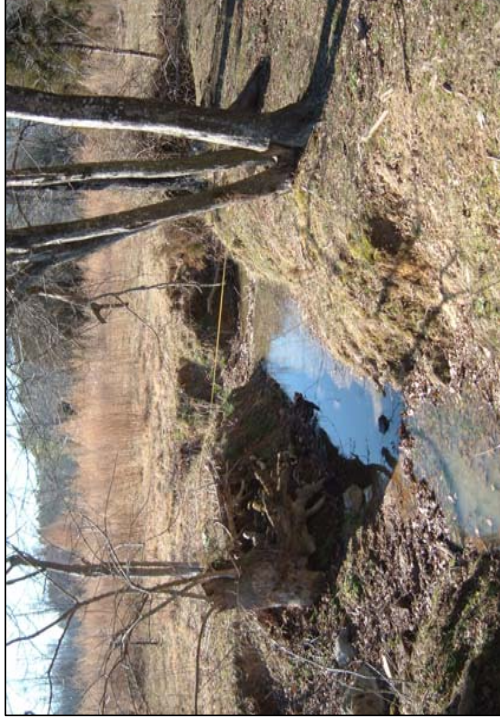
<b>River Basin:</b>	Cape Fear
<b>Watershed:</b>	UTCC
<b>XS ID</b>	XS T2-6 Riffle
<b>Drainage Area (sq mi):</b>	0.07
<b>Date:</b>	February 2006
<b>Field Crew:</b>	Mryncaza, Helms, Hayes, Spiller, French

**Stream Type:** G4c

SUMMARY DATA	
<b>Bankfull Elevation:</b>	504.6
<b>Bankfull Cross-Sectional Area:</b>	6.4
<b>Bankfull Width:</b>	7.2
<b>Flood Prone Area Elevation:</b>	505.9
<b>Flood Prone Width:</b>	9.3
<b>Max Depth at Bankfull:</b>	1.3
<b>Mean Depth at Bankfull:</b>	0.9
<b>W / D Ratio:</b>	8.0
<b>Entrenchment Ratio:</b>	1.3
<b>Bank Height Ratio:</b>	2.5
<b>Slope (ft/ft):</b>	0.014
<b>Discharge (cfs)</b>	28

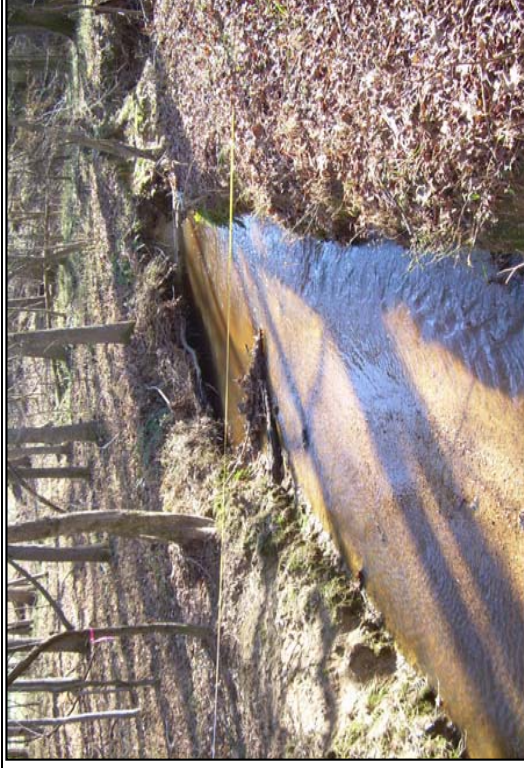
<b>River Basin:</b>	Cape Fear
<b>Watershed:</b>	Collins Creek
<b>XS ID</b>	XS1 Riffle
<b>Drainage Area (sq mi):</b>	
<b>Date:</b>	12/27/2006
<b>Field Crew:</b>	A. Helms, A. Spiller, B. Roberts

Stream Type: E4

SUMMARY DATA		
Parameter	Value	Station
Bankfull Elevation:	499.14	499.14
Bankfull Cross-Sectional Area:	33.4	33.4
Bankfull Width:	20.1	20.1
Flood Prone Area Elevation:	502.48	502.48
Flood Prone Width:	>60	>60
Max Depth at Bankfull:	3.34	3.34
Mean Depth at Bankfull:	1.66	1.66
W / D Ratio:	12.1	12.1
Entrenchment Ratio:	3.0	3.0
Bank Height Ratio:	0.89	0.89
Slope (ft/ft):	0.003	0.003
Discharge (cfs)	114	114

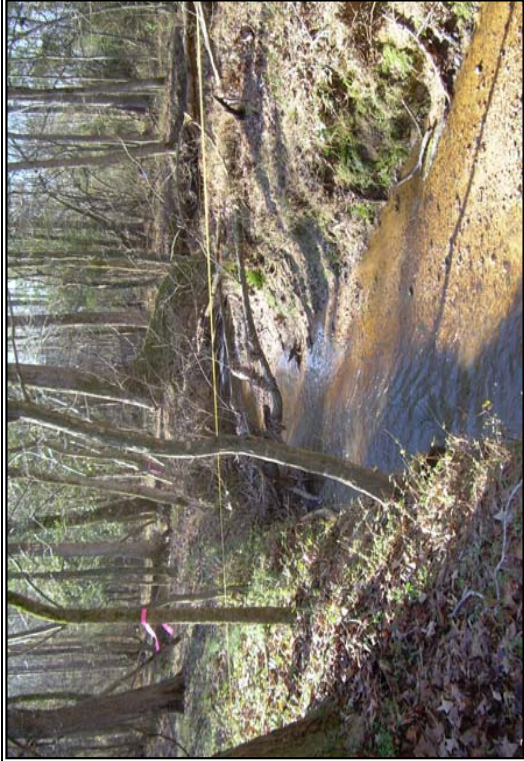
<b>River Basin:</b>	Cape Fear
<b>Watershed:</b>	Collins Creek
<b>XS ID</b>	XS2 Riffle
<b>Drainage Area (sq mi):</b>	
<b>Date:</b>	12/27/2006
<b>Field Crew:</b>	A. Helms, A. Spiller, B. Roberts

**Stream Type:** E4

SUMMARY DATA	
<b>Bankfull Elevation:</b>	498.92
<b>Bankfull Cross-Sectional Area:</b>	32.4
<b>Bankfull Width:</b>	11.9
<b>Flood Prone Area Elevation:</b>	502.54
<b>Flood Prone Width:</b>	>60
<b>Max Depth at Bankfull:</b>	3.62
<b>Mean Depth at Bankfull:</b>	2.72
<b>W / D Ratio:</b>	4.4
<b>Entrenchment Ratio:</b>	5.0
<b>Bank Height Ratio:</b>	1.10
<b>Slope (ft/ft):</b>	0.003
<b>Discharge (cfs)</b>	141

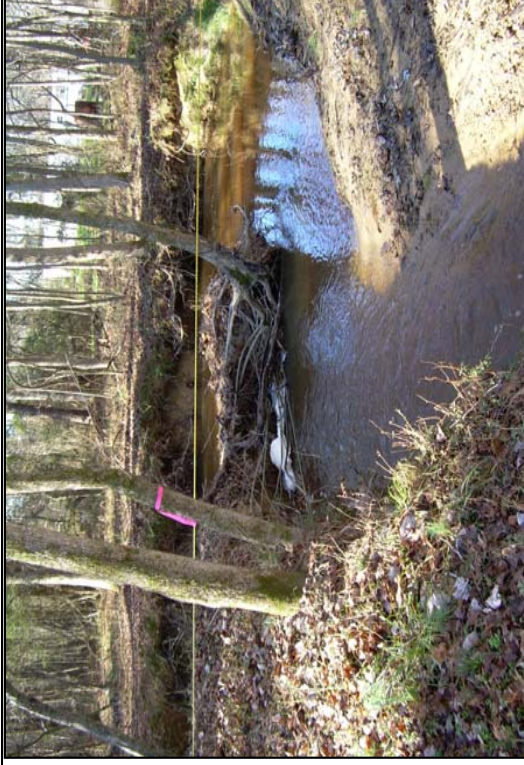
<b>River Basin:</b>	Cape Fear
<b>Watershed:</b>	Collins Creek
<b>XS ID</b>	XS3 Pool
<b>Drainage Area (sq mi):</b>	
<b>Date:</b>	12/27/2006
<b>Field Crew:</b>	A. Helms, A. Spiller, B. Roberts

Stream Type: E4

SUMMARY DATA	
<b>Bankfull Elevation:</b>	498.83
<b>Bankfull Cross-Sectional Area:</b>	57.9
<b>Bankfull Width:</b>	24.3
<b>Flood Prone Area Elevation:</b>	-
<b>Flood Prone Width:</b>	-
<b>Max Depth at Bankfull:</b>	4.19
<b>Mean Depth at Bankfull:</b>	2.4
<b>W / D Ratio:</b>	-
<b>Entrenchment Ratio:</b>	-
<b>Bank Height Ratio:</b>	-
<b>Slope (ft/ft):</b>	0.003
<b>Discharge (cfs)</b>

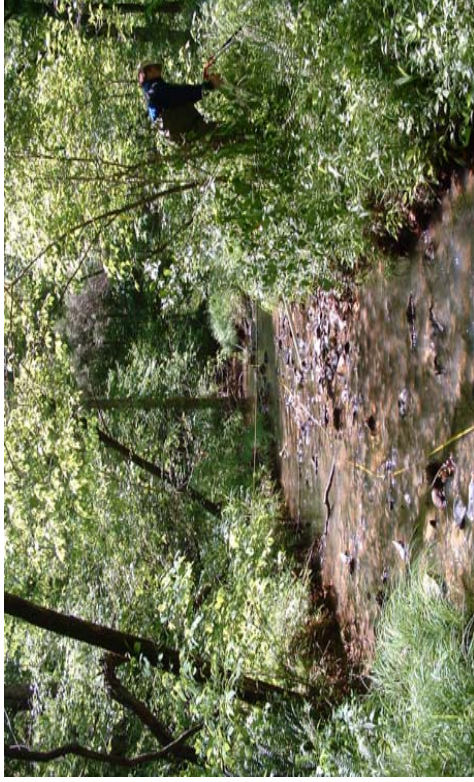
<b>River Basin:</b>	Yadkin
<b>Watershed:</b>	UT to Back Creek
<b>XS ID</b>	XS#3 Riffle
<b>Drainage Area (sq mi):</b>	0.63
<b>Date:</b>	-
<b>Field Crew:</b>	A. Schlindwein, M. Schlegel

Stream Type: C4

Station	Rod Ht.	Elevation
19	4.53	95.47
22	4.59	95.41
28.5	4.78	95.22
30.5	5.64	94.36
31	6.77	93.23
33	7.06	92.94
35	6.78	93.22
37	6.65	93.35
39.3	6.6	93.40
39.7	5.97	94.03
40.3	5.76	94.24
43	5.27	94.73
46	4.84	95.16
48.5	5.15	94.85
52.5	4.88	95.12
56	3.9	96.10
61	3.45	96.55
64	3.7	96.30

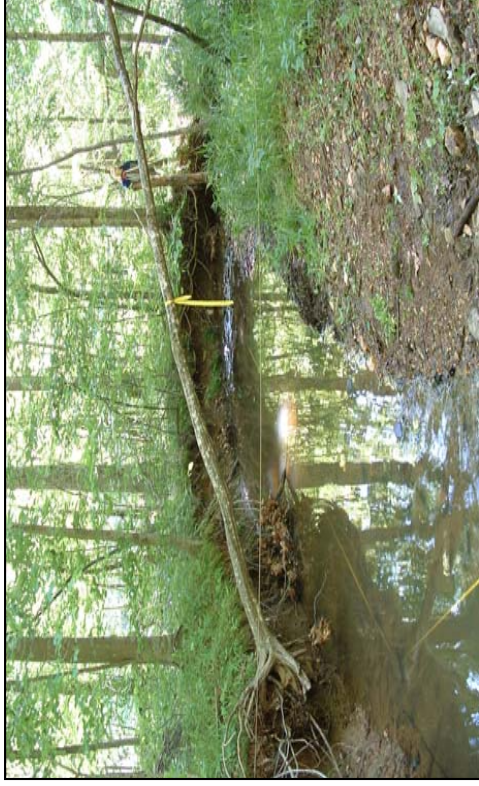
<b>River Basin:</b>	Yadkin
<b>Watershed:</b>	UT to Back Creek
<b>XS ID</b>	XS#5 Pool
<b>Drainage Area (sq mi):</b>	0.63
<b>Date:</b>	-
<b>Field Crew:</b>	A. Schlindwein, M. Schlegel

**Stream Type:** C4

Station	Rod Ht.	Elevation
4	4.92	95.08
14	4.84	95.16
17.5	4.97	95.03
18	7.5	92.50
20.4	8.5	91.50
22.5	7.82	92.18
23.7	7.57	92.43
25	7.15	92.85
29.5	5.96	94.04
33	5.86	94.14
36	4.86	95.14
42	4.69	95.31
48	4.69	95.31
56	4.71	95.29

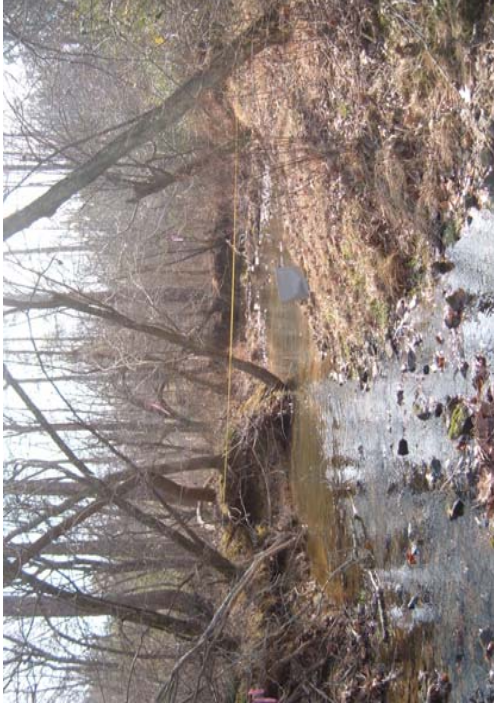
<b>River Basin:</b>	Cape Fear
<b>Watershed:</b>	Long Branch-Reference Reach
<b>XS ID</b>	XS - 1, Pool
<b>Drainage Area (sq mi):</b>	1.49
<b>Date:</b>	
<b>Field Crew:</b>	A. Helms, A. French, A. Spiller, G. Mrynzca

Station	Elevation
0	100.00
7	99.98
10	99.69
13	95.83
16	95.12
19	94.91
20.5	95.29
21.5	95.60
23	96.05
24.5	96.17
26.5	96.82
28	97.38
32	97.59
34	97.66
36.5	98.94
53	98.93

SUMMARY DATA	
<b>Bankfull Elevation:</b>	97.4
<b>Bankfull Cross-Sectional Area:</b>	25.5
<b>Bankfull Width:</b>	16.2
<b>Flood Prone Area Elevation:</b>	-
<b>Flood Prone Width:</b>	-
<b>Max Depth at Bankfull:</b>	2.5
<b>Mean Depth at Bankfull:</b>	1.6
<b>W / D Ratio:</b>	-
<b>Entrenchment Ratio:</b>	-
<b>Bank Height Ratio:</b>	-
<b>Water Surface Slope (ft/ft):</b>	0.004

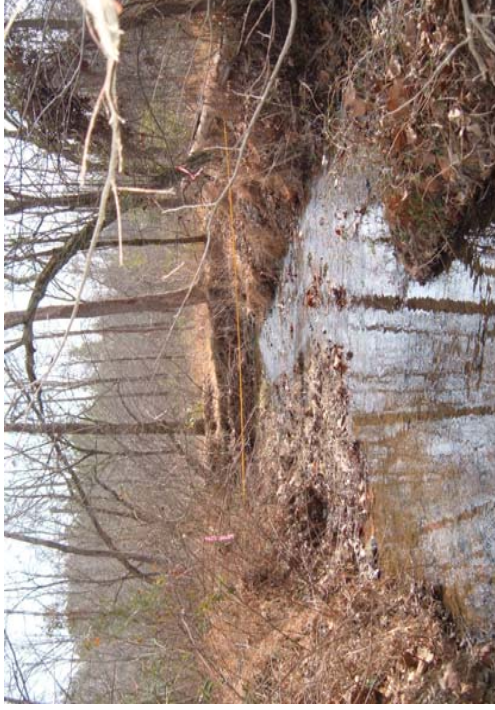
<b>River Basin:</b>	Cape Fear
<b>Watershed:</b>	Long Branch-Reference Reach
<b>XS ID</b>	XS - 2, Riffle
<b>Drainage Area (sq mi):</b>	1.49
<b>Date:</b>	
<b>Field Crew:</b>	A. Helms, A. French, A. Spiller, G. Mrynzca

Station	Elevation
0	99.15
3	98.81
7	97.17
11	97.62
15	97.48
18	97.27
21	97.66
25	98.20
26	97.37
29	95.90
31	95.59
33	95.55
34.5	95.46
36	95.42
38	95.40
40	95.43
41	95.48
42	96.38
43	97.00
45	97.76
48	98.64
52	98.71
56	98.79

SUMMARY DATA	
<b>Bankfull Elevation:</b>	97.3
<b>Bankfull Cross-Sectional Area:</b>	25.1
<b>Bankfull Width:</b>	18.6
<b>Flood Prone Area Elevation:</b>	99.1
<b>Flood Prone Width:</b>	>55
<b>Max Depth at Bankfull:</b>	1.9
<b>Mean Depth at Bankfull:</b>	1.3
<b>W / D Ratio:</b>	13.8
<b>Entrenchment Ratio:</b>	>2.5
<b>Bank Height Ratio:</b>	1.5
<b>Water Surface Slope (ft/ft):</b>	0.004

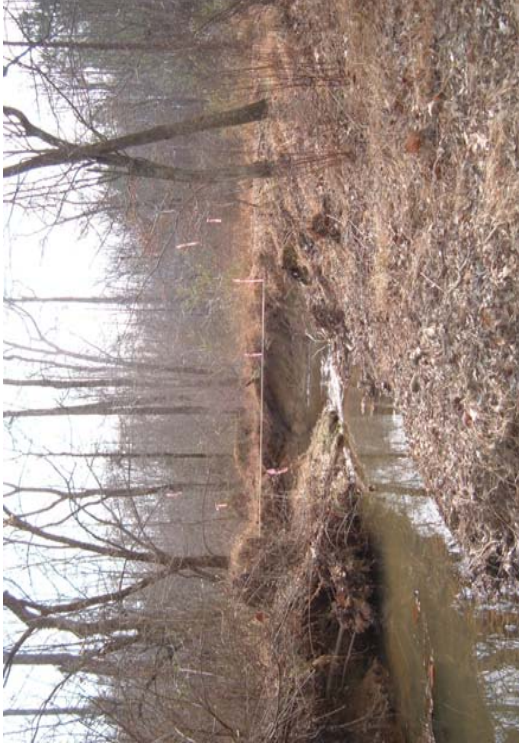
<b>River Basin:</b>	Cape Fear
<b>Watershed:</b>	Long Branch-Reference Reach
<b>XS ID</b>	XS - 3, Riffle
<b>Drainage Area (sq mi):</b>	1.49
<b>Date:</b>	
<b>Field Crew:</b>	A. Helms, A. French, A. Spiller, G. Mrynca

Station	Elevation
0	98.31
4	98.04
8	98.32
11	97.59
12.5	96.05
17	95.13
17.5	94.73
20	94.57
22.5	94.66
24	95.29
26	96.52
27	97.79
31	98.12
35	97.68
38	97.75
40	97.73

SUMMARY DATA	
<b>Bankfull Elevation:</b>	97.0
<b>Bankfull Cross-Sectional Area:</b>	25.0
<b>Bankfull Width:</b>	14.8
<b>Flood Prone Area Elevation:</b>	99.4
<b>Flood Prone Width:</b>	>40
<b>Max Depth at Bankfull:</b>	2.4
<b>Mean Depth at Bankfull:</b>	1.7
<b>W / D Ratio:</b>	8.8
<b>Entrenchment Ratio:</b>	>2.5
<b>Bank Height Ratio:</b>	1.2
<b>Water Surface Slope (ft/ft):</b>	0.004

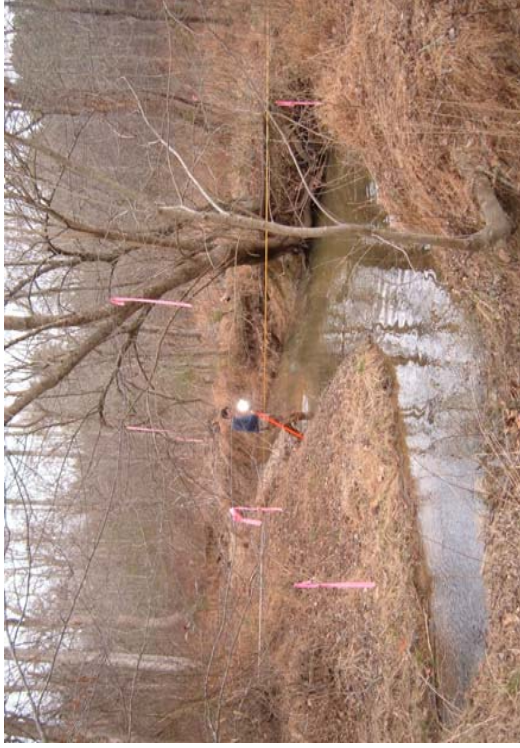
**Cape Fear River Basin, Long Branch-Reference Reach, XS - 4, Pool**

Station	Elevation
0	98.38
6	98.02
11	97.91
13	97.00
16	96.64
19	95.91
21.4	95.23
22	94.45
24.3	94.07
27	93.84
31	94.13
32	94.62
34	95.94
36	97.69
37.5	98.40
42	98.11
46	98.07
49	97.89

SUMMARY DATA	
<b>Bankfull Elevation:</b>	96.6
<b>Bankfull Cross-Sectional Area:</b>	33.4
<b>Bankfull Width:</b>	18.8
<b>Flood Prone Area Elevation:</b>	-
<b>Flood Prone Width:</b>	-
<b>Max Depth at Bankfull:</b>	2.8
<b>Mean Depth at Bankfull:</b>	1.8
<b>W / D Ratio:</b>	-
<b>Entrenchment Ratio:</b>	-
<b>Bank Height Ratio:</b>	-
<b>Water Surface Slope (ft/ft):</b>	0.004

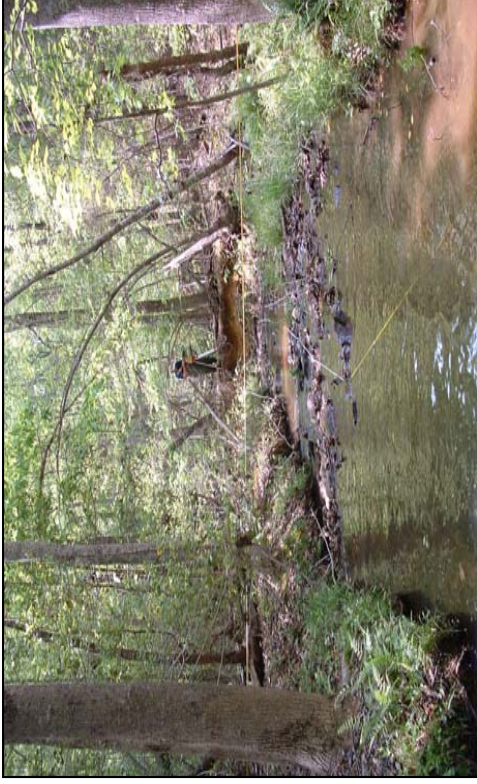
<b>River Basin:</b>	Cape Fear
<b>Watershed:</b>	UT to Richland Creek
<b>XS ID</b>	XS#1 Riffle
<b>Drainage Area (sq mi):</b>	0.9
<b>Date:</b>	
<b>Field Crew:</b>	A. Schliindwein, M. Schlegel

**Stream Type:** C3/C4

Station	Rod Ht.	Elevation
1	1.75	100.45
6	2.19	100.01
14	3.54	98.66
19	3.76	98.44
22	3.73	98.47
25	4.51	97.69
26.3	5.2	97.00
26.8	6.15	96.05
28	5.95	96.25
29	5.78	96.42
31	5.75	96.45
33	5.62	96.58
35	5.61	96.59
37.5	5.65	96.55
38.5	5.12	97.08
40	4.73	97.47
43	4.23	97.97
47	4.36	97.84
51	4.23	97.97
59	3.87	98.33
61	3.72	98.48
70.5	2.46	99.74
73	2.38	99.82

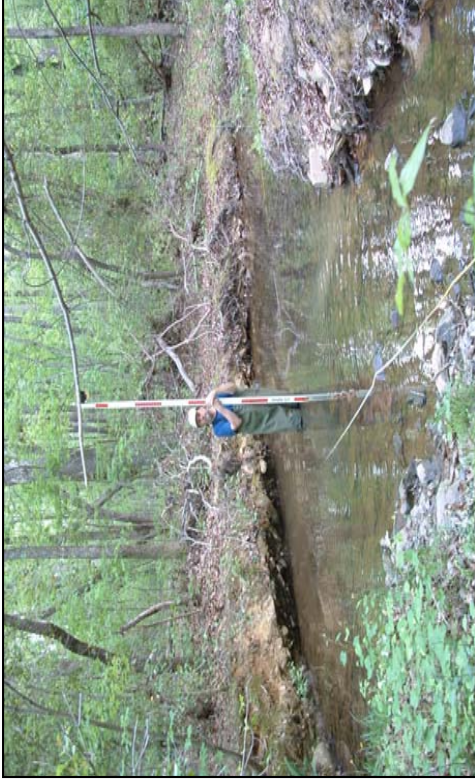
<b>River Basin:</b>	Cape Fear
<b>Watershed:</b>	UT to Richland Creek
<b>XS ID</b>	XS#2 Pool
<b>Drainage Area (sq mi):</b>	0.9
<b>Date:</b>	
<b>Field Crew:</b>	A. Schlindwein, M. Schlegel

**Stream Type:** C3/C4

SUMMARY DATA	
<b>Bankfull Elevation:</b>	96.76
<b>Bankfull Cross-Sectional Area:</b>	35.60
<b>Bankfull Width:</b>	15.20
<b>Flood Prone Area Elevation:</b>	99.85
<b>Flood Prone Width:</b>	-
<b>Max Depth at Bankfull:</b>	3.09
<b>Mean Depth at Bankfull:</b>	2.34
<b>W / D Ratio:</b>	-
<b>Entrenchment Ratio:</b>	-
<b>Bank Height Ratio:</b>	-
<b>Slope (ft/ft):</b>	-
<b>Discharge (cfs)</b>	-

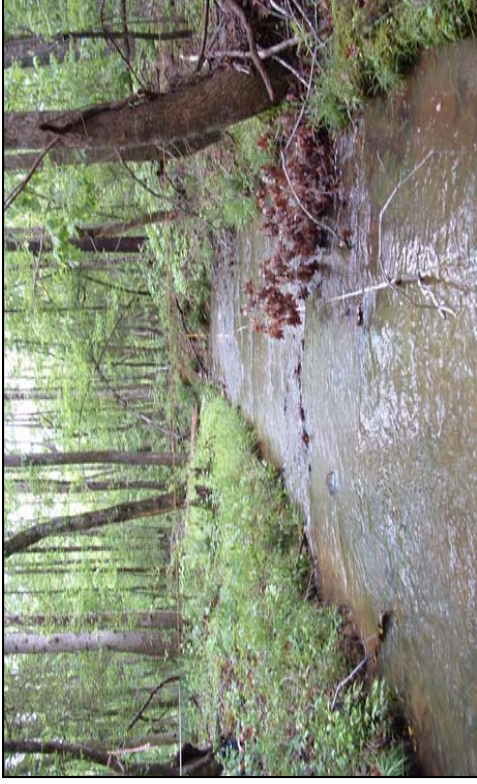
<b>River Basin:</b>	Cape Fear
<b>Watershed:</b>	UT to Richland Creek
<b>XS ID</b>	XS#3 Riffle
<b>Drainage Area (sq mi):</b>	0.9
<b>Date:</b>	
<b>Field Crew:</b>	A. Schlindwein, M. Schlegel

**Stream Type:** C3/C4

Station	Rod Ht.	Elevation
16	4.57	96.71
25	5.22	96.06
31	6.75	94.53
34	7.19	94.09
37.5	7.37	93.91
39.3	8.07	93.21
39.6	9.25	92.03
42	9.22	92.06
46	9.33	91.95
49	9.12	92.16
50.7	8.93	92.35
51	8.09	93.19
53.5	6.69	94.59
57	5.94	95.34
63	5.29	95.99
67	4.99	96.29
70	4.17	97.11
78	0.9	100.38
