# **Collins Creek Restoration Plan**

Orange County, North Carolina

State Contract No. D05011

**Prepared for:  
North Carolina Ecosystem Enhancement Program**

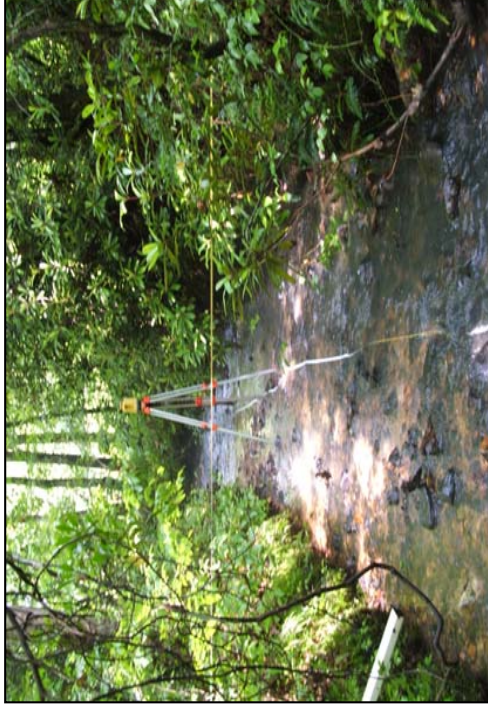
<b>River Basin:</b>	Yadkin
<b>Watershed:</b>	UT to Fisher River
<b>XS ID</b>	XS#1 Riffle
<b>Drainage Area (sq mi):</b>	0.38
<b>Date:</b>	6/9/2005
<b>Field Crew:</b>	G. Mryncza, A. Spiller

Stream Type: B4c

Station	Rod Ht.	Elevation
0.0	2.22	100.00
3.0	2.15	100.07
5.0	2.50	99.72
7.0	2.98	99.24
8.0	3.49	98.73
8.8	4.00	98.22
9.0	4.96	97.26
12.0	5.03	97.19
14.0	5.25	96.97
16.0	5.16	97.06
17.0	5.20	97.02
18.0	5.06	97.16
18.7	4.00	98.22
19.5	2.65	99.57
20.0	1.66	100.56

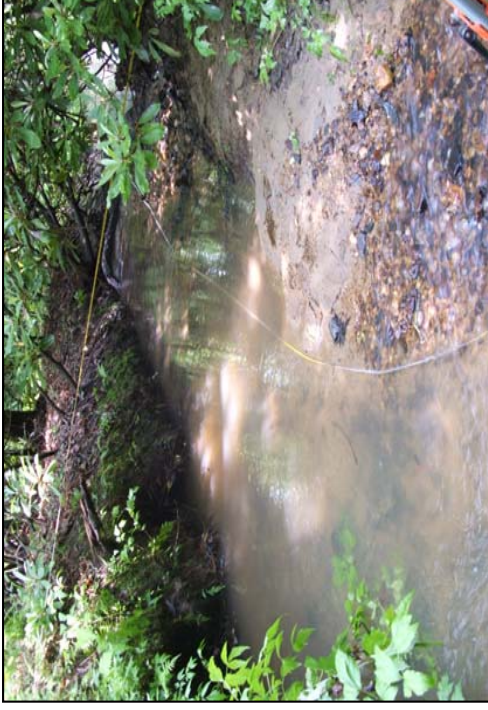
<b>River Basin:</b>	Yadkin
<b>Watershed:</b>	UT to Fisher River
<b>XS ID</b>	XS#3 Pool
<b>Drainage Area (sq mi):</b>	0.38
<b>Date:</b>	6/9/2005
<b>Field Crew:</b>	G. Mryncza, A. Spiller

Stream Type: B4c

Station	Rod Ht.	Elevation
0.0	1.33	100.00
3.0	1.78	99.55
5.0	2.35	98.98
5.5	2.82	98.51
5.7	3.81	97.52
6.0	4.52	96.81
6.5	5.79	95.54
8.0	5.82	95.51
9.0	5.50	95.83
10.0	5.02	96.31
11.5	4.80	96.53
13.0	3.90	97.43
14.0	3.55	97.78
16.0	3.03	98.30
20.0	2.66	98.67

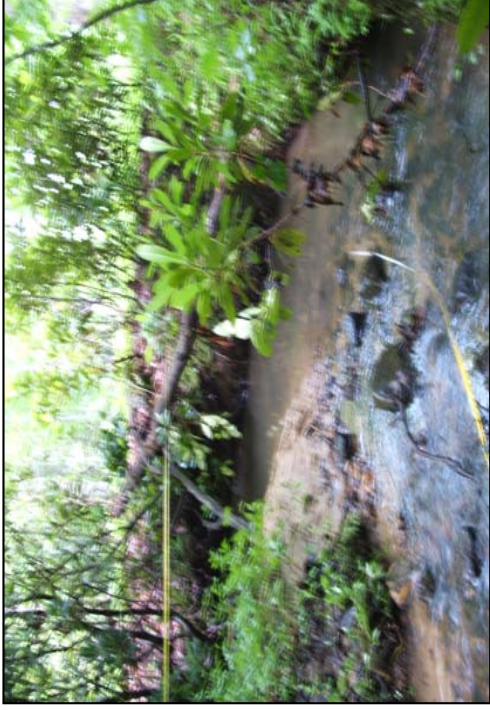
<b>River Basin:</b>	Yadkin
<b>Watershed:</b>	UT to Fisher River
<b>XS ID</b>	XS#2 Pool
<b>Drainage Area (sq mi):</b>	0.38
<b>Date:</b>	6/9/2005
<b>Field Crew:</b>	G. Mryncza, A. Spiller

Stream Type: B4c

Station	Rod Ht.	Elevation
0.0	2.68	100.00
3.0	2.94	99.74
5.0	3.61	99.07
6.0	4.10	98.58
6.8	4.56	98.12
7.0	4.70	97.98
9.0	4.94	97.74
11.0	5.21	97.47
12.0	5.64	97.04
13.0	6.00	96.68
15.0	6.59	96.09
17.0	6.42	96.26
18.0	6.50	96.18
18.2	4.93	97.75
19.0	3.56	99.12
20.0	2.80	99.88

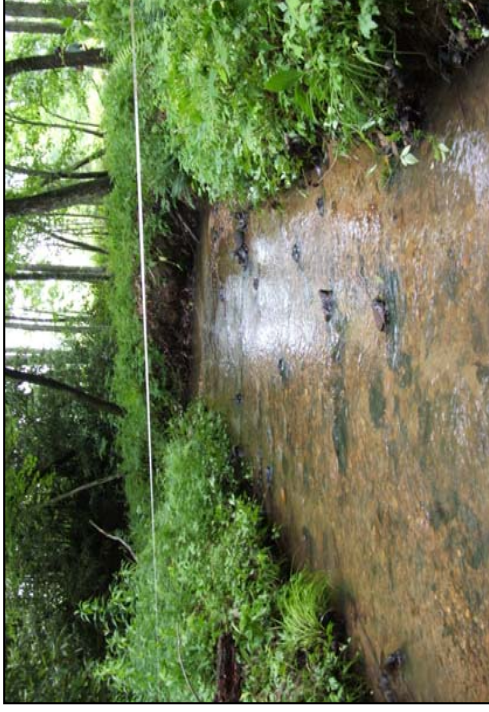
<b>River Basin:</b>	Yadkin
<b>Watershed:</b>	UT to Fisher River
<b>XS ID</b>	XS#4 Riffle
<b>Drainage Area (sq mi):</b>	0.38
<b>Date:</b>	6/9/2005
<b>Field Crew:</b>	G. Mryncza, A. Spiller

Stream Type: B4c

Station	Rod Ht.	Elevation
0.0	4.62	100.00
3.0	5.54	99.08
7.0	6.01	98.61
8.5	6.34	98.28
9.0	7.04	97.58
9.5	7.66	96.96
11.0	7.67	96.95
12.0	7.79	96.83
14.0	7.58	97.04
16.0	7.57	97.05
17.0	7.51	97.11
17.5	6.34	98.28
19.0	5.90	98.72
21.0	5.06	99.56
25.0	4.37	100.25

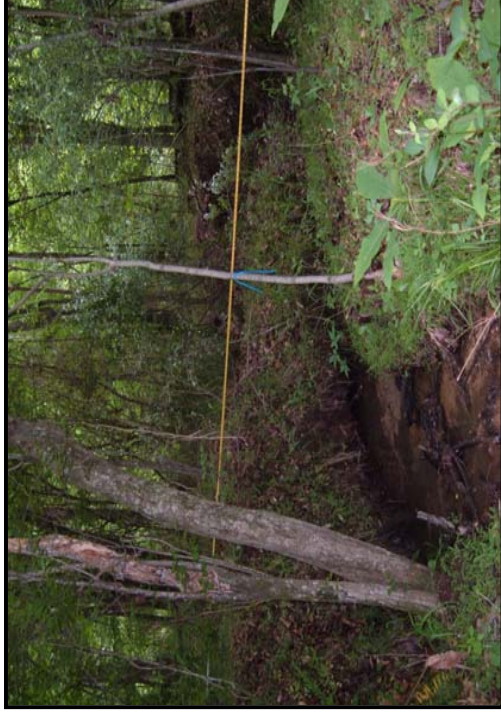
<b>River Basin:</b>	Cape Fear
<b>Watershed:</b>	UT Wilkinson-Reference Reach
<b>XS ID</b>	XS - 1, Pool
<b>Drainage Area (sq mi):</b>	0.145
<b>Date:</b>	5/9/2006
<b>Field Crew:</b>	A. Helms, A. French

SUMMARY DATA	
<b>Bankfull Elevation:</b>	98.4
<b>Bankfull Cross-Sectional Area:</b>	8.6
<b>Bankfull Width:</b>	10.8
<b>Flood Prone Area Elevation:</b>	-
<b>Flood Prone Width:</b>	-
<b>Max Depth at Bankfull:</b>	2.2
<b>Mean Depth at Bankfull:</b>	0.8
<b>W / D Ratio:</b>	-
<b>Entrenchment Ratio:</b>	-
<b>Bank Height Ratio:</b>	-
<b>Water Surface Slope (ft/ft):</b>	0.018

Station	Elevation
0	99.89
3	99.77
7	99.90
9	99.66
10	99.01
10.8	96.30
11.3	96.22
12.6	96.62
13.3	96.87
14	97.34
15	97.86
18	98.19
21	98.40
25	99.15
30	99.66
33	99.72

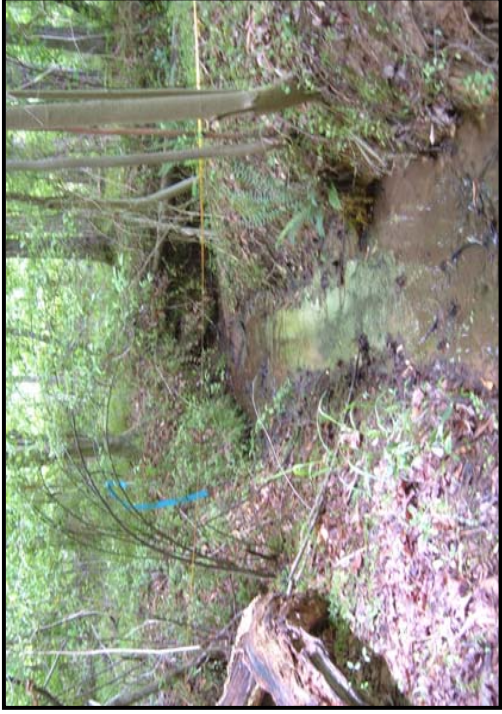
<b>River Basin:</b>	Cape Fear
<b>Watershed:</b>	UT Wilkinson-Reference Reach
<b>XS ID</b>	XS - 2, Riffle
<b>Drainage Area (sq mi):</b>	0.145
<b>Date:</b>	5/9/2006
<b>Field Crew:</b>	A. Helms, A. French

Station	Elevation
1	99.70
5	99.80
9	99.57
12	98.23
16	97.33
18	96.84
18.7	96.37
19.7	96.32
21	96.41
22	97.72
24	98.81
26	99.13
30	99.22
35	99.38

SUMMARY DATA	
<b>Bankfull Elevation:</b>	97.7
<b>Bankfull Cross-Sectional Area:</b>	6.2
<b>Bankfull Width:</b>	7.7
<b>Flood Prone Area Elevation:</b>	99.1
<b>Flood Prone Width:</b>	16.0
<b>Max Depth at Bankfull:</b>	1.4
<b>Mean Depth at Bankfull:</b>	0.8
<b>W/D Ratio:</b>	9.6
<b>Entrenchment Ratio:</b>	2.1
<b>Bank Height Ratio:</b>	2.0
<b>Water Surface Slope (ft/ft):</b>	0.018

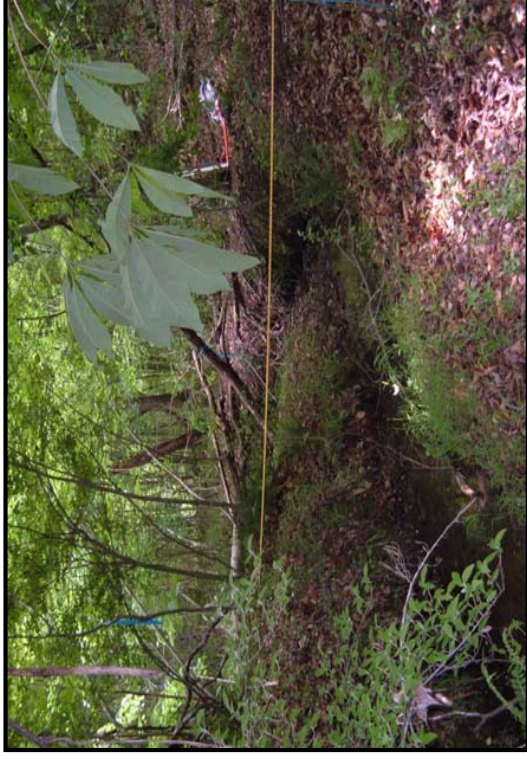
<b>River Basin:</b>	Cape Fear
<b>Watershed:</b>	UT Wilkinson-Reference Reach
<b>XS ID</b>	XS - 3, Riffle
<b>Drainage Area (sq mi):</b>	0.145
<b>Date:</b>	5/9/2006
<b>Field Crew:</b>	A. Helms, A. French

Station	Elevation
0	100.47
5	100.60
10	100.82
14	100.61
16	100.09
17	99.36
18	97.56
18.7	97.67
19.7	97.64
20.7	97.63
22	97.83
23.2	98.10
25	98.86
27	99.35
29	99.59
32	100.32
35	100.97
39	101.20

SUMMARY DATA	
<b>Bankfull Elevation:</b>	98.9
<b>Bankfull Cross-Sectional Area:</b>	7.0
<b>Bankfull Width:</b>	7.7
<b>Flood Prone Area Elevation:</b>	100.2
<b>Flood Prone Width:</b>	16.0
<b>Max Depth at Bankfull:</b>	1.3
<b>Mean Depth at Bankfull:</b>	0.9
<b>W / D Ratio:</b>	8.5
<b>Entrenchment Ratio:</b>	2.1
<b>Bank Height Ratio:</b>	2.3
<b>Water Surface Slope (ft/ft):</b>	0.018

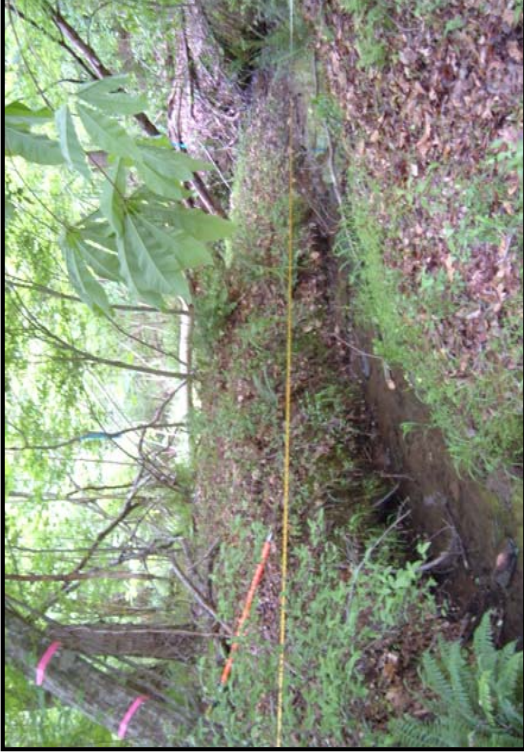
<b>River Basin:</b>	Cape Fear
<b>Watershed:</b>	UT Wilkinson-Reference Reach
<b>XS ID</b>	XS - 4, Pool
<b>Drainage Area (sq mi):</b>	0.145
<b>Date:</b>	5/9/2006
<b>Field Crew:</b>	A. Helms, A. French

Station	Elevation
0	100.88
5	100.71
10	100.98
12	100.31
13	99.22
13.8	97.58
15	97.55
16.8	97.84
18.4	98.67
21	98.72
24	99.47
28	100.07
33	100.90
37	101.15
40	100.98

SUMMARY DATA	
<b>Bankfull Elevation:</b>	99.2
<b>Bankfull Cross-Sectional Area:</b>	8.8
<b>Bankfull Width:</b>	10.0
<b>Flood Prone Area Elevation:</b>	-
<b>Flood Prone Width:</b>	-
<b>Max Depth at Bankfull:</b>	1.7
<b>Mean Depth at Bankfull:</b>	0.9
<b>W / D Ratio:</b>	-
<b>Entrenchment Ratio:</b>	-
<b>Bank Height Ratio:</b>	-
<b>Water Surface Slope (ft/ft):</b>	0.018

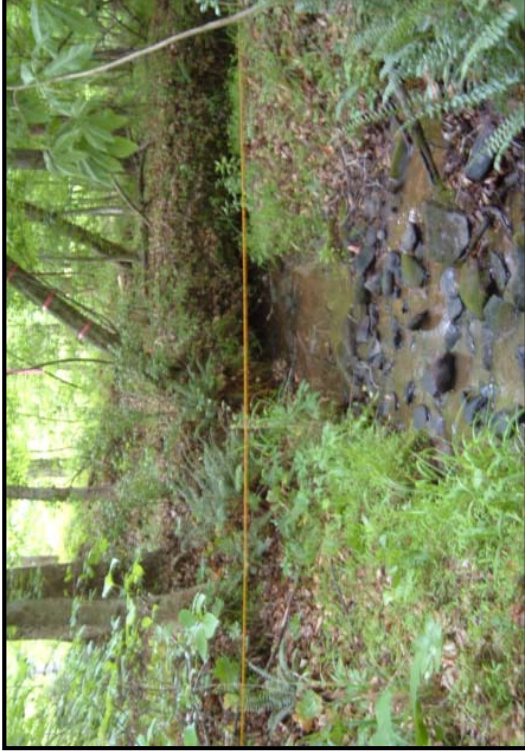
<b>River Basin:</b>	Cape Fear
<b>Watershed:</b>	UT Wilkinson-Reference Reach
<b>XS ID</b>	XS - 5, Riffle
<b>Drainage Area (sq mi):</b>	0.145
<b>Date:</b>	5/9/2006
<b>Field Crew:</b>	A. Helms, A. French

Station	Elevation
0.00	101.00
5.00	101.06
10.00	101.01
13.00	100.20
15.00	98.96
17.00	98.83
18.80	97.94
20.00	97.94
22.00	98.05
23.00	98.08
24.50	97.75
26.00	99.70
30.00	100.90
36.00	101.26

SUMMARY DATA	
<b>Bankfull Elevation:</b>	98.8
<b>Bankfull Cross-Sectional Area:</b>	6.1
<b>Bankfull Width:</b>	8.3
<b>Flood Prone Area Elevation:</b>	99.9
<b>Flood Prone Width:</b>	13.0
<b>Max Depth at Bankfull:</b>	1.1
<b>Mean Depth at Bankfull:</b>	0.7
<b>W / D Ratio:</b>	11.4
<b>Entrenchment Ratio:</b>	1.6
<b>Bank Height Ratio:</b>	2.7
<b>Water Surface Slope (ft/ft):</b>	0.018

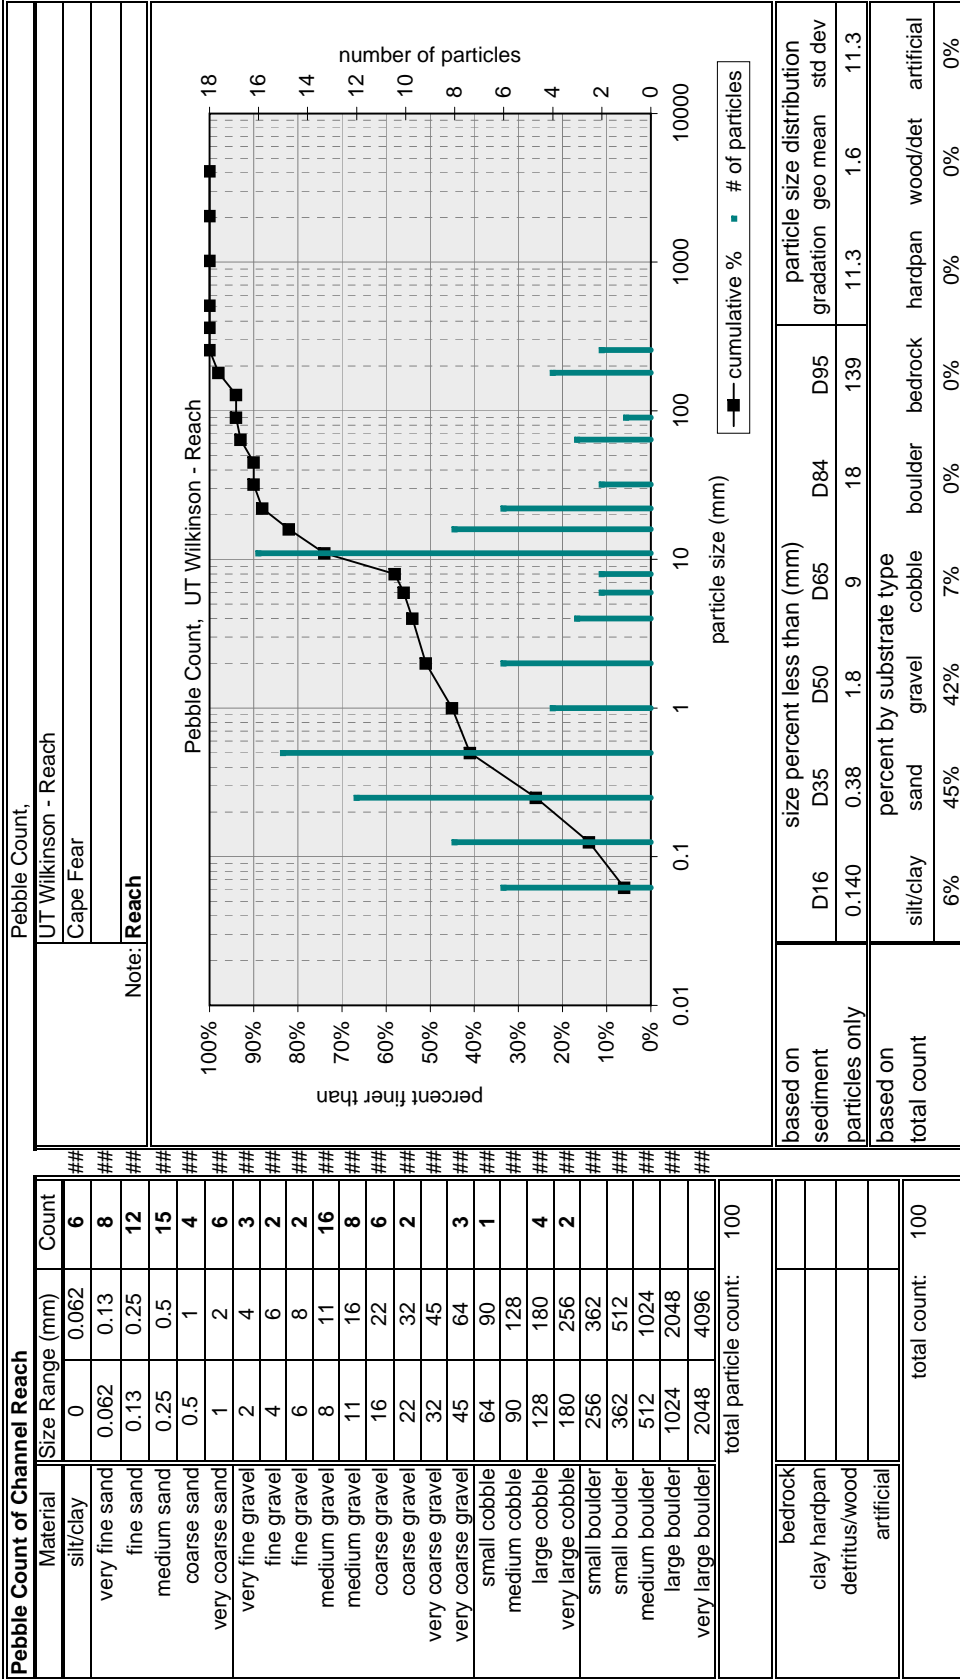
notes	inc distance	Elevation BM: 100		FS TP	FS bed	depth water	FS LB	FS RB	FS BKF	FS WS	AZ azimuth	ELEV bed	ELEV water srf	ELEV LF	ELEV RB	ELEV BKF	ELEV WS
		BS	HI														
TW	0	0	100									98.70					99.07
RIFF-start	8.18	8.2	100									98.85					99.04
RI	12.69	20.9	100									98.63					
RI	6.10	27.0	100									98.48					
RIFF-end	6.72	33.7	100									98.23					98.39
TW	3.93	37.6	100									98.09					98.37
TW	9.17	46.8	100									98.12					98.33
TW	7.32	54.1	100									97.87					
RIFF-start	2.85	57.0	100									97.96					98.27
RIFF-end	11.38	68.4	100									97.59					97.95
TW	7.69	76.0	100									97.53					
TW	7.78	83.8	100									97.51					97.85
TW	7.69	91.5	100									97.36					97.75
TW	11.66	103.2	100									97.44					97.69
TW	6.14	109.3	100									97.19					
TW	9.79	119.1	100									97.05					97.37
RIFF-start	7.15	126.2	100									97.21					97.34
RIFF-end	10.36	136.6	100									96.75					97.14

TW	5.82	142.4	100									96.73					
TW	8.26	150.7	100									96.35					96.90
POOL-start	2.81	153.5	100									96.45					96.86
POOL	2.63	156.1	100									96.17					
POOL-end	2.41	158.5	100									96.51					96.87
TW	11.78	170.3	100									96.20					96.70
POOL-start	6.31	176.6	100									96.33					96.67
POOL	3.81	180.4	100									96.08					
POOL-end	4.80	185.2	100									96.30					96.64
RIFF-start	5.96	191.2	100									96.39					96.71
RI	6.43	197.6	100									96.32					
RIFF-end	7.27	204.9	100									96.27					96.54
