Collins Creek Stream Restoration Site

EEP Project #92205

Monitoring Year 05 CLOSEOUT REPORT

Project Type: Stream Restoration

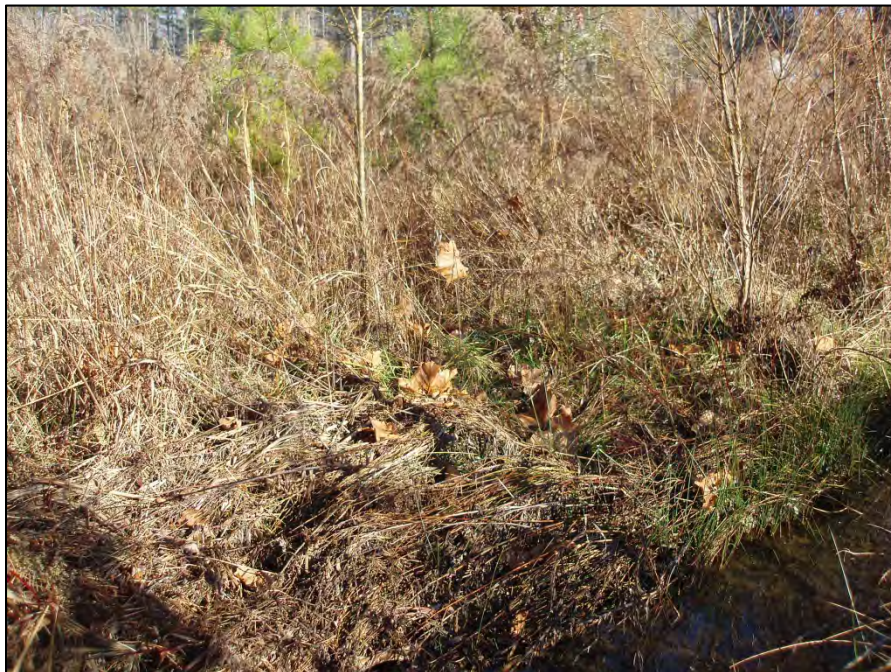
Table 5. Verification of Bankfull Events Collins Creek Stream Restoration Site		
Date of Data Collection	Date of Occurrence	Method
10/1/08	7/5/2008	Stream Gauge
10/1/08	8/27/2008	Stream Gauge
10/1/08	9/6/2008	Stream Gauge
10/1/08	9/10/2008	Stream Gauge
10/1/08	9/16/2008	Stream Gauge
1/12/10	3/1/2009	Stream Gauge
1/12/10	3/15/2009	Stream Gauge
1/12/10	6/5/2009	Stream Gauge
1/12/10	6/10/2009	Stream Gauge
1/12/10	11/11/2009	Stream Gauge
1/12/10	12/2/2009	Stream Gauge
9/30/10	1/14/2010	Stream Gauge
9/30/10	1/25/2010	Stream Gauge
9/30/10	2/5/2010	Stream Gauge
9/30/10	5/18/2010	Stream Gauge
9/30/10	9/29/2010	Stream Gauge
5/25/11	5/4/2011	Stream Gauge
7/27/11	5/9/2011-5/22/2011	Stream Gauge
12/13/12		See Photo
