COLONIAL FARMS WETLAND MITIGATION SITE ANNUAL MONITORING REPORT – YEAR 2

Edgecombe County, NC

NCDMS ID No. 100191

Monitoring Year 2 – 2023

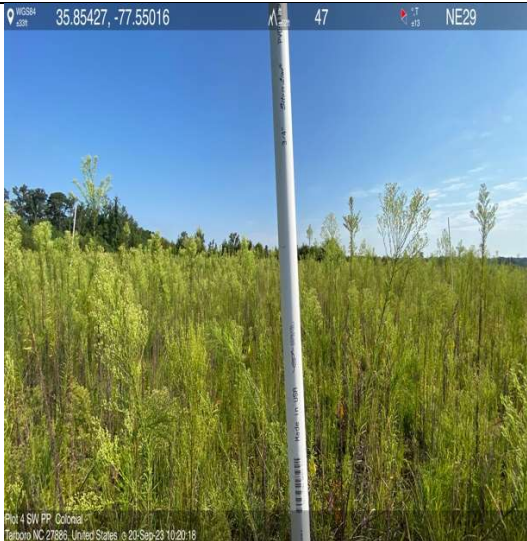
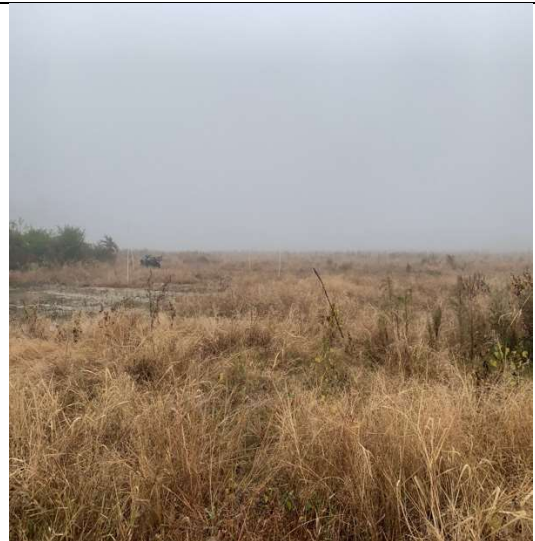
Photo #4
 Date: 09/20/2023
 Feature: Plot 4
 Direction: Northeast

- Vegetation assessment for MY2 was conducted in September 2023. Vegetation surveys of the 10 fixed and 4 random vegetation plots resulted in calculated stem densities ranging from 323-971 stems per acre and an 105% overall survival rate (see note on supplemental planting below) of planted stems from the as-built (baseline) condition. The calculated average stem density for the Site was 679 stems per acre, well above the interim success criteria of 320 stems per acres in MY3. All 14 vegetation plots exceeded the MY3 interim success criteria. Vegetation plot photographs are included in Appendix A and vegetation plot data is included in Appendix B.

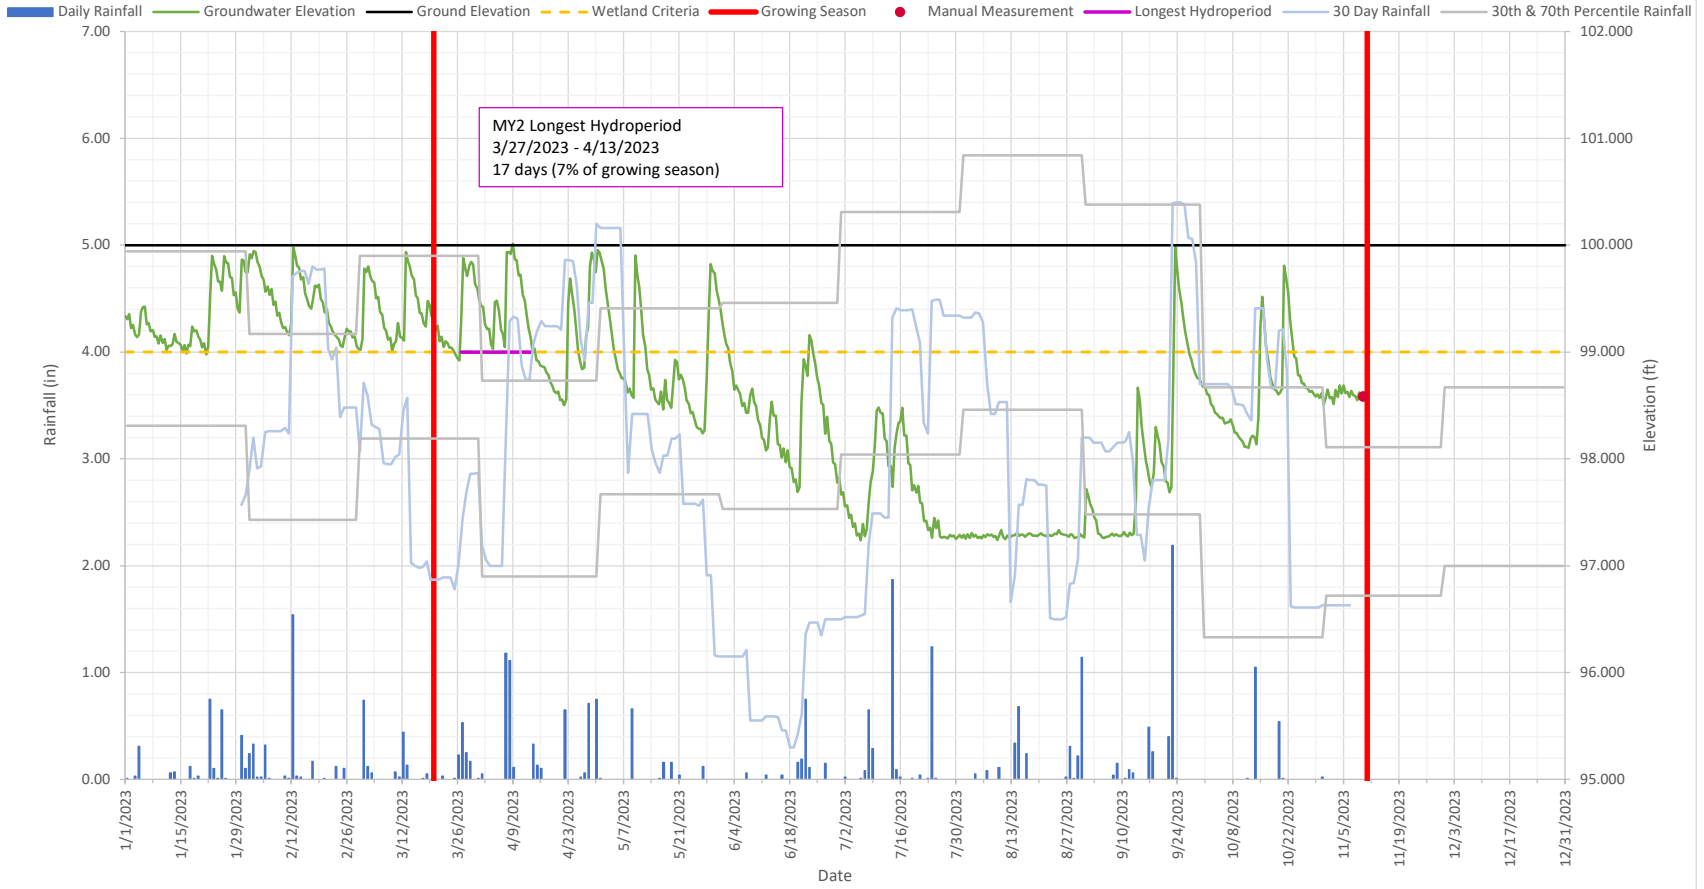
Colonial Farms Wetland Mitigation Site - MY2 2023 Reference Groundwater Well

- Assessment of data collected by the reference groundwater well located in a forested wetland to the east of the Site indicates that groundwater within 12 inches of the ground surface had a maximum hydroperiod of 17 days (7% of the growing season) during the MY2 growing season.

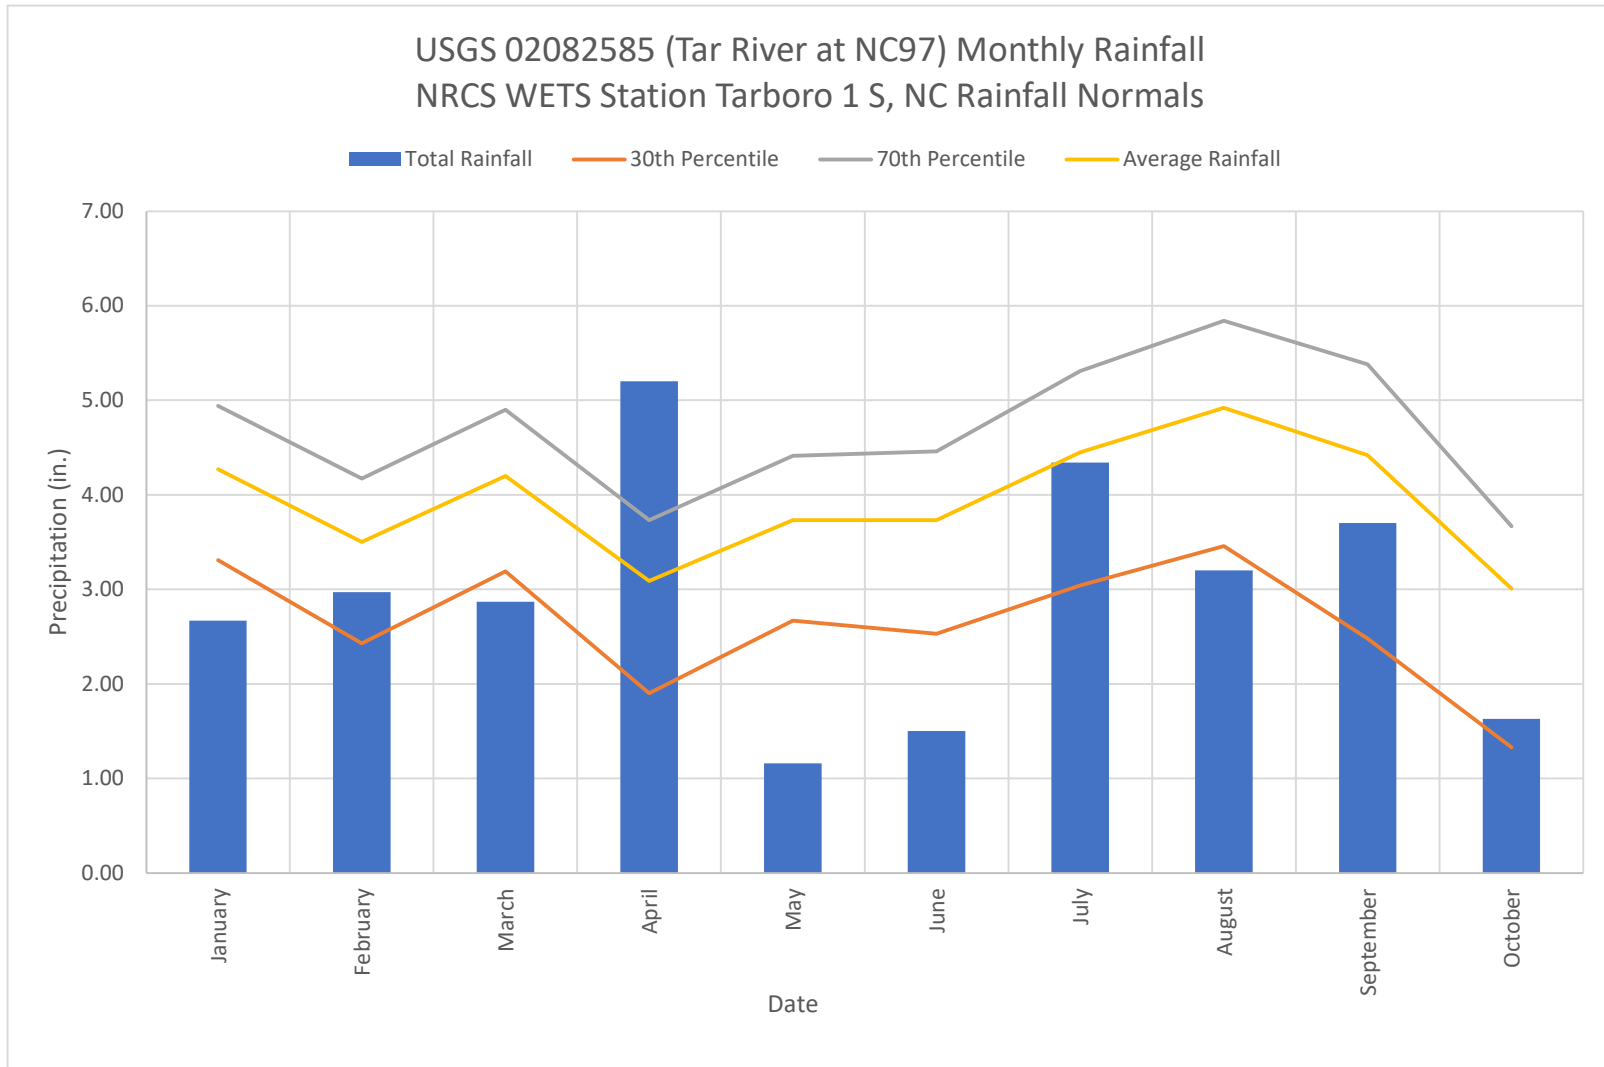
Cumulative Monthly Rainfall Summary
Colonial Farms Wetland Mitigation Site
DMS ID No. 100191
DWR Project No. 2021-0399v2
Monitoring Year 2 – 2023

- The Site rainfall gauge experienced equipment malfunction. Therefore, rainfall data was obtained from USGS gauge station 02082585 (Tar River at NC97), located approximately 15 miles northwest of the Site in Rocky Mount, NC and presented for the entire monitoring year. The Site's rainfall gauge will be replaced and maintained throughout the subsequent monitoring years to ensure that accurate precipitation data is obtained and presented for monitoring periods.

- The area received less than average rainfall during 2023. Rainfall data analysis indicates that five of the first ten months in 2023 (January – October) experienced cumulative rainfall less than the 30th percentile value for the month. April 2023 was the only month that did exceed the 70th percentile value for the month. As shown in graphs in Appendix C, 44% of the 30-day rainfall within the growing season was below the 30th percentile, and 75% was below the average rainfall. A large percentage of the 30-day rainfall within the growing season was also below the 30th percentile daily normals as compiled using the Antecedent Precipitation Tool (APT) presented in Appendix C.

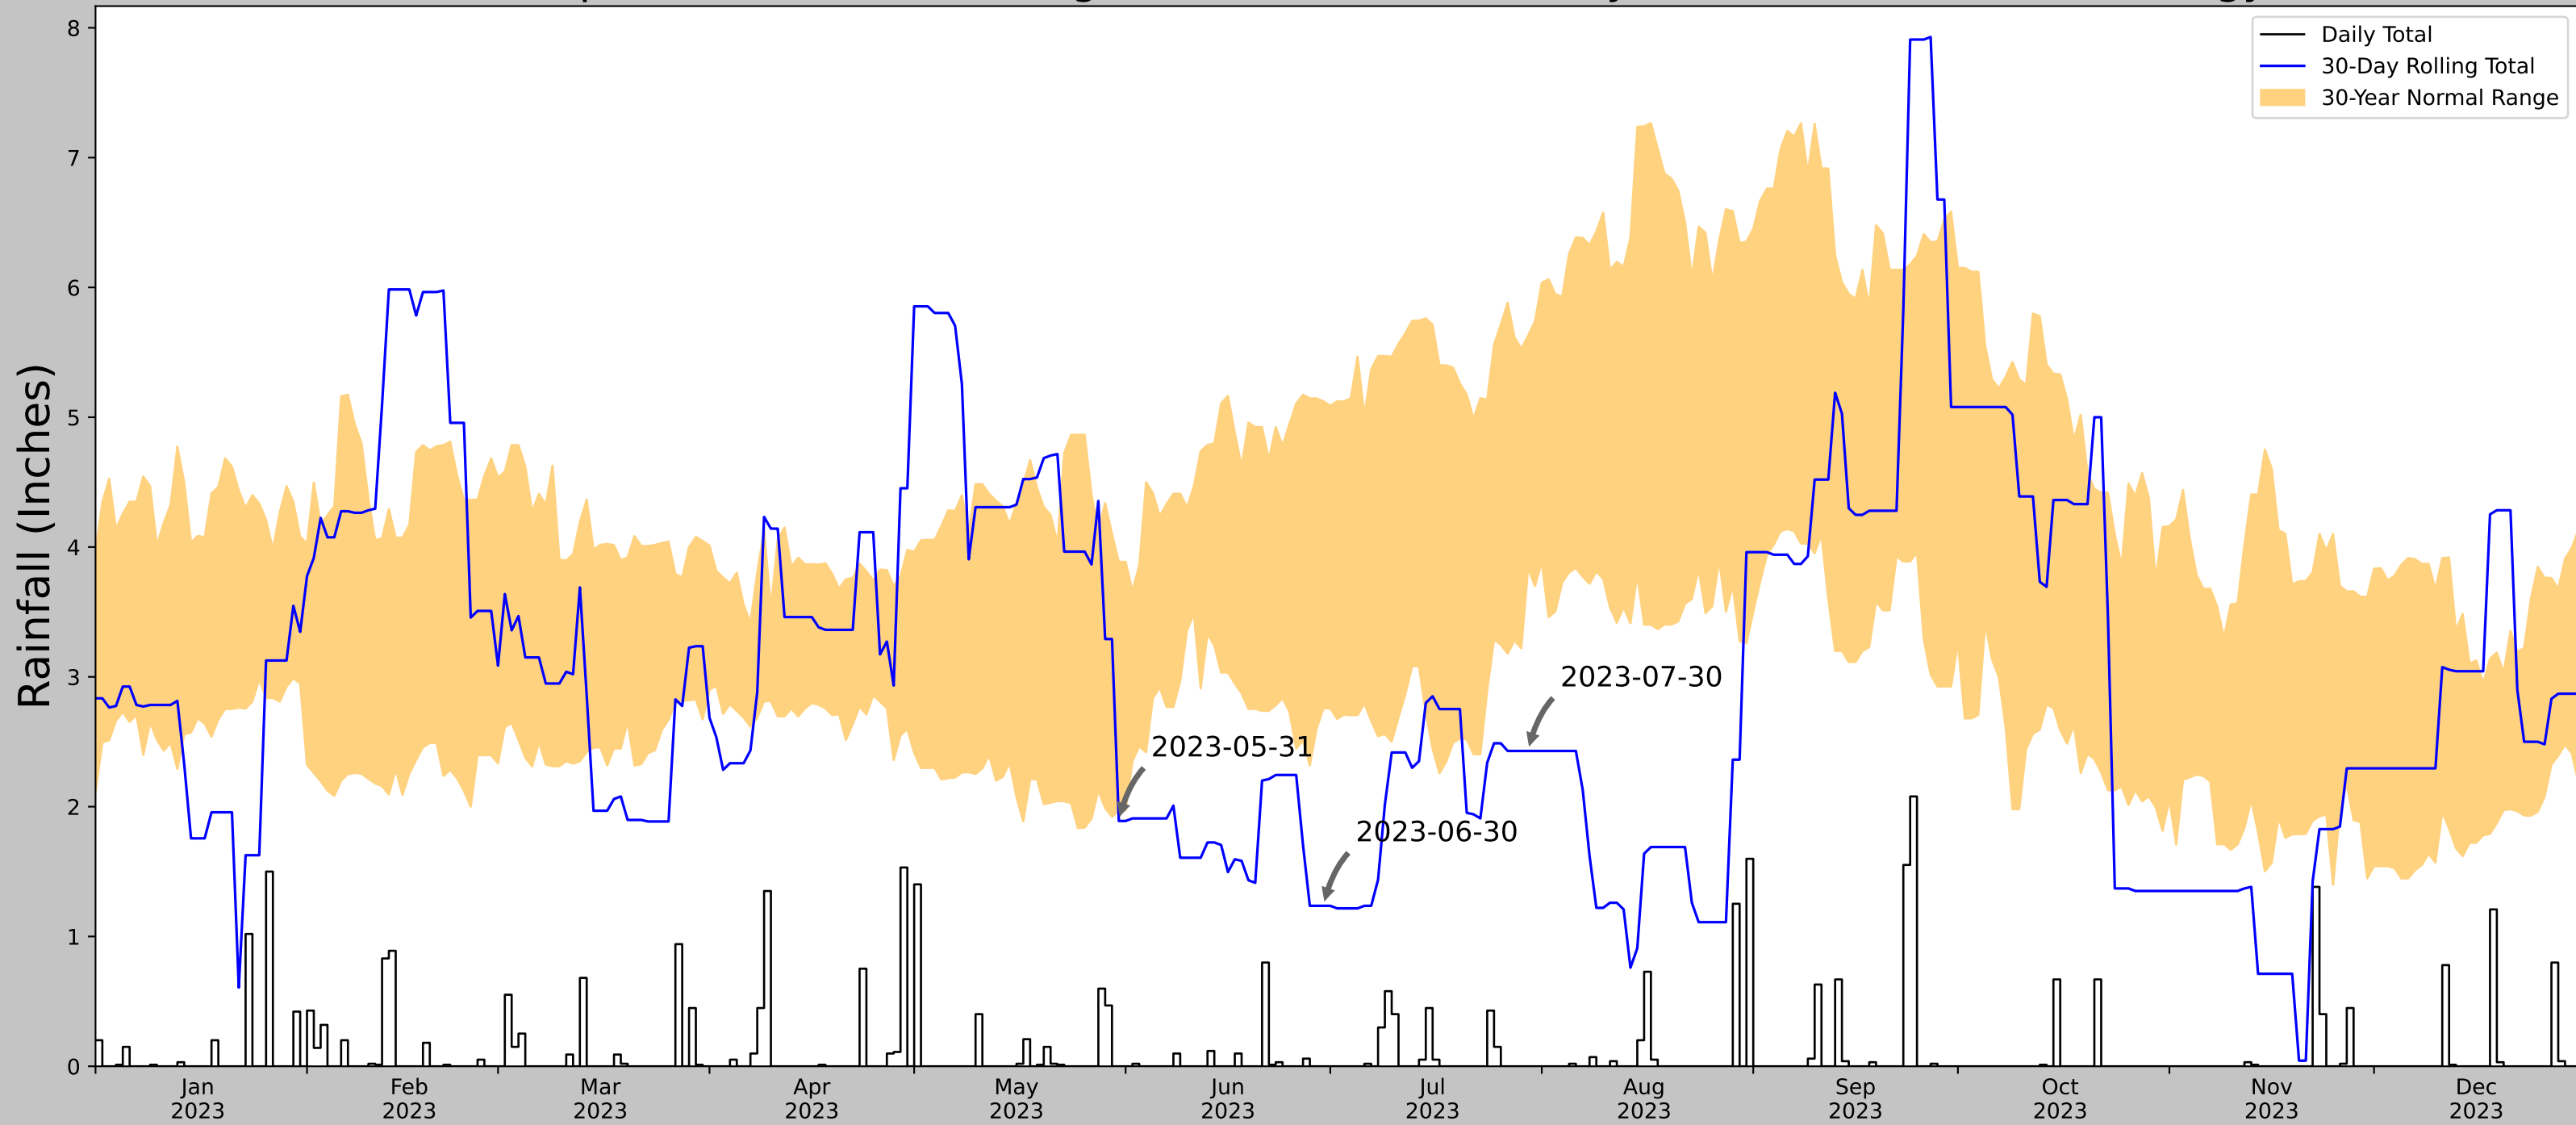
Antecedent Precipitation vs Normal Range based on NOAA's Daily Global Historical Climatology Network

Coordinates	35.853767, -77.549397
Observation Date	2023-07-30
Elevation (ft)	43.315
Drought Index (PDSI)	Moderate drought
WebWIMP H ₂ O Balance	Dry Season

30 Days Ending	30 th %ile (in)	70 th %ile (in)	Observed (in)	Wetness Condition	Condition Value	Month Weight	Product
2023-07-30	3.83937	5.627953	2.429134	Dry	1	3	3
2023-06-30	2.75748	5.122047	1.236221	Dry	1	2	2
2023-05-31	1.966535	3.885827	1.889764	Dry	1	1	1
Result							Drier than Normal - 6

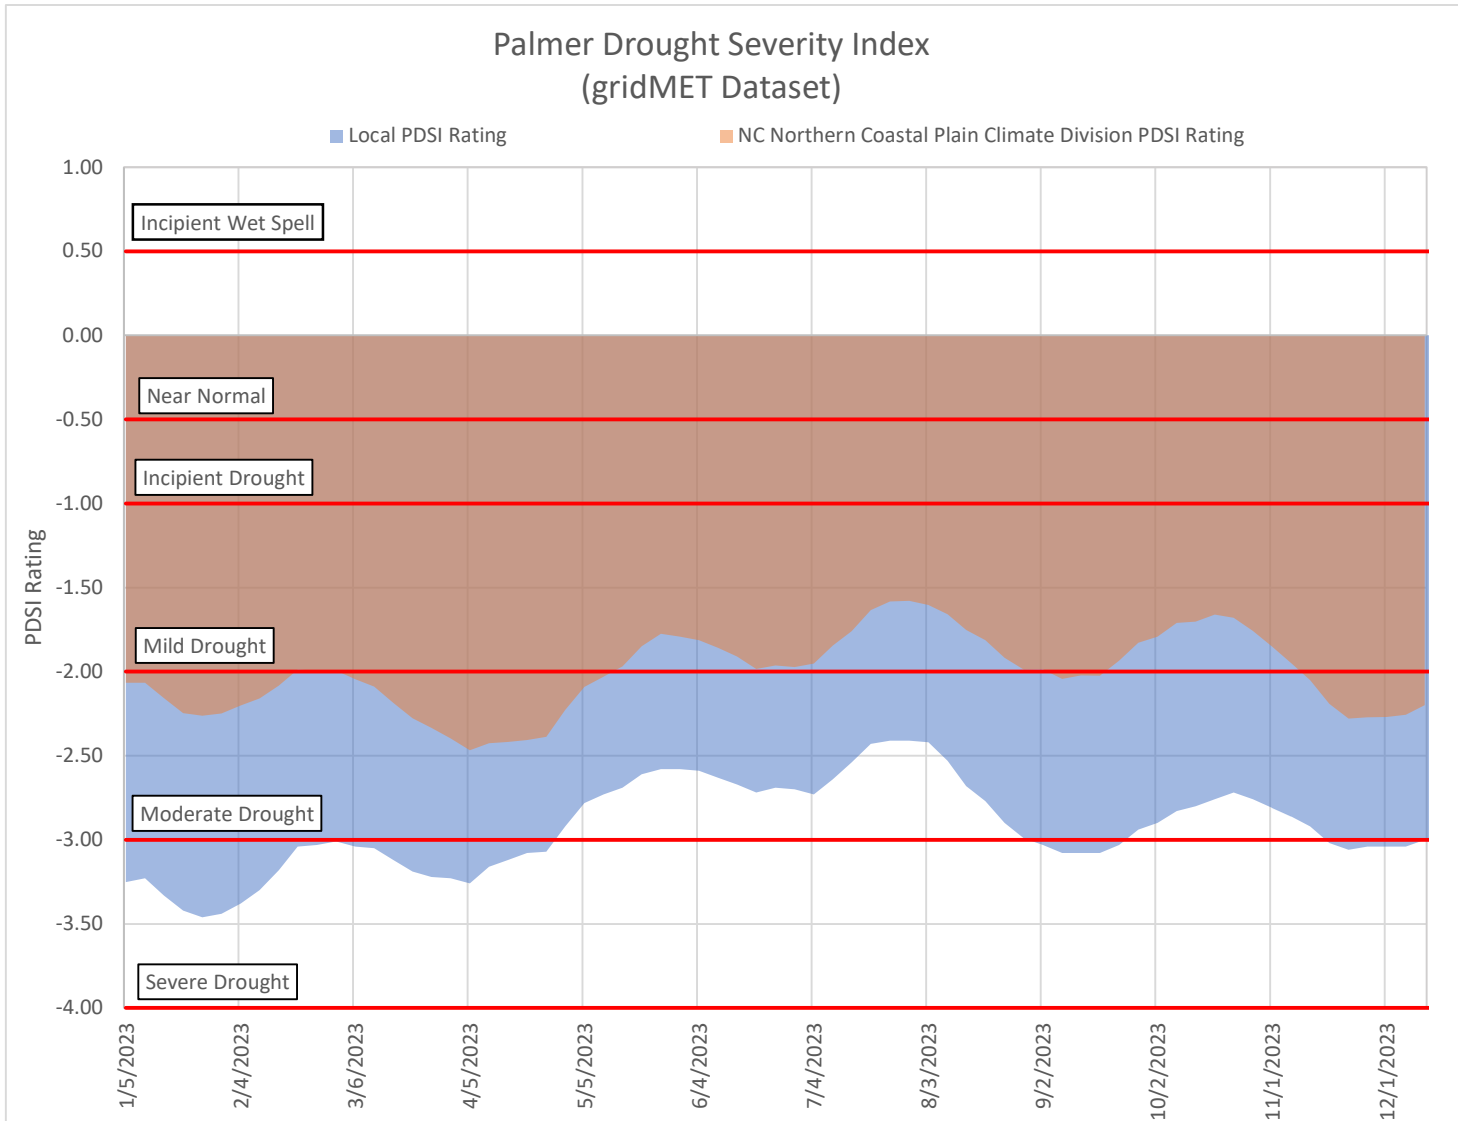
Palmer Drought Severity Index (PDSI)
Colonial Farms Wetland Mitigation Site
DMS ID No. 100191
DWR Project No. 2021-0399v2
Monitoring Year 2 – 2023

- According to the PDSI data, the Site experienced moderate drought for 53% of the year and severe drought for 47% of the year. According to PDSI ratings for the Site's climate division (NC Northern Coastal Plain), the division spent 53% of the year in mild drought and 48% in moderate drought. A summary of the PDSI ratings for the Site and climate division is attached in Appendix D.

- Drought conditions persisted throughout the Northern Coastal Plain climate division for 2023, and more locally, the Site and adjacent areas underwent intensified drought conditions when compared to the region's climate division.
