**COLONIAL FARMS WETLAND MITIGATION SITE
DRAFT ANNUAL MONITORING REPORT – YEAR 1**

Edgecombe County, NC

NCDMS ID No. 100191

November 2022

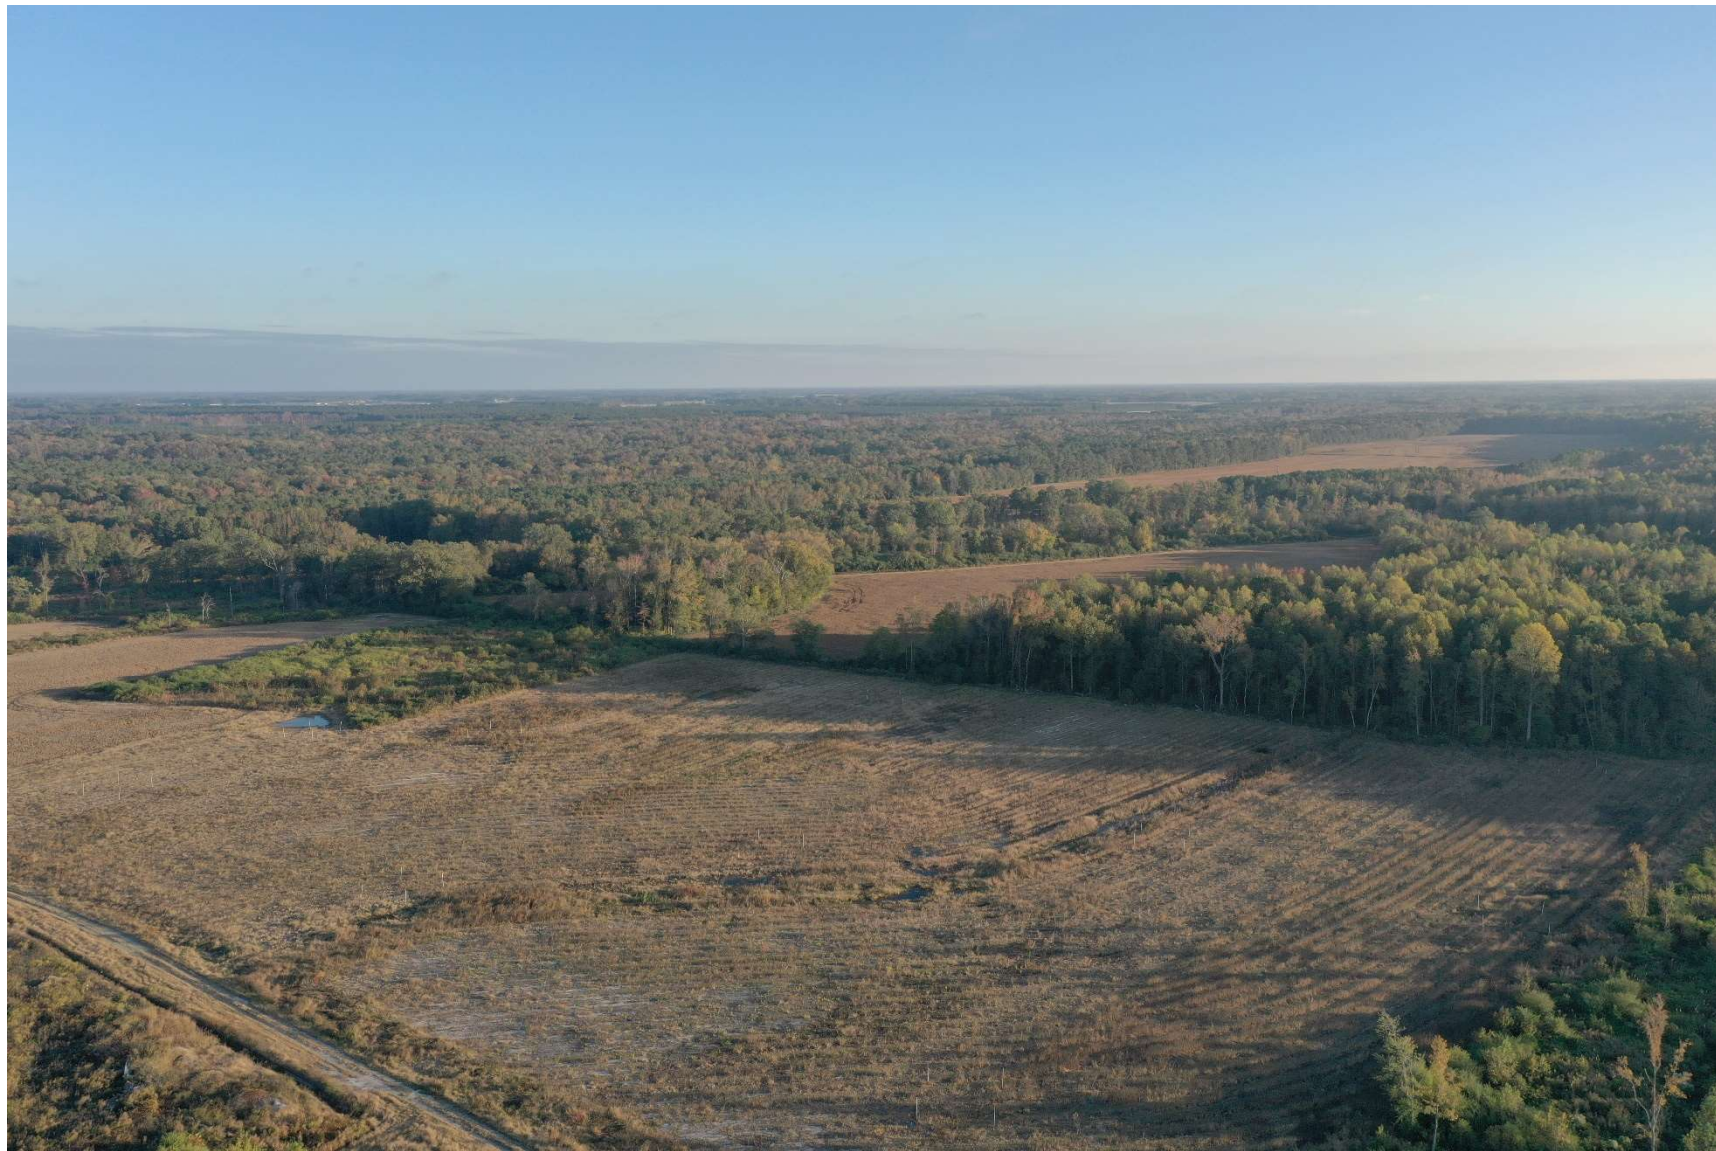
Site Aerial (view SE) – taken 10/25/2022

- Visual assessment of the Site indicates that the Site is stable and planted vegetation is in good health. The constructed ditch plug at the northeast corner of the Site shows no sign of deterioration from overland runoff or scour beneath the perched culvert passing beneath the farm road. There are no signs of erosion or excessive sediment deposition at the Site.

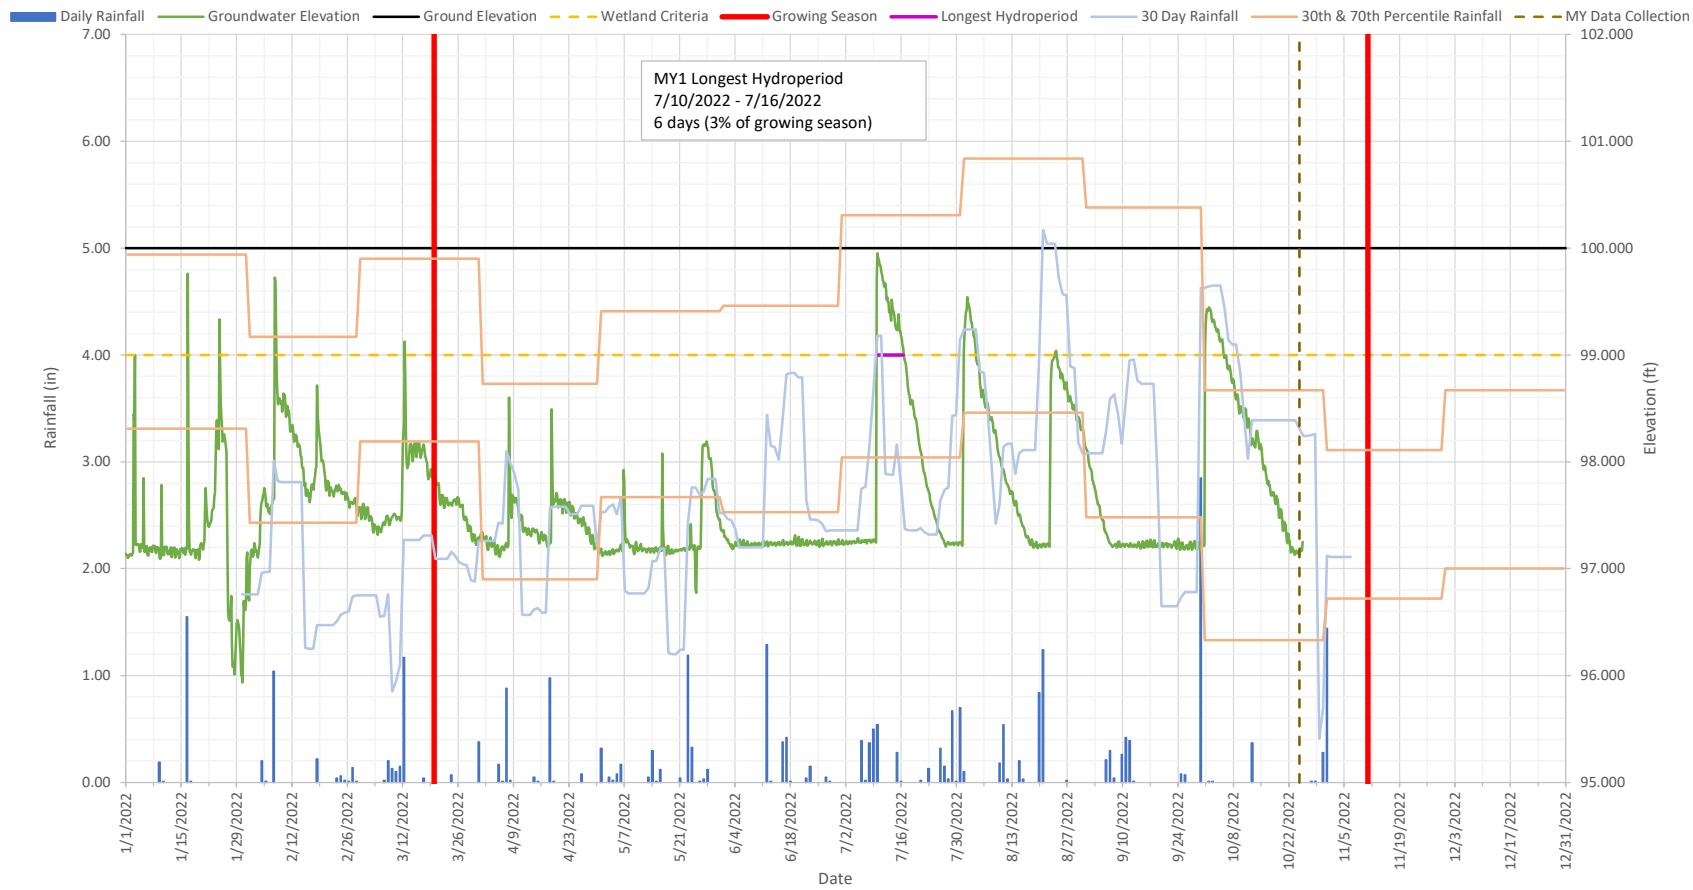
Colonial Farms Wetland Mitigation Site - MY1 2022 Groundwater Well 3

c. GW 3 data collection stops in August. Was there a malfunction, and if so, has the well been repaired/replaced?

GW3 data was not plotted correctly. GW3 plot has been revised. Please let us know if you have any further comments or questions related to the MY1 Annual Report. We look forward to working with you and ensuring a successful project moving forward.

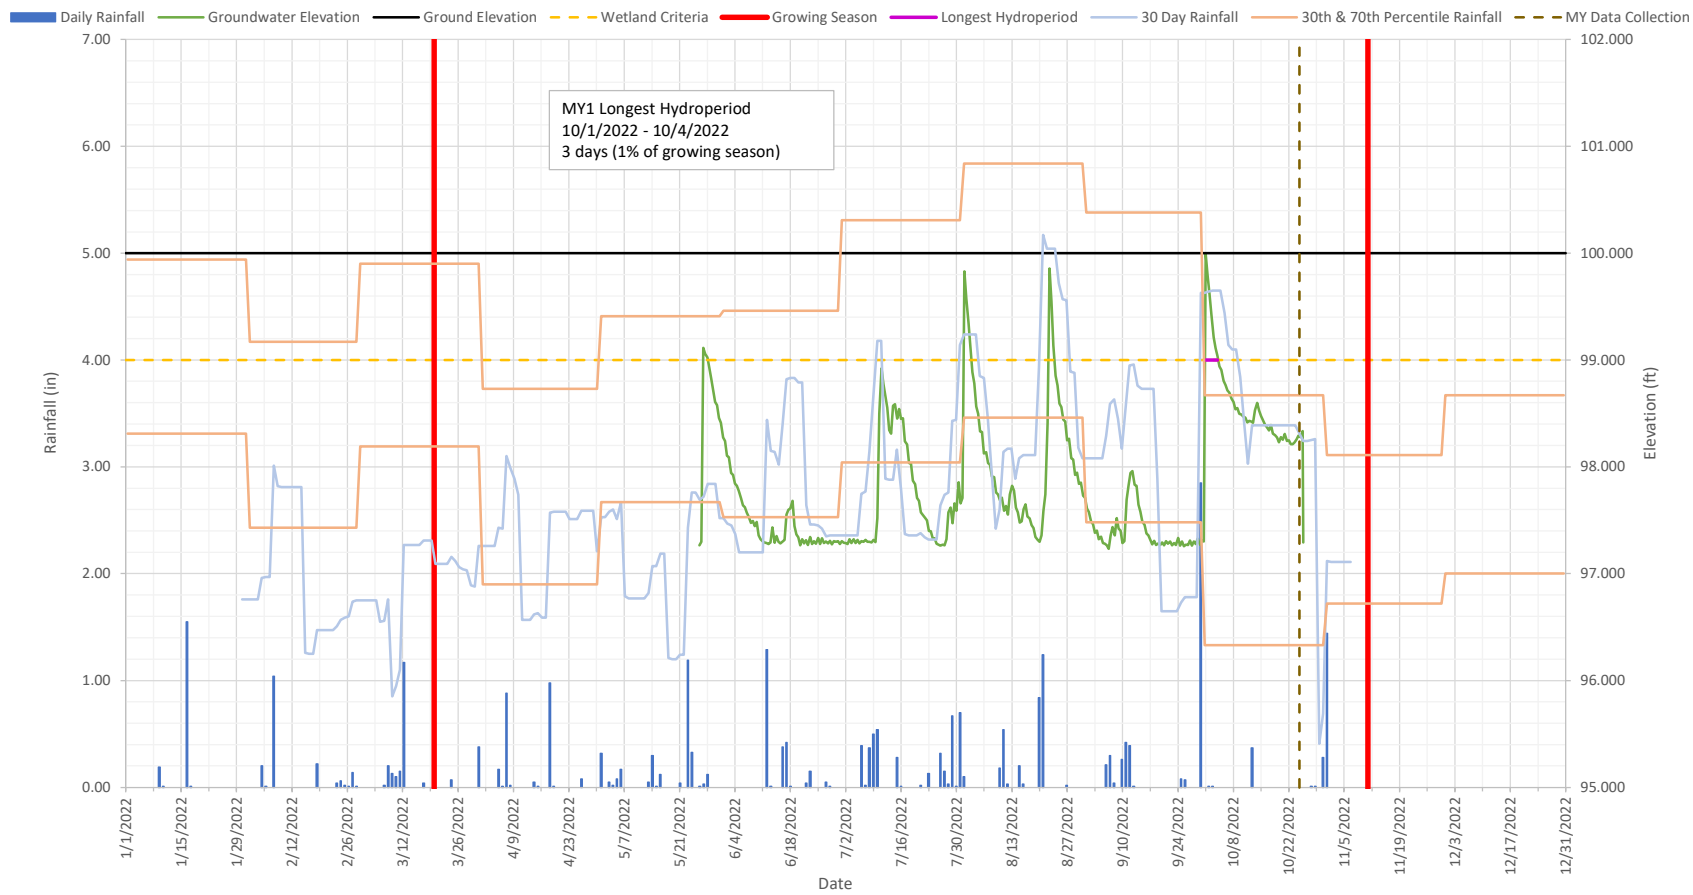
Colonial Farms Wetland Mitigation Site - MY1 2022 Reference Groundwater Well

- Assessment of data collected by the reference groundwater well located in a forested wetland to the east of the Site indicates that groundwater within 12 inches of the ground surface had a maximum hydroperiod of 3 days (1% of the growing season) during the MY1 growing season. The area received less than average rainfall during 2022. Rainfall data analysis indicates that six of the first ten months in 2022 (January – October) experienced cumulative rainfall less than the 30th percentile value for the month.
