AS-BUILT MITIGATION PLAN
COLUMBUS SWAMP WETLAND RESTORATION SITE
ROBESON/COLUMBUS COUNTIES, NORTH CAROLINA
(Contract 000619)

FULL DELIVERY PROJECT
TO PROVIDE RIPARIAN WETLAND MITIGATION
IN THE LUMBER RIVER BASIN
CATALOGING UNIT 03040203

February 2009

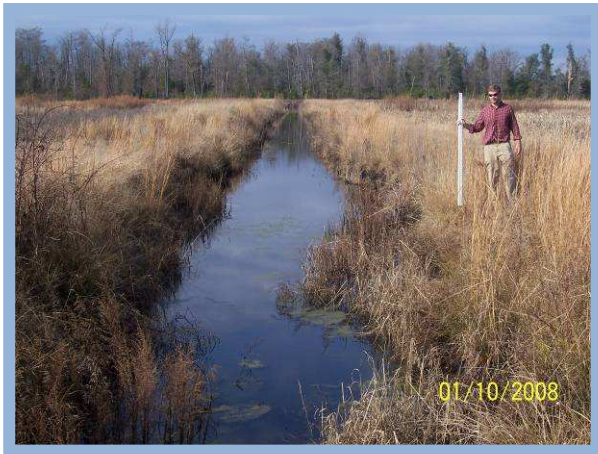
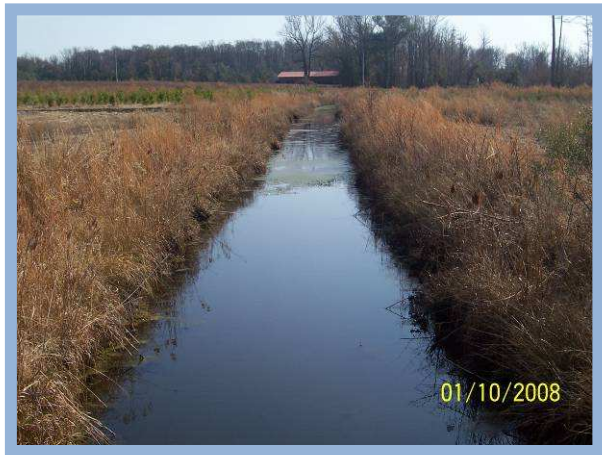
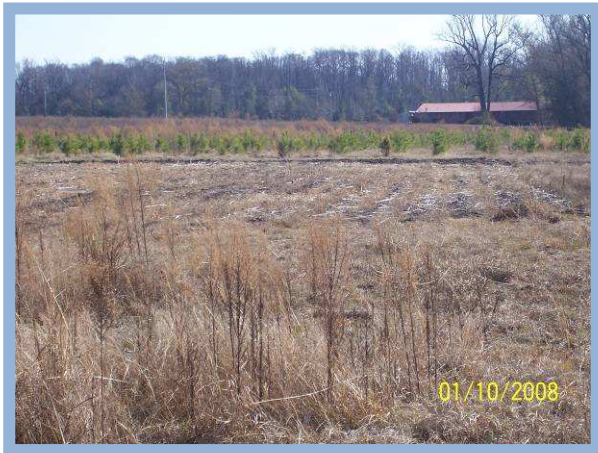
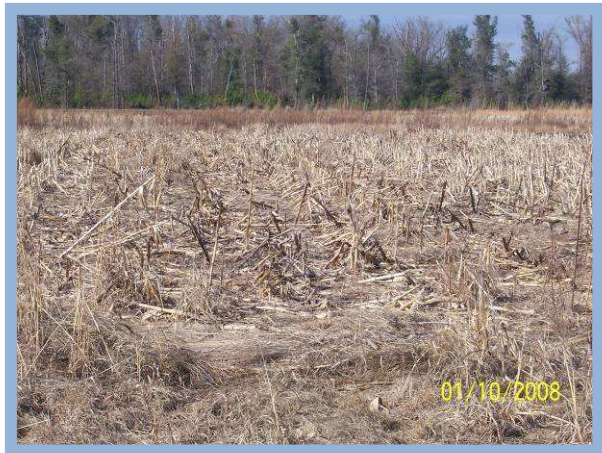
**Columbus Swamp Preconstruction Conditions
Taken January 2008**

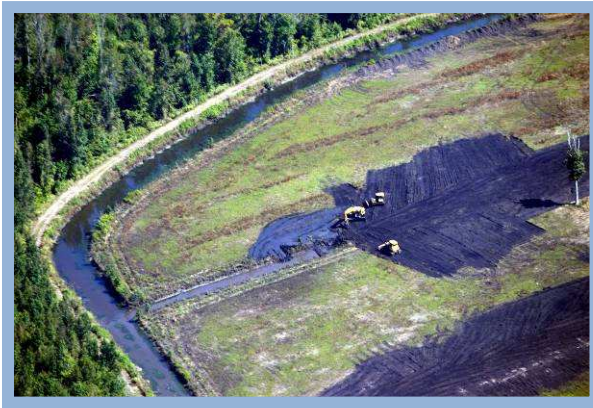
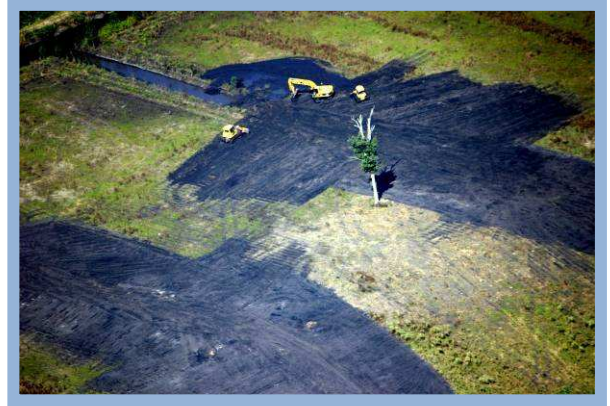
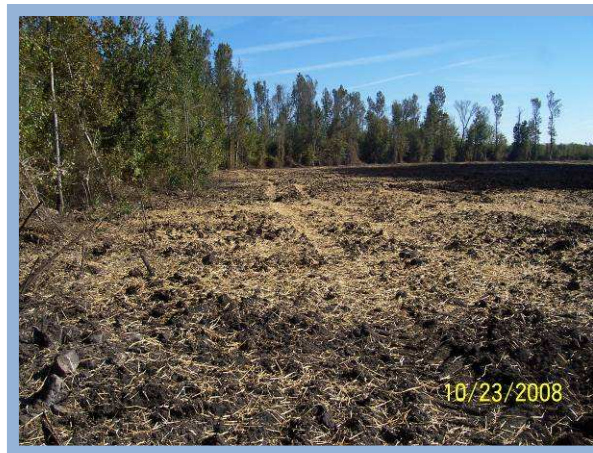
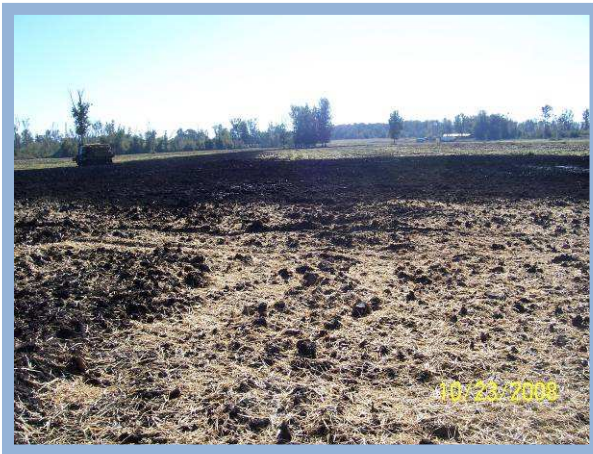
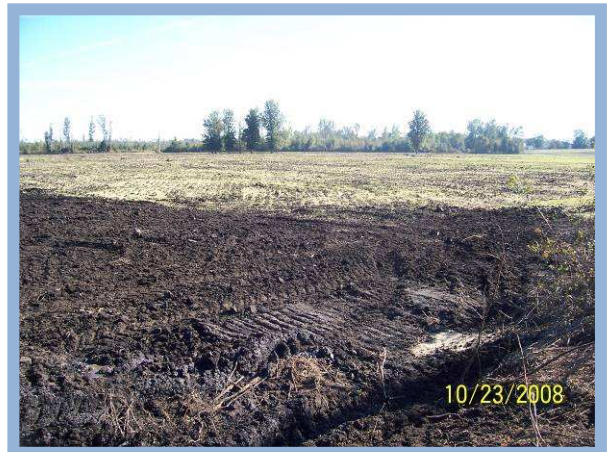
**Columbus Swamp During Construction
Taken October 2008**
