**YEAR 4 (2012)**  
**ANNUAL MONITORING REPORT**  
**COLUMBUS SWAMP WETLAND RESTORATION SITE**  
**ROBESON/COLUMBUS COUNTIES, NORTH CAROLINA**  
**(Contract 000619)**

**FULL DELIVERY PROJECT**  
**TO PROVIDE RIPARIAN WETLAND MITIGATION**  
**IN THE LUMBER RIVER BASIN**  
**CATALOGING UNIT 03040203**

**November 2012**

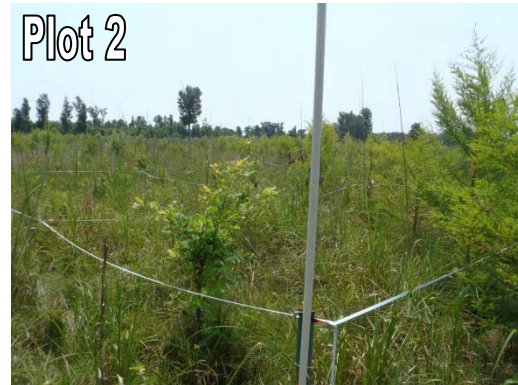
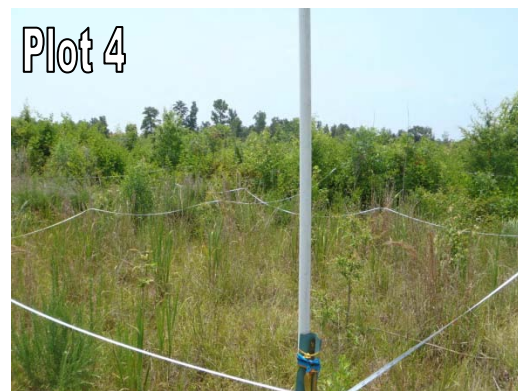
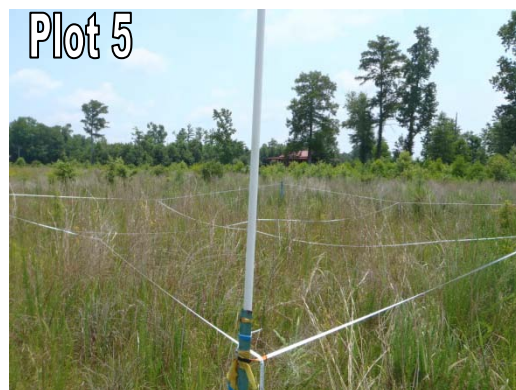
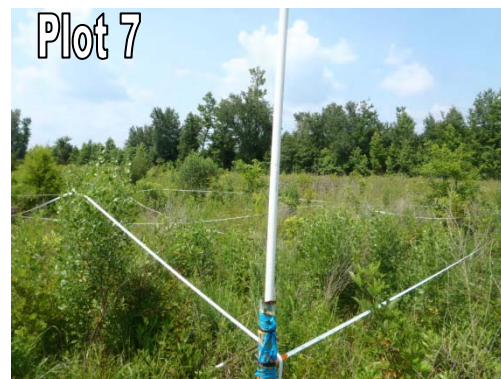
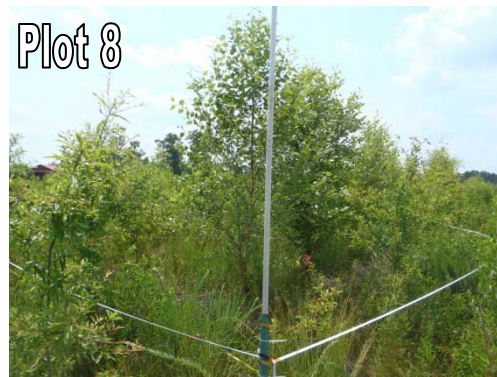
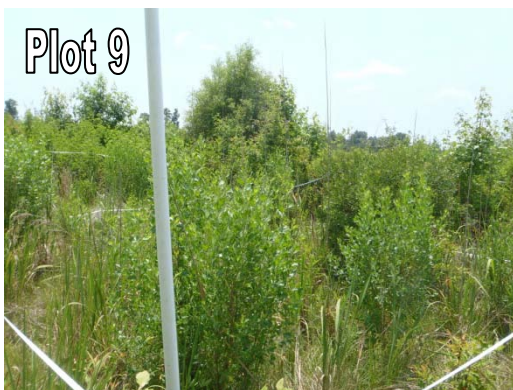
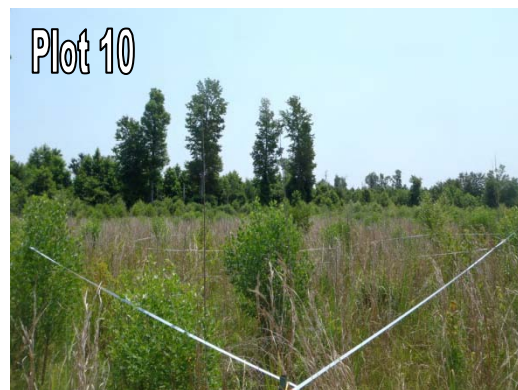
Columbus Swamp Wetland Restoration Site  
Year 4 (2012) Annual Monitoring  
Vegetation Plot Photos  
Taken June 2012

Vegetation sampling across the Site was above the required average density with an overall average of 1028 planted stems per acre. In Year 1 (2009), one of the ten vegetation plots (Plot 3) contained no planted stems due to extreme wetness in that portion of the Site. Groundwater Gauge 3, immediately adjacent to this plot, indicated the longest hydroperiod (108 consecutive days or 44.6% of the growing season) of all gauges on the Site for the same year. Ground observations indicated that approximately four acres around Plot 3 were vegetated by heavy stands of obligate wetland plants with evidence of standing water. Supplemental planting in this area occurred in late 2009 with species tolerant of long periods of soil saturation or surface inundation (*Nyssa biflora*, *Taxodium distichum*, and *Betula nigra*). This area appears to be doing well and no vegetation problem areas were noted during the year 4 (2012) monitoring season.

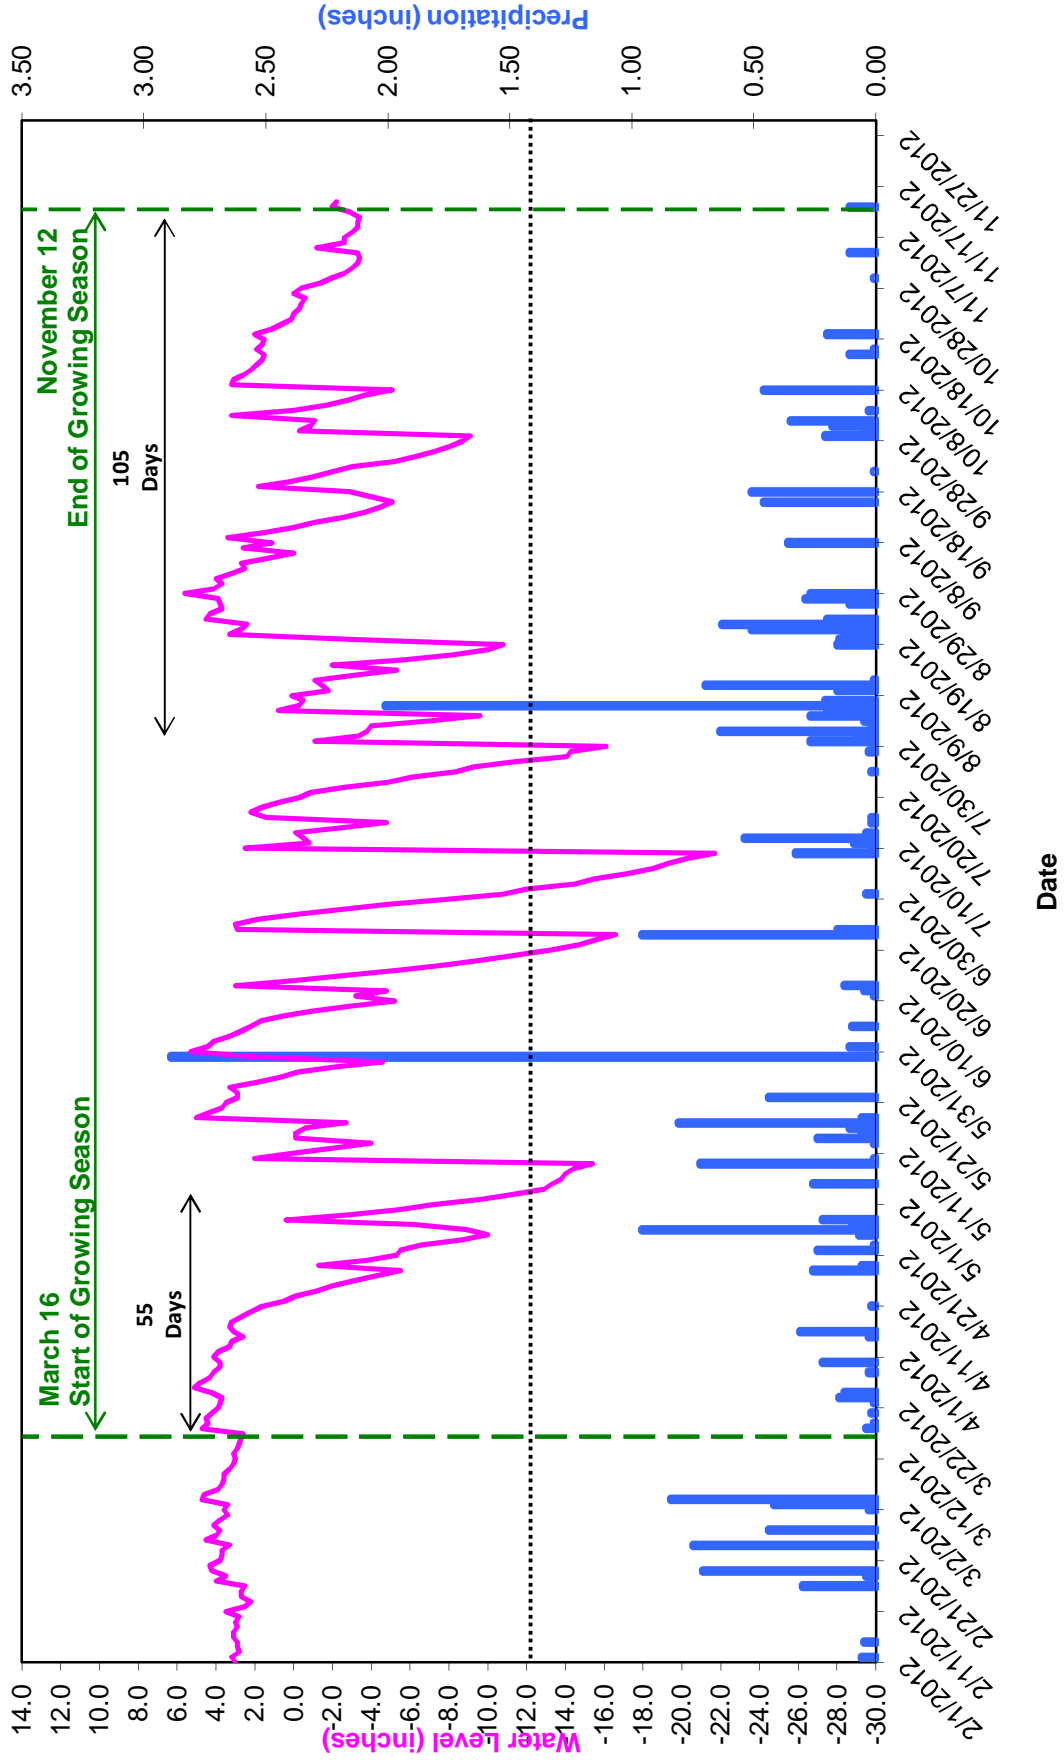
# Columbus Swamp Ground Water Gauge 1 Year 4 (2012 Data)

All monitored gauges within restoration areas were inundated/saturated within 12 inches of the surface for greater than 10 percent of the growing season (Table 6). Hydrographs containing groundwater and precipitation data for each gauge can be found in Appendix C.

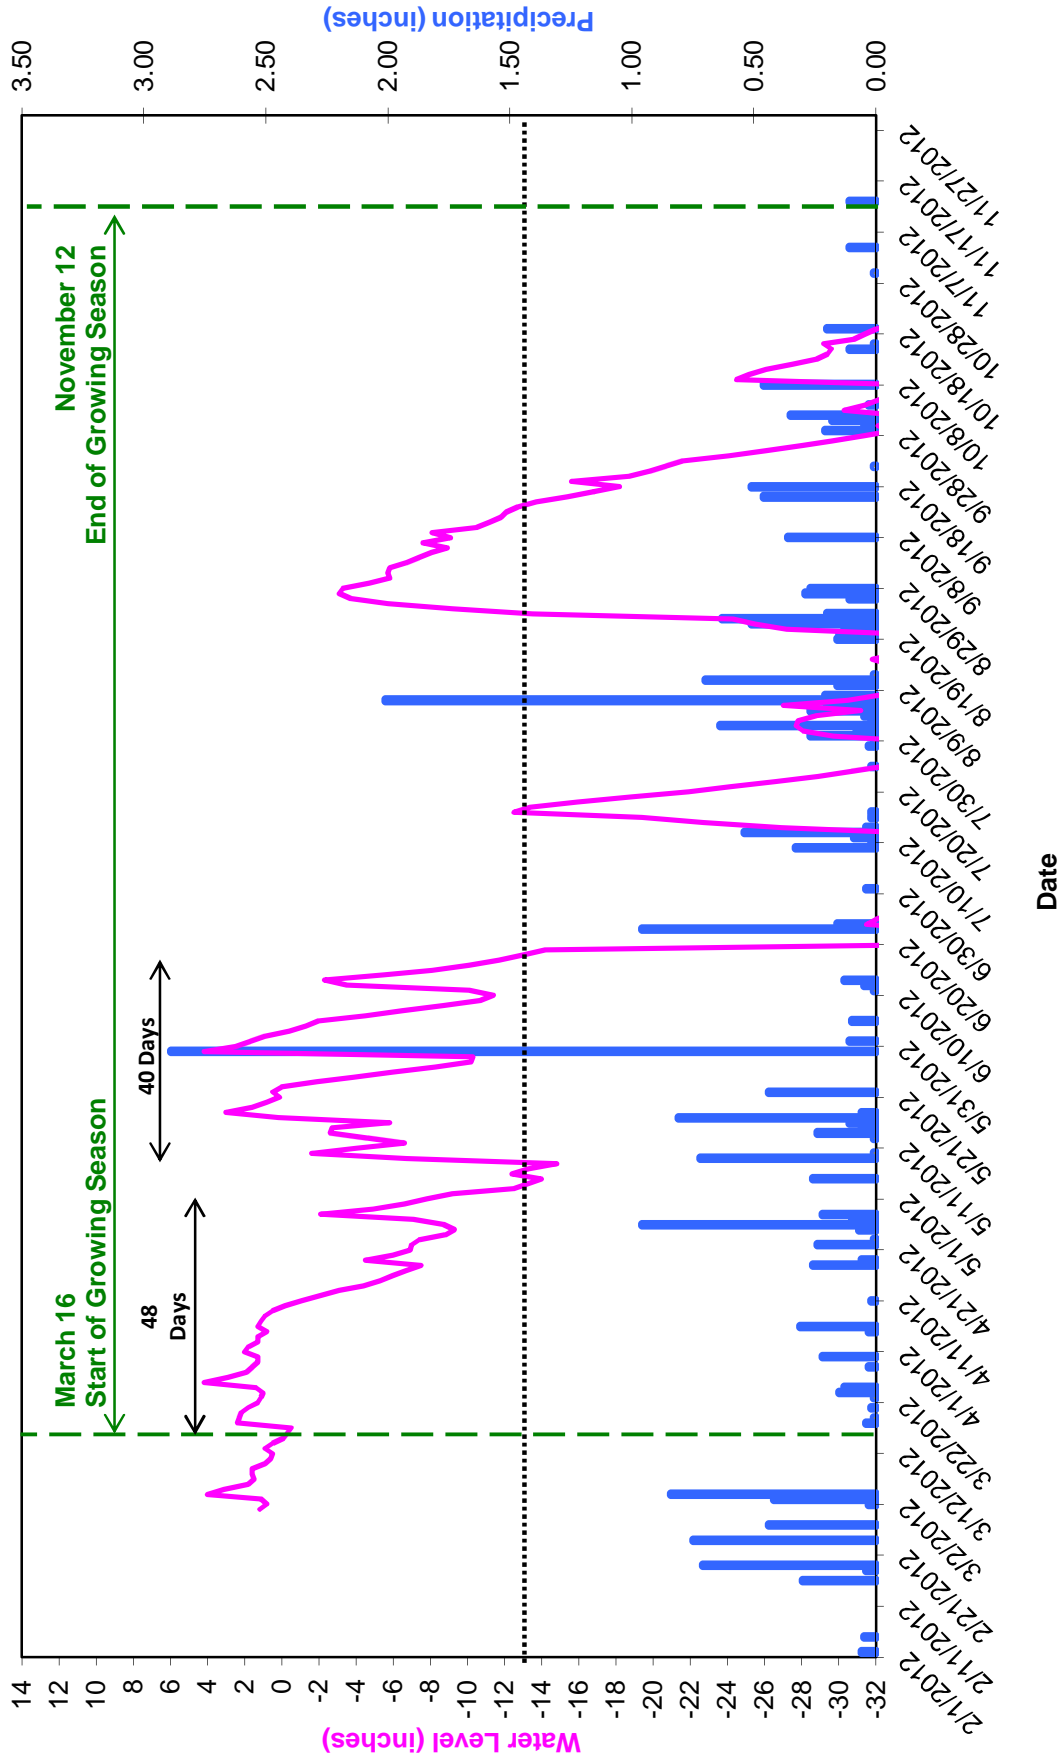
# Columbus Swamp Ground Water Reference Gauge Year 4 (2012 Data)

Wetland hydroperiods measured by a groundwater gauge located within the reference area will be compared to the hydroperiods exhibited by groundwater gauges in the restoration area to further evaluate restoration success. Success criteria outlined by the groundwater model indicates that the wetland restoration area should maintain saturation within one foot of the soil surface for at least 75 percent of the hydroperiod exhibited by the reference wetland gauges in any given year.
