**ANNUAL MONITORING REPORT  
YEAR 5 (2010)  
CONETOE BUFFER RESTORATION SITE  
PITT COUNTY, NORTH CAROLINA  
(Contract Number D05026-1)**

**CONETOE BUFFER RESTORATION SITE  
ANNUAL MONITORING REPORT  
YEAR 5 (2010)  
PITT COUNTY, NORTH CAROLINA**

**Conetoe Buffer Restoration Site  
Year 5 (2010) Annual Monitoring  
Vegetation Plot Photos Taken June 2010**

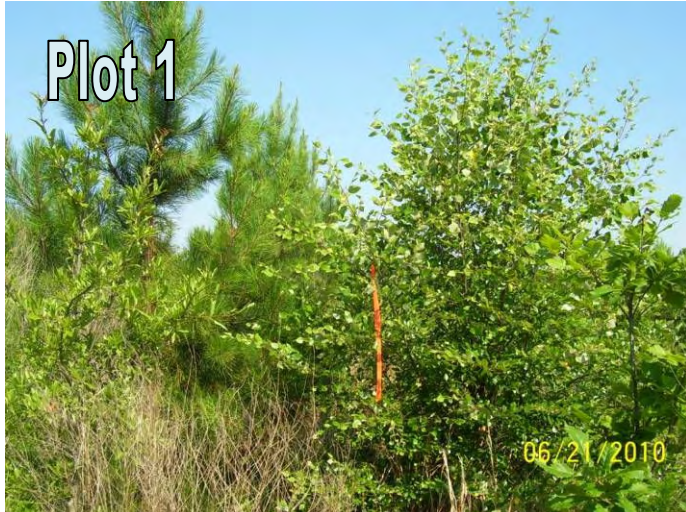
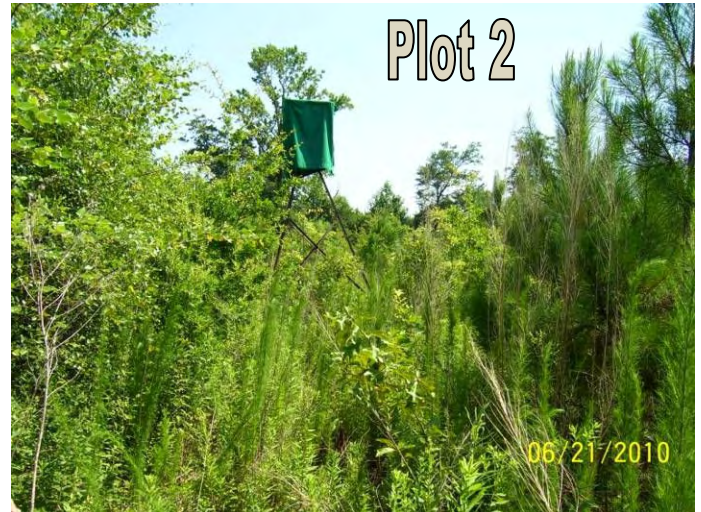
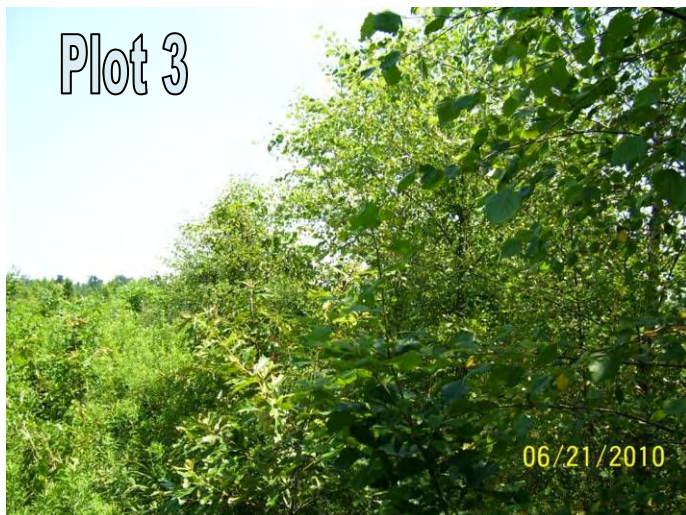
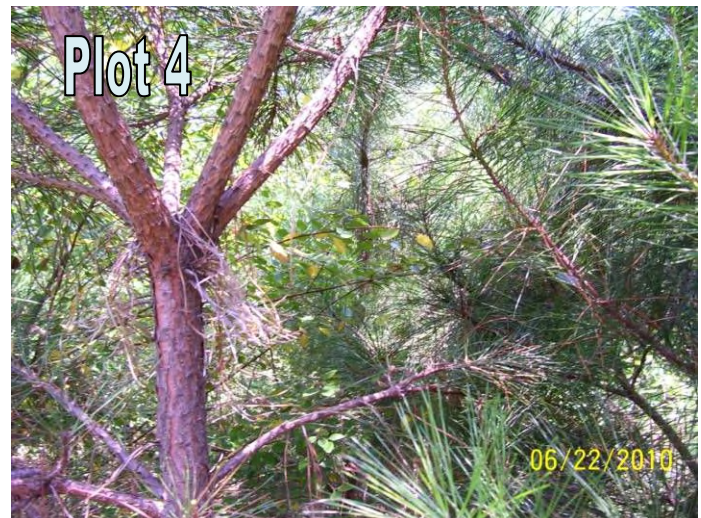
Quantitative sampling of vegetation was conducted in June 2010. Results are provided in Table 2. Vegetation success criteria for year 5 (320 stems per acre) were exceeded for the 2010 annual monitoring year with 1541 tree stems per acre across the Site. In addition, each individual plot met success criteria and had increasing species diversity with 7 to 8 species present within each plot.
