**Conoconnara Mitigation Project
Halifax County, North Carolina**

DENR-EEP Contract No. 16-D05024

Year 5 Monitoring Report

WK Dickson and Co., Inc.
720 Corporate Center Drive
Raleigh, NC 27607
(919) 782-0495

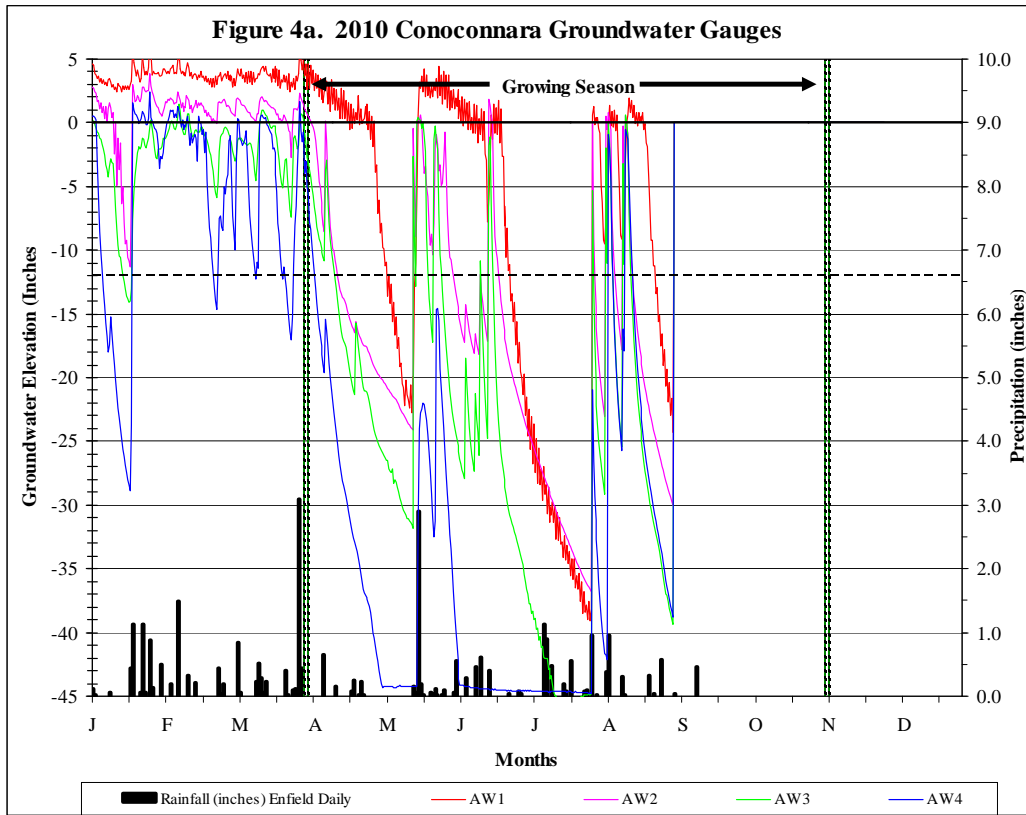
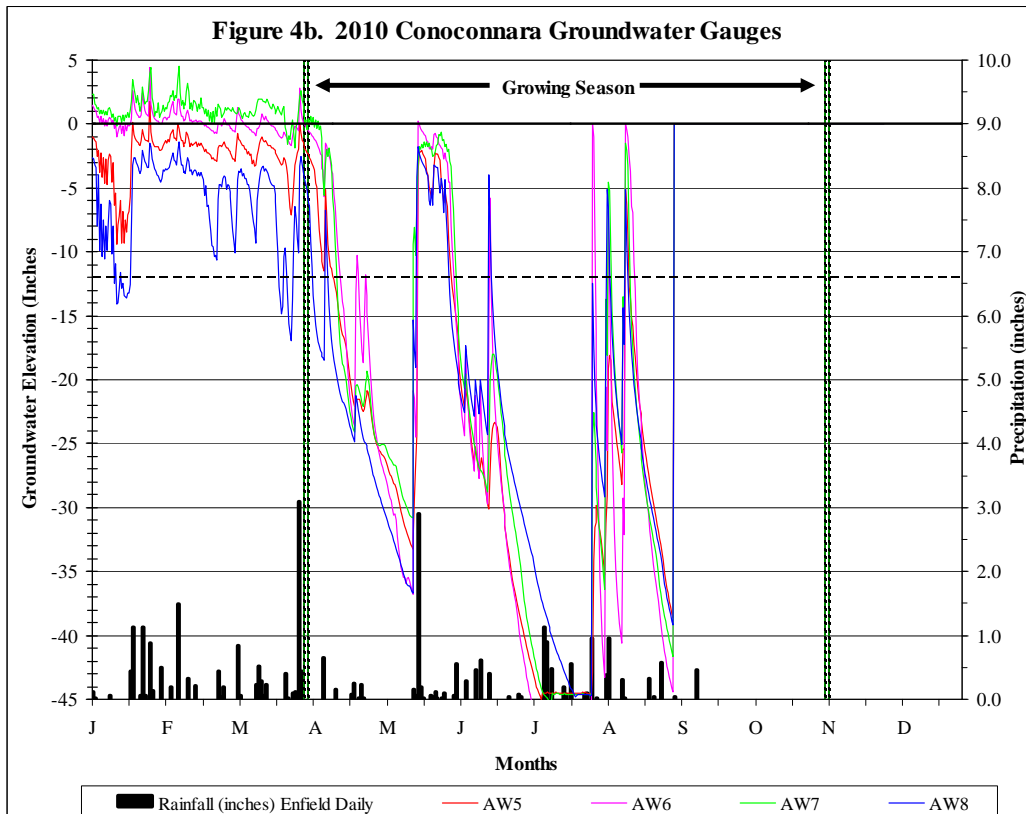
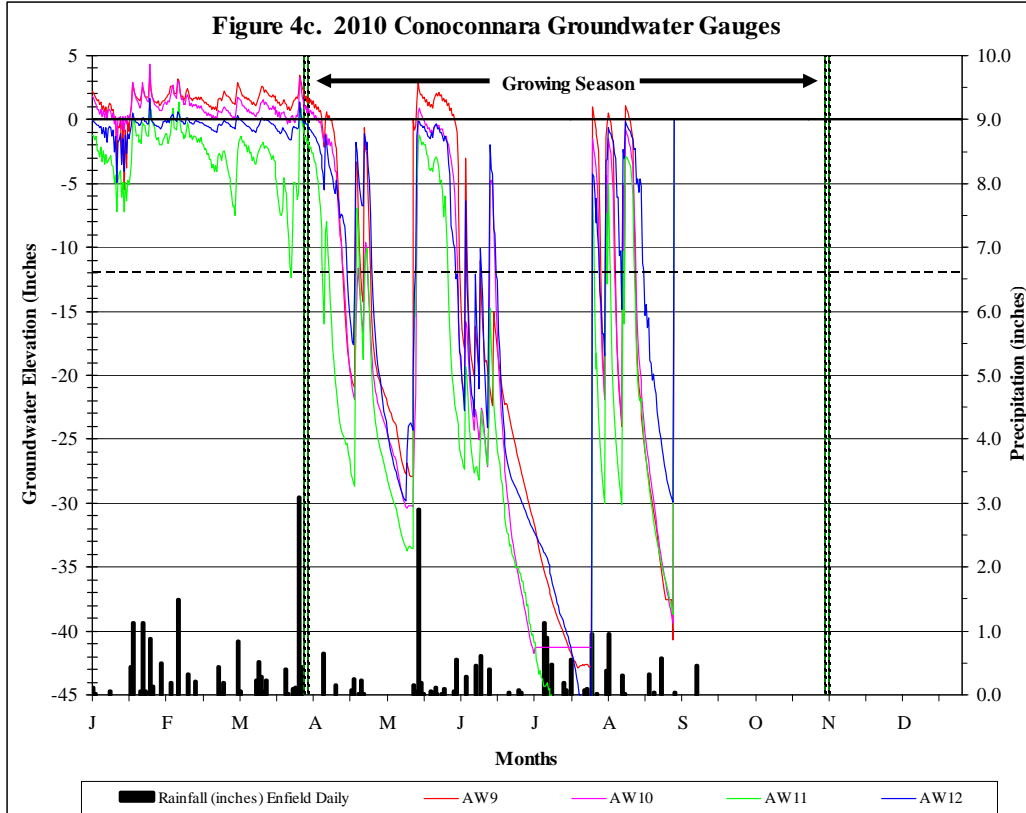
Figure 4. Groundwater Hydrographs

Locations of each automatic groundwater gauge and its 2011 growing season results can be found on **Figure 3**. Detailed results of hydrology monitoring in 2011 are presented in **Table 4** and **Figure 4**.

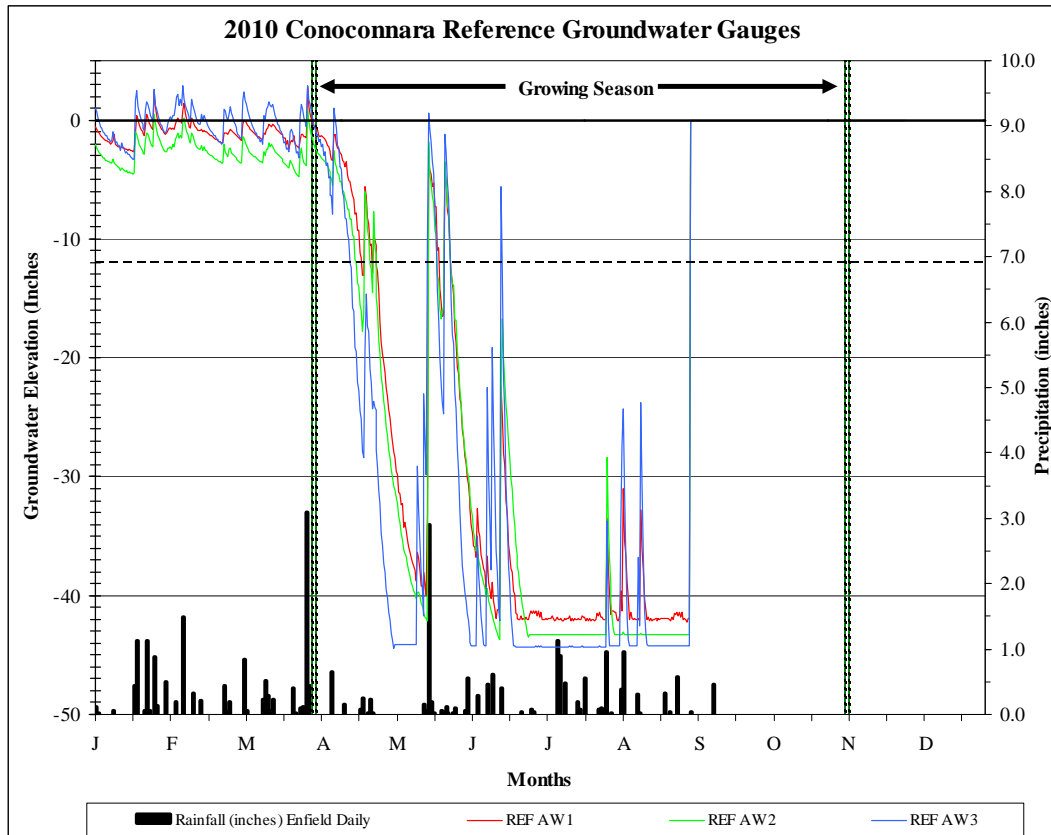
Figure 5. Reference Hydrographs

Three automated reference wells were observed during the 2011 growing season. The same hydroperiod statistics were calculated for each reference monitoring station during the growing season as were calculated for the site monitoring stations (**Table 4**). The reference wetland groundwater gauges exhibited wetland hydroperiods of fourteen to eighteen percent of the growing season, which exceeds the seven percent success criterion for the site. Raw data collected from the monitoring gauges is provided in **Appendix C**.

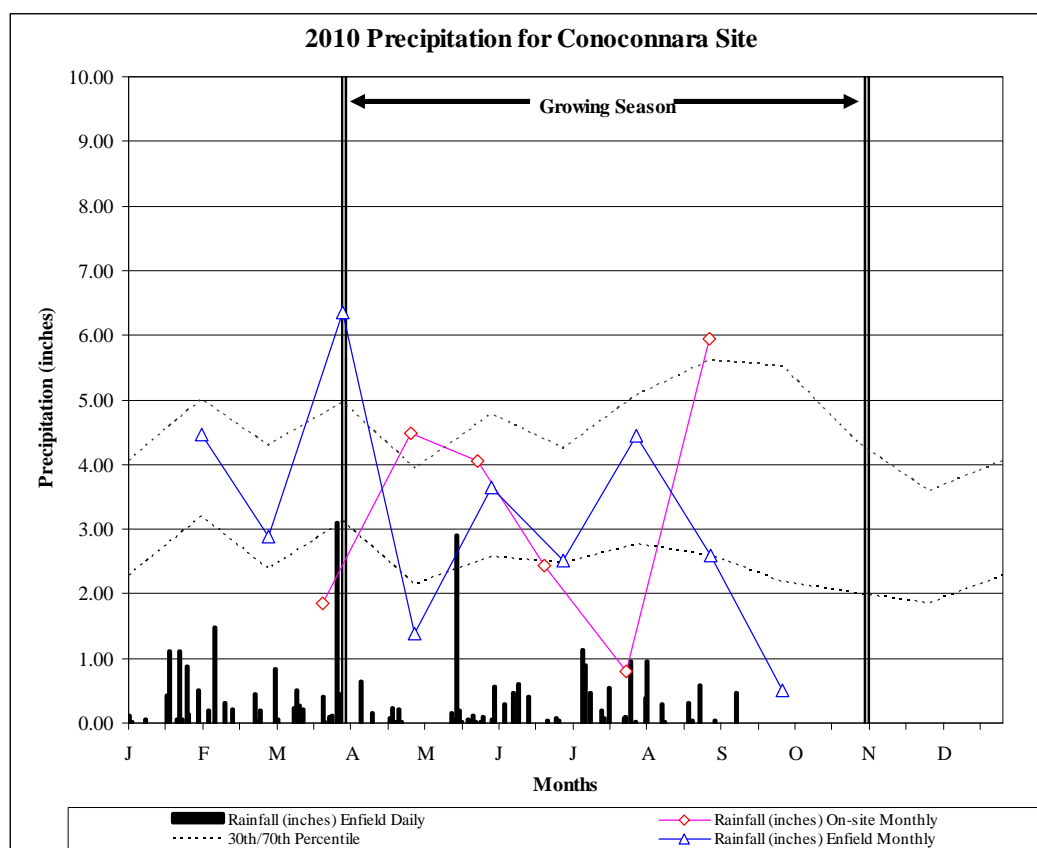
Figure 6. 2011 Precipitation Data

Table 5 and Figure 6 compare the 2011 monthly rainfall to historical precipitation for Halifax County (NRCS WETS Tables). Observed precipitation data were collected from an automated weather station in Enfield and an on-site manual rain gauge (Appendix C).

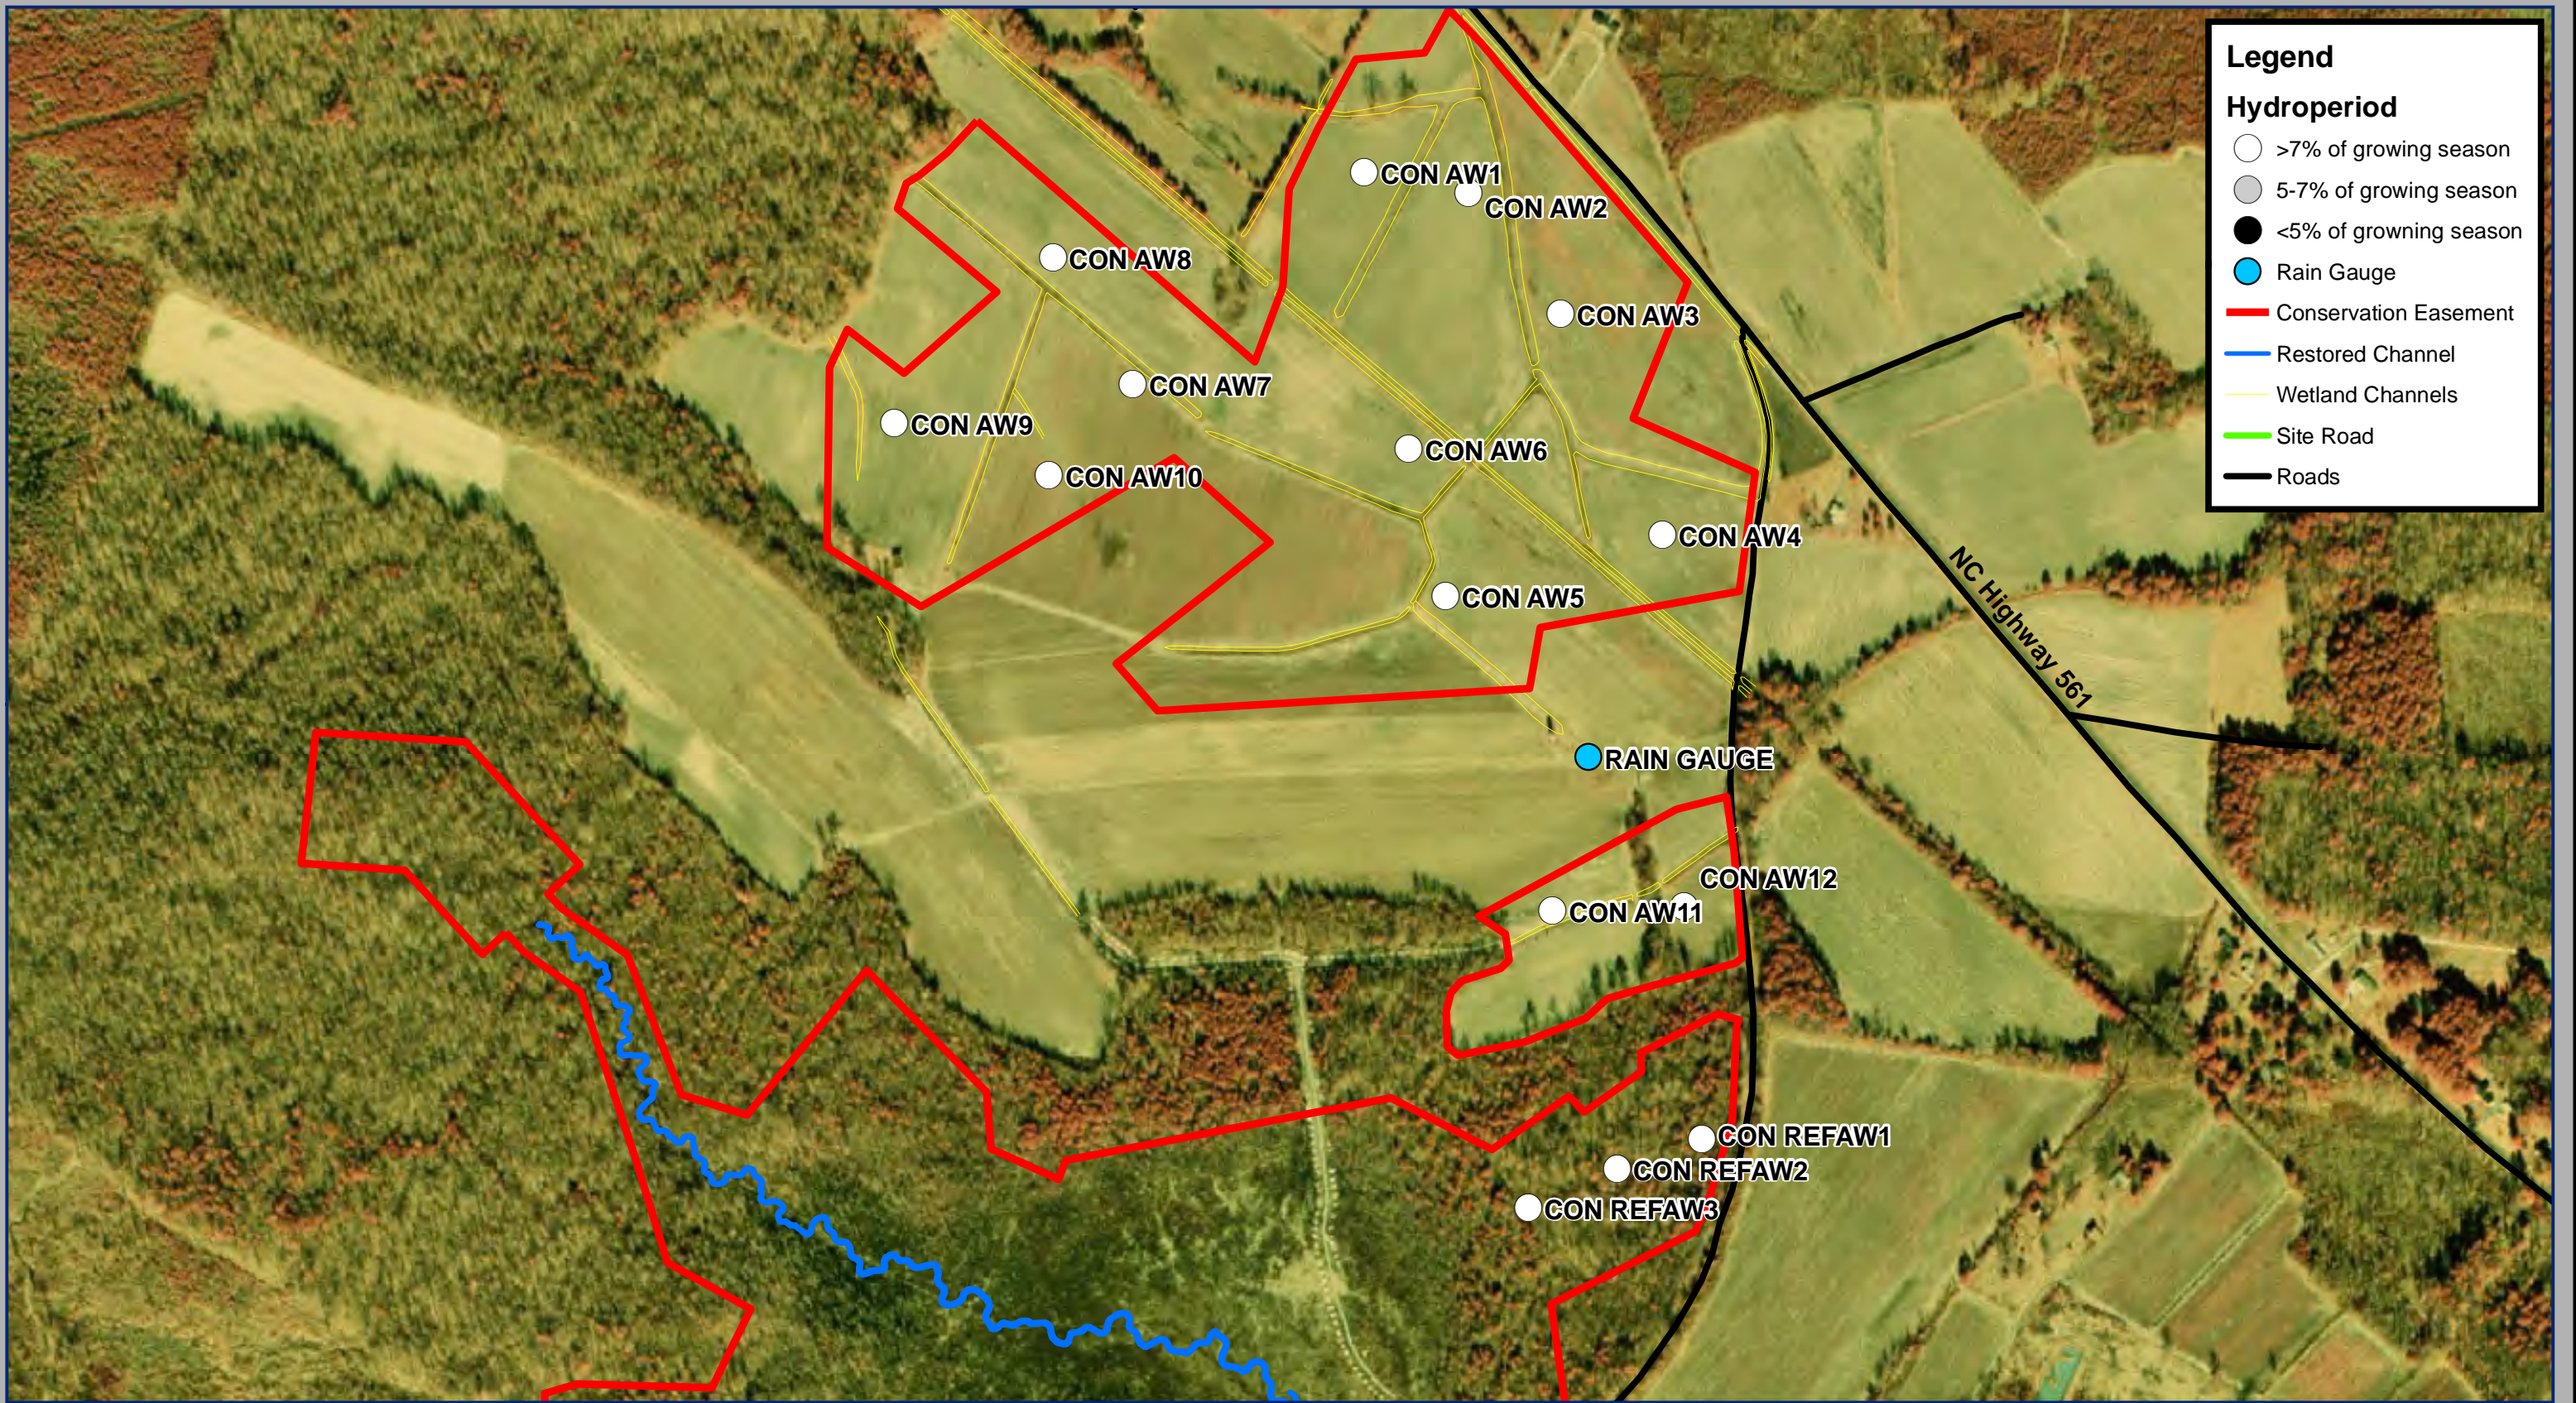
Data collected from the groundwater monitoring gauges on the Conoconnara Mitigation Site document that 12 of 12 hydrology monitoring stations (AW1, AW2, AW3, AW5, AW6, AW7, AW8, AW9, AW10, and AW12) recorded hydroperiods of at least seven percent of the growing season. The significant consecutive hydroperiods occurred during March through April, and May through June. Monitoring demonstrated that the hydrologic parameters of the mitigation site are similar to those of the reference site. **Figure 7** displays the hydrology monitoring results across the site. **Table 6** provides a summary of hydrologic monitoring results for five years of monitoring. Consistent with the characteristics of the soils at the Site, the precipitation-driven hydrology of the restored non-riverine wetlands has steadily improved over time. The data collected for the 2011 growing season indicates that the site is performing as described in the Mitigation Plan and has achieved the specified success criterion.

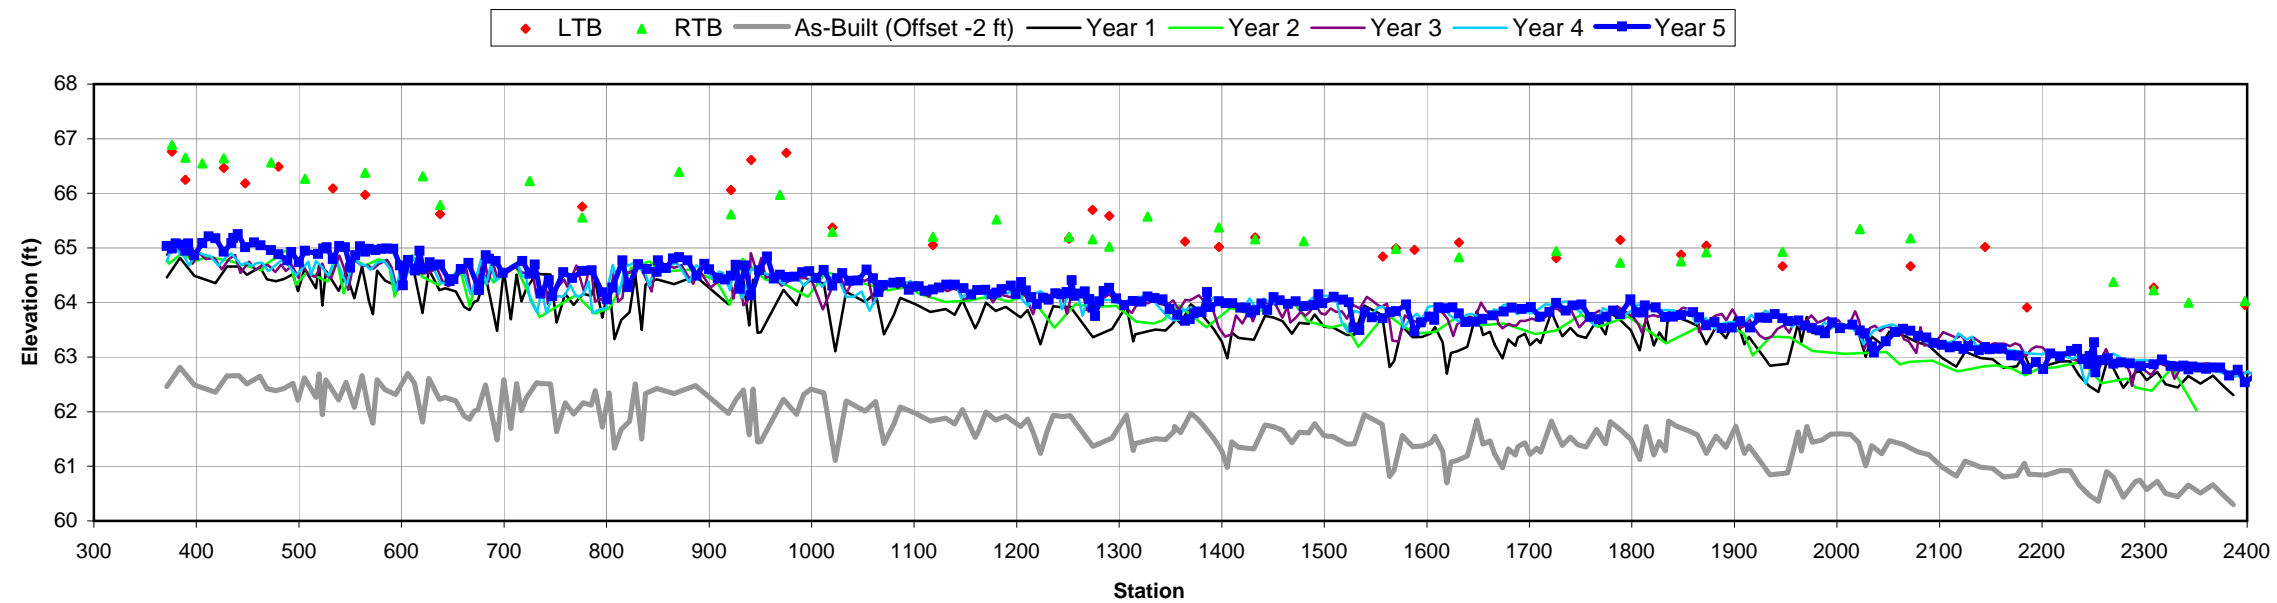
Year 4
Conoconnara Profile - Reach 1
STA 3+71 to STA 23+87

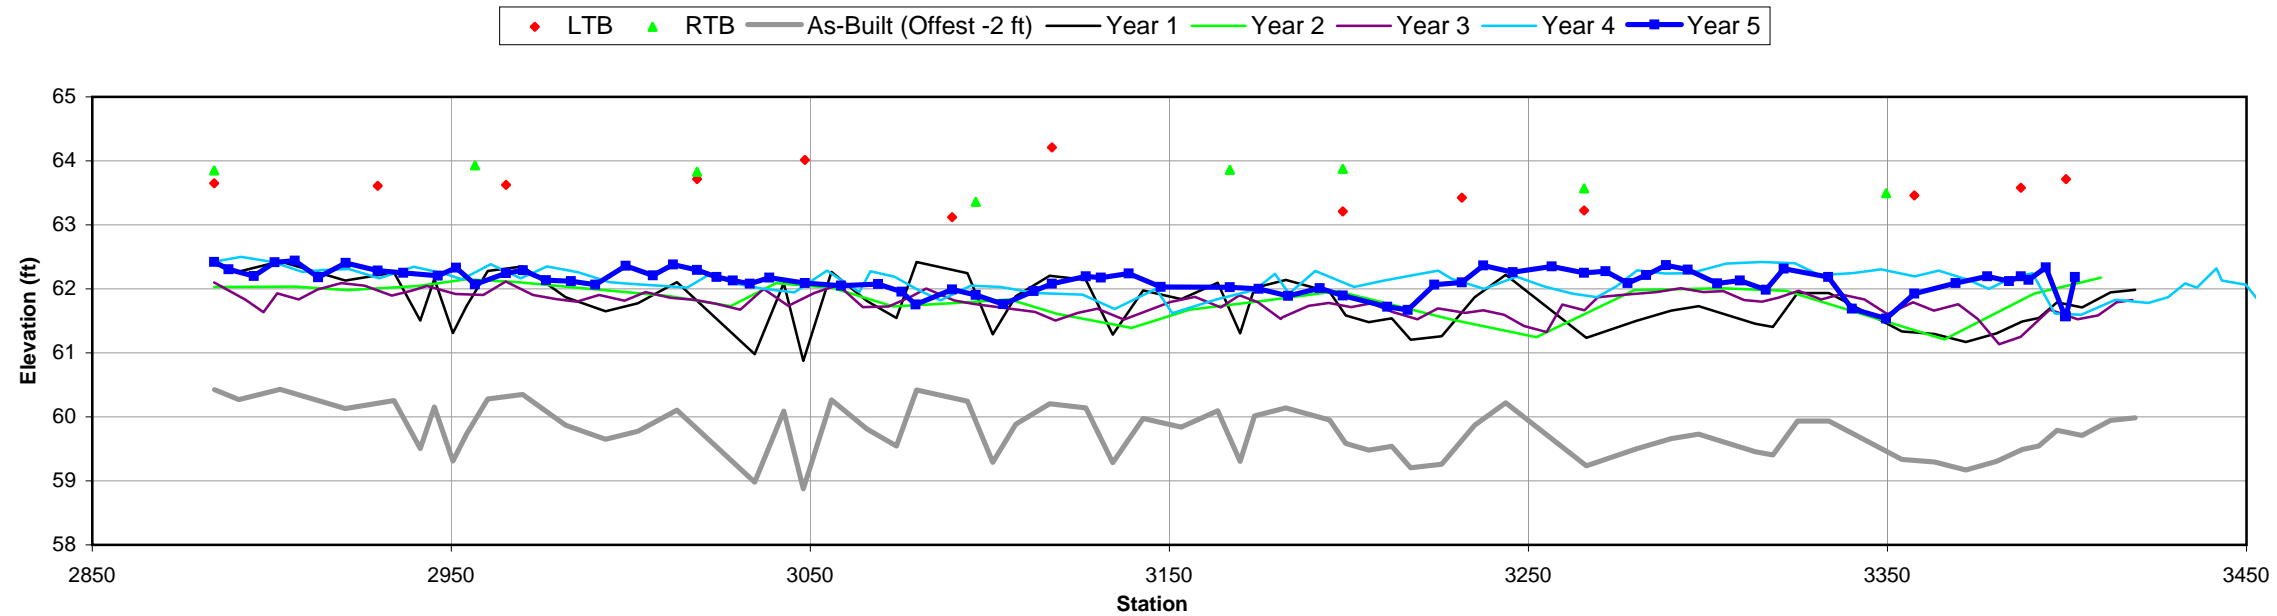
Year 4
Conoconnara Profile - Reach 2
STA 28+84 to STA 34+19

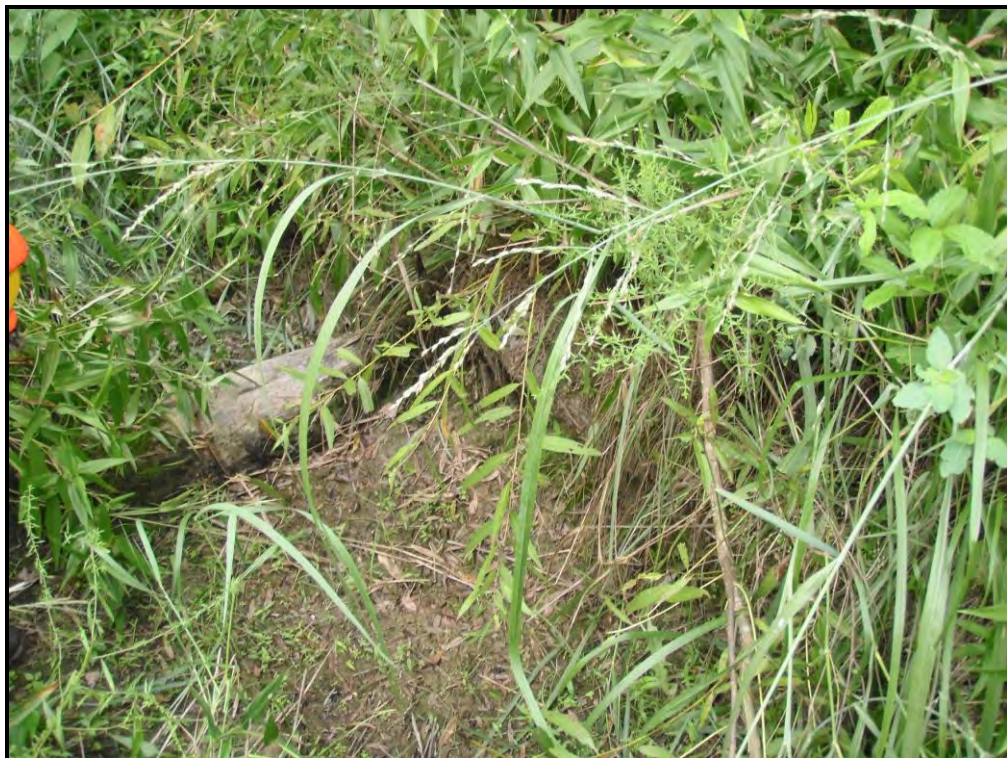
SOA	Station	Feature	Description
1	22+20	Log Grade Control	Erosion behind right log toe, bed is stable, bank is vegetated, no repair recommended

Photo #4
Log Grade Control, Sta. 22+20
