MY1 FINAL MONITORING REPORT

Cool Run Stream and Riparian Wetland Mitigation Site

Brunswick County, NC

DMS Project ID No. 100142

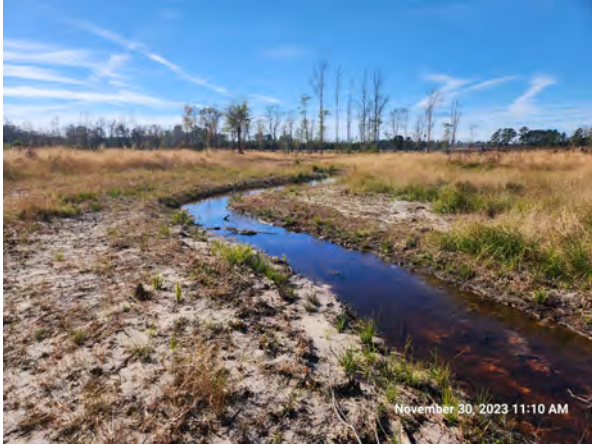
(1) PS1 (looking southwest - downstream)

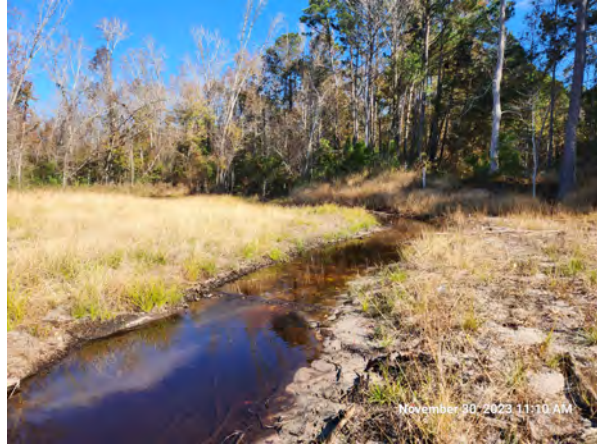
(2) PS1 (looking northeast towards CE boundary)

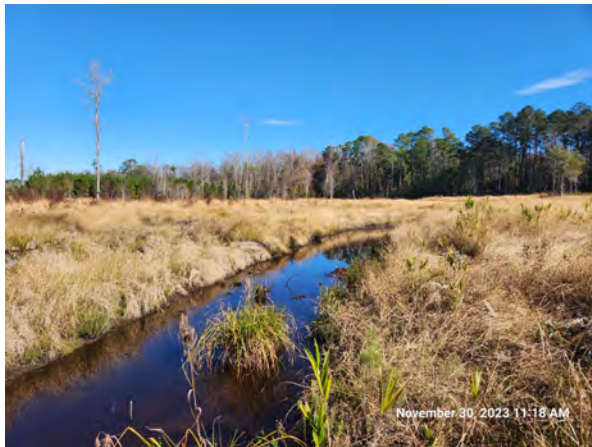
(3) PS2 (looking northeast along Cool Run)

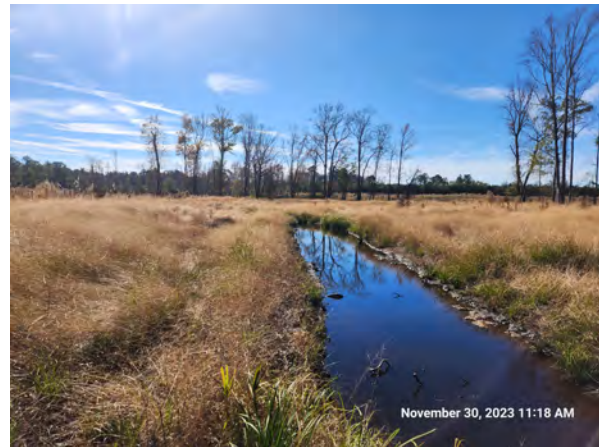
(4) PS2 (looking west along Cool Run)

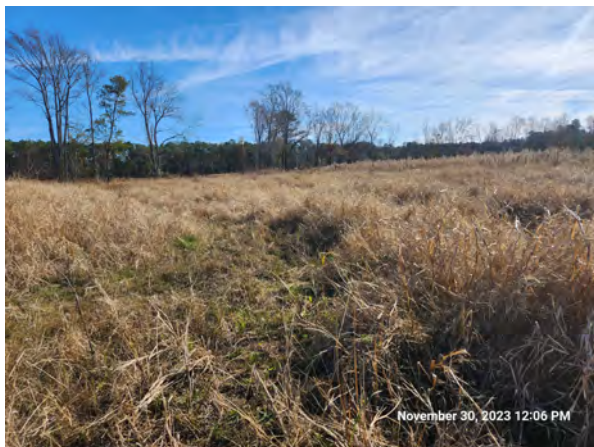
(5) PS3 (looking east along UT1)

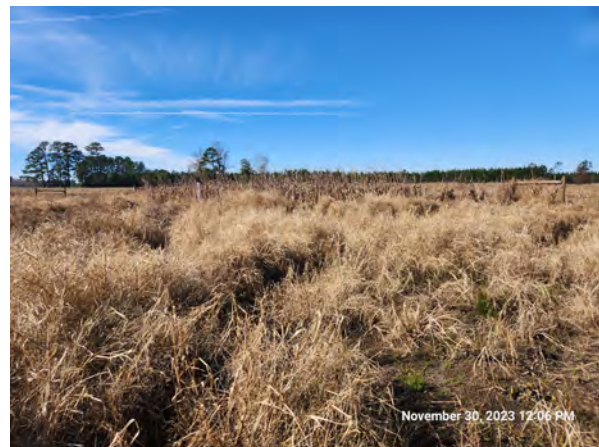
(6) PS3 (looking west towards CE Boundary)

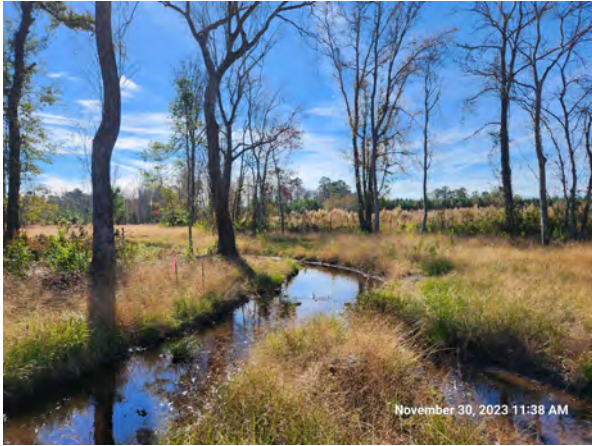
(7) PS4 (looking south at confluence Of Cool Run and UT1)

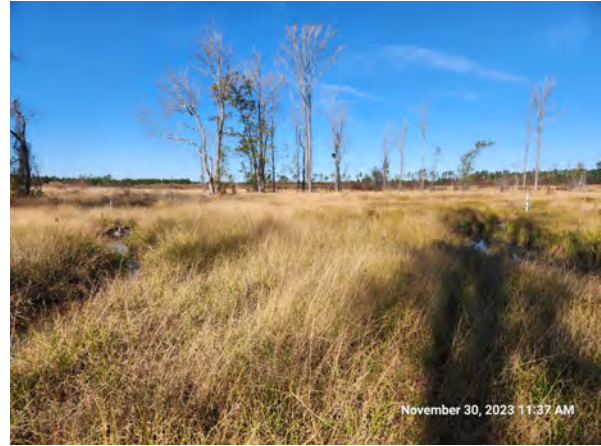
(8) PS4 (looking northwest)

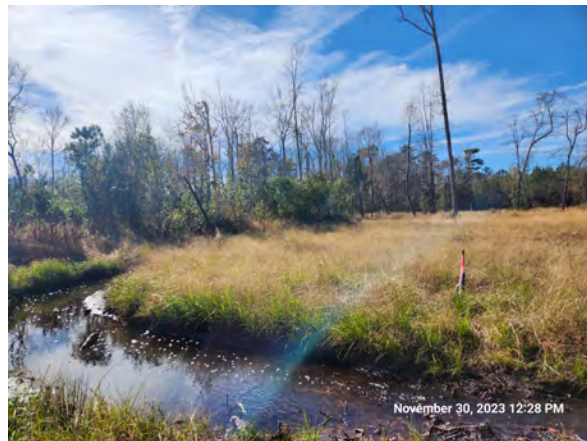
(9) PS5 (looking south)

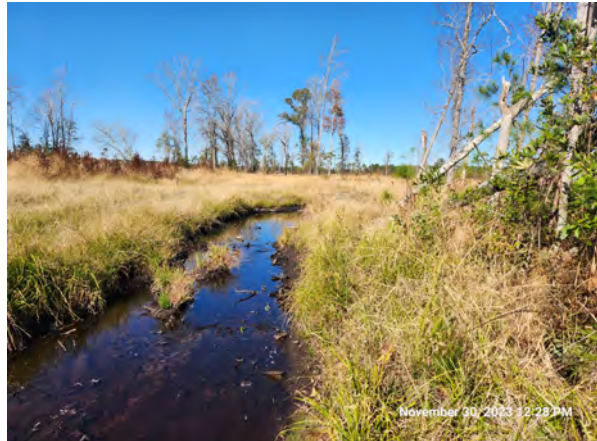
(10) PS5 (looking northwest)

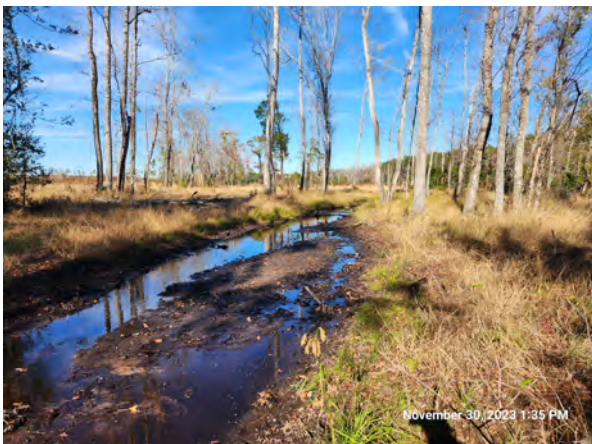
(11) PS6 (looking north)

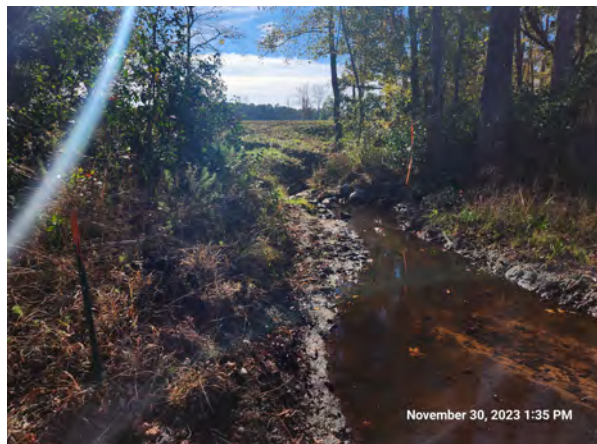
(12) PS6 (looking south towards CE Boundary)

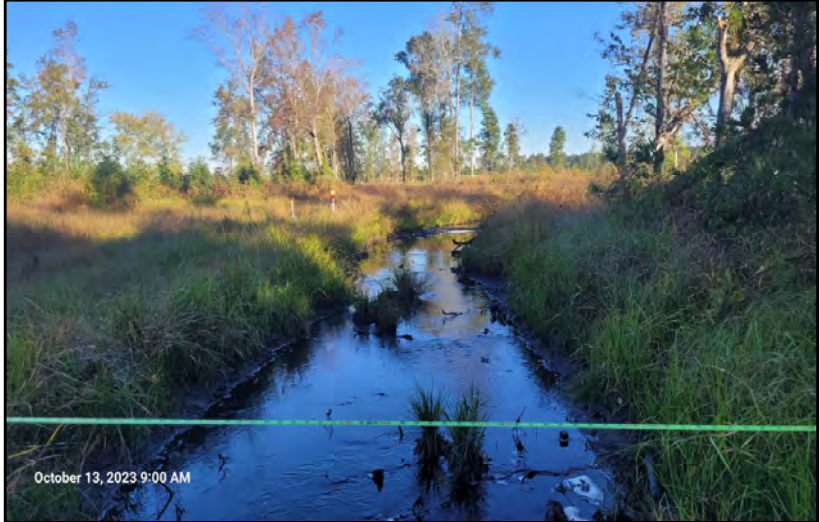
River Basin	Lumber River Basin
Watershed	3040207
XS ID	Cool Run, XS1, Pool
Feature	Riffle
Date	10/13/2023
Field Crew	TMW & WF

Dimensions	Cross Section 1 (Pool)					
	Base	MY1	MY2	MY3	MY4	MY5
Bankfull Elevation (ft) - Based on As Built-Bankfull Area	40.73	41.01	--	--		
Bank Height Ratio	1.00	0.90	--	--		
Thalweg Elevation	39.41	39.72				
Low Top Of Bank Elevation	40.73	40.88				
Low Top of Bank Max Depth (ft)	1.32	1.16				
Low Top Of Bank Cross Sectional Area (ft ²)	11.89	9.70

Bankfull elevation adjusted to current monitoring year's low top of bank elevation

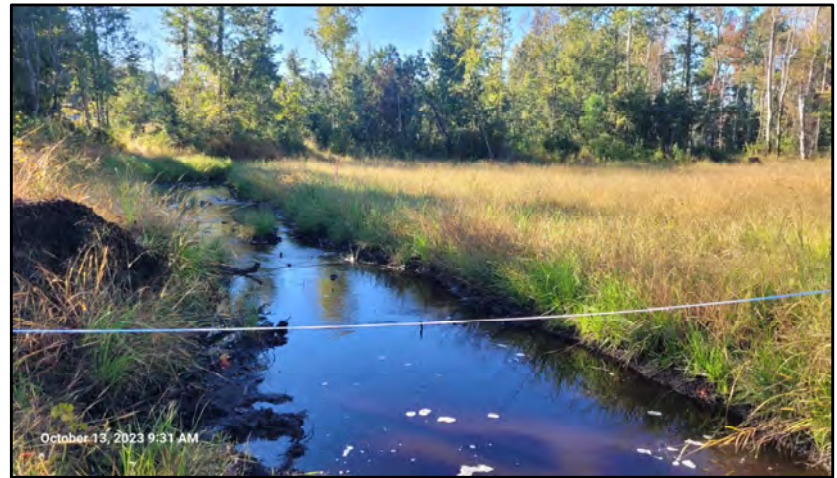
River Basin	Lumber River Basin
Watershed	03040207
XS ID	Cool Run, XS2, Riffle
Feature	Pool
Date	10/13/2023
Field Crew	TMW & WF

Dimensions	Cross Section 1 (Riffle)					
	Base	MY1	MY2	MY3	MY4	MY5
Bankfull Elevation (ft) - Based on As Built-Bankfull Area	--	--	--	--		
Bank Height Ratio	--	--	--	--		
Thalweg Elevation	37.74	38.94				
Low Top Of Bank Elevation	40.87	40.92				
Low Top of Bank Max Depth (ft)	3.13	1.93				
Low Top Of Bank Cross Sectional Area (ft ²)	24.00	14.33

Bankfull elevation adjusted to current monitoring year's low top of bank elevation

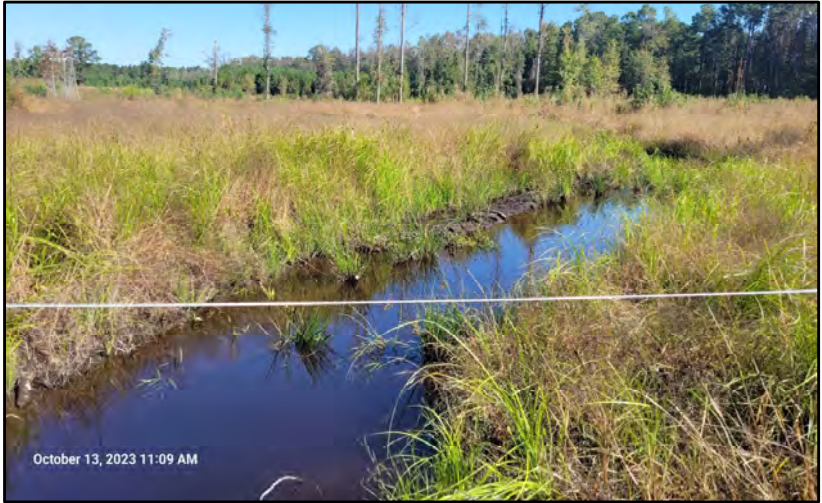
River Basin	Lumber River Basin
Watershed	03040207
XS ID	Cool Run, XS3, Pool
Feature	Pool
Date	10/13/2023
Field Crew	TMW & WF

Dimensions	Cross Section 1 (Riffle)					
	Base	MY1	MY2	MY3	MY4	MY5
Bankfull Elevation (ft) - Based on As Built-Bankfull Area	--	--	--	--		
Bank Height Ratio	--	--	--	--		
Thalweg Elevation	40.70	40.79				
Low Top Of Bank Elevation	42.09	42.16				
Low Top of Bank Max Depth (ft)	1.39	1.37				
Low Top Of Bank Cross Sectional Area (ft ²)	8.80	7.48

Bankfull elevation adjusted to current monitoring year's low top of bank elevation

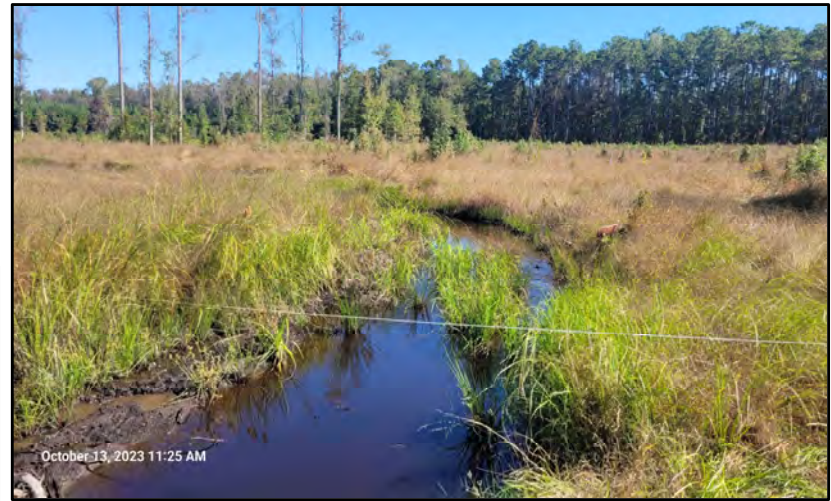
River Basin	Lumber River Basin
Watershed	03040207
XS ID	Cool Run, XS4, Riffle
Feature	Riffle
Date	10/13/2023
Field Crew	TMW & WF

Dimensions	Cross Section 1 (Riffle)					
	Base	MY1	MY2	MY3	MY4	MY5
Bankfull Elevation (ft) - Based on As Built-Bankfull Area	42.07	42.33	--	--		
Bank Height Ratio	1.00	0.88	--	--		
Thalweg Elevation	41.10	41.28				
Low Top Of Bank Elevation	42.07	42.20				
Low Top of Bank Max Depth (ft)	0.97	0.92				
Low Top Of Bank Cross Sectional Area (ft ²)	10.30	8.22

Bankfull elevation adjusted to current monitoring year's low top of bank elevation

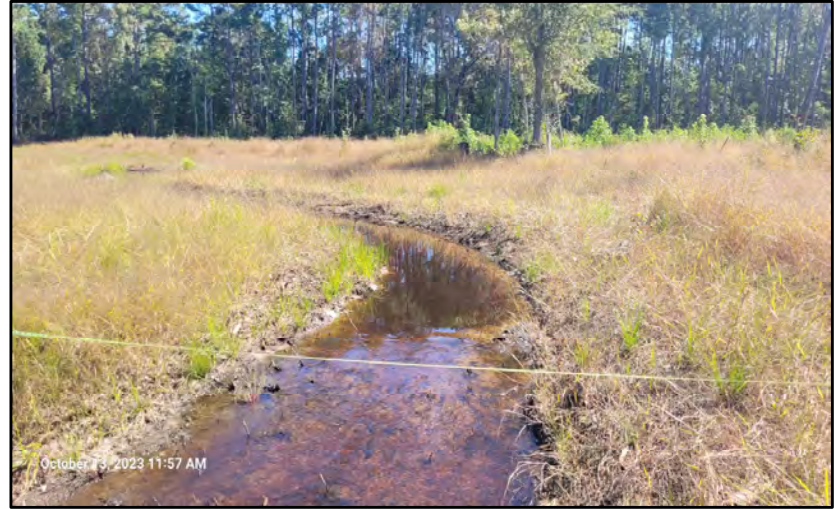
River Basin	Lumber River Basin
Watershed	03040207
XS ID	Cool Run, XS6, Riffle
Feature	Riffle
Date	10/13/2023
Field Crew	TMW & WF

Dimensions	Cross Section 1 (Riffle)					
	Base	MY1	MY2	MY3	MY4	MY5
Bankfull Elevation (ft) - Based on As Built-Bankfull Area	43.47	43.58	--	--		
Bank Height Ratio	1.00	0.90	--	--		
Thalweg Elevation	42.39	42.45				
Low Top Of Bank Elevation	43.47	43.47				
Low Top of Bank Max Depth (ft)	1.08	1.02				
Low Top Of Bank Cross Sectional Area (ft ²)	10.40	8.72

Bankfull elevation adjusted to current monitoring year's low top of bank elevation

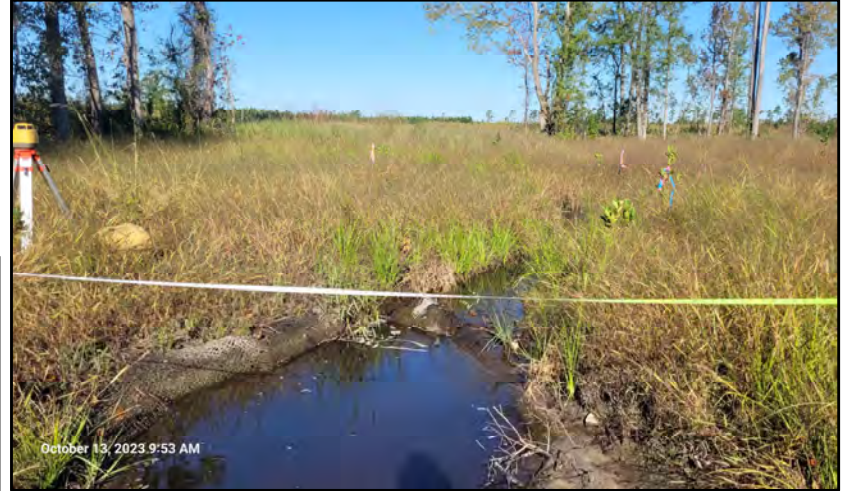
River Basin	Lumber River Basin
Watershed	03040207
XS ID	UT1, XS7, Pool
Feature	Pool
Date	10/13/2023
Field Crew	TMW &WF

Dimensions	Cross Section 1 (Riffle)					
	Base	MY1	MY2	MY3	MY4	MY5
Bankfull Elevation (ft) - Based on As Built-Bankfull Area	--	--		--		
Bank Height Ratio	--	--	--	--		
Thalweg Elevation	40.71	40.79				
Low Top Of Bank Elevation	41.89	42.01				
Low Top of Bank Max Depth (ft)	1.18	1.22				
Low Top Of Bank Cross Sectional Area (ft ²)	7.70	5.32

Bankfull elevation adjusted to current monitoring year's low top of bank elevation

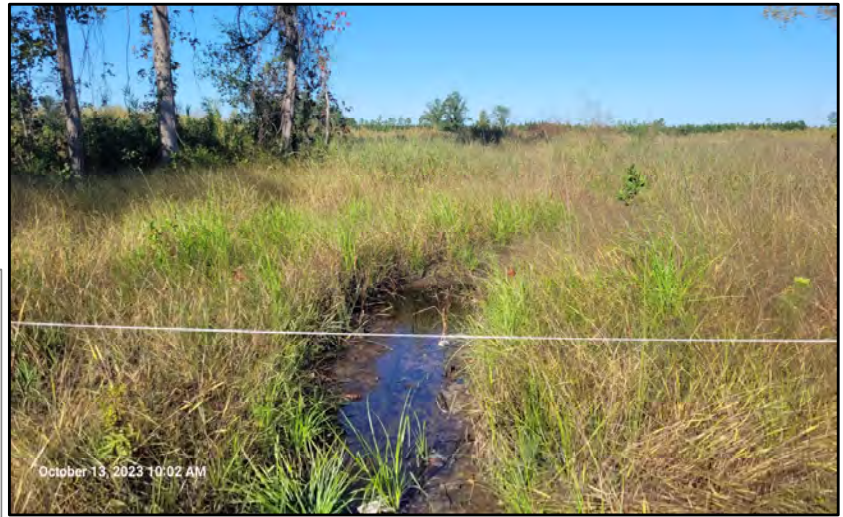
River Basin	Lumber River Basin
Watershed	03040207
XS ID	UT1, XS8, Riffle
Feature	Riffle
Date	10/13/2023
Field Crew	TMW & WF

Dimensions	Cross Section 1 (Riffle)					
	Base	MY1	MY2	MY3	MY4	MY5
Bankfull Elevation (ft) - Based on As Built-Bankfull Area	42.44	42.59	--	--		
Bank Height Ratio	1.00	0.85	--	--		
Thalweg Elevation	41.49	41.61				
Low Top Of Bank Elevation	42.44	42.44				
Low Top of Bank Max Depth (ft)	0.95	0.83				
Low Top Of Bank Cross Sectional Area (ft ²)	3.90	2.73

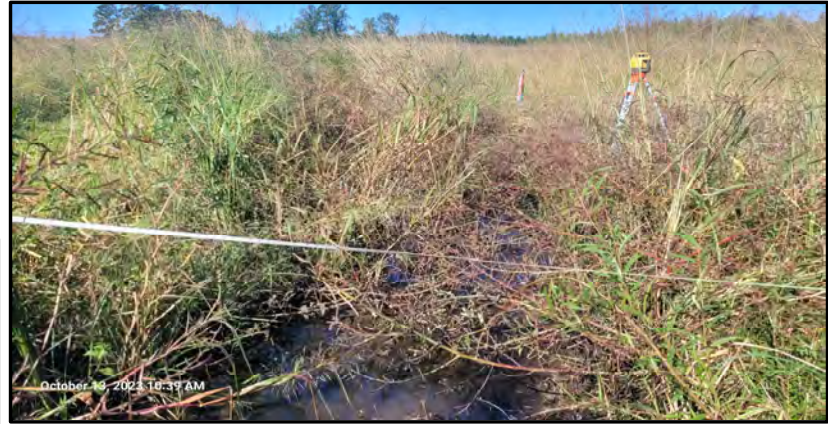
River Basin	Lumber River Basin
Watershed	03040207
XS ID	UT1, XS9, Pool
Feature	Pool
Date	45212
Field Crew	TMW & WF

Dimensions	Cross Section 1 (Riffle)					
	Base	MY1	MY2	MY3	MY4	MY5
Bankfull Elevation (ft) - Based on As Built-Bankfull Area	--	--	--	--		
Bank Height Ratio	--	--	--	--		
Thalweg Elevation	41.86	42.29				
Low Top Of Bank Elevation	43.02	43.11				
Low Top of Bank Max Depth (ft)	1.16	0.82				
Low Top Of Bank Cross Sectional Area (ft ²)	3.80	2.02

Bankfull elevation adjusted to current monitoring year's low top of bank elevation

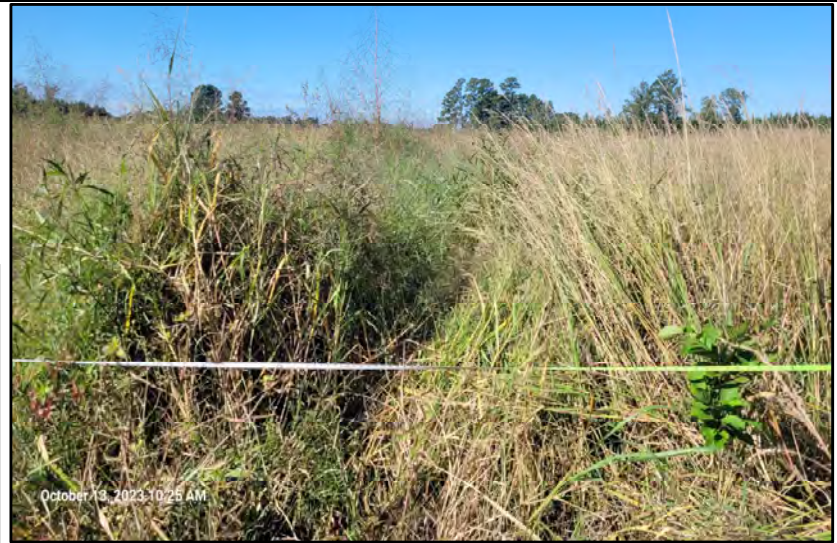
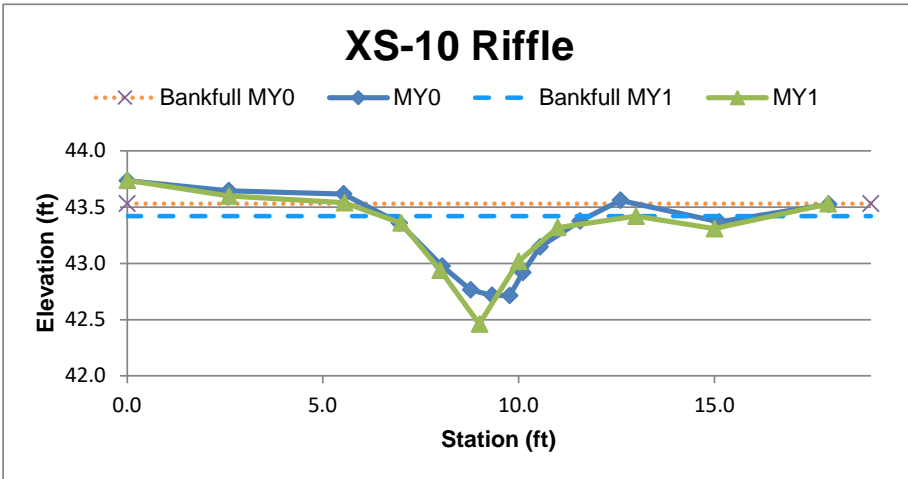
River Basin	Lumber River Basin
Watershed	03040207
XS ID	UT1, XS10, Riffle
Feature	Riffle
Date	10/13/2023
Field Crew	TMW & WF

Dimensions	Cross Section 1 (Riffle)					
	Base	MY1	MY2	MY3	MY4	MY5
Bankfull Elevation (ft) - Based on As Built-Bankfull Area	43.56	43.53	--	--		
Bank Height Ratio	1.00	0.90	--	--		
Thalweg Elevation	42.72	42.46				
Low Top Of Bank Elevation	43.56	43.42				
Low Top of Bank Max Depth (ft)	0.84	0.96				
Low Top Of Bank Cross Sectional Area (ft ²)	2.80	2.03

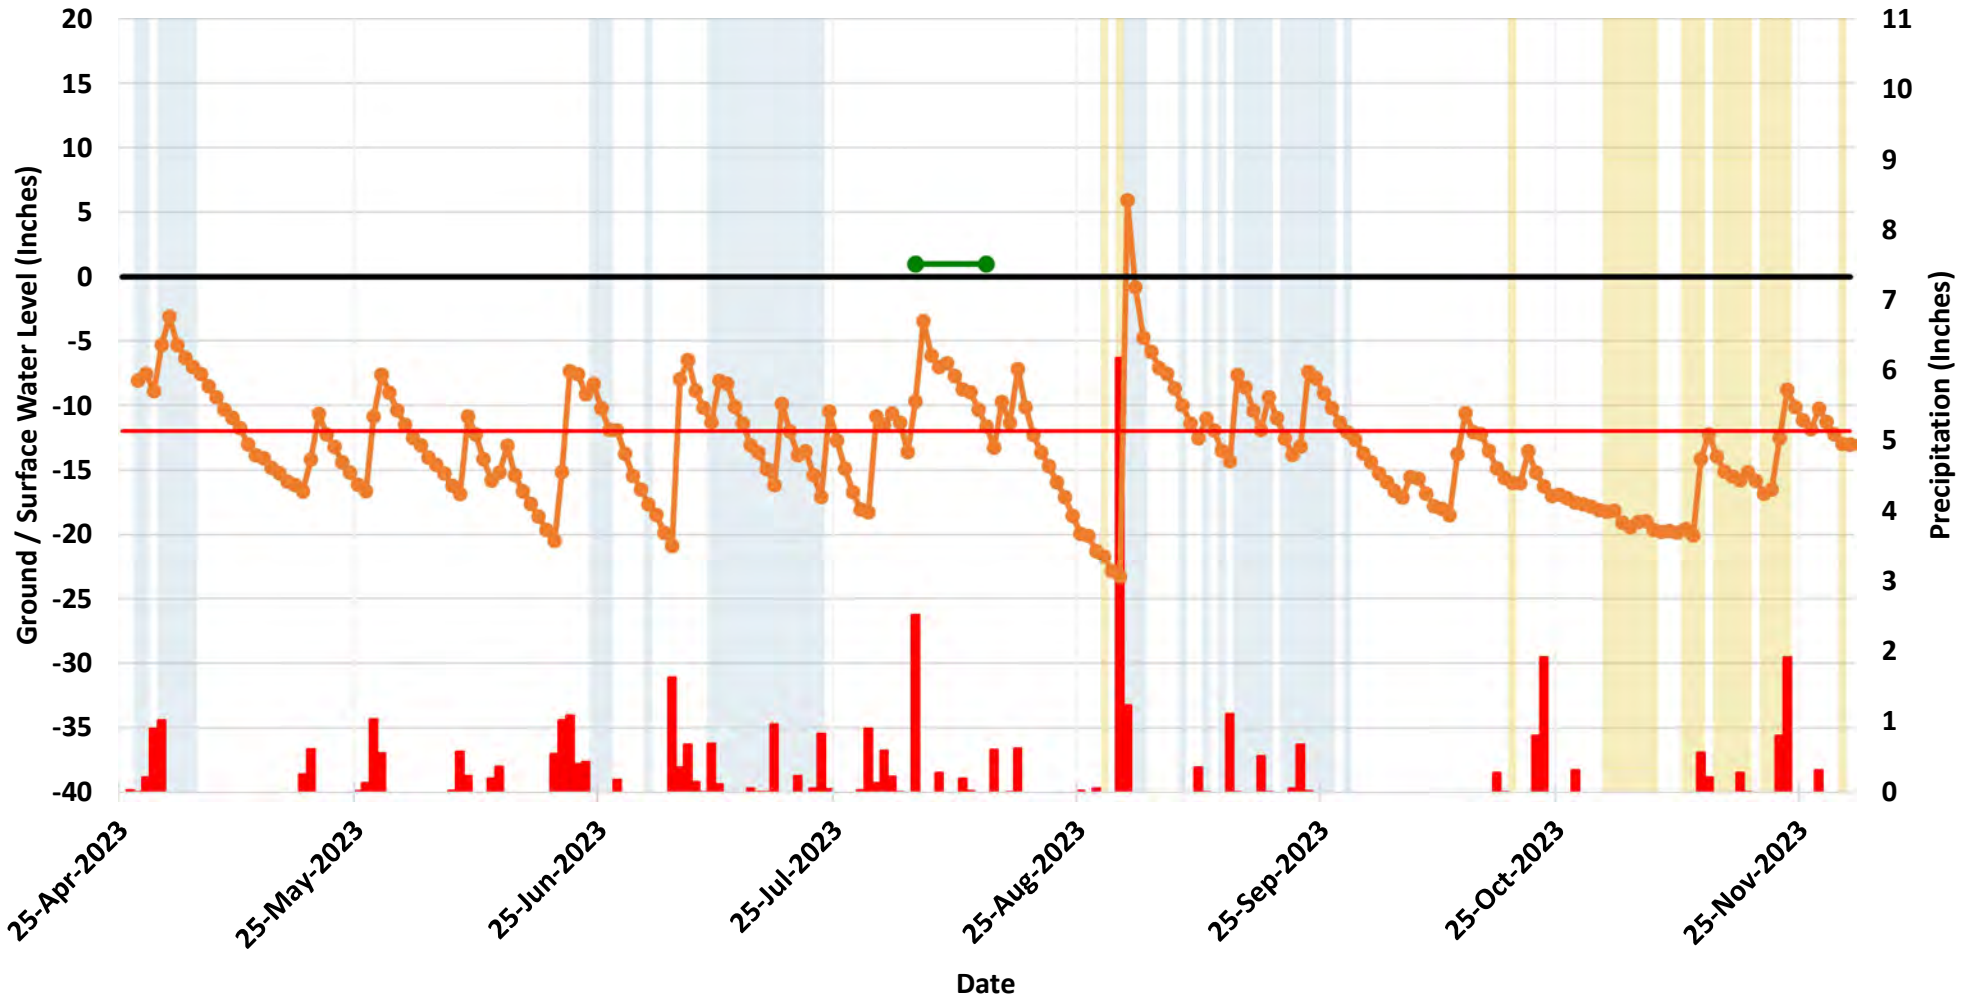
- Well 2 (768797)
- 0" Ground Surface
- 12" Threshold
- Drier than Normal Conditions (APT)
- Wetter than Normal Conditions (APT)
- Onsite Rainfall
- Gauge 2 Consecutive Days Meeting Wetland Criteria: 10 Days, 4.8% of Growing Season

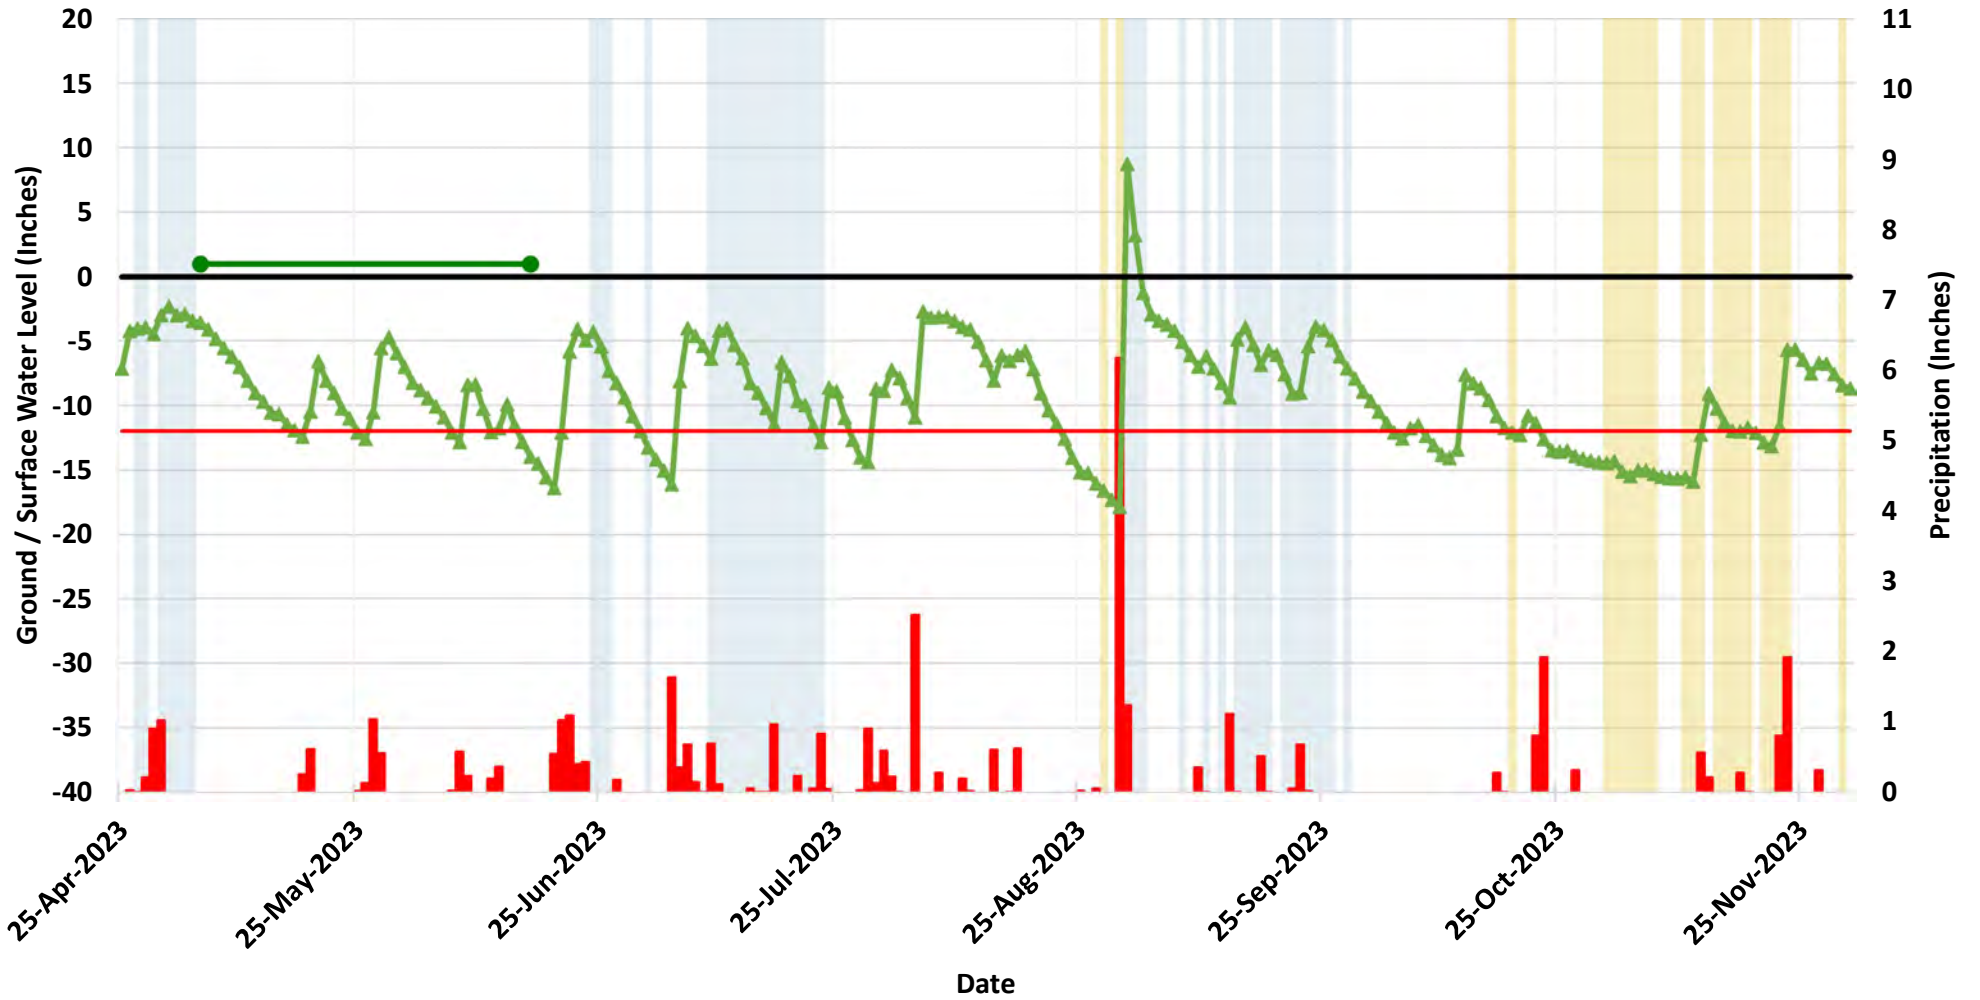
- Well 3 (766822)
- Gauge 3 Consecutive Days Meeting Wetland Criteria
- 41 Days, 19.5% of Growing Season
- Drier than Normal Conditions (APT)
- Wetter than Normal Conditions (APT)
- Onsite Rainfall
- 0" Ground Surface
- 12" Threshold

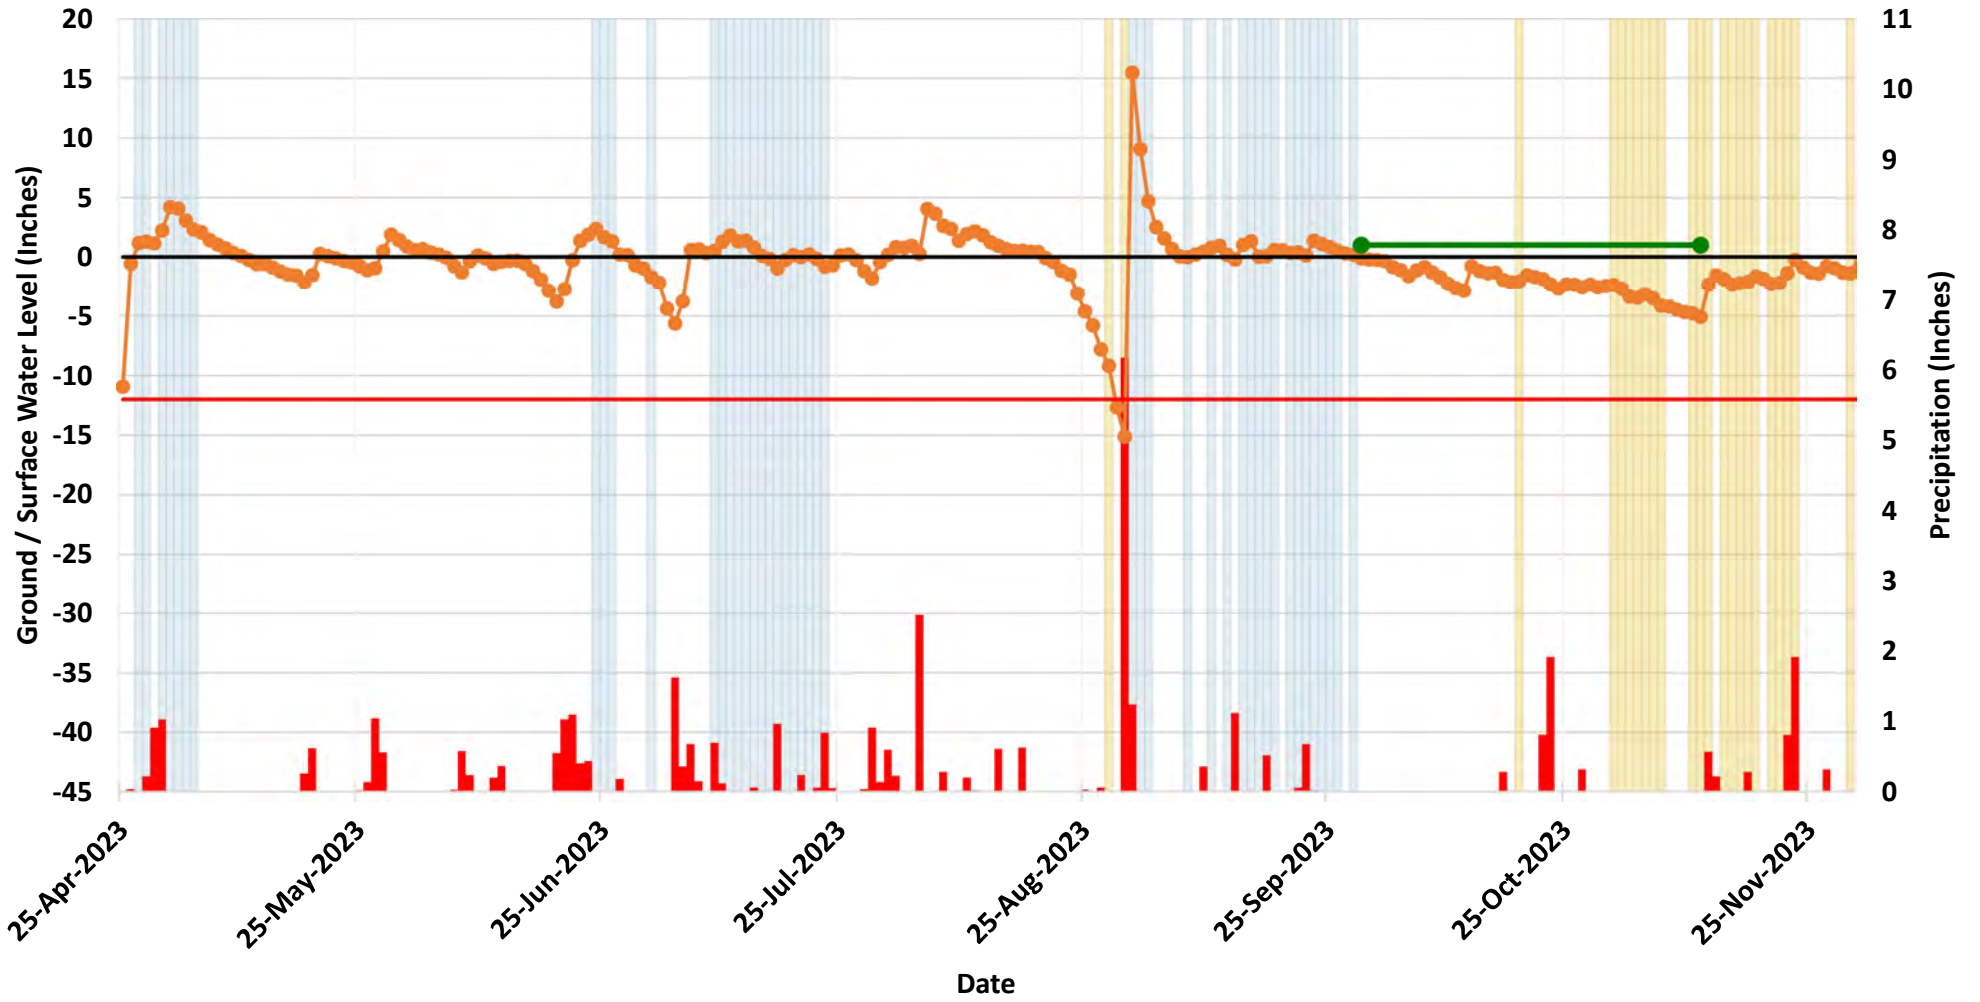
Gauge 5 - Hydrology Assessment

- Drier than Normal Conditions (APT)
- Wetter than Normal Conditions (APT)
- Onsite Rainfall
- Gauge 5 (768797)
- 0" Ground Surface
- 12" Threshold
- Gauge 5 Consecutive Days Meeting Wetland Criteria **63 Days, 30% of Growing Season**

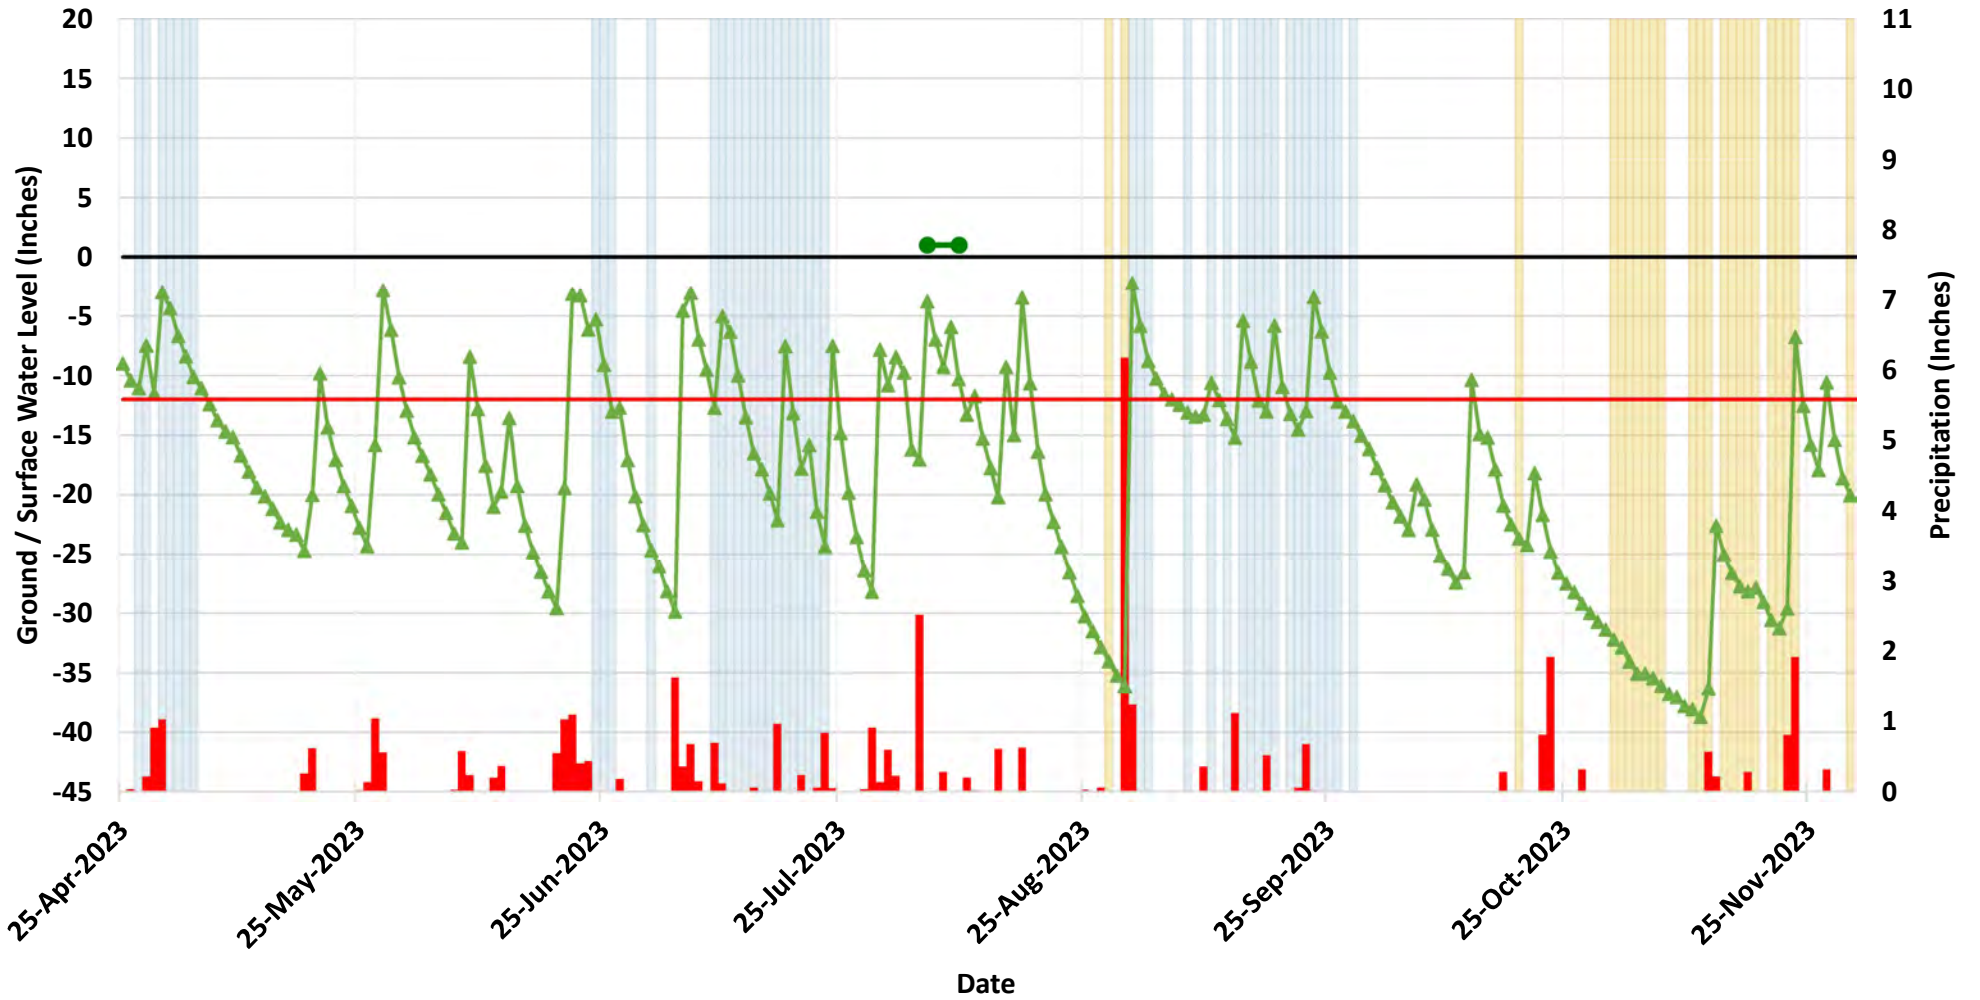
- Drier than Normal Conditions (APT)
- Wetter than Normal Conditions (APT)
- Onsite Rainfall
- ▲ Gauge 6 (766822)
- 0" Ground Surface
- -12" Threshold
- Gauge 6 Consecutive Days Meeting Wetland Criteria 5 Days, 2.4% of Growing Season

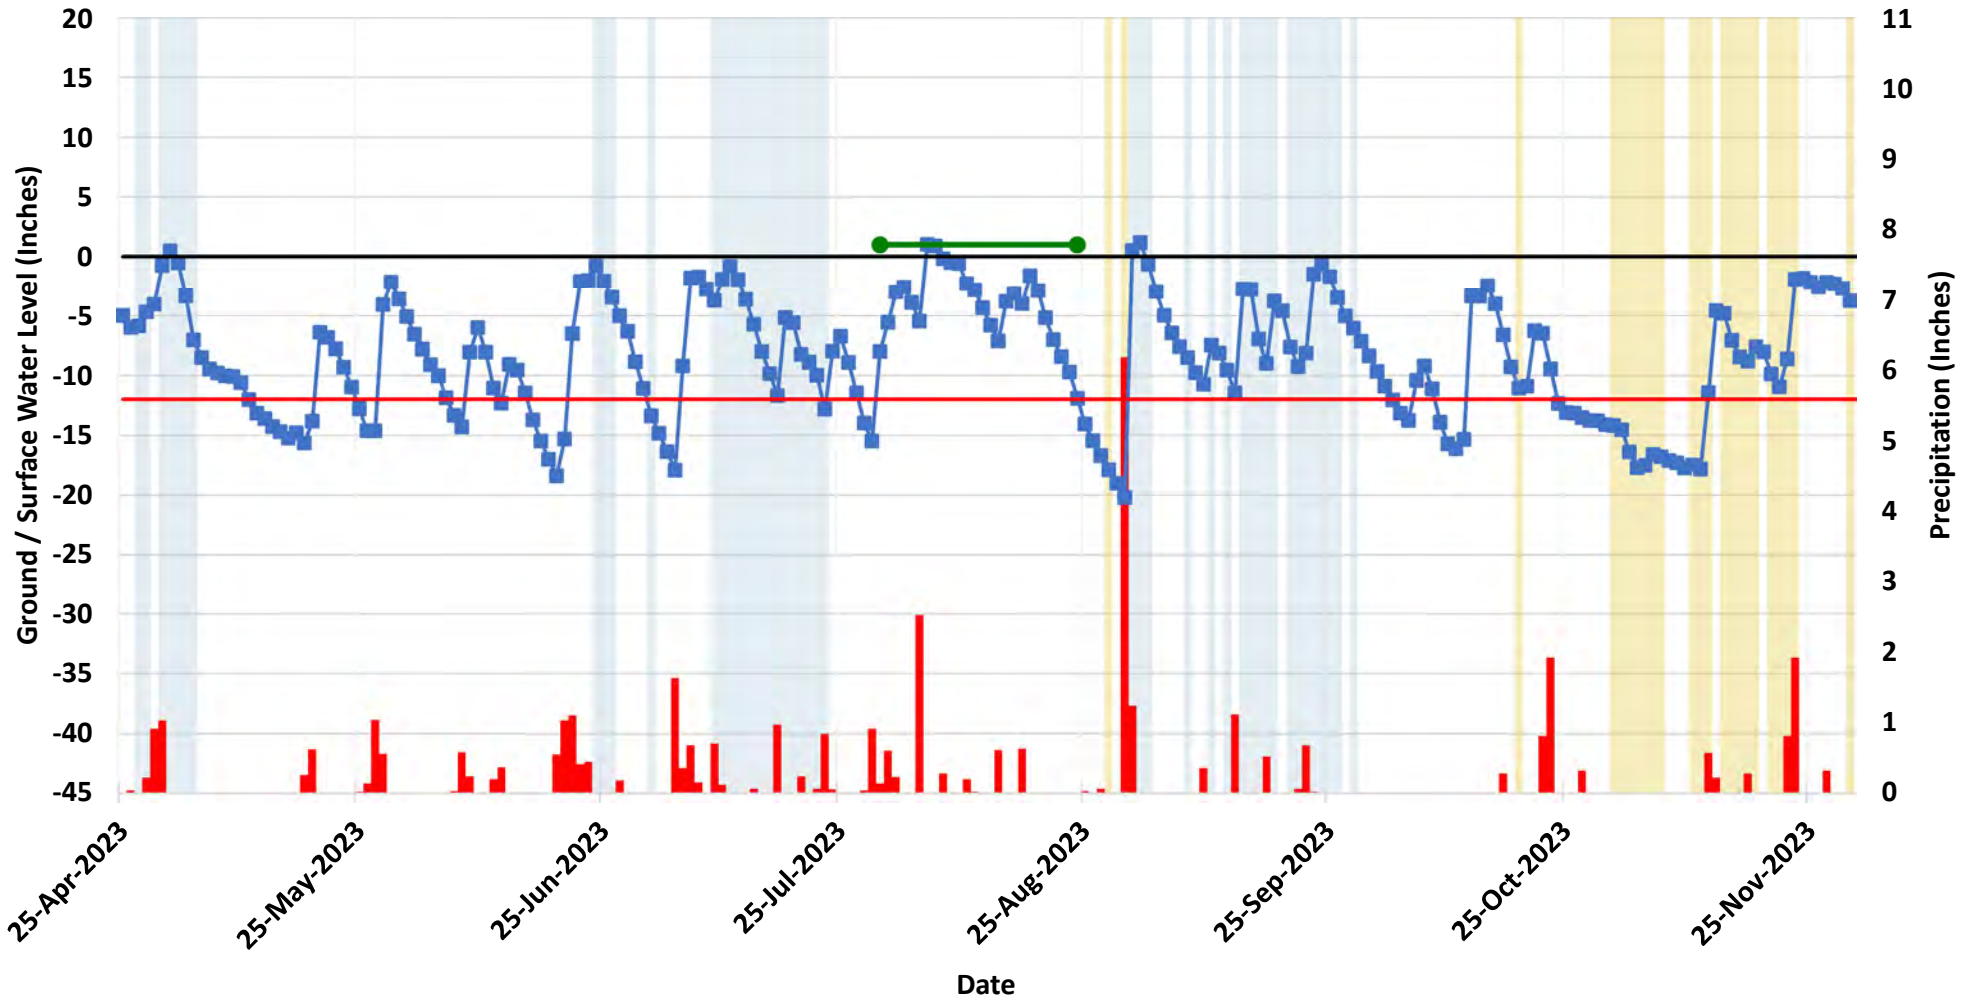
- Wetter than Normal Conditions (APT)
- Drier than Normal Conditions (APT)
- Gauge 7 (767055)
- 0" Ground Surface
- Onsite Rainfall
- 12" Threshold
- Gauge 7 Consecutive Days Meeting Wetland Criteria: 26 Days, 12.4% of Growing Season

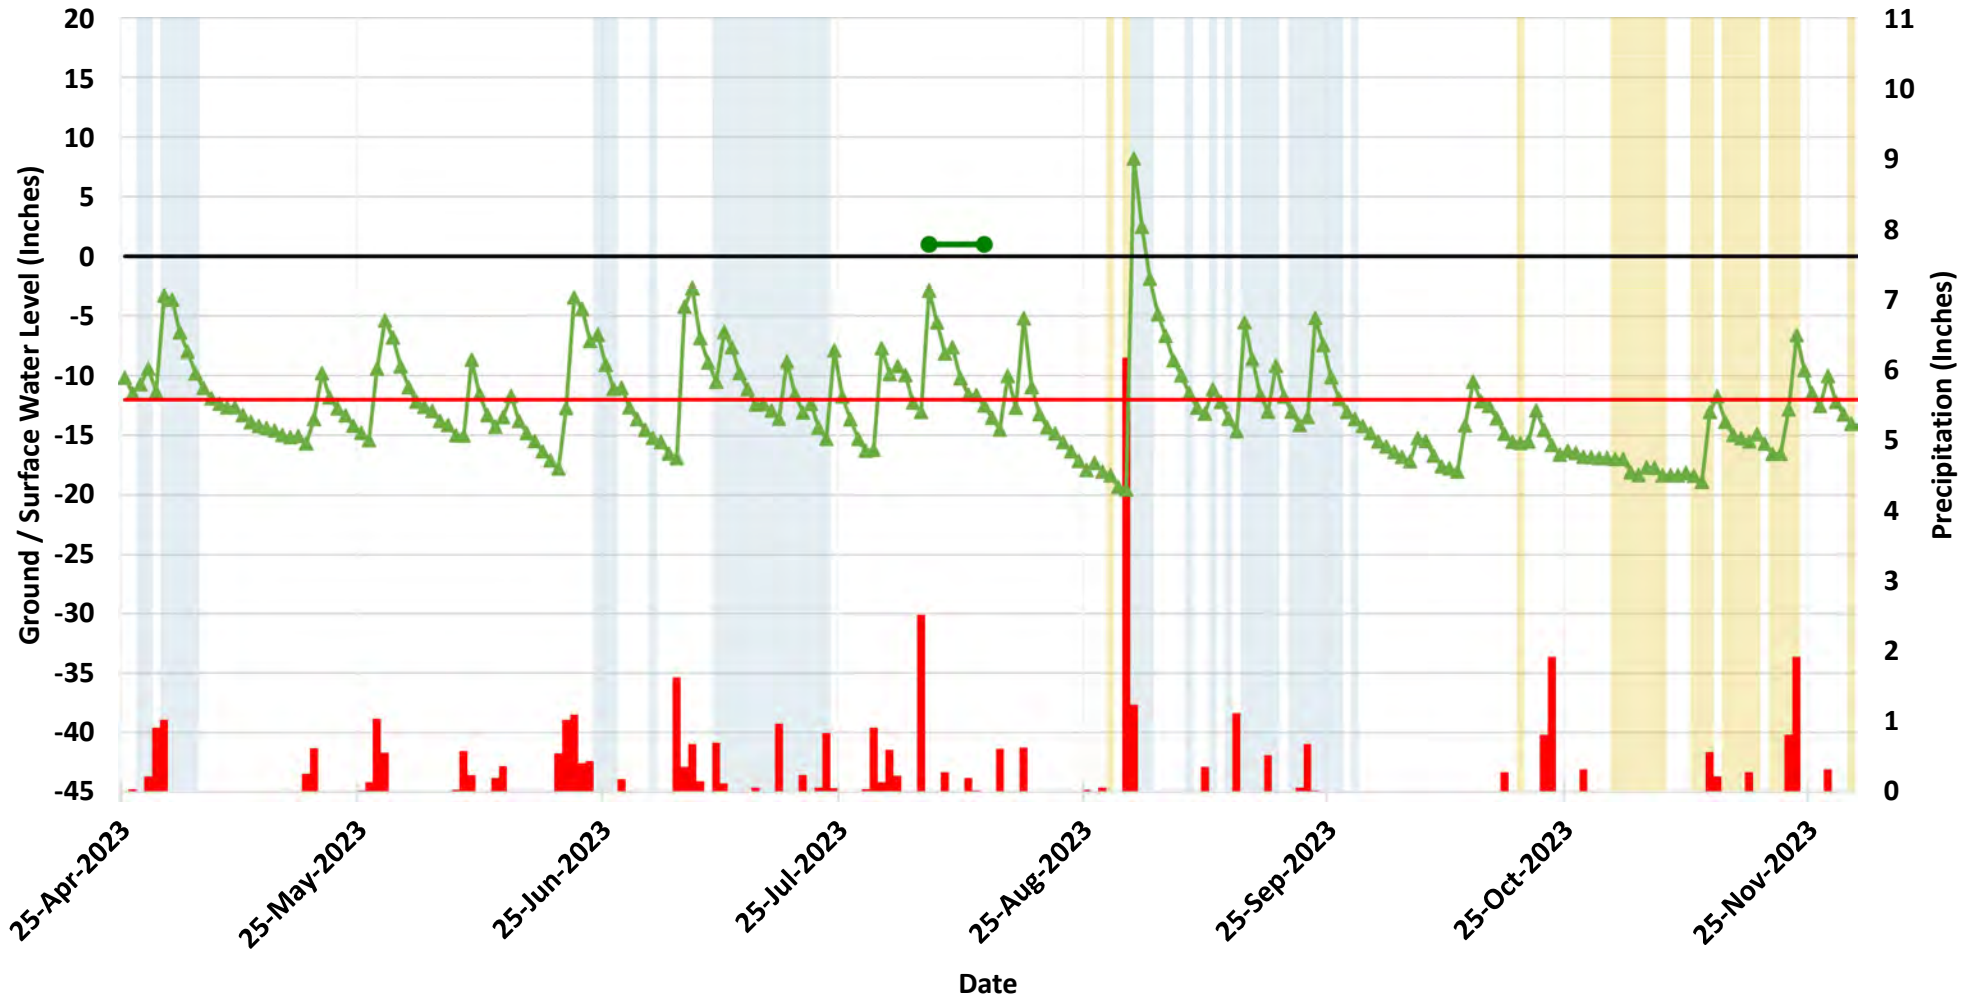
- Drier than Normal Conditions (APT)
- Wetter than Normal Conditions (APT)
- Onsite Rainfall
- Gauge 11 (767706)
- 0" Ground Surface
- 12" Threshold
- Gauge 11 Consecutively Meeting Wetland Criteria 8 Days, 3.8% of Growing Season

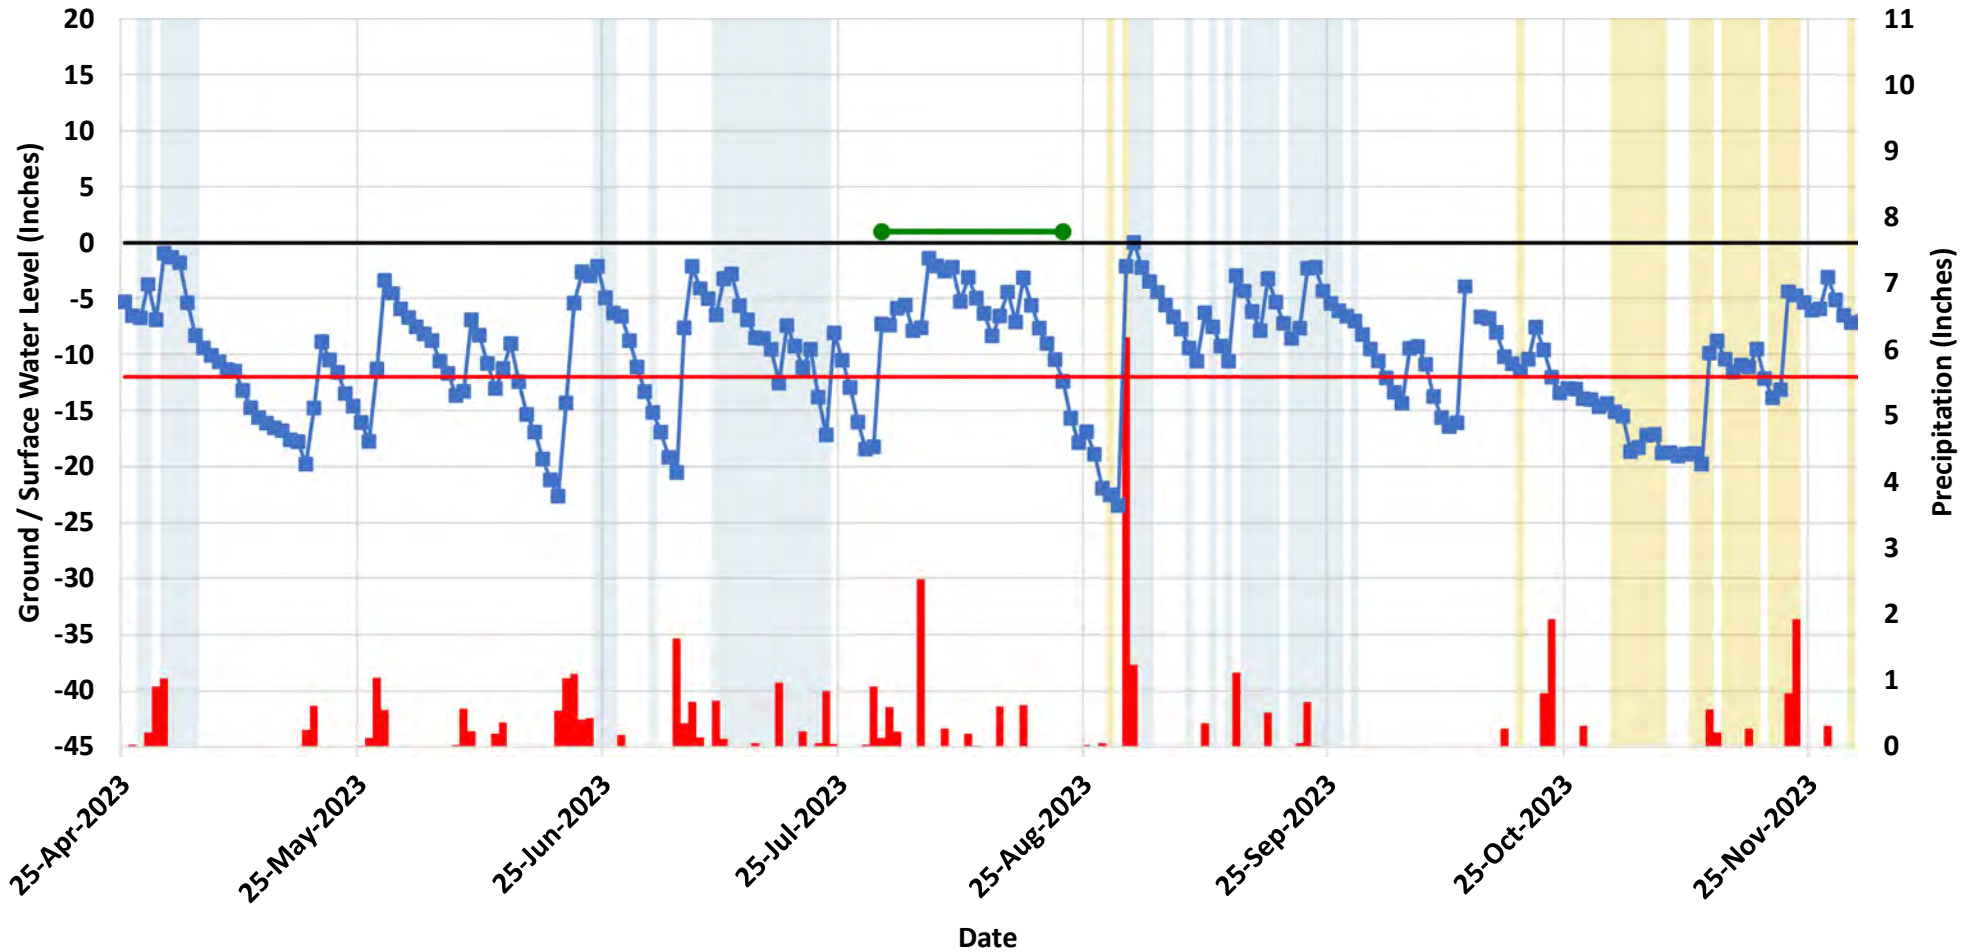
- Drier than Normal Conditions (APT)
- Wetter than Normal Conditions (APT)
- Onsite Rainfall
- Gauge 12 (768854)
- 0" Ground Surface
- -12" Threshold
- Gauge 12 Consecutive Days Meeting Wetland Criteria 24 Days, 11.4% of Growing Season
