MY1 FINAL MONITORING REPORT

Cool Run Stream and Riparian Wetland Mitigation Site

Brunswick County, NC

DMS Project ID No. 100142

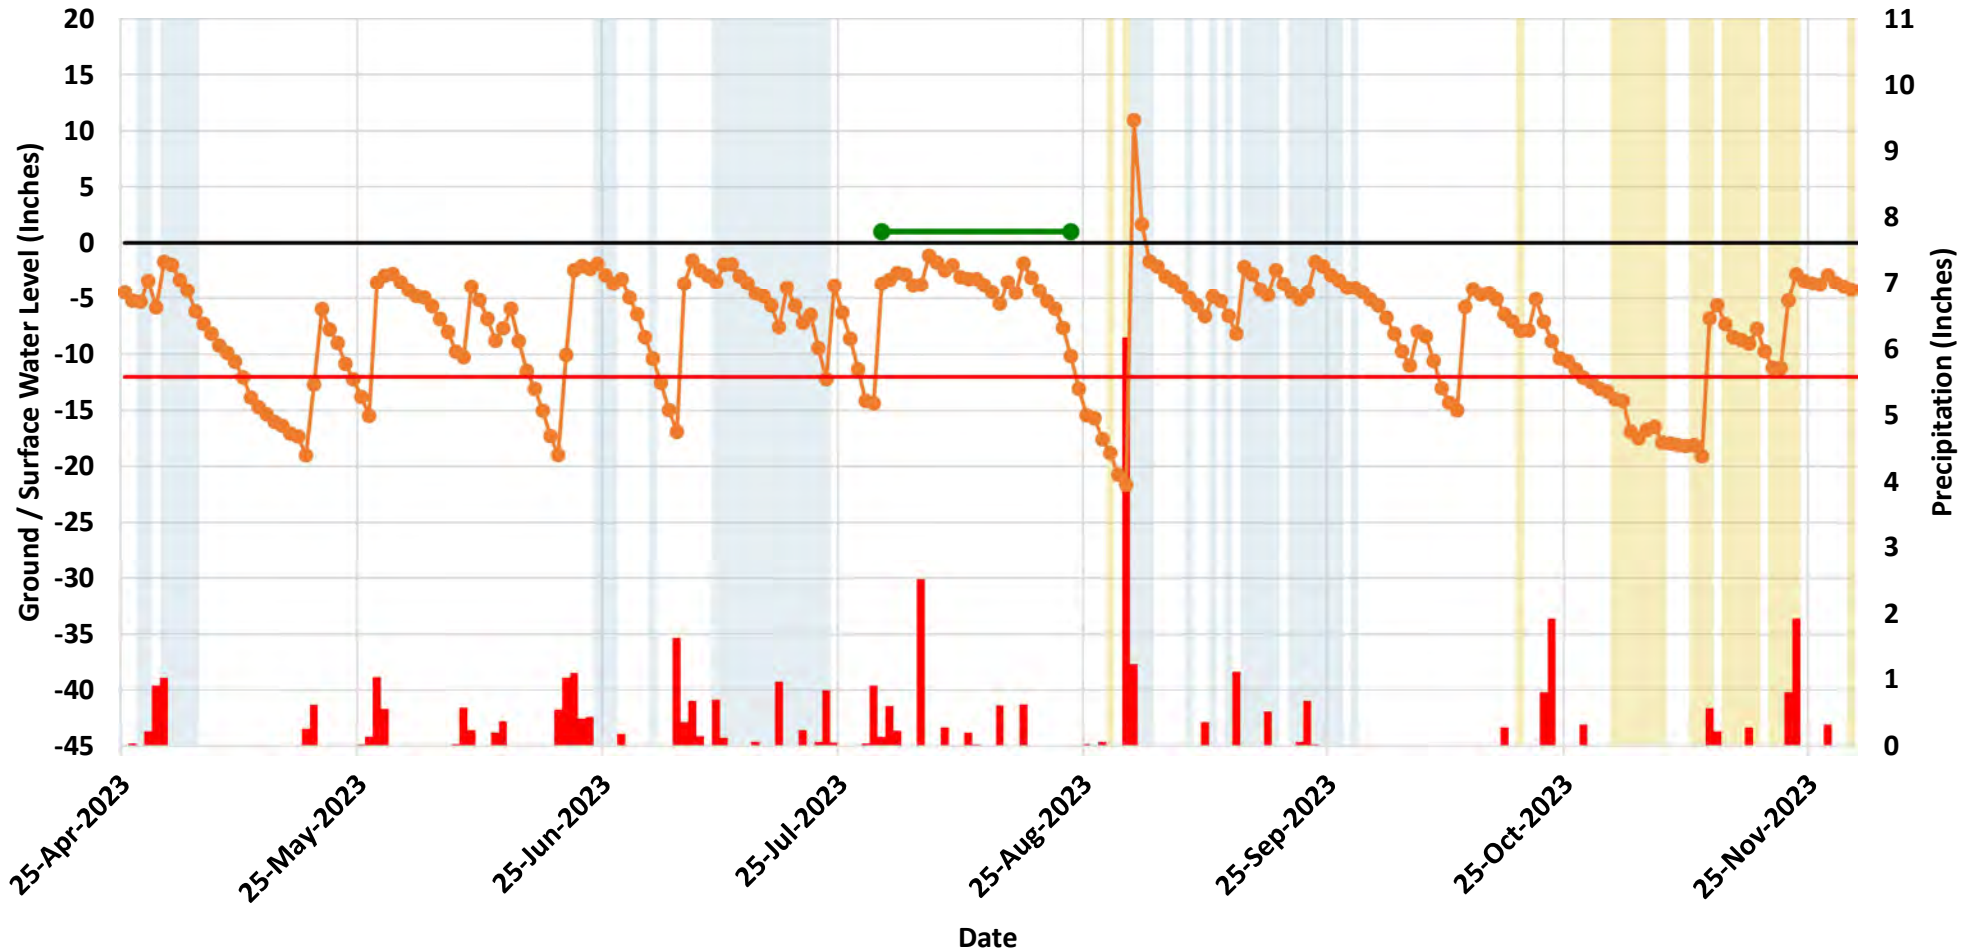
- Drier than Normal Conditions (APT)
 - Wetter than Normal Conditions (APT)
 - Onsite Rainfall
 - Gauge 13 (765536)
 - 0" Ground Surface
 - -12" Threshold
 - Gauge 13 Consecutive Days Meeting Wetland Criteria
- 25 Days, 11.9% of Growing Season

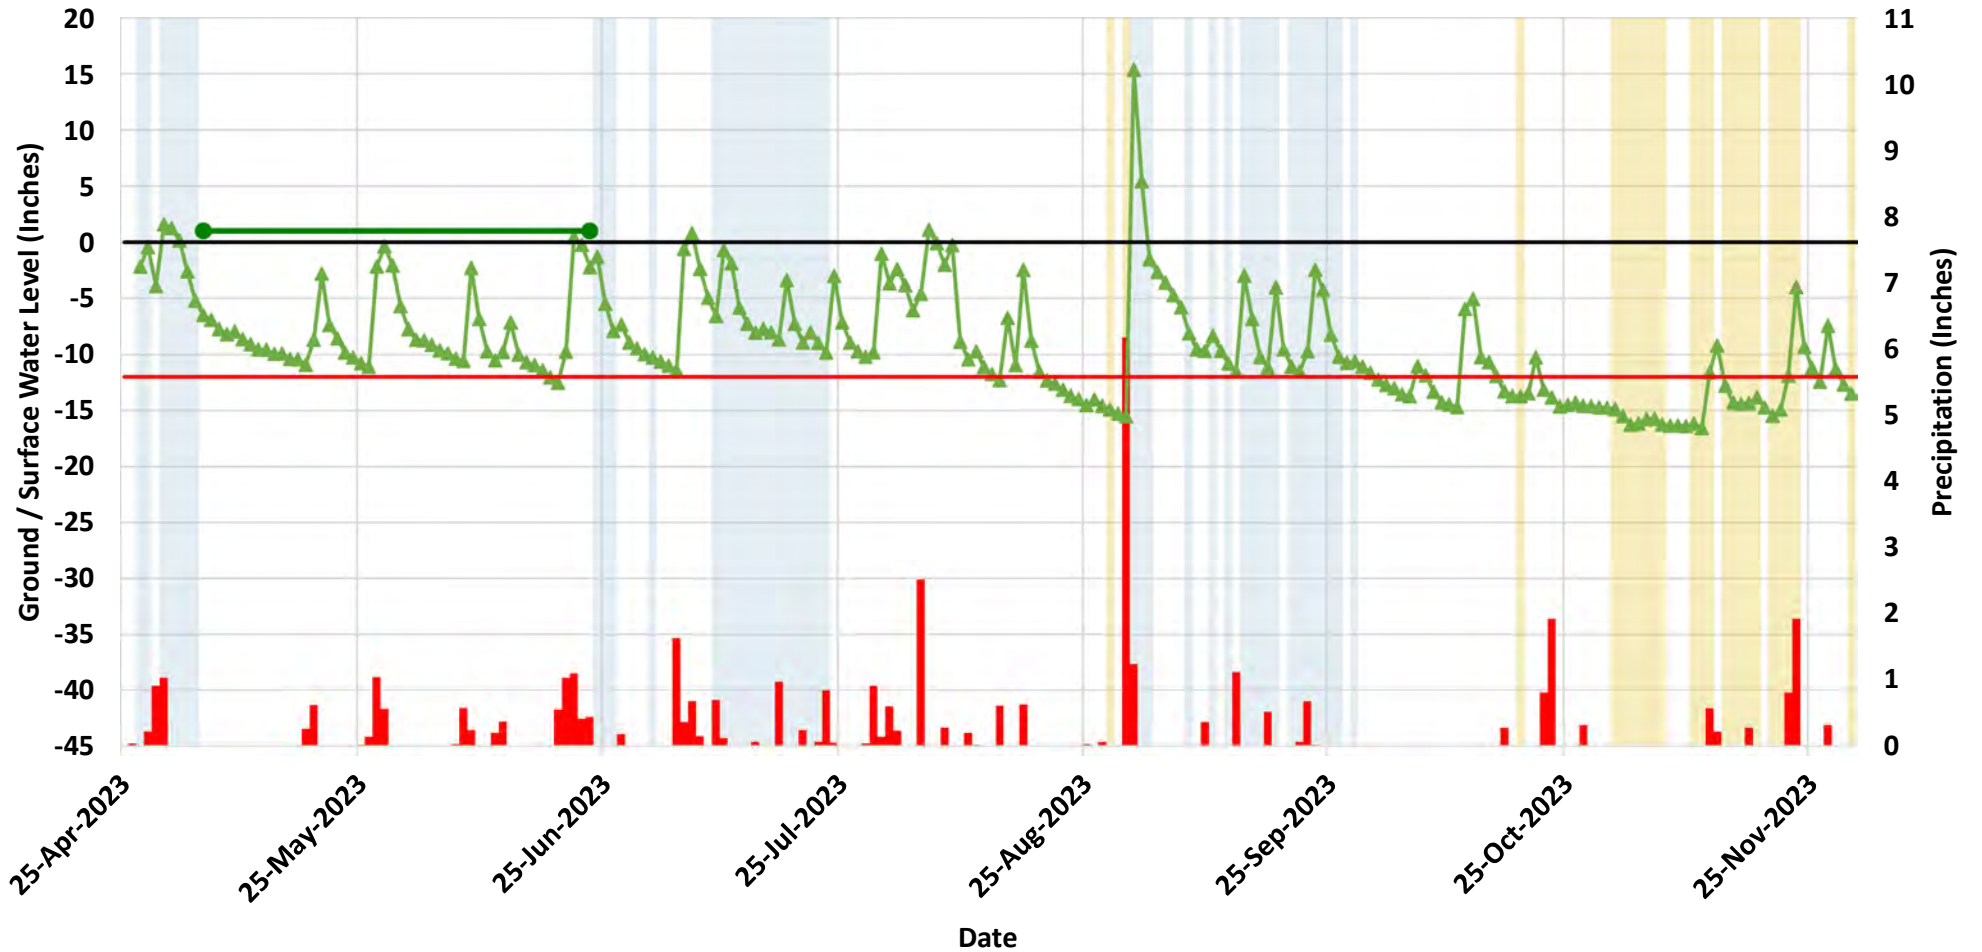
- Drier than Normal Conditions (APT)
- Wetter than Normal Conditions (APT)
- Onsite Rainfall
- Gauge 14 (768851)
- 0" Ground Surface
- 12" Threshold
- Gauge 14 Consecutive Days Meeting Wetland Criteria 50 Days, 23.8% of Growing Season

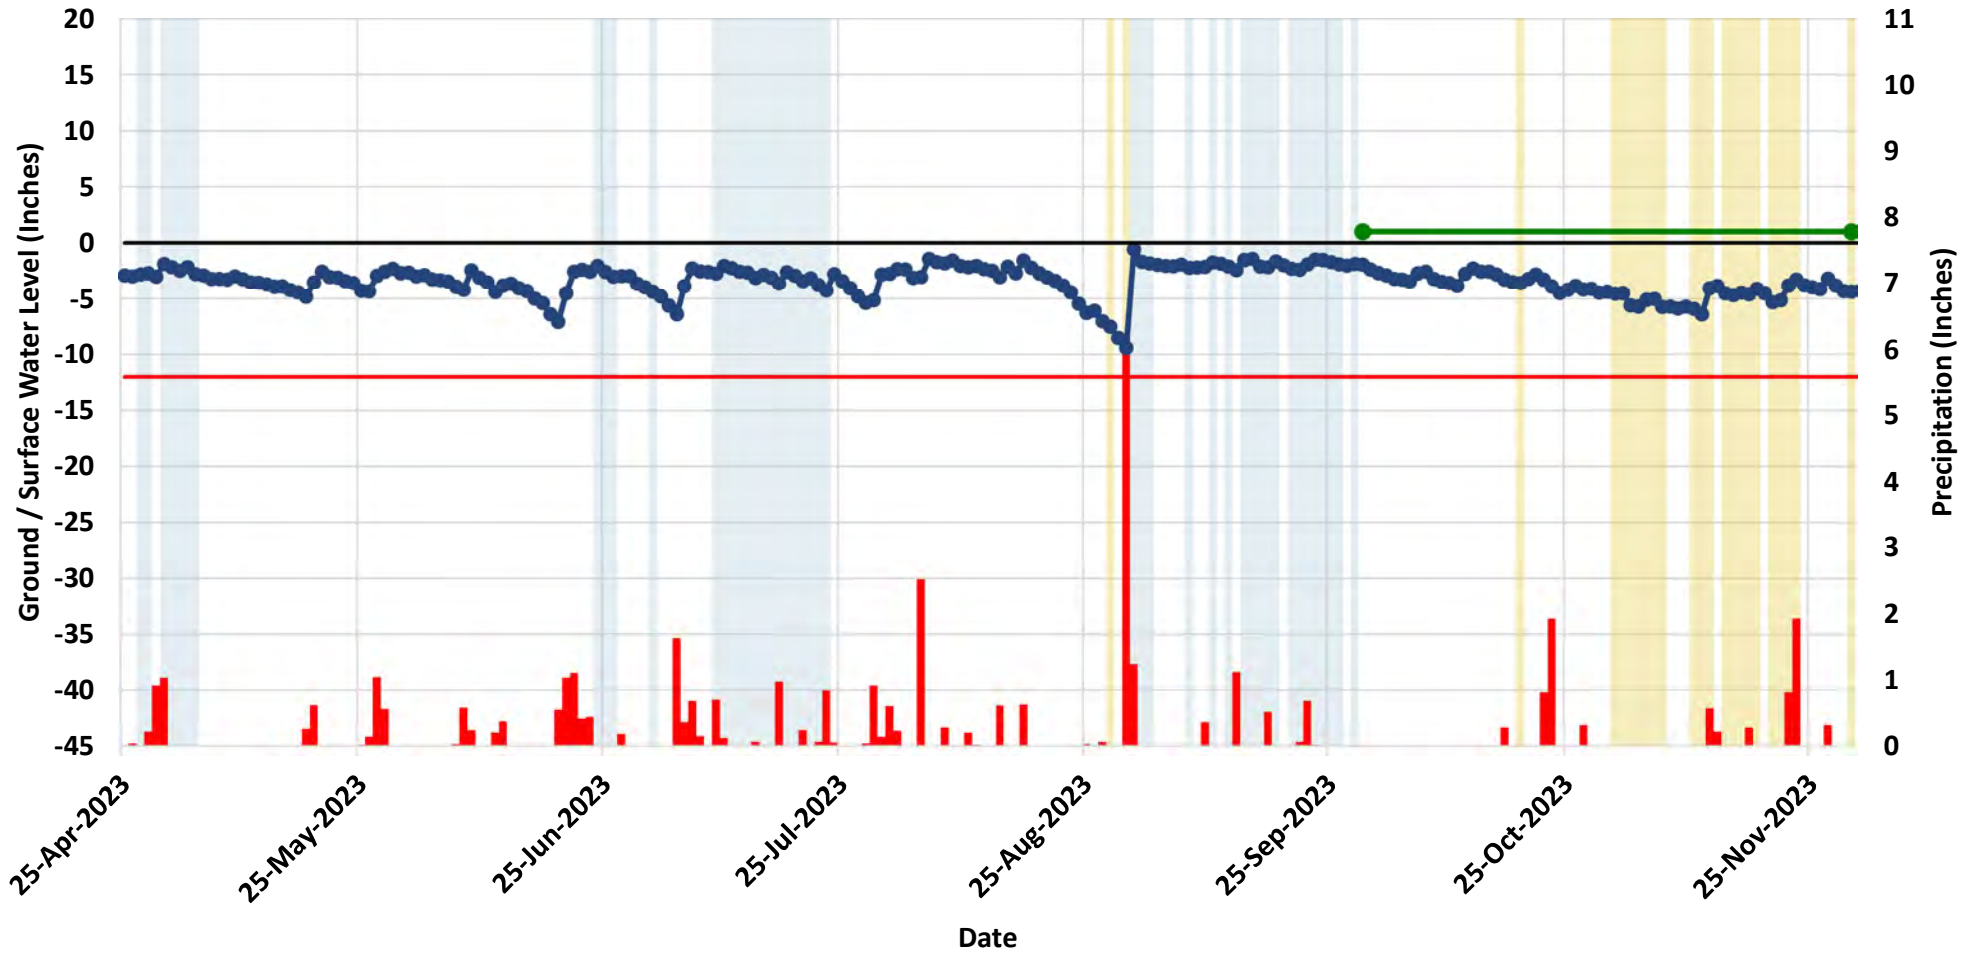
- Drier than Normal Conditions (APT)
- Wetter than Normal Conditions (APT)
- Onsite Rainfall
- Gauge 15 (768845)
- 0" Ground Surface
- -12" Threshold
- Gauge 15 Consecutive Days Meeting Wetland Criteria 63 Days, 30% of Growing Season
