MITIGATION PLAN

COOL SPRINGS MITIGATION SITE

Harnett County, NC
NCDEQ Contract No. 0302-02
DMS ID No. 100166

Cape Fear River Basin
HUC 03030004

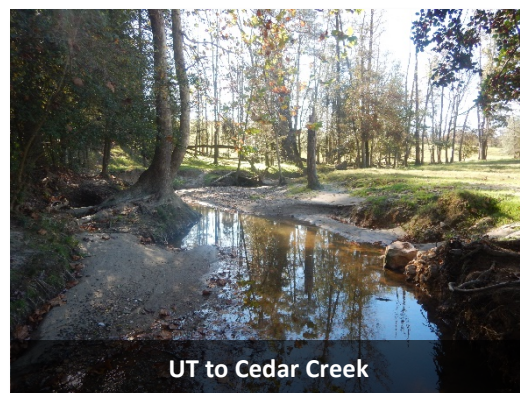
Ut to Cedar Creek

UT to Cedar Creek flows over a mix of bedrock, cobble, gravel, and fines. The stream flows out of an adjacent wooded parcel south of the Site and flows northward across the Site to its confluence with Cedar Creek at Cool Springs Road. Cattle have access to the entire length of this stream on the project site and use it continuously for water and shade. However, due to the bedrock and wooded buffer, Reach 1 is one of the more stable streams on the Site. It is only slightly incised and bank erosion mostly occurs at areas of frequent cattle access. The stream is confined in a narrow valley with steep side slopes and has a steep longitudinal slope for much of its length on the Site. The stream pattern is generally straight. There are four badly eroding ephemeral gullies that flow into Reach 1 from the east side of the Site. Reach 2 is a short reach that is incised (bank height ratio is approximately 2.7) and unstable. This reach has no vegetated buffer along most of the left bank and cattle have trampled the banks of this reach. There is an existing culvert crossing on Reach 1 and a ford crossing at the break between Reaches 1 and 2.

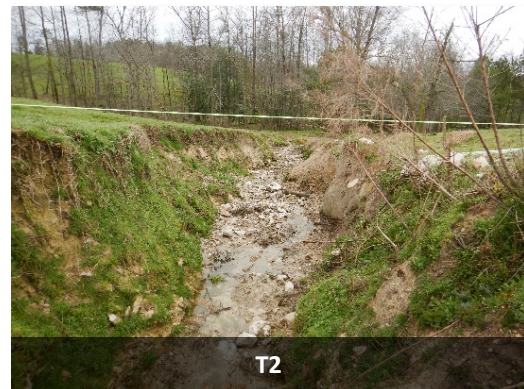
T2 originates from a spring in an open pasture downslope from the chicken houses and a feeding area for cattle. It flows northwestward for over 400 feet and joins UT to Cedar Creek Reach 1 near the midpoint of that reach. T2 is incised (bank height ratio is approximately 4.0), severely eroded, and cattle have access to the creek for its entire length. There are a few trees along the reach, but the buffer is mostly vegetated with pasture grass only. The reach has a steep slope (7.7%), and the bed material is comprised of cobble, gravel, and fines. The pattern is generally straight with two long meanders.

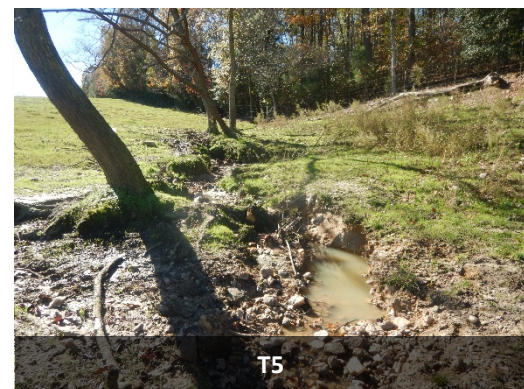
T5 is a short stream that originates near the western property line and flows into Reach 1 of T4. The stream is not incised and has minimal erosion, but cattle have access to this reach. It is straight and has a narrow, wooded buffer and a gravel and cobble bed. The T4 ford also crosses this reach.

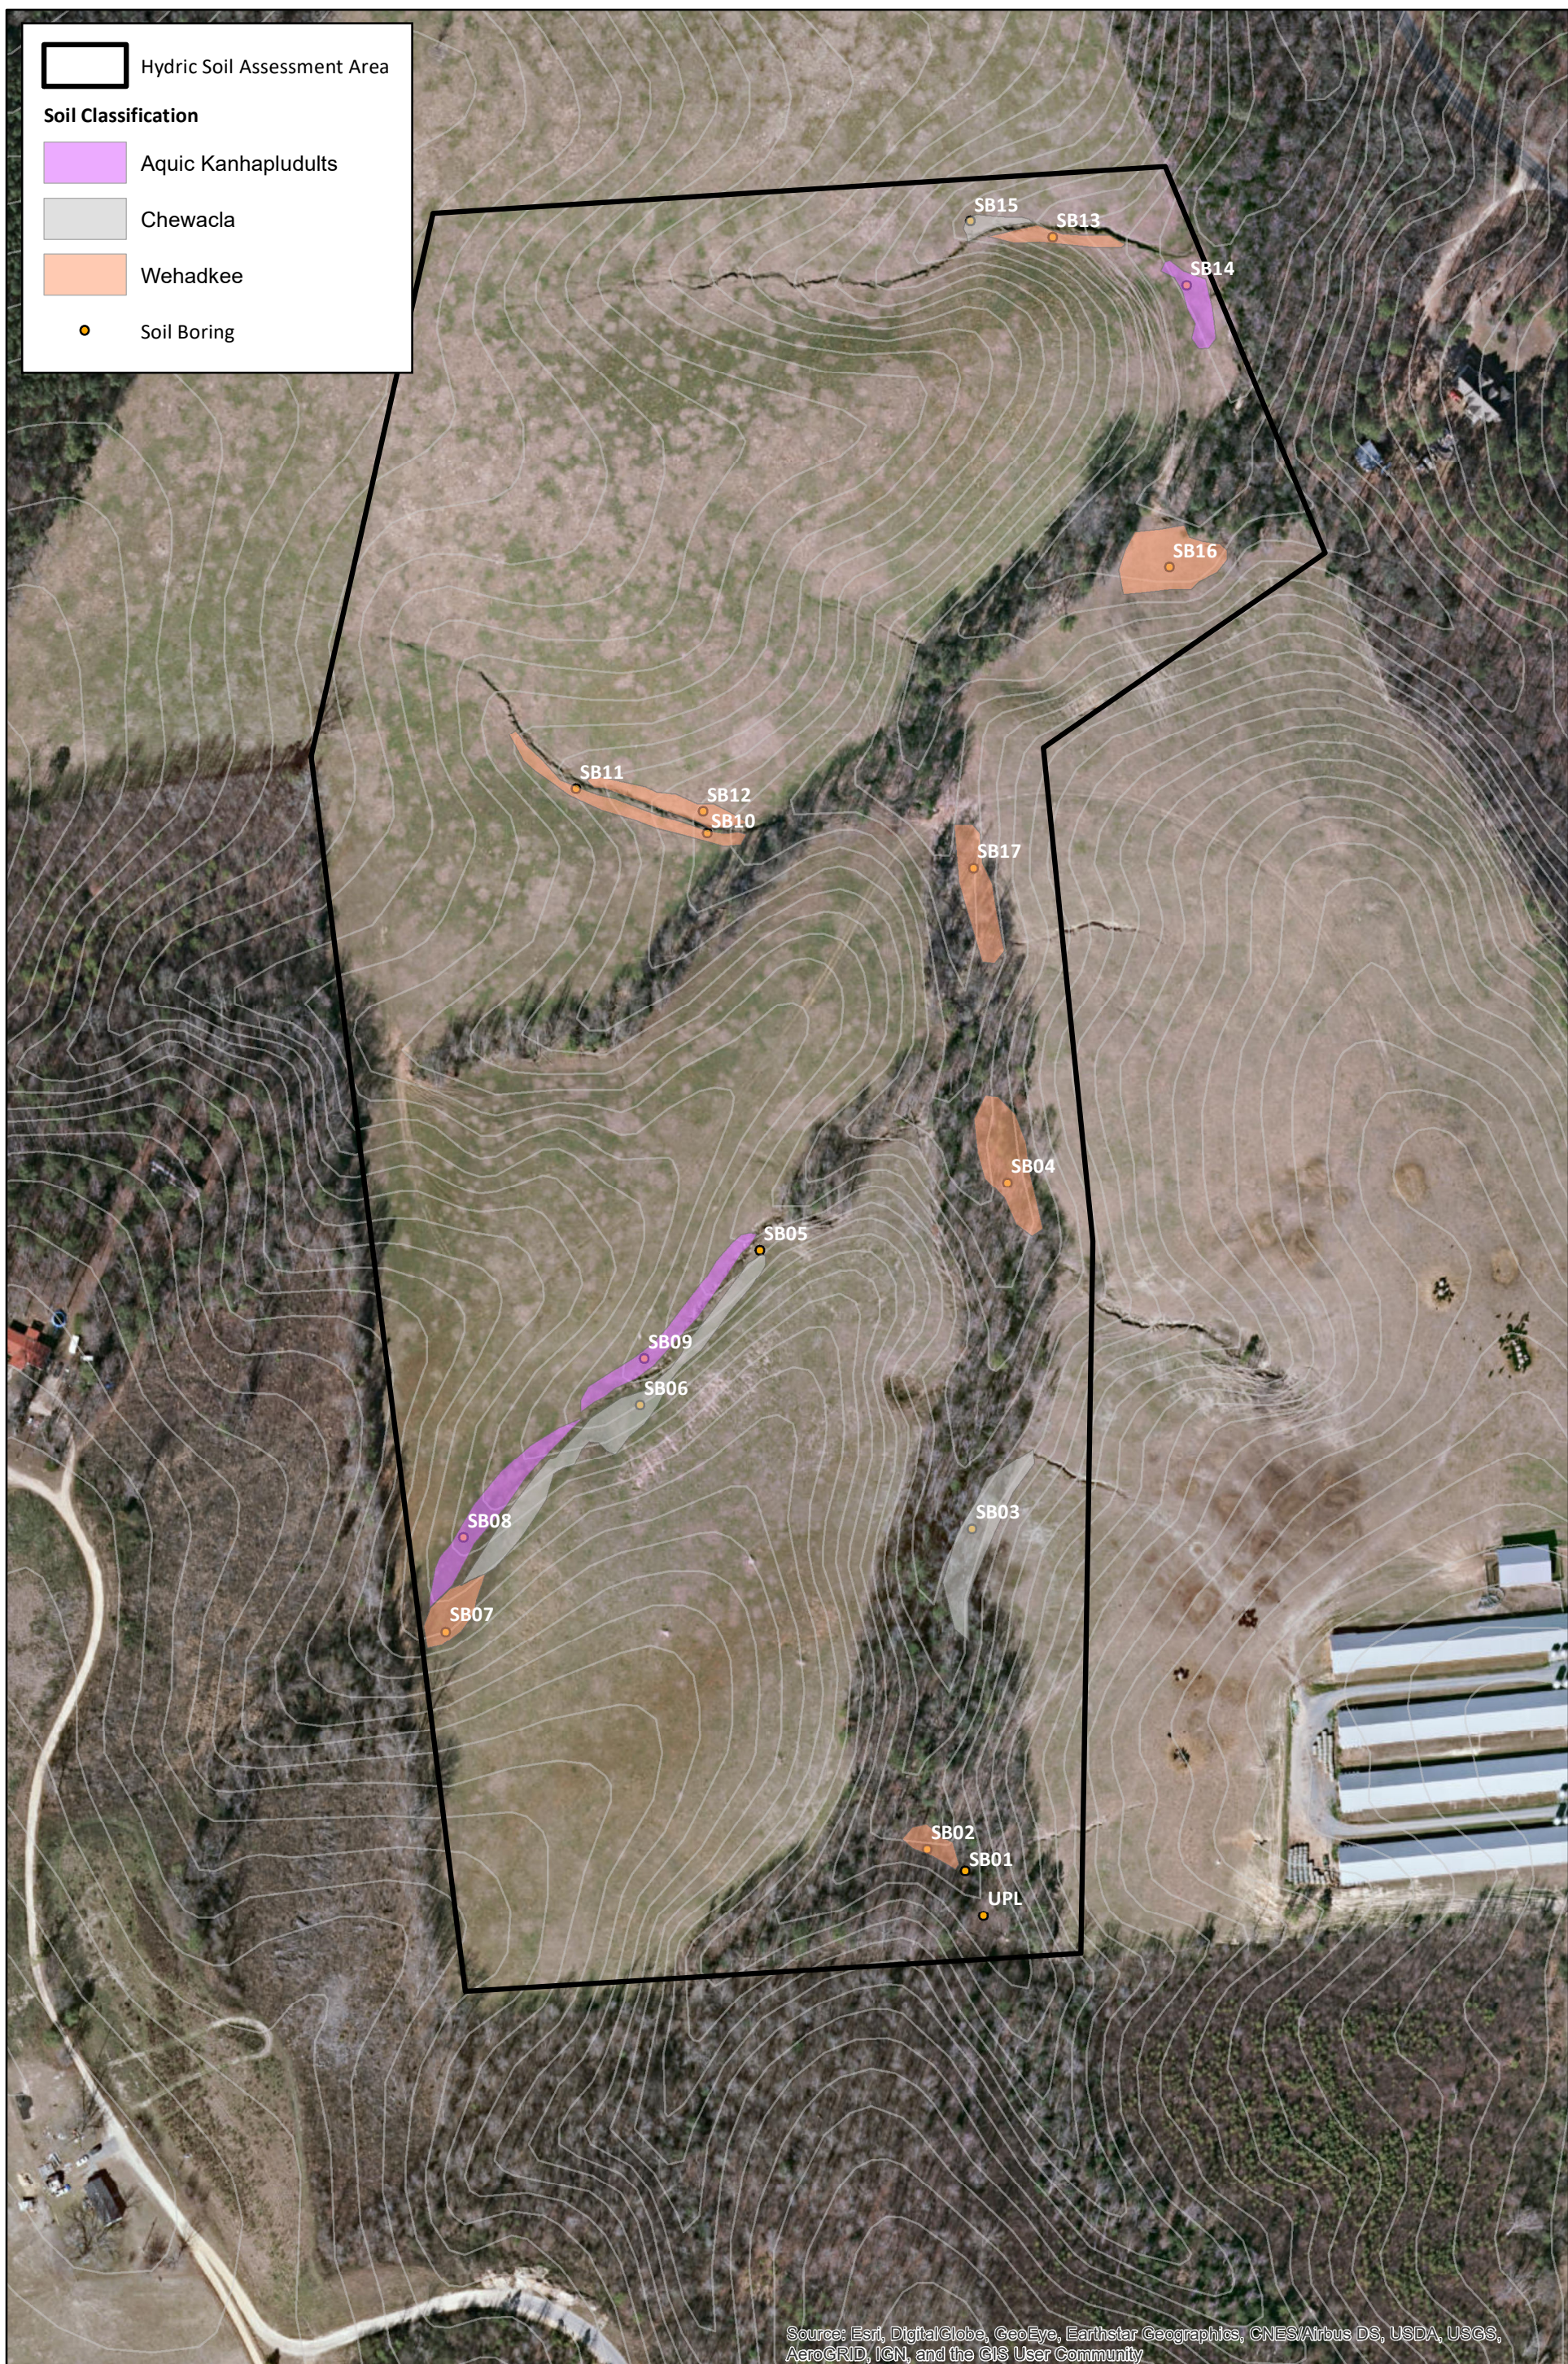
Figure A. Preliminary Soils Investigation Map
Cool Springs Mitigation Site
Cape Fear 03030004

A licensed soil scientist (LSS) visited the Site on March 11, 2020 to evaluate potential wetland mitigation areas. The soils investigation concluded there are three separate hydric soil types within the Site. The Wehadkee and Chewacla series are commonly observed in the North Carolina Piedmont. The third soil type exhibited hydric soil indicator F3, had an aquic moisture regime, and appeared to be derived from weathered Piedmont residuum but was not an appropriate match for any series with aquic conditions currently mapped in this part of North Carolina. Taxonomically it is best described as an Aquic Kanhapludult. The assumption that this soil belongs to the Kanhapludult great group instead of the Hapludult great group is based on proximity to the nearby mapped Pacolet series which is in the Kanhapludult great group. Presence of hydric soils in the absence of a contemporary wetland hydrology regime suggests such areas were likely wetlands prior to agricultural conversion. A complete copy of the hydric soil investigation report and hydric soils map can be found in Appendix 4.

Additional soil sample locations were quickly assessed but not recorded. Soil borings shown in the figure were representative of the areas in which they were observed. Hydric soil polygon boundaries were determined using the field observations of soils as well as observation of landscape characteristics that are known to correlate with hydric soil occurrences such as topography, relief, evidence of groundwater discharge or water accumulation, and hydrophytic vegetation.
