BASELINE MONITORING REPORT
Coon Creek Riparian Buffer and Nutrient Offset Mitigation Project
Granville County, North Carolina

NCEEP Project Identification No. 95807
NCEEP RFP No. 16-004795
NCEEP Contract No. 5153

BASELINE MONITORING REPORT

VEGETATION & MITIGATION PLAN (AS-BUILT)

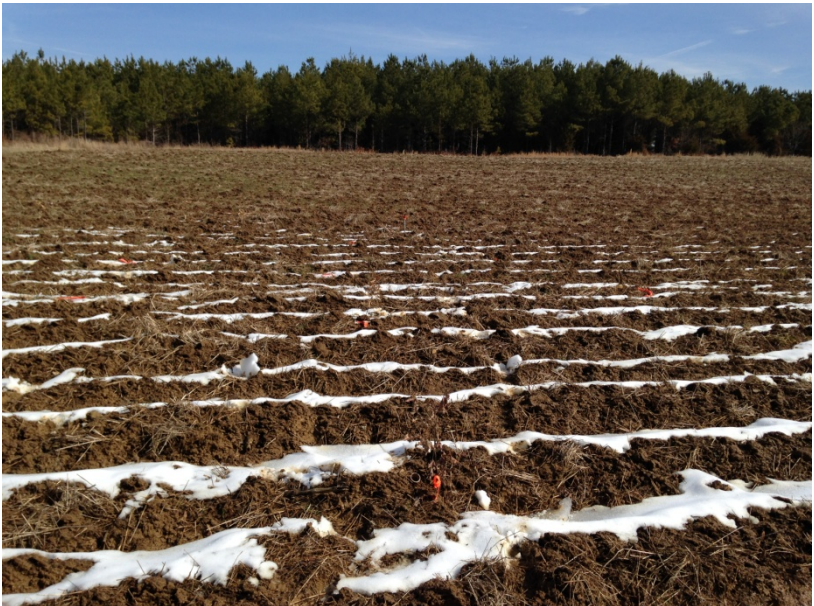
Client Name NCEEP		Site Location Granville County		Project No. 95807
Photo No. 16	Date 2/17/14

Description Vegetation Monitoring Plot and Photo Point 16, view northwest from southwest corner.
