**Coon Creek Riparian Buffer and Nutrient Offset Mitigation Project
2014 Monitoring Report
Monitoring Year 1 of 5**

**Granville County, North Carolina
Tar-Pamlico River Basin
USGS Hydrologic Unit 03020101**

**NCEEP Project No. 95807
NCEEP Contract No. 5153**

FINAL – 2014 Monitoring Report – Year 1 of 5

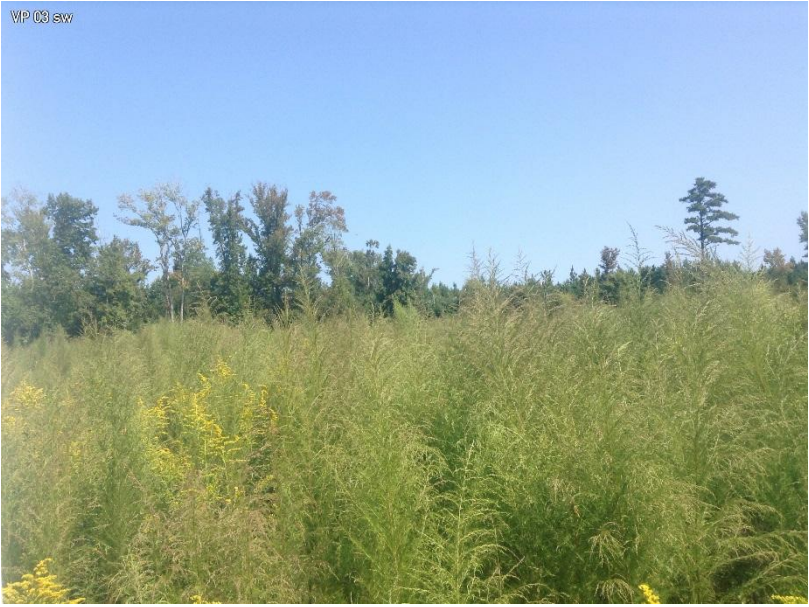
Client Name NCEEP		Site Location Granville County	Project No. 95807
Photo No. 3	Date 9/18/14

Description Vegetation Monitoring Plot and Photo Point 3, view northwest from southwest corner.

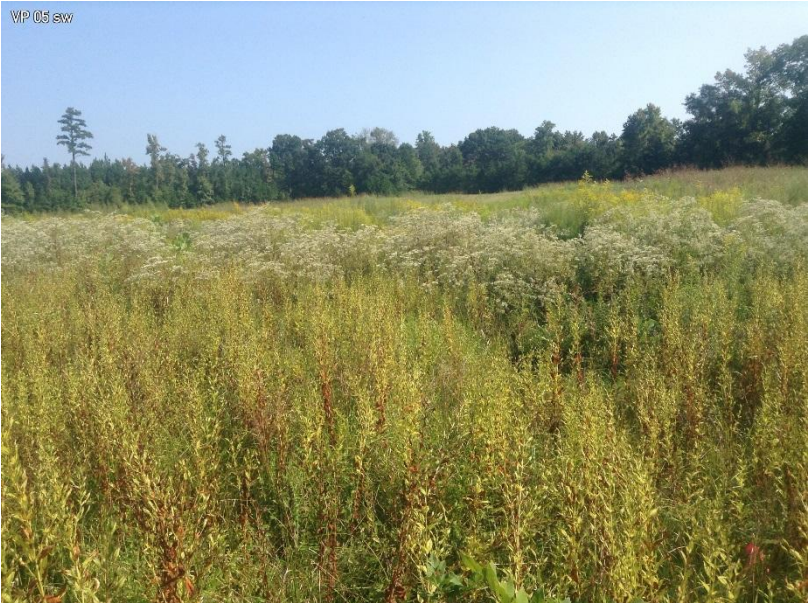
Client Name NCEEP		Site Location Granville County	Project No. 95807
Photo No. 5	Date 9/18/14

Description Vegetation Monitoring Plot and Photo Point 5, view northwest from southwest corner.

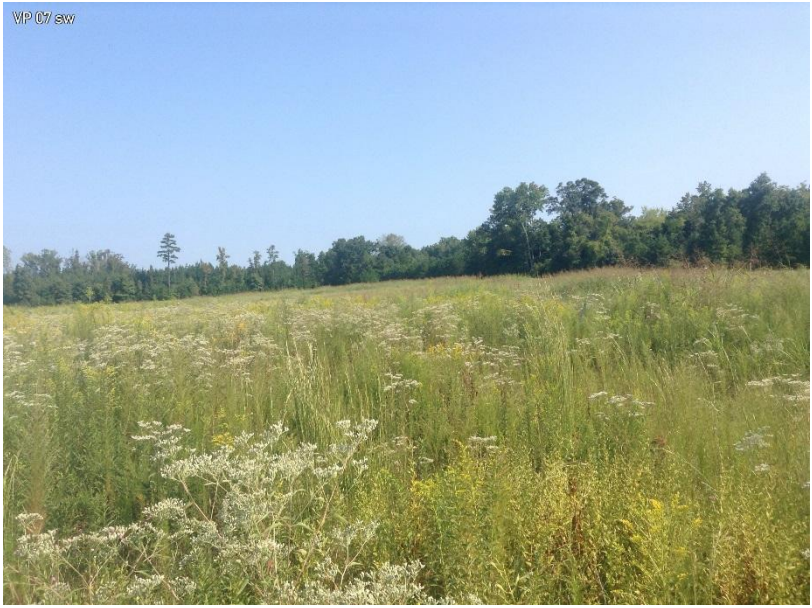
Client Name NCEEP		Site Location Granville County	Project No. 95807
Photo No. 7	Date 9/18/14

Description Vegetation Monitoring Plot and Photo Point 7, view northwest from southwest corner.

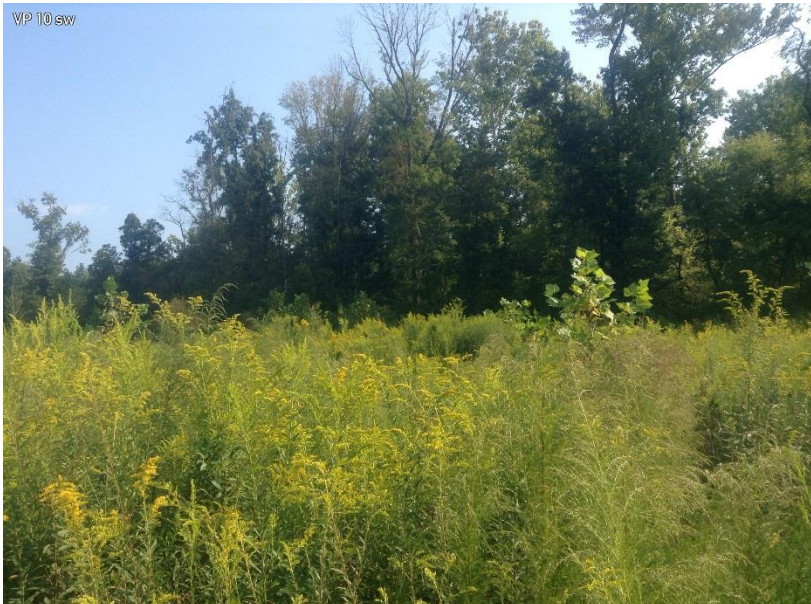
Client Name NCEEP		Site Location Granville County	Project No. 95807
Photo No. 10	Date 9/18/14

Description Vegetation Monitoring Plot and Photo Point 10, view northwest from southwest corner.

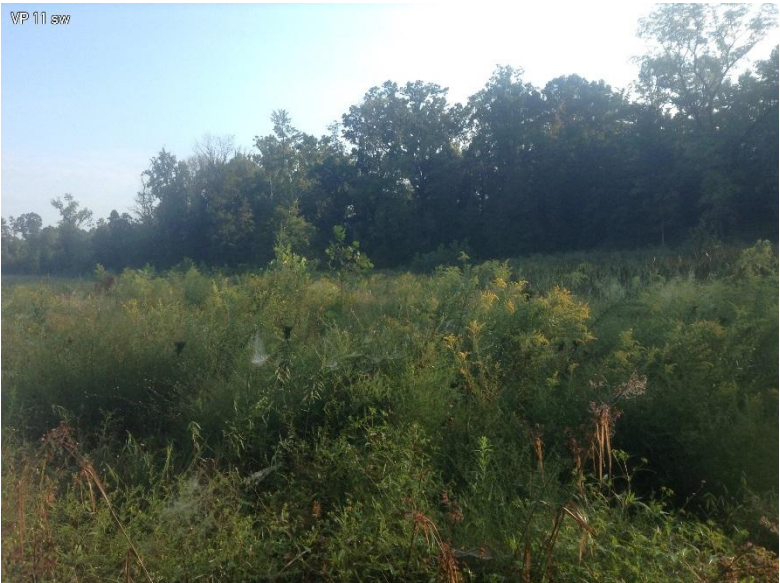
Client Name NCEEP		Site Location Granville County	Project No. 95807
Photo No. 11	Date 9/18/14

Description Vegetation Monitoring Plot and Photo Point 11, view northwest from southwest corner.

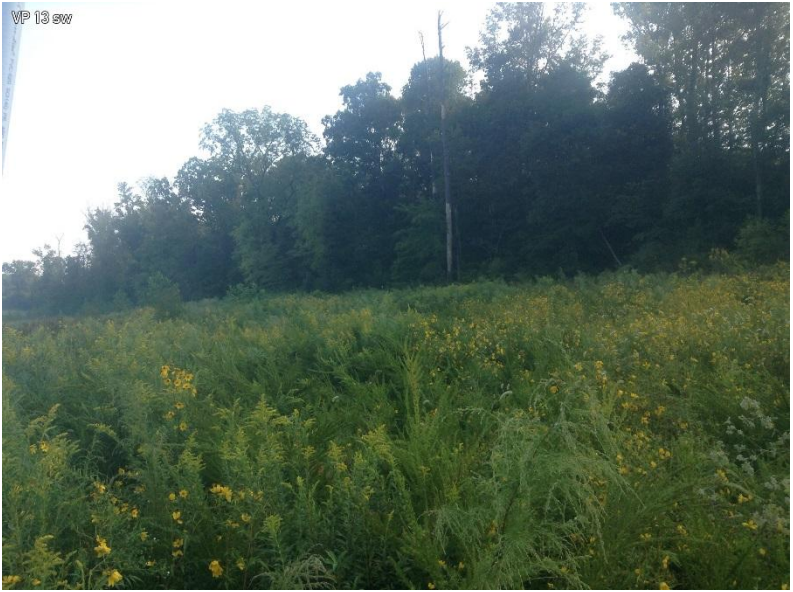
Client Name NCEEP		Site Location Granville County	Project No. 95807
Photo No. 13	Date 9/18/14

<p>VP 13 sw</p>	
Description Vegetation Monitoring Plot and Photo Point 13, view northwest from southwest corner.

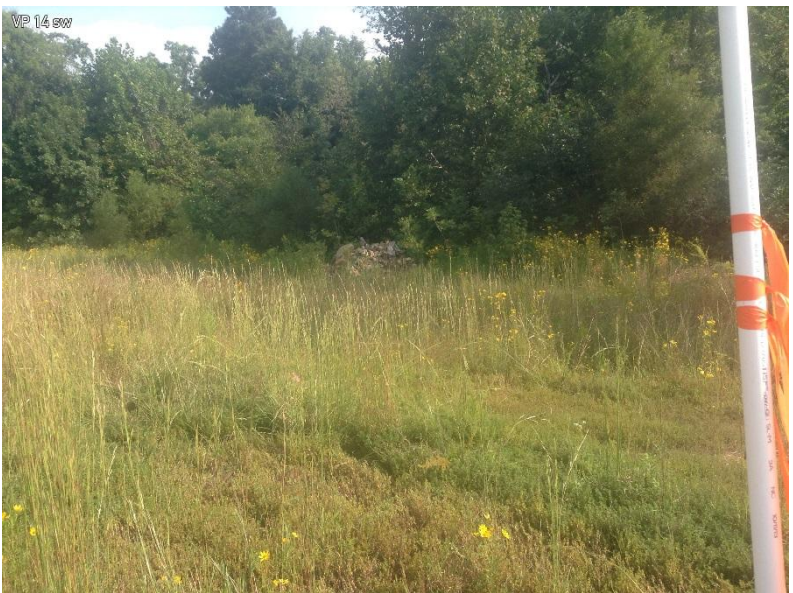
Client Name NCEEP		Site Location Granville County	Project No. 95807
Photo No. 14	Date 9/17/14

<p>VP 14 sw</p>	
Description Vegetation Monitoring Plot and Photo Point 14, view northwest from southwest corner.

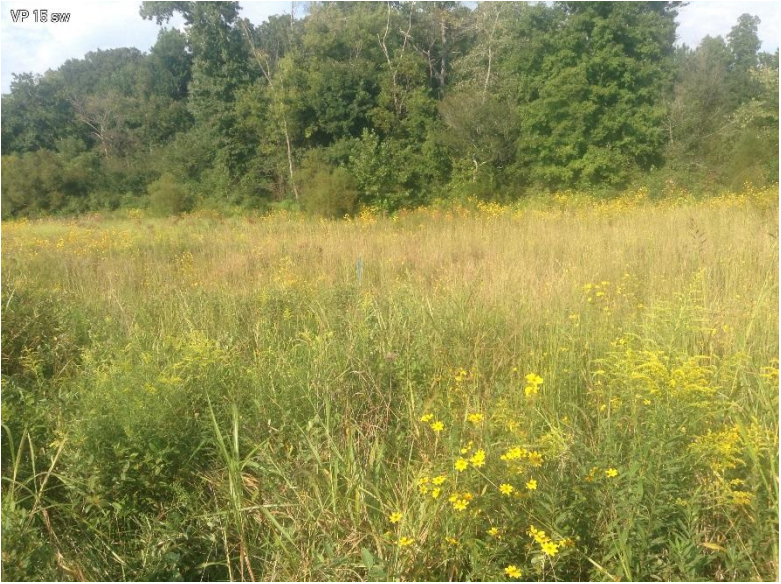
Client Name NCEEP		Site Location Granville County	Project No. 95807
Photo No. 15	Date 9/17/14

<p>VP 15 sw</p>	
Description Vegetation Monitoring Plot and Photo Point 15, view northwest from southwest corner.

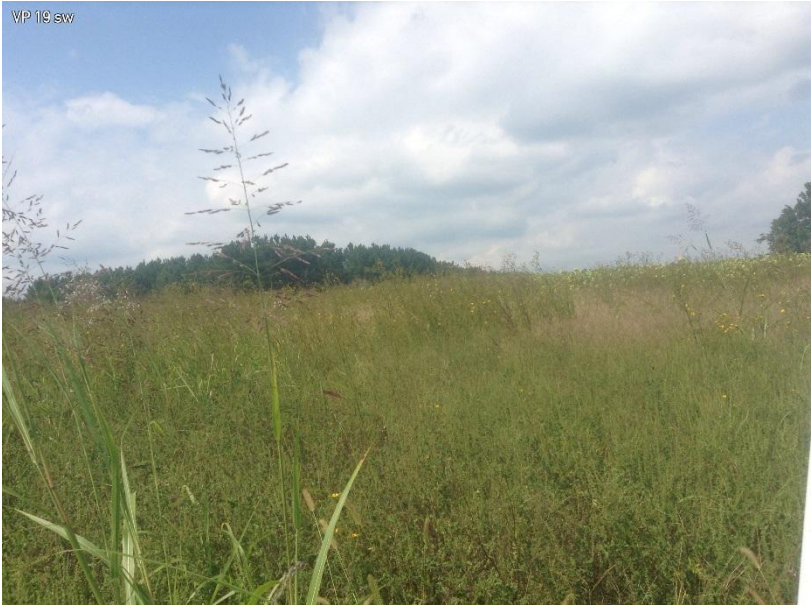
Client Name NCEEP		Site Location Granville County	Project No. 95807
Photo No. 19	Date 9/17/14

Description Vegetation Monitoring Plot and Photo Point 19, view northwest from southwest corner.

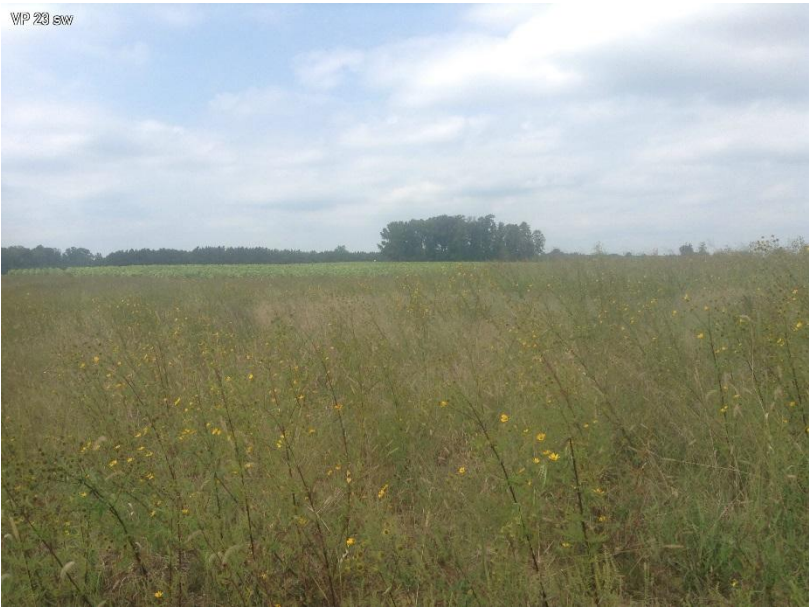
Client Name NCEEP		Site Location Granville County	Project No. 95807
Photo No. 23	Date 9/17/14

Description Vegetation Monitoring Plot and Photo Point 23, view northwest from southwest corner.
