**Coon Creek Riparian Buffer and Nutrient Offset Mitigation Project  
2016 Monitoring Report  
Monitoring Year 3 of 5**

**Granville County, North Carolina  
Tar-Pamlico River Basin  
USGS Hydrologic Unit 03020101**

**NCDMS Project No. 95807  
NCDMS Contract No. 5153**

**FINAL** - 2016 Monitoring Report – Year 3 of 5

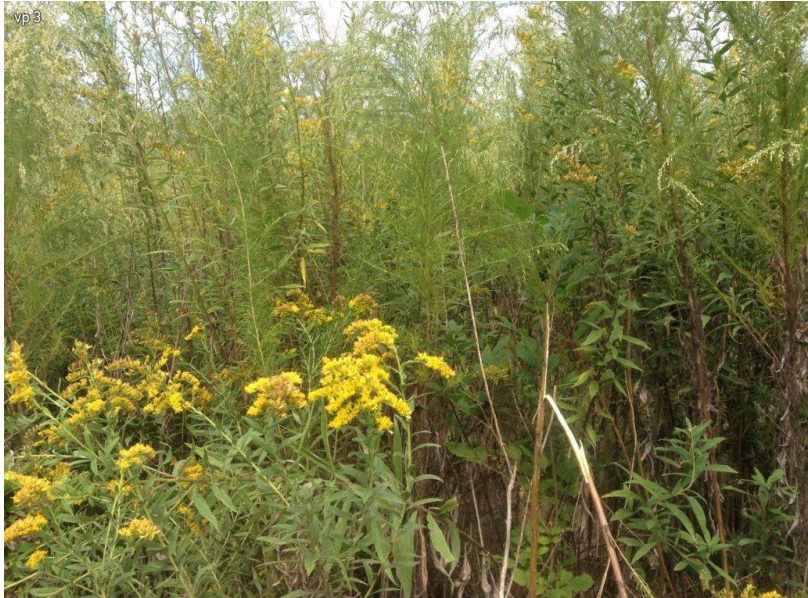
<b>Client Name</b> NCDMS		<b>Site Location</b> Granville County	<b>Project No.</b> 95807
<b>Photo No.</b> 3	<b>Date</b> 10/4/16

<b>Description</b> Vegetation Monitoring Plot and Photo Point 3, view northwest from southwest corner.

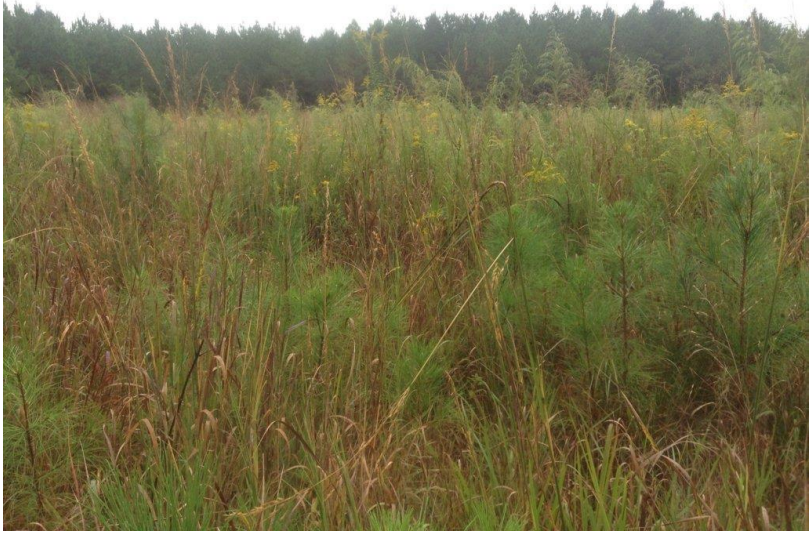
<b>Client Name</b> NCDMS		<b>Site Location</b> Granville County	<b>Project No.</b> 95807
<b>Photo No.</b> 16	<b>Date</b> 9/30/16

<b>Description</b> Vegetation Monitoring Plot and Photo Point 16, view northwest from southwest corner.

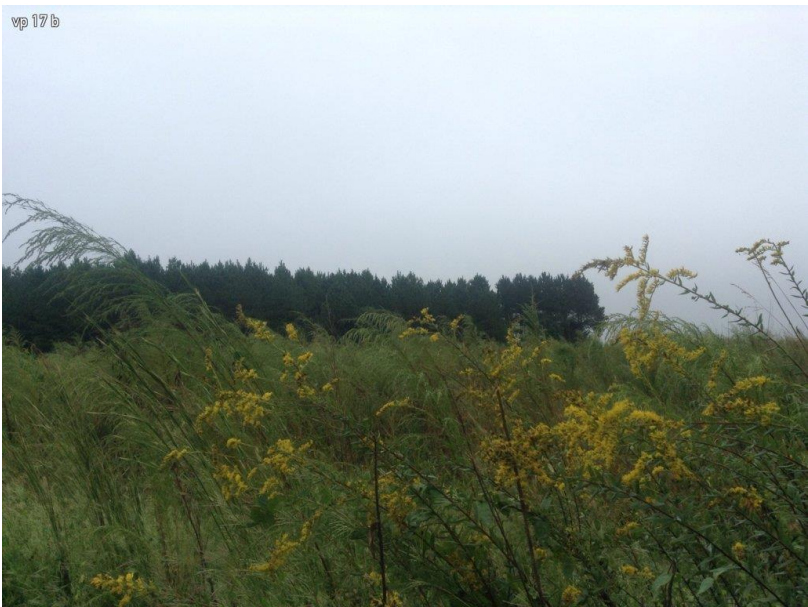
<b>Client Name</b> NCDMS		<b>Site Location</b> Granville County	<b>Project No.</b> 95807
<b>Photo No.</b> 17	<b>Date</b> 9/30/16

<b>Description</b> Vegetation Monitoring Plot and Photo Point 17, view northwest from southwest corner.

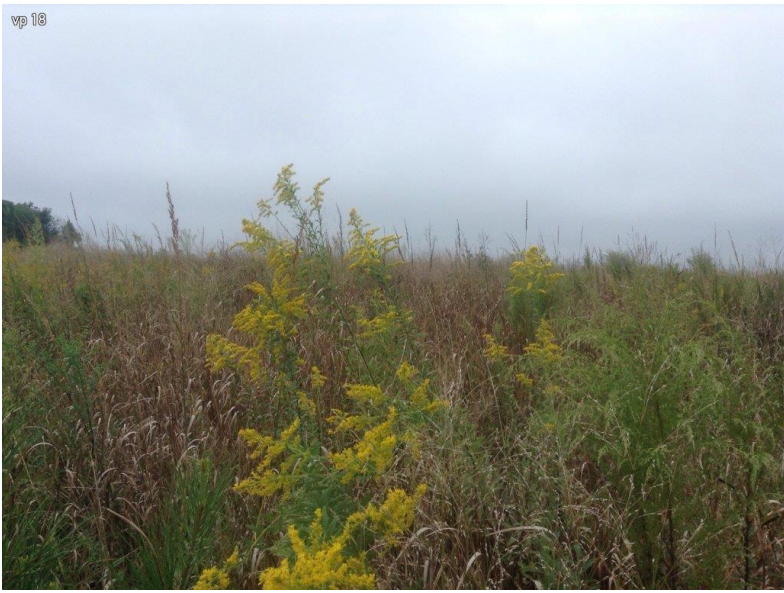
<b>Client Name</b> NCDMS		<b>Site Location</b> Granville County	<b>Project No.</b> 95807
<b>Photo No.</b> 18	<b>Date</b> 9/30/16

<b>Description</b> Vegetation Monitoring Plot and Photo Point 18, view northwest from southwest corner.

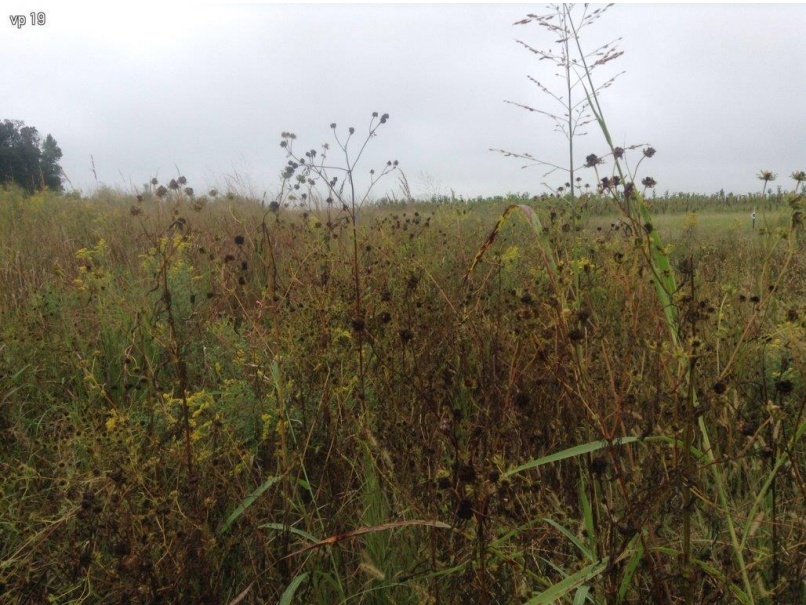
<b>Client Name</b> NCDMS		<b>Site Location</b> Granville County	<b>Project No.</b> 95807
<b>Photo No.</b> 19	<b>Date</b> 9/30/16

<b>Description</b> Vegetation Monitoring Plot and Photo Point 19, view northwest from southwest corner.

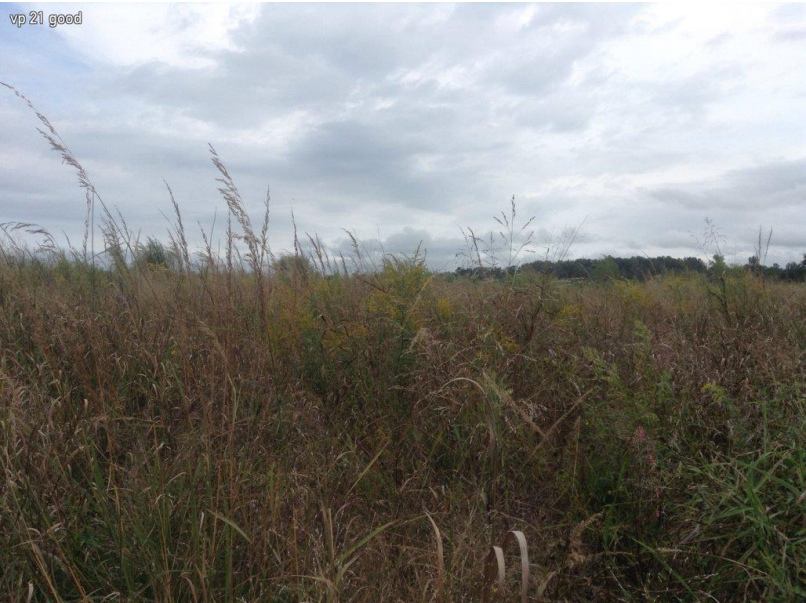
<b>Client Name</b> NCDMS		<b>Site Location</b> Granville County	<b>Project No.</b> 95807
<b>Photo No.</b> 21	<b>Date</b> 9/30/16

<b>Description</b> Vegetation Monitoring Plot and Photo Point 21, view northwest from southwest corner.

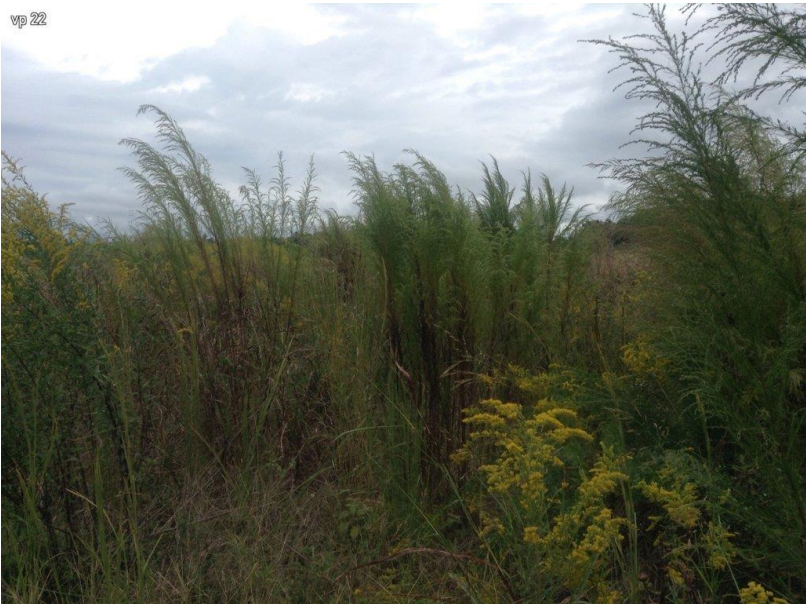
<b>Client Name</b> NCDMS		<b>Site Location</b> Granville County	<b>Project No.</b> 95807
<b>Photo No.</b> 22	<b>Date</b> 9/30/16

<b>Description</b> Vegetation Monitoring Plot and Photo Point 22, view northwest from southwest corner.

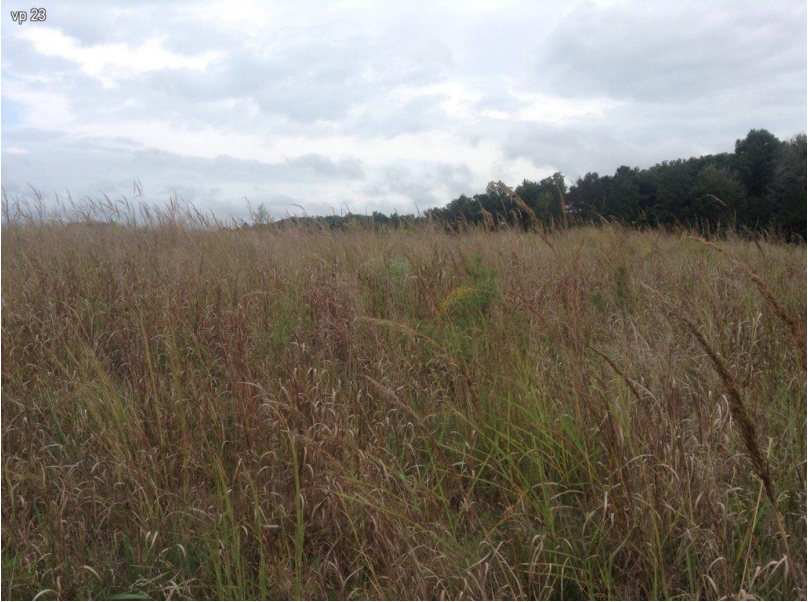
<b>Client Name</b> NCDMS		<b>Site Location</b> Granville County	<b>Project No.</b> 95807
<b>Photo No.</b> 23	<b>Date</b> 9/30/16

<b>Description</b> Vegetation Monitoring Plot and Photo Point 23, view northwest from southwest corner.
