**Coon Creek Riparian Buffer and Nutrient Offset Mitigation Project
2017 Monitoring Report
Monitoring Year 4 of 5**

**Granville County, North Carolina
Tar-Pamlico River Basin
USGS Hydrologic Unit 03020101**

**NCDMS Project No. 95807
NCDMS Contract No. 5153
DWR-13-0689**

2017 Monitoring Report – Year 4 of 5

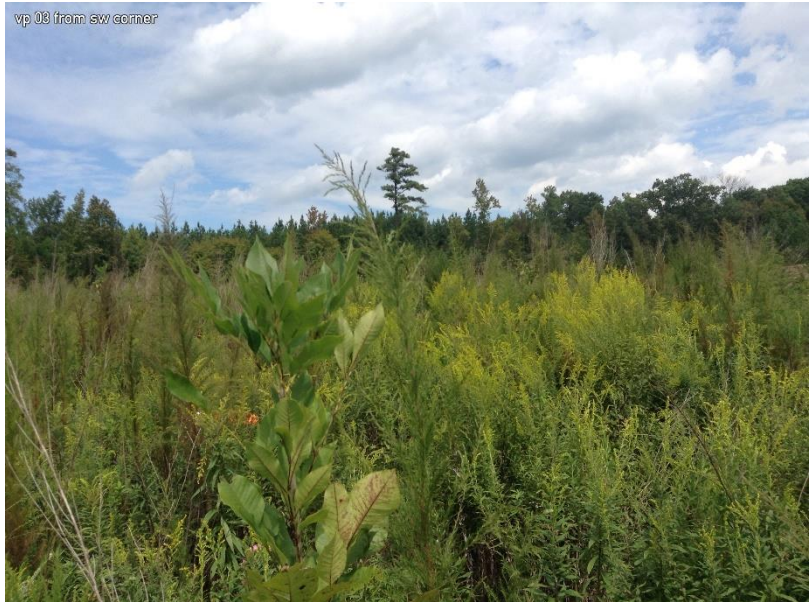
Client Name NCDMS		Site Location Granville County	Project No. 95807
Photo No. 3	Date 9/14/17

Description Vegetation Monitoring Plot and Photo Point 3, view northeast from southwest corner.

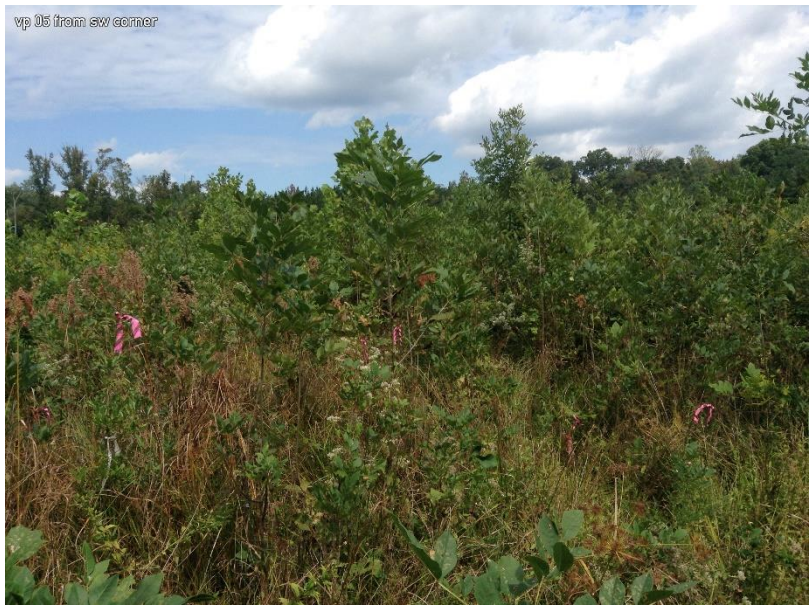
Client Name NCDMS		Site Location Granville County	Project No. 95807
Photo No. 5	Date 9/14/17

Description Vegetation Monitoring Plot and Photo Point 5, view northeast from southwest corner.

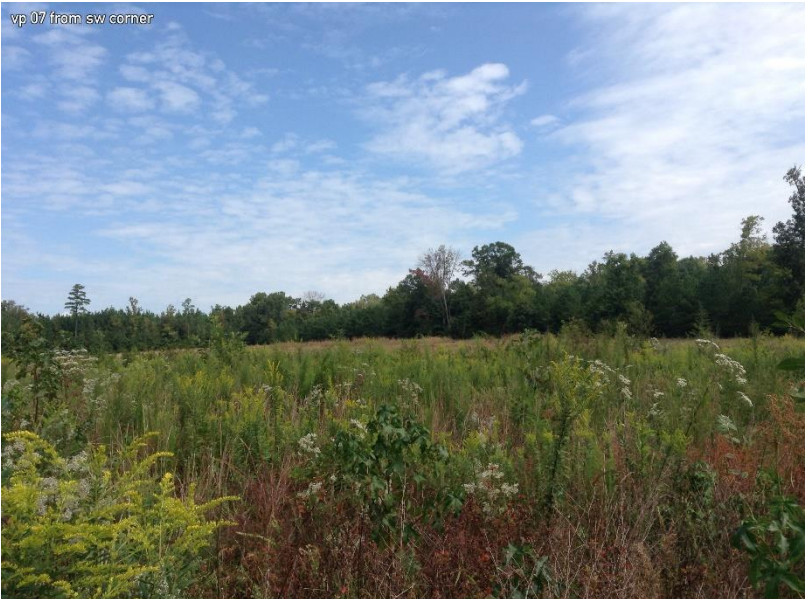
Client Name NCDMS		Site Location Granville County	Project No. 95807
Photo No. 7	Date 9/14/17

<p>vp 07 from sw corner</p>	
Description Vegetation Monitoring Plot and Photo Point 7, view northeast from southwest corner.

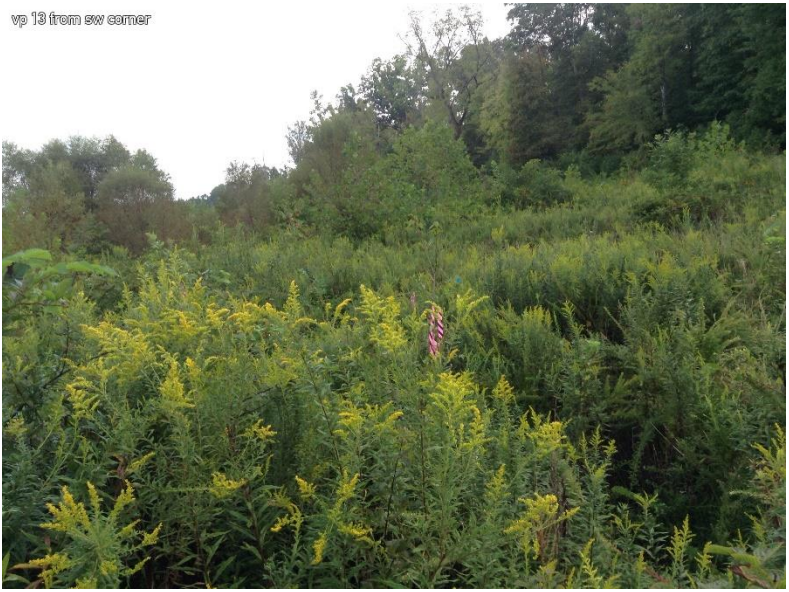
Client Name NCDMS		Site Location Granville County	Project No. 95807
Photo No. 13	Date 9/14/17	<p>vp 13 from sw corner</p>

Description Vegetation Monitoring Plot and Photo Point 13, view northeast from southwest corner.

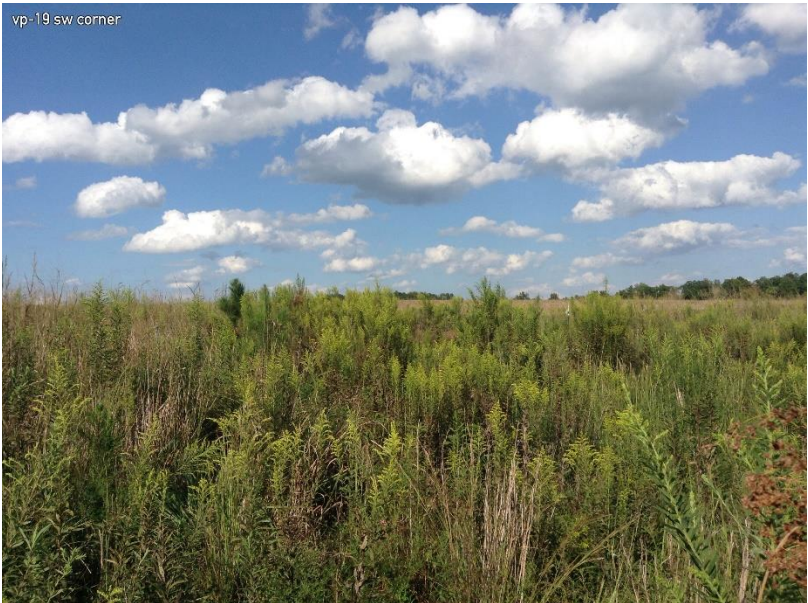
Client Name NCDMS		Site Location Granville County	Project No. 95807
Photo No. 19	Date 9/13/17

Description Vegetation Monitoring Plot and Photo Point 19, view northeast from southwest corner.

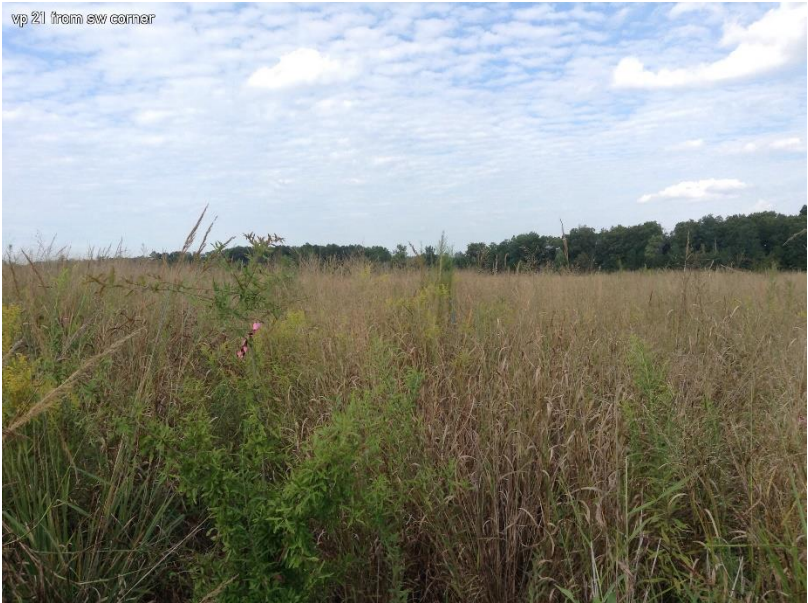
Client Name NCDMS		Site Location Granville County	Project No. 95807
Photo No. 21	Date 9/14/17

Description Vegetation Monitoring Plot and Photo Point 21, view northeast from southwest corner.

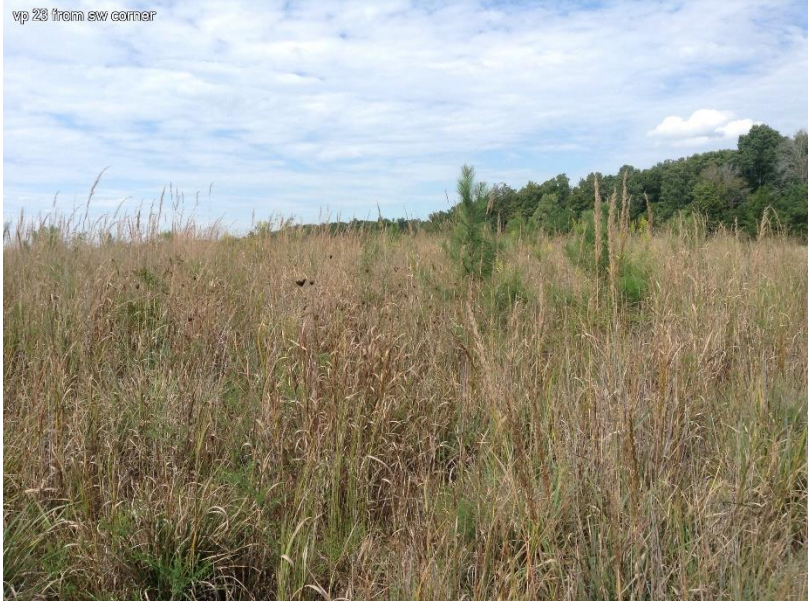
Client Name NCDMS		Site Location Granville County	Project No. 95807
Photo No. 23	Date 9/14/17

<p>vp 23 from sw corner</p>	
Description Vegetation Monitoring Plot and Photo Point 23, view northeast from southwest corner.

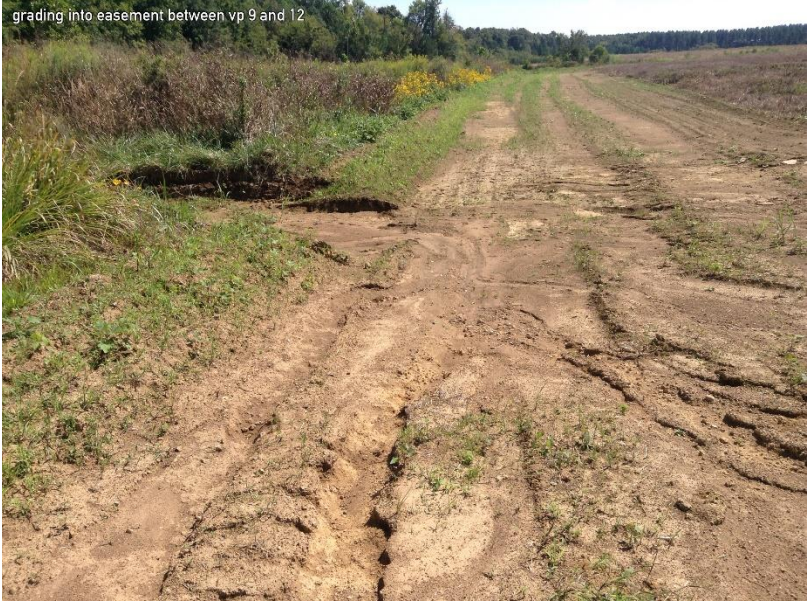
Client Name NCDMS		Site Location Granville County	Project No. 95807
Photo No. 25	Date 9/13/17

Grading into the easement was observed between Vegetation Monitoring Plot 9 and 12. This does not appear to have impacted planted stems or contributed sediment to the project stream. The grading appears to have been done by the landowner to address a drainage problem on the farm road at the edge of the easement. OBG/EEE will work with the landowner to adequately reach a solution, and the area within the easement returned to original grade and re-seeded with an appropriate native species seed mix.

Description Grading into the easement between Vegetation Monitoring Plot 9 and 12 (Photo 2 of 2).
