COOR ISLAND PHASE B NUTRIENT OFFSET SITE

As-built & Baseline Monitoring Report
Wayne County, North Carolina
Neuse River Basin - 03020201

DMS Project ID No. 100650 Full Delivery Contract No. 519674731-02 DWR Project No. 2021-0021v2 RFP No. 16-519674731

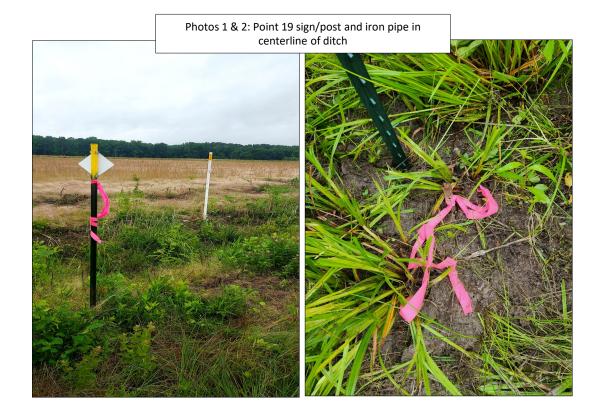
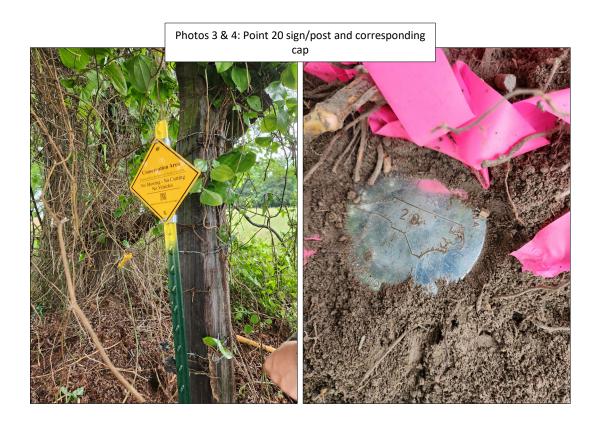
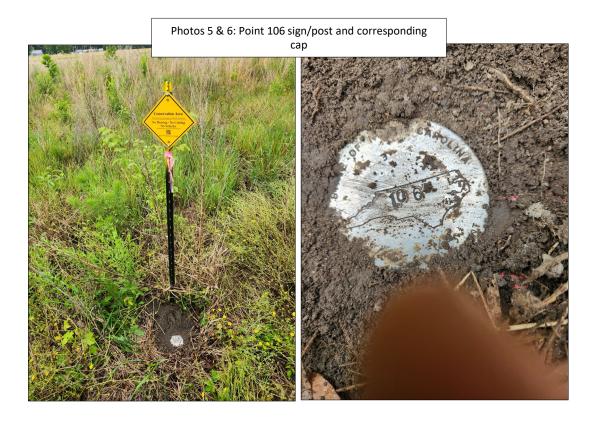
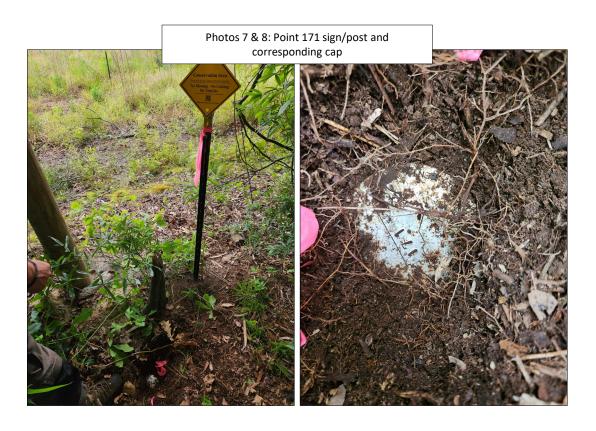
Coor Island Phase B Nutrient Offset Mitigation Site As-Built Site Visit Response to Comments (May 2024) Photo Log

- 7. Ensure for all corners, as per the recorded plat and the RFP, a 30" by 5/8" rebar with 3 ¼" aluminum cap is installed and stamped with the corresponding corner number located on the plat for each of the conservation easement corners.
 - The following easement corners (19, 20, 106, and 171) have been verified and documented in the attached photos. Also, regarding point 19 the iron pipe is in the centerline of the ditch and the T-post is set on the bank.
- Remove all debris from within the conservation easement area. See KML where areas were noted on this
 field visit. It is possible other areas exist. Make every effort to get all the old fencing out of the CE.
 Noted, the scattered debris will be removed from the conservation easement and documented in the MY1
 report.

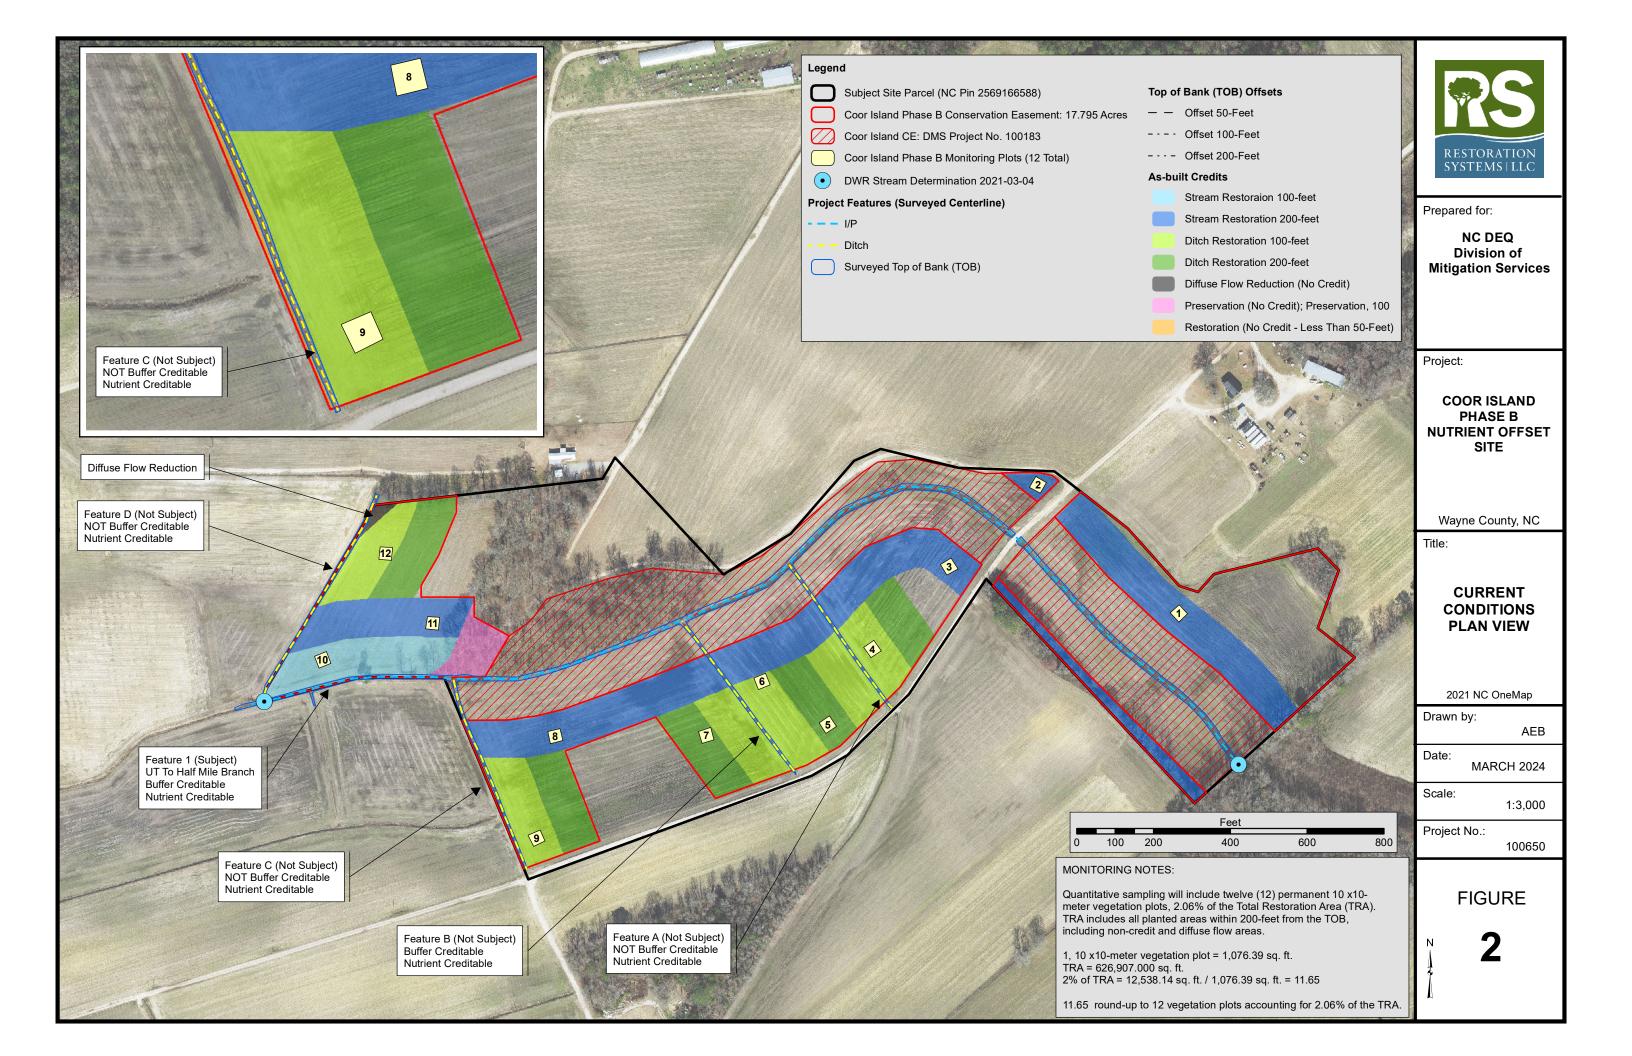
CREDIT DETERMINATION PLAN

TOTAL RIPARIAN BUFFER AND NUTRIENT OFFSET MITIGATION									
MITIGATION TOTALS	SQ. FT	ACRES							
NO CREDIT (LESS THAN 50FT.)	1,794.00	0.04							
I/P RESTORATION 0-100FT (NOC - RBC CONVERSION ELIGIBLE)	46,945.00	1.07							
I/P RESTORATION 101-200FT (NOC - RBC CONVERSION ELIGIBLE)	293,514.00	6.73							
PRESERVATION (NO CREDIT)	17,832.00	0.40							
DITCH RESTORATION 0-100FT (NOC ONLY)	155,565.00	3.57							
DITCH RESTORATION 101-200FT (NOC ONLY)	126,903.00	2.91							
DIFFUSE FLOW REDUCTION (NO CREDIT)	2,175.00	0.04
