RE: Response to DMS Comments on the Final Draft Mitigation Plan Cowford, Project ID #10095, DMS Contract #0007746

Final Mitigation Plan Cowford Project

**DMS Project #: 100095 | Contract #: 7746 | USACE Action ID: SAW- 2019-00487
DWR Project #: 2019-0495 | RFP: 16-007577**

March 2021

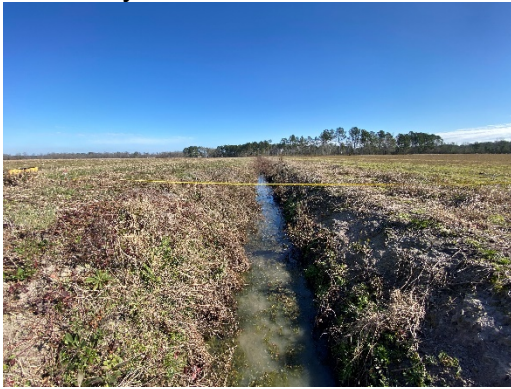
KJ1-A Banks

Reach KJ1-A originates at an ephemeral/intermittent break, located at the confluence of 3 ditches on the eastern boundary of the proposed conservation easement. The reach has a mild valley with limited longitudinal slope, has been historically ditched, and no longer provides significant ecological functions. KJ1-A flows west through row crop fields to KJ1-B. Much if not all the reach's morphology is currently driven by ditching instead of natural channel processes. The break between reach A and B was selected because the valley steepens and becomes more defined downstream of this point. Row crops are directly adjacent to both banks. Drain tiles from the adjacent fields currently outlet directly into the reach.

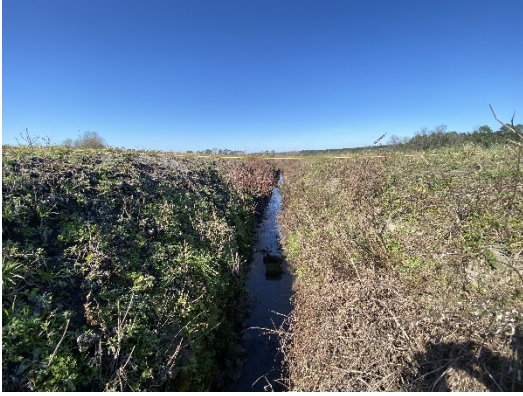
KJ1-B Banks

Reach KJ1-B originates at downstream end of KJ1-A and flows west through hydric soils to a proposed culvert crossing and easement break. The reach has been ditched and has further degraded such that it lacks floodplain connection, appropriate pattern, and bedform diversity. There is an existing 41 LF culvert crossing approximately in the middle of the reach. Row crops are directly adjacent to both banks. Drain tiles from the adjacent fields currently outlet directly into the reach.

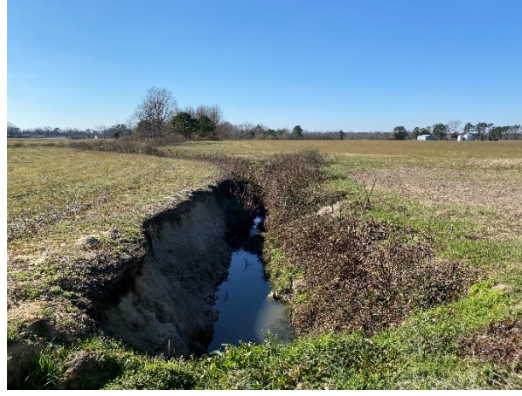
Below the crossing on KJ1-B

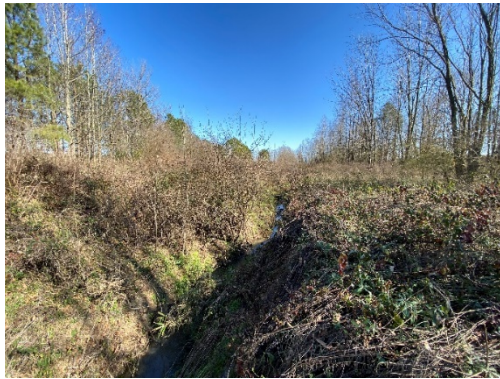
KJ1-C Banks

Reach KJ1-C originates downstream of the proposed easement break and continues west to the downstream limits of the conservation easement. The reach has a relatively steep (~1%), defined valley. Directly downstream of the easement, the channel flows under NC HWY 258 through a 48” CMP. The reach has been ditched and has further degraded and entrenched such that it lacks floodplain connection, appropriate pattern, and bedform diversity. Managed forest, from an expired CRP easement, forms an immature buffer along much of the right bank while row crops form much of the left bank.

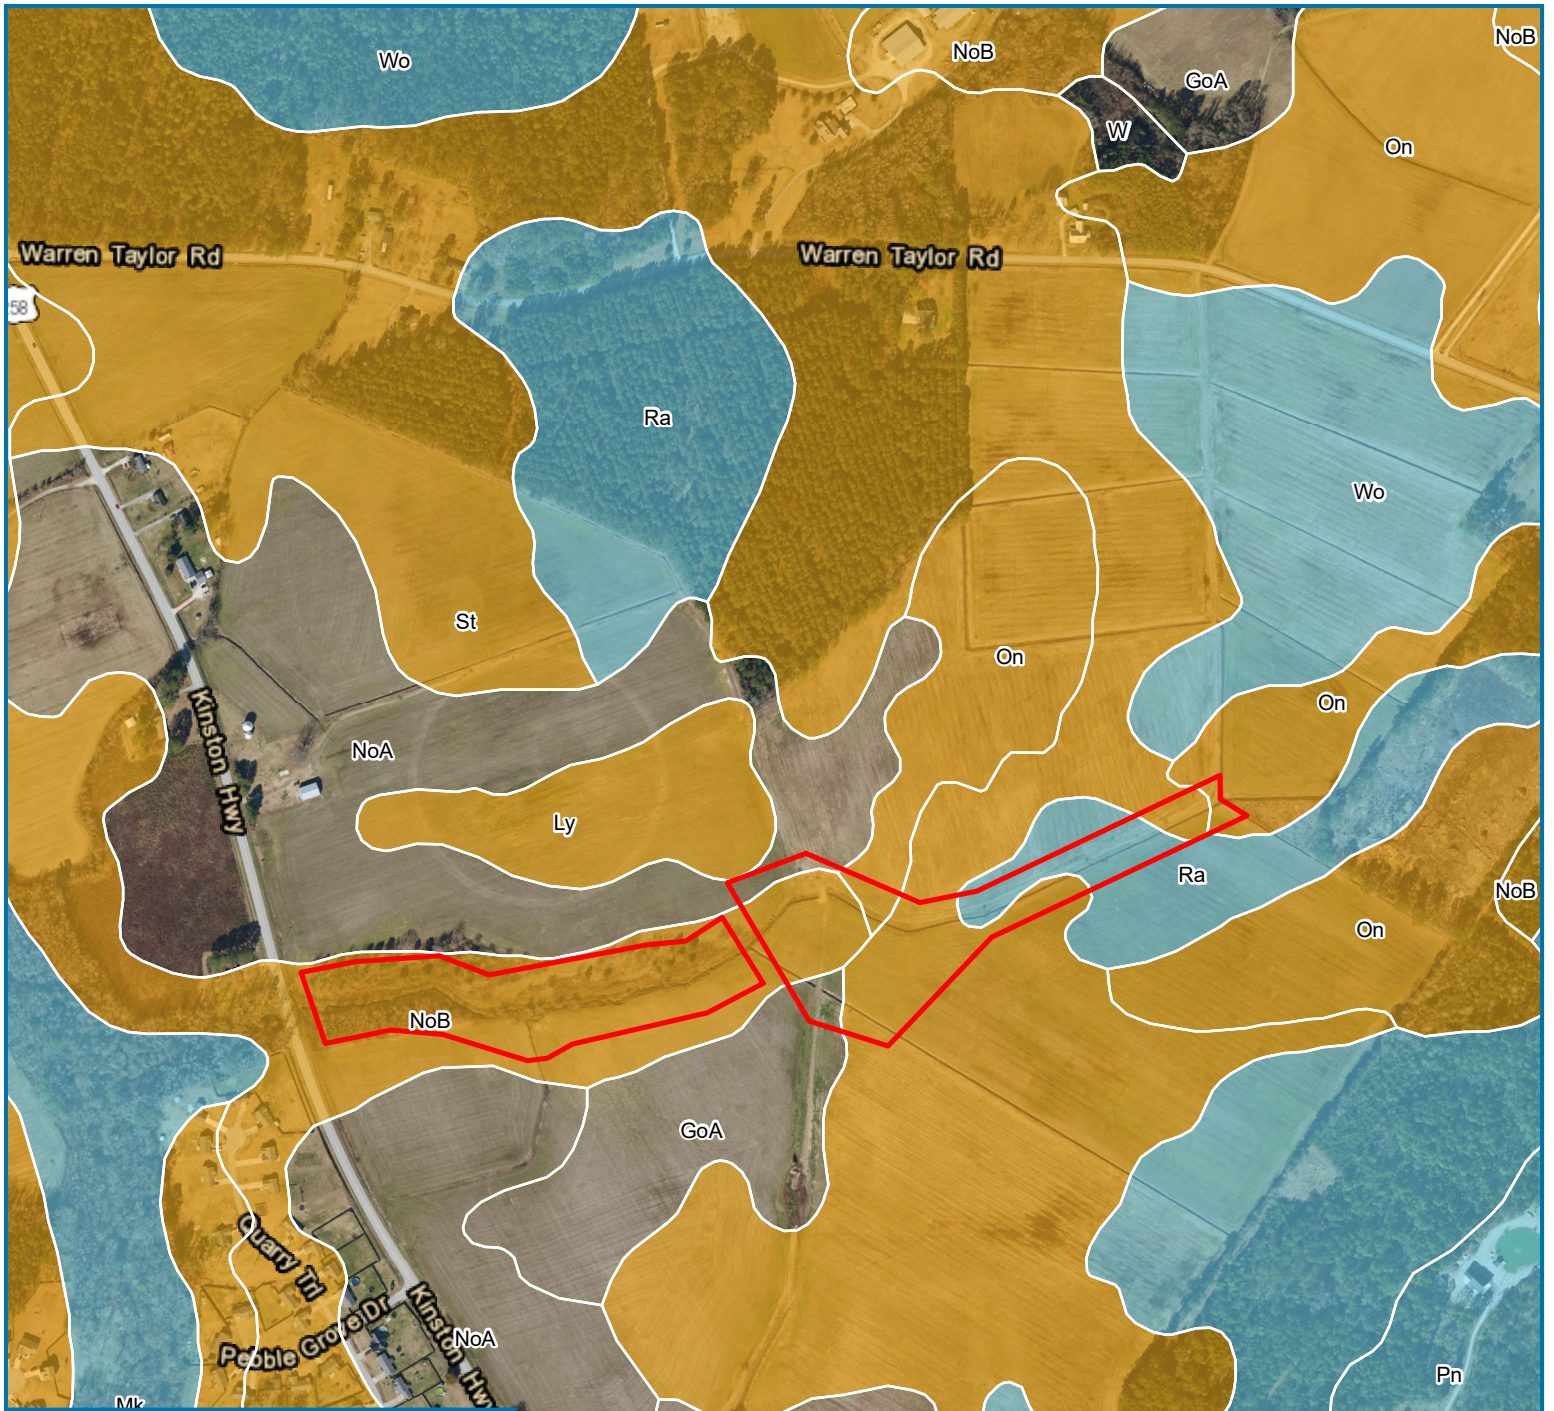
- Proposed Easement
- Hydric (100%)
- Predominantly Hydric (66-99%)
- Predominantly Hydric (33-65%)
- Predominantly Nonhydric (1-32%)
- Nonhydric (0%)

A detailed hydric soil investigation for Cowford Mitigation Site was completed in January of 2020 by a soil scientist. A series of approximately 75 soil borings were performed to describe and verify the presence and estimate the extent of hydric soil and soils that appear to exhibit relict or historic hydric indicators (**Appendix M**). Soils were characterized and classified using the Field Indicators of Hydric Soils in the United States, Version 7.0 (USDA-NRCS 2010). Hydric indicators were found within 12 inches of the soil surface and found in both riparian and non-riparian landscapes. The hydric soil indicators found include the F3-Depleted Matrix, S7- Dark Surface, A11-Depleted Below Dark Surface, A12-Thick Dark Surface, S5-Sandy Redox, and S9-Thin Dark Surface. Also present were *S5-Sandy Redox*, *S9-Thin Dark Surface*, and *F3-Depleted Matrix*. The range of the indicators points to the complexity of the soils at the location, and these can all be found on both riparian and non-riparian landscapes.

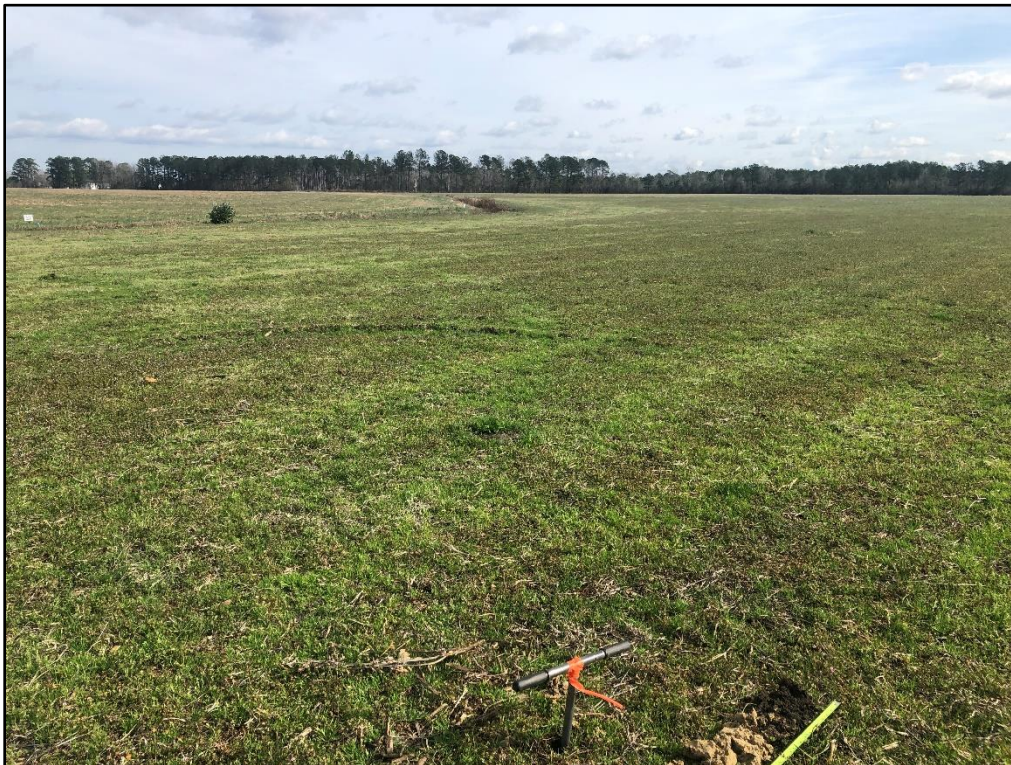
2. Landscape looking across floodplain upstream. SB#125.

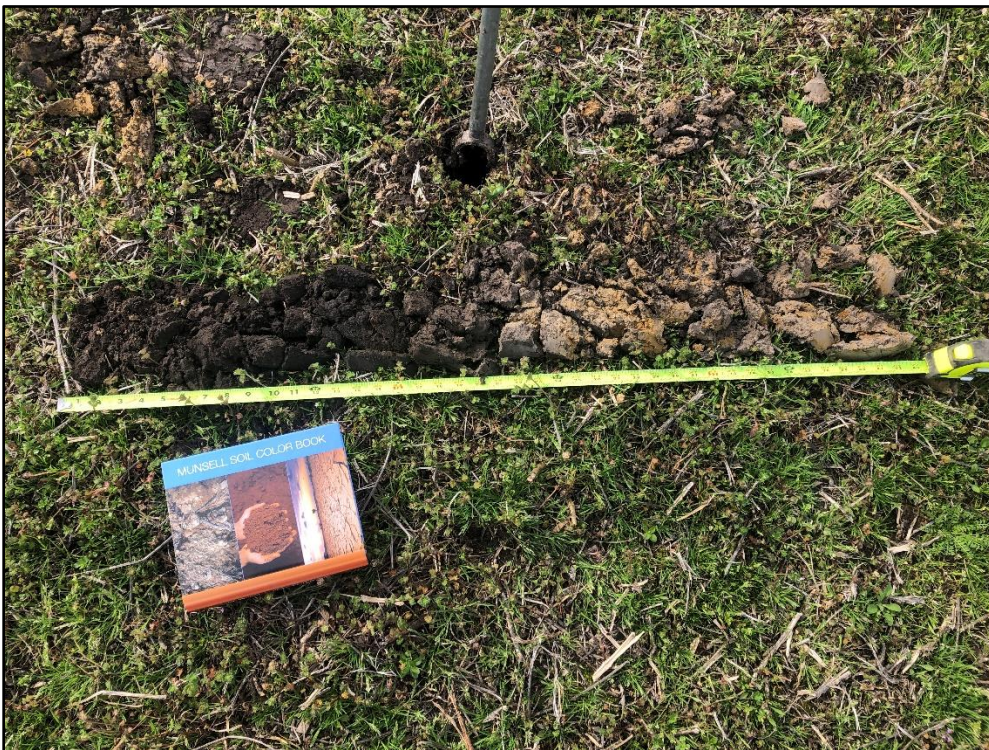
3 BASELINE AND EXISTING CONDITIONS
