**Cox Site  
Wetland and Stream Restoration Plan  
Johnston County, North Carolina**

**March 2005**

# Cox Site Wetland and Stream Restoration Plan Johnston County, North Carolina

Design Report Prepared by Buck Engineering PC

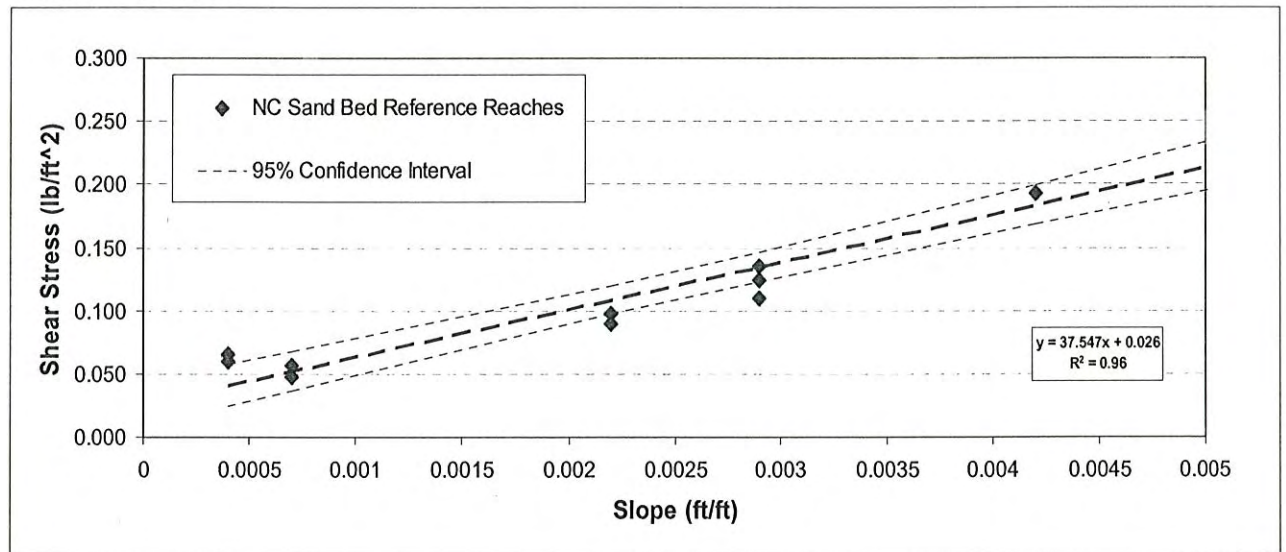
**Figure 2.2**

Comparison between bankfull shear stress and channel slope for the design reaches and Coastal Plain reference reach data.

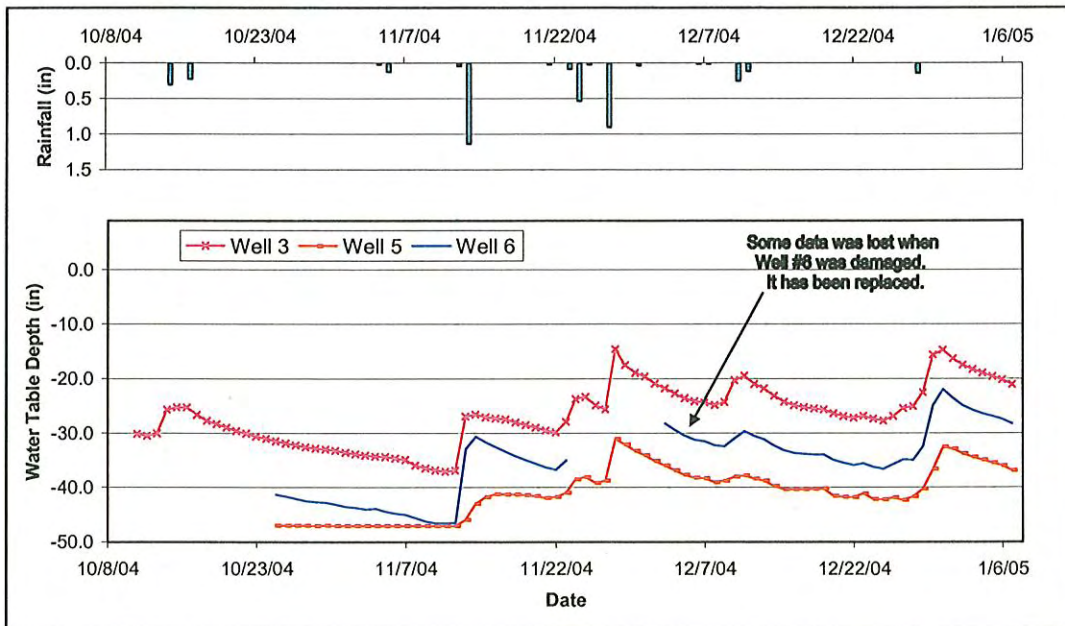
**Figure 5.2**

Hydrographs of the Groundwater Monitoring Wells Compared to Local Rainfall on the Cox Site (October 2004 through January 2005)

Since water table response has been shown to be very similar on the Cox and Westbrook Sites, the detailed hydrologic analysis performed for the Westbrook Site, as part of the mitigation plan development for that site, is used here to estimate the hydrologic conditions of the Cox Site. A complete record of the analyses performed on the Westbrook Site is provided in Appendix E, and is summarized in the paragraphs that follow.

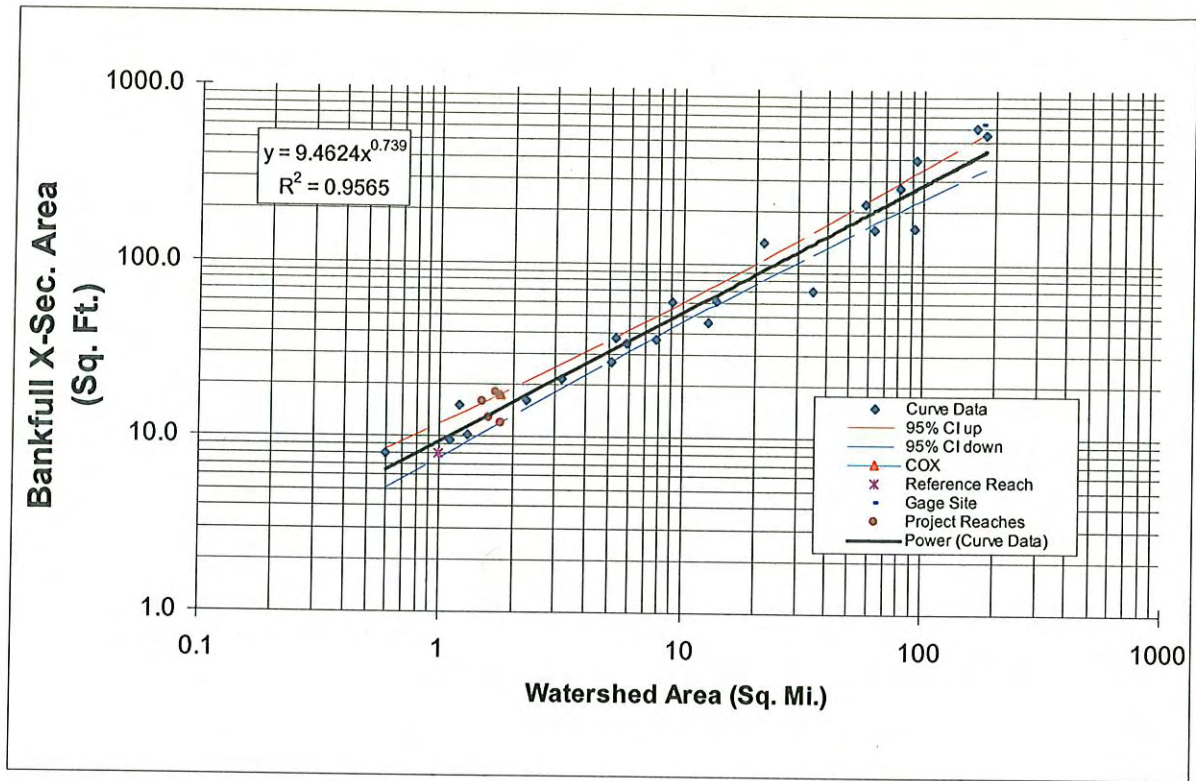
**Figure 6.1**

NC Coastal Regional Curves with Bankfull Discharge for Project Reaches and Reference Cross-Sections

**Note:** Project data points were not used in determining the regression line.

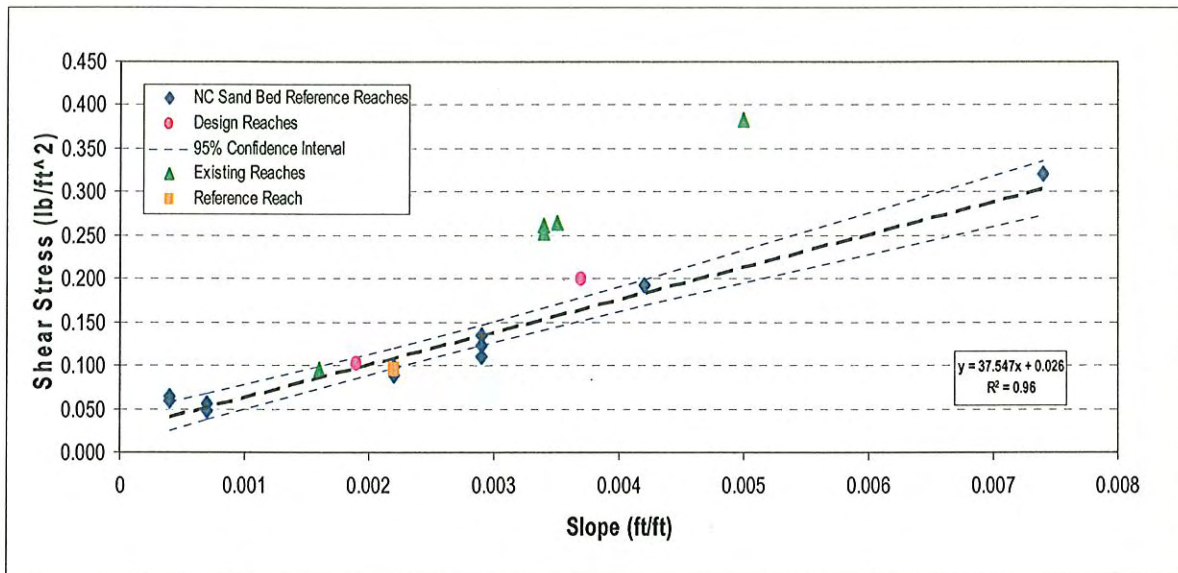
The design shear stress and stream power values plot within the scatter of data points collected from reference reaches. This analysis provides evidence that the stresses predicted for the design channel are well within the range of stable values calculated for the reference reaches. Therefore, the design channel is expected to have adequate stream power to move its sediment load without resulting in excessive scour.

**Figure 8.1**  
Comparison Between Bankfull Shear Stress and Channel Slope for Design Reaches and Coastal Plain Reference Reach Data

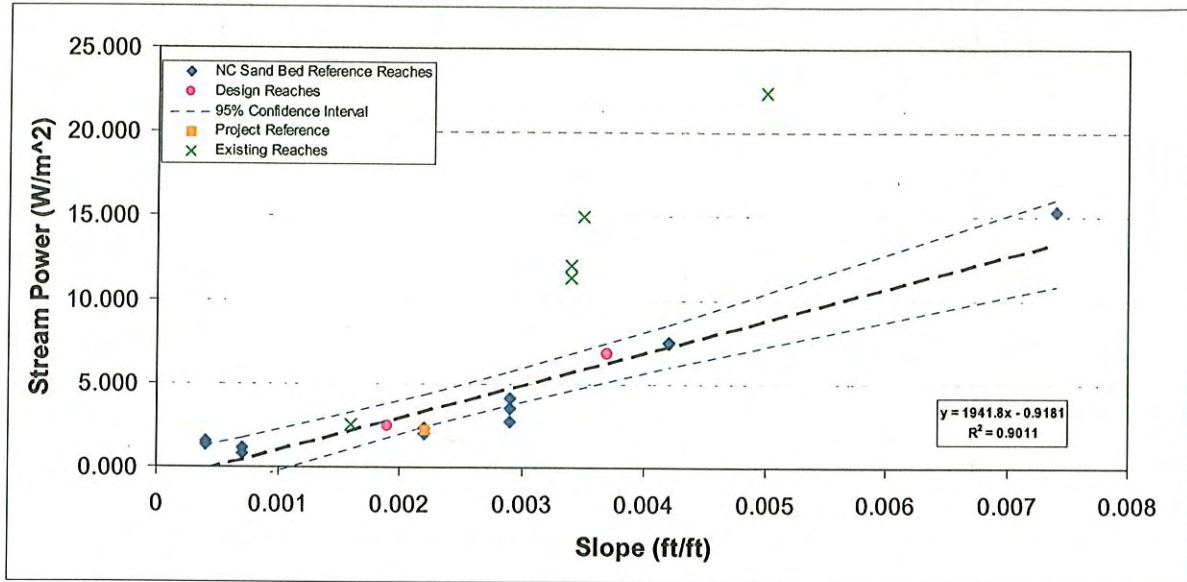
**Figure 8.2.**  
 Comparison Between Stream Power and Channel Slope for Design Reaches and Coastal Plain Reference Reach Data

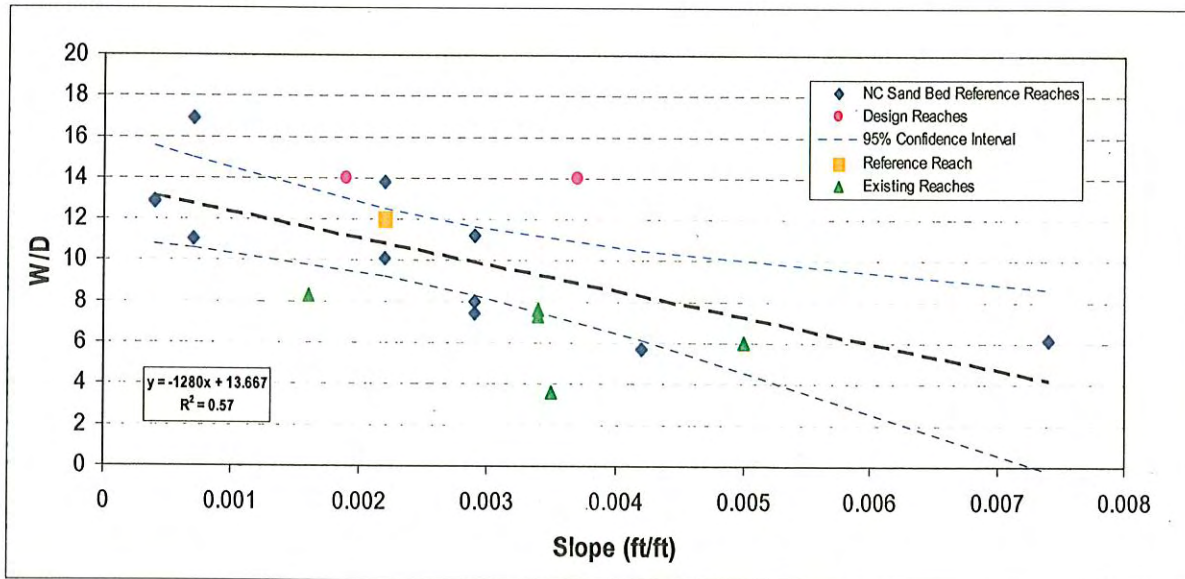
**Figure 8.3**  
 Comparison Between Width-to-Depth Ratio (W/D) and Channel Slope for Design Reaches and Coastal Plain Reference Reach Data

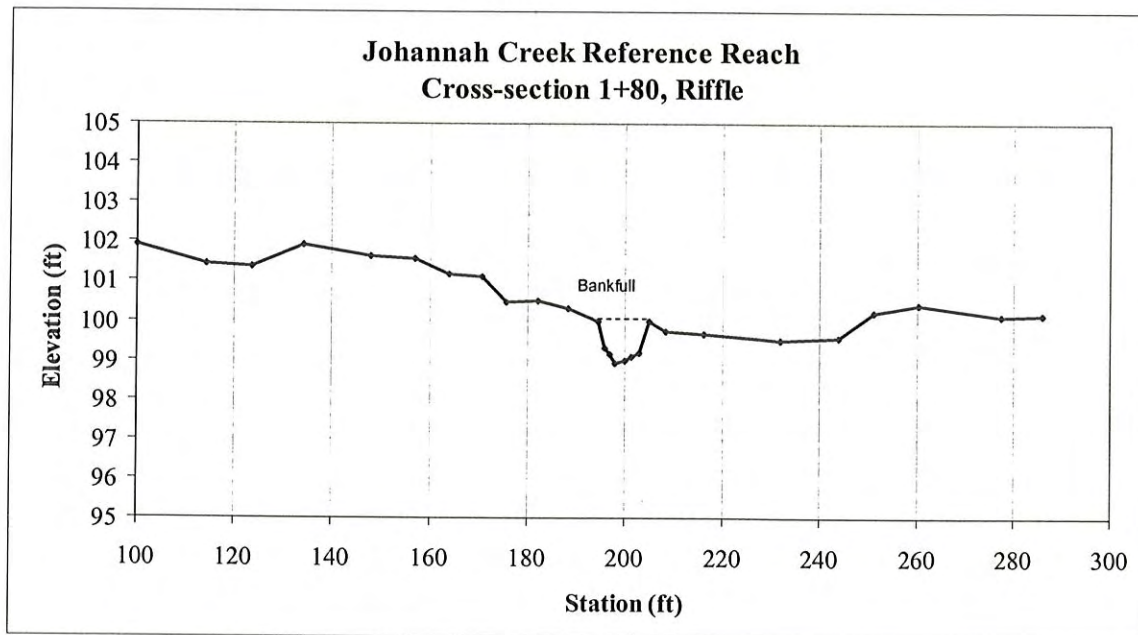
**Figure 9.2**  
Cross-Section for the Johannah Creek Reference Reach

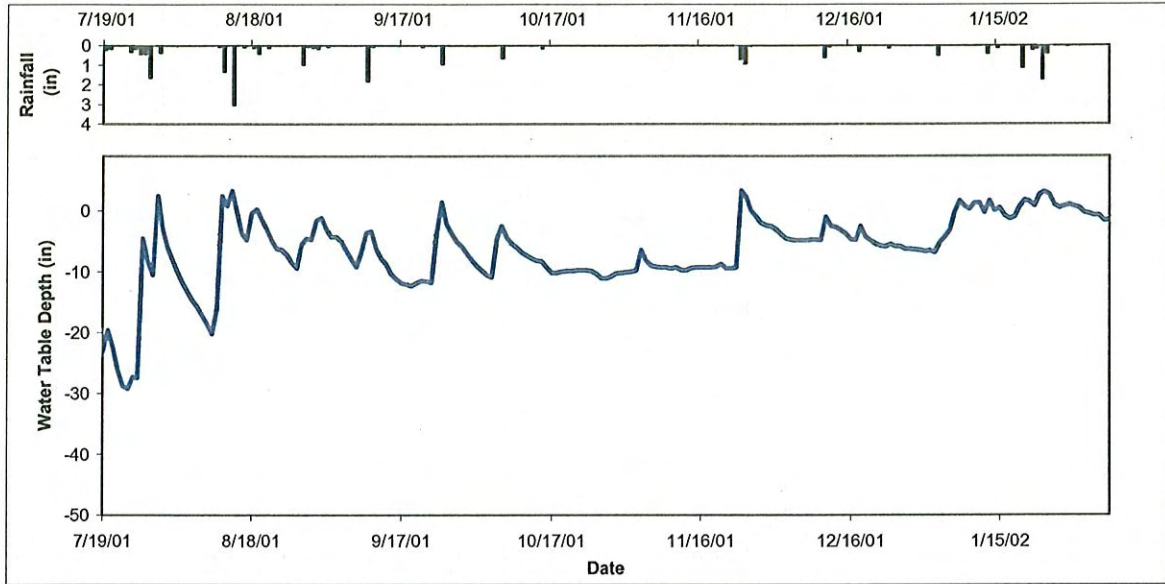
**Figure 9.3**

Water table monitoring wells were installed within the reference site, and monitoring data were collected from June 2001 to the present. An example subset of the data is shown in Figure 9.3. Based on the data collected, the site exhibits wetland hydrology, and exhibits a range of saturation and wetness during the wetter periods of the year (late fall, winter, and early spring).

Water Table Depths Recorded in a Monitoring Well Installed within the Reference Site

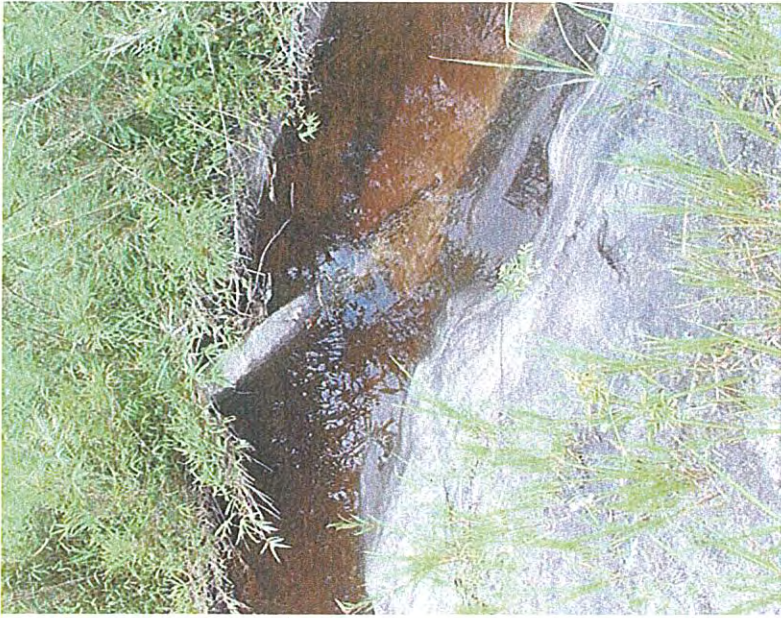
**Exhibit 2.8**  
Examples of Instream Structures

**Log Vane**

**Log Weir**

**Root Wads**

There are a variety of in-stream structural elements used in restoration. Exhibit 2.8 illustrates a few typical structures. These elements are comprised of natural materials such as stone, wood, and live vegetation. Their shape and location works with the flow dynamics to reinforce, stabilize, and enhance the function of the stream channel. In-stream structures provide three primary functions: grade control, stream bank protection, and habitat enhancement.

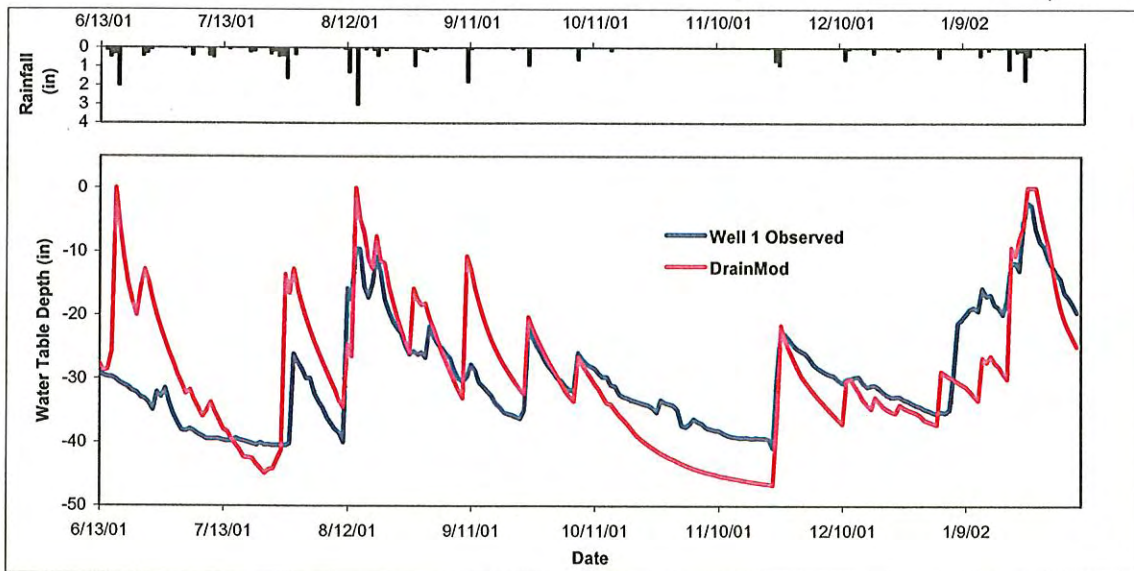
**Figure 2-4 Comparison between observed and simulated water table depths for Well 1 for existing condition.**

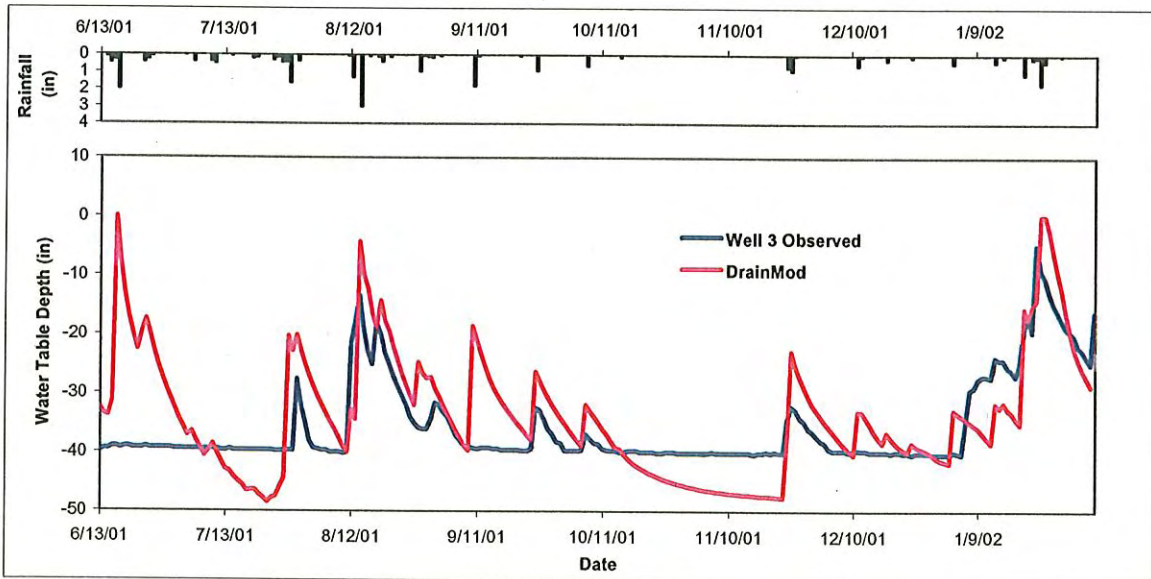
**Figure 2-6 Comparison between observed and simulated water table depths for Well 3 for existing condition.**

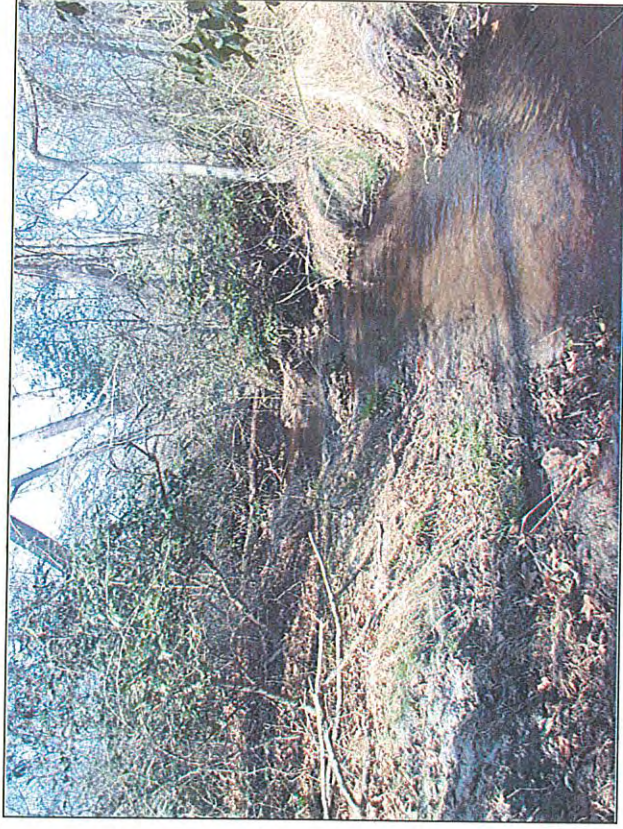
Cox Branch Channel Showing Incision.

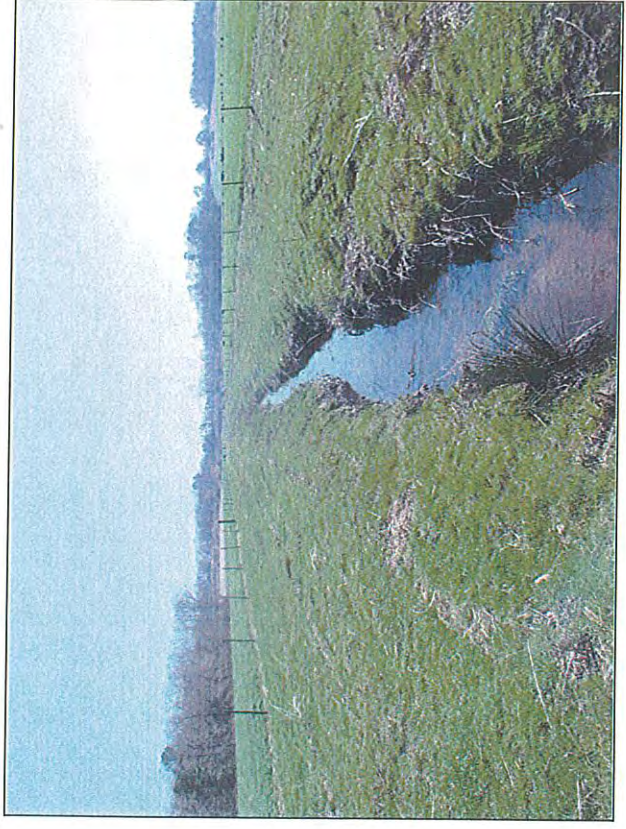
Bank Erosion in Cox Branch.
