# **FINAL MITIGATION PLAN**

## **Crooked Creek #2 Restoration Project**

**EEP ID # 94687**

August 19, 2013

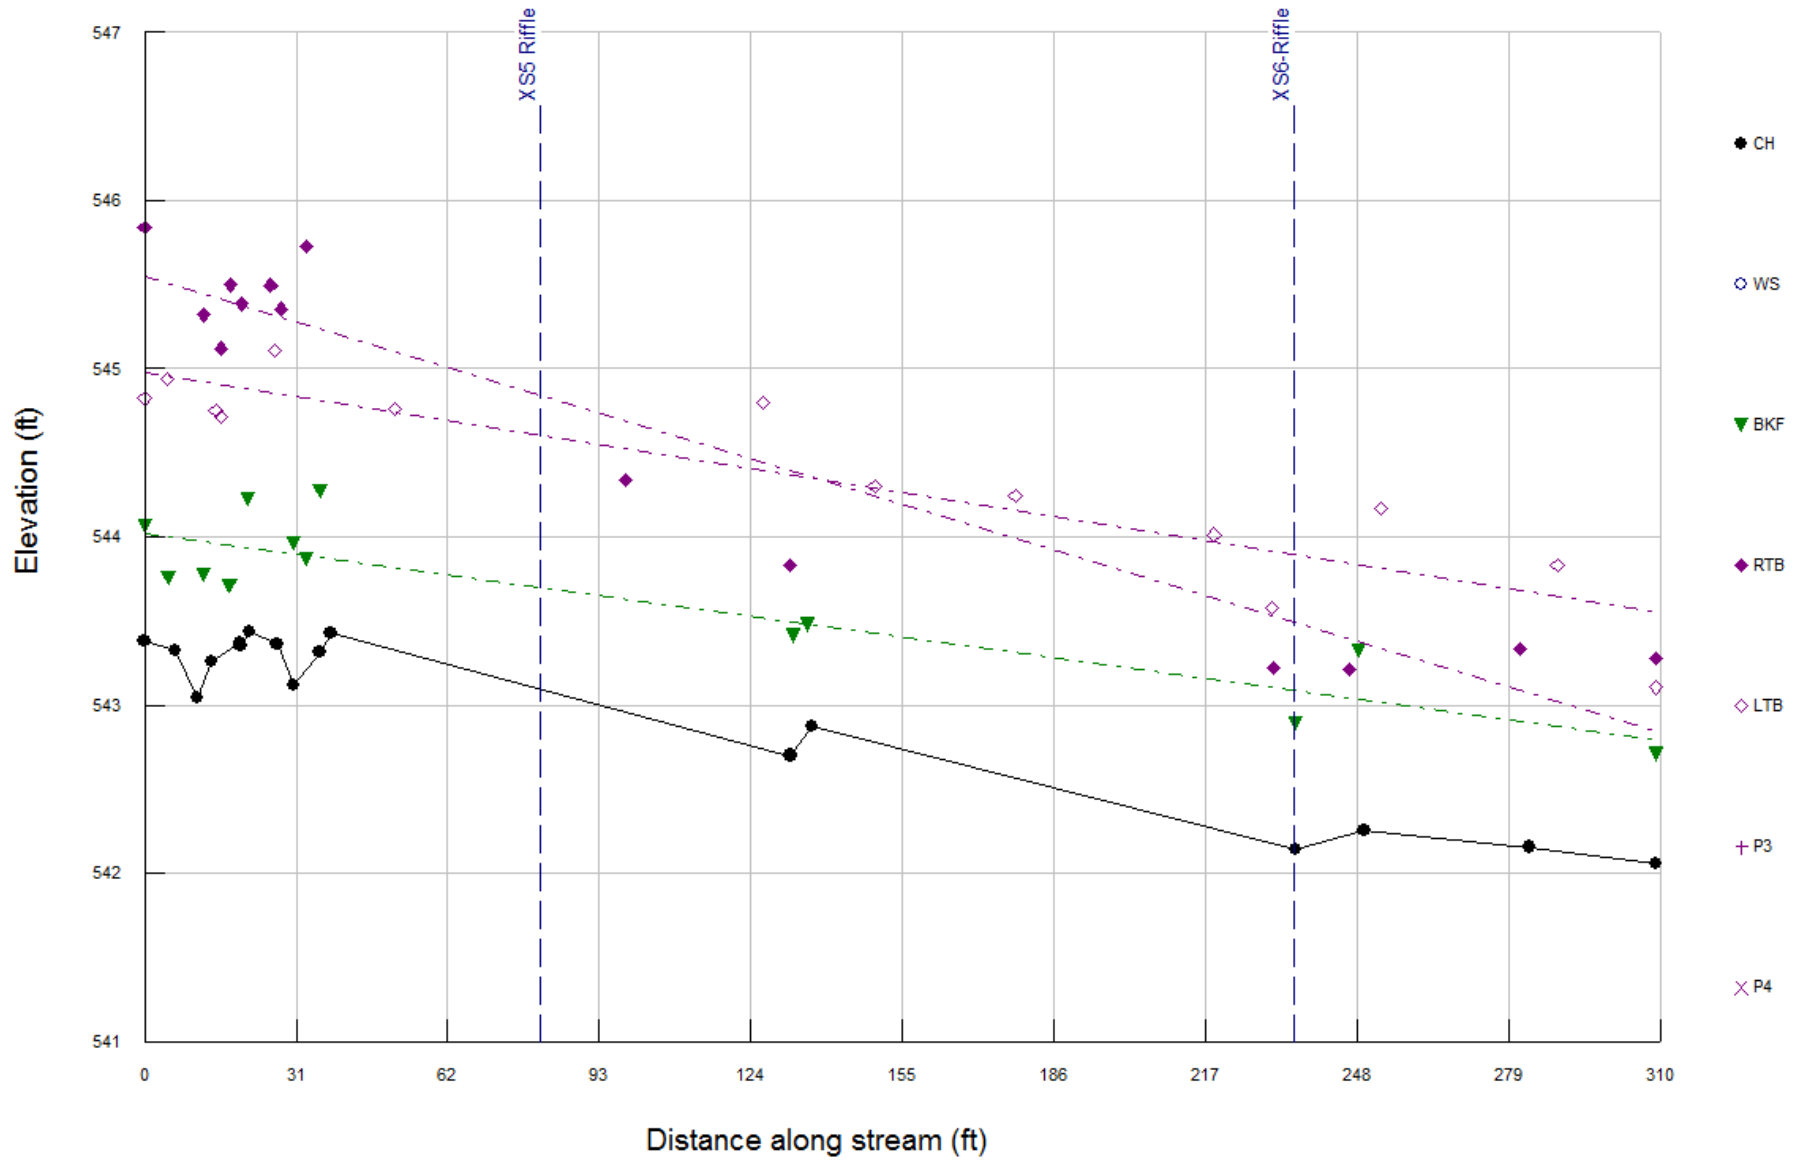
# UT1 Longitudinal Profile

River Name: UT1  
 Reach Name: Reach 1 - Upstream  
 Profile Name: UT1 Reach 1 (Upstream) Profile  
 Survey Date: 06/10/11

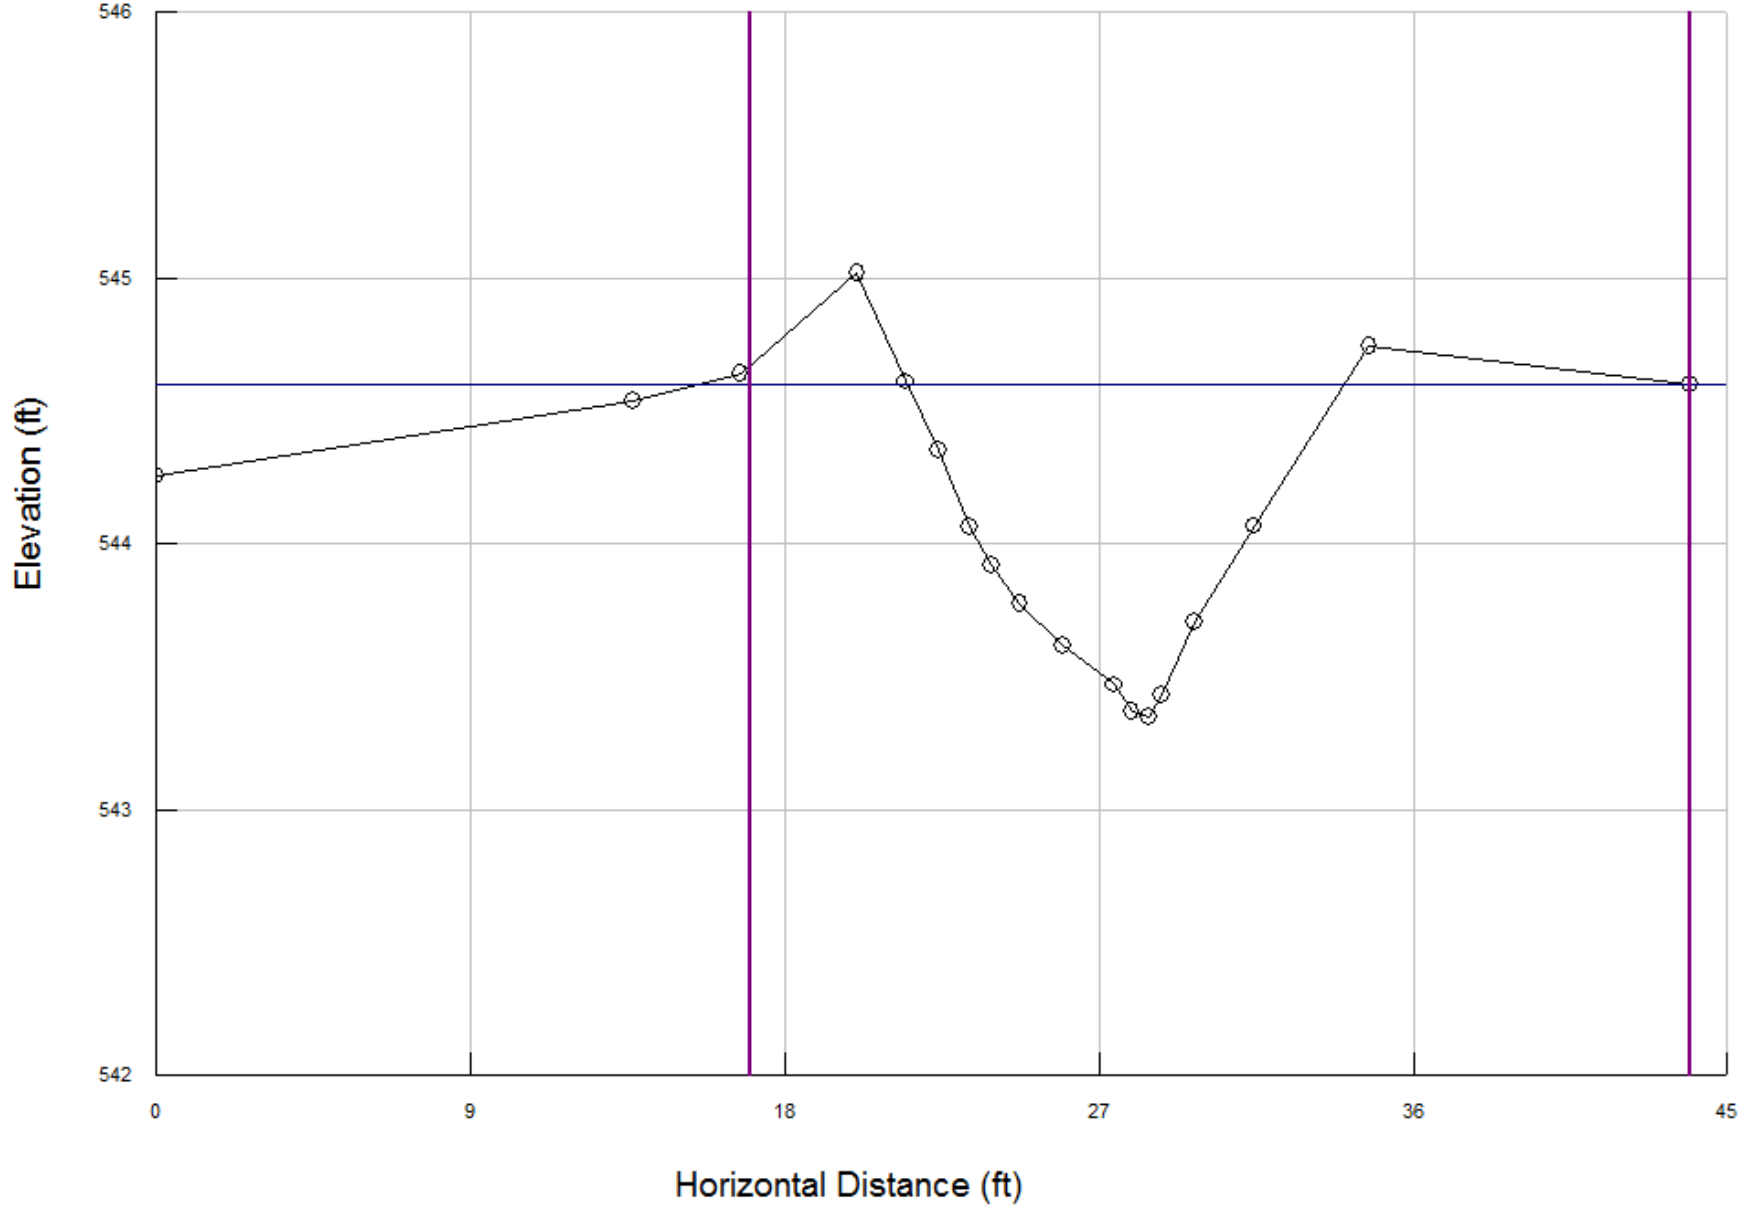
UT1\_XS5  
RIVERMORPH CROSS SECTION SUMMARY

River Name: UT1  
 Reach Name: Reach 1 - Upstream  
 Cross Section Name: XS5 Rifle  
 Survey Date: 06/10/11

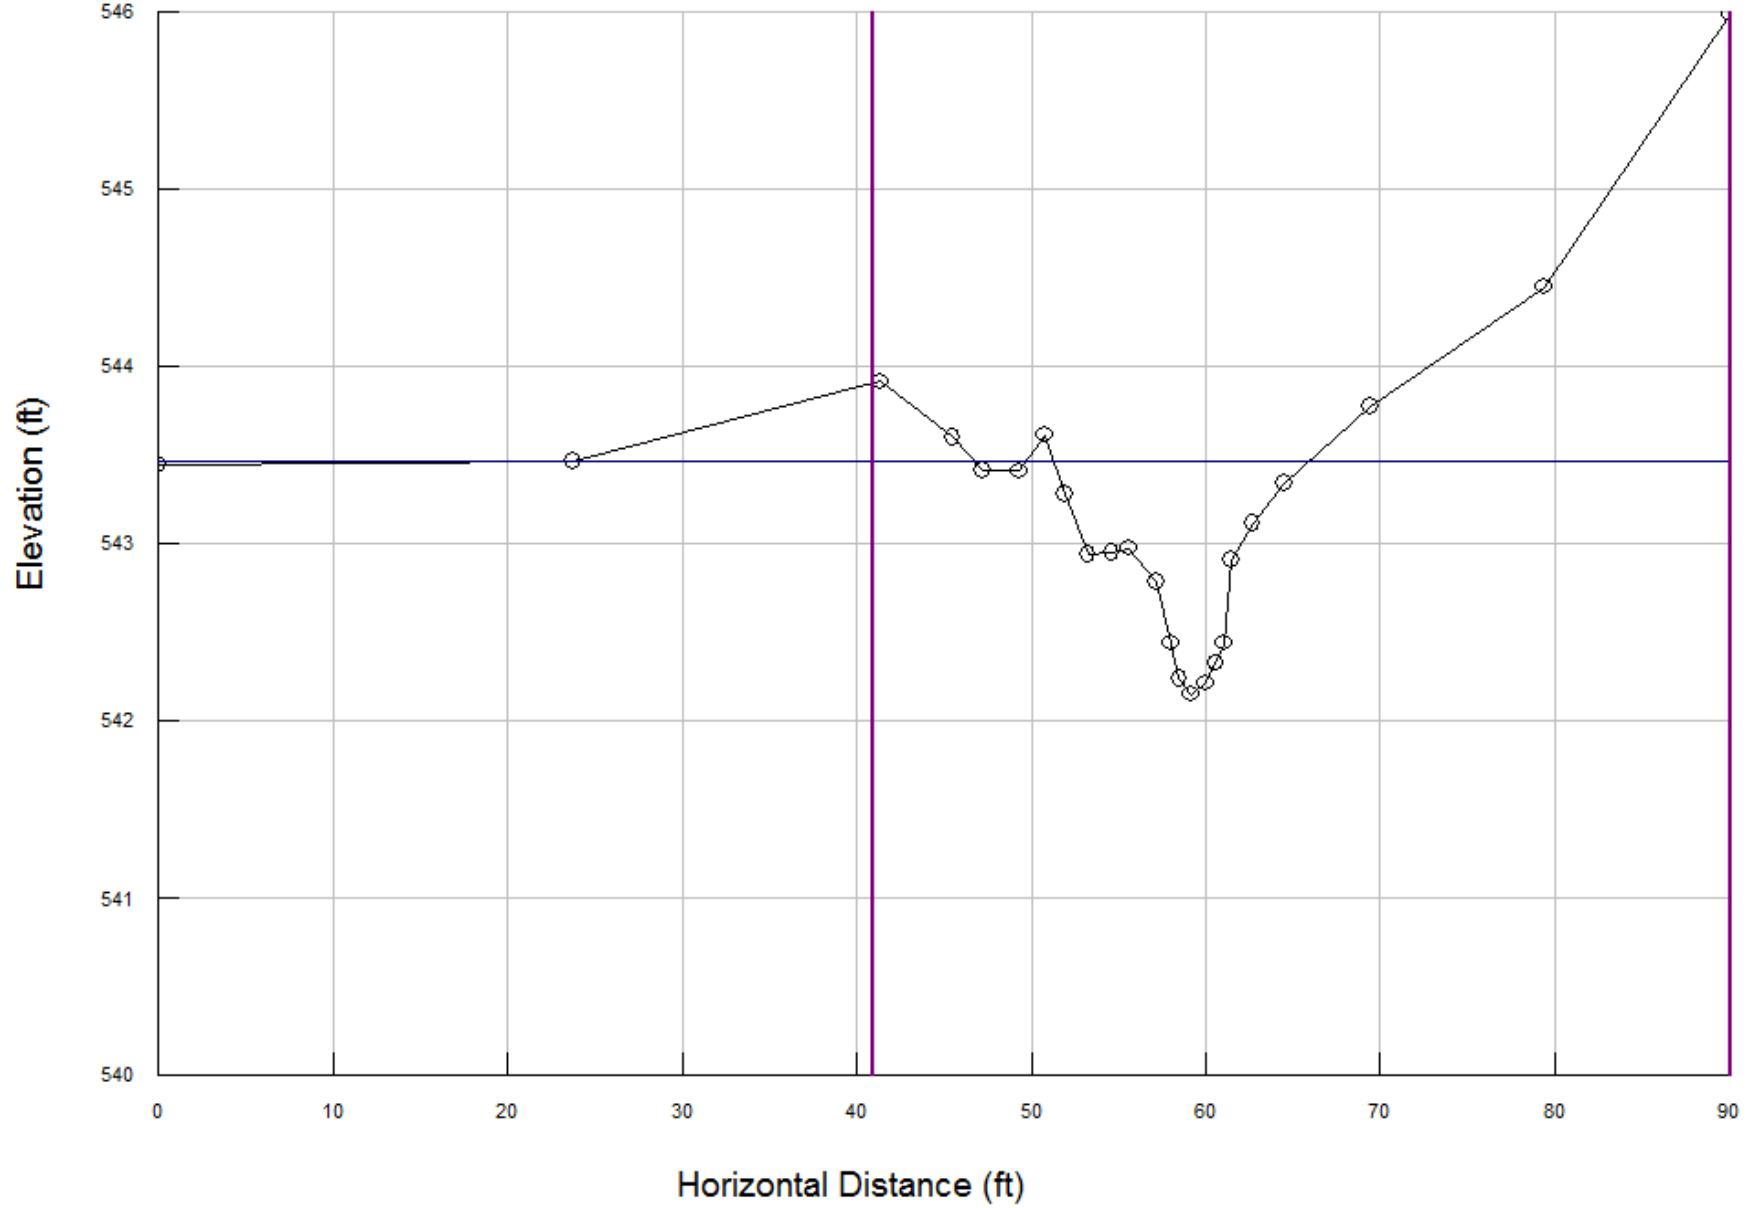
UT1\_XS6  
RIVERMORPH CROSS SECTION SUMMARY

River Name: UT1  
 Reach Name: Reach 1 - Upstream  
 Cross Section Name: XS6-Riffle  
 Survey Date: 06/10/11

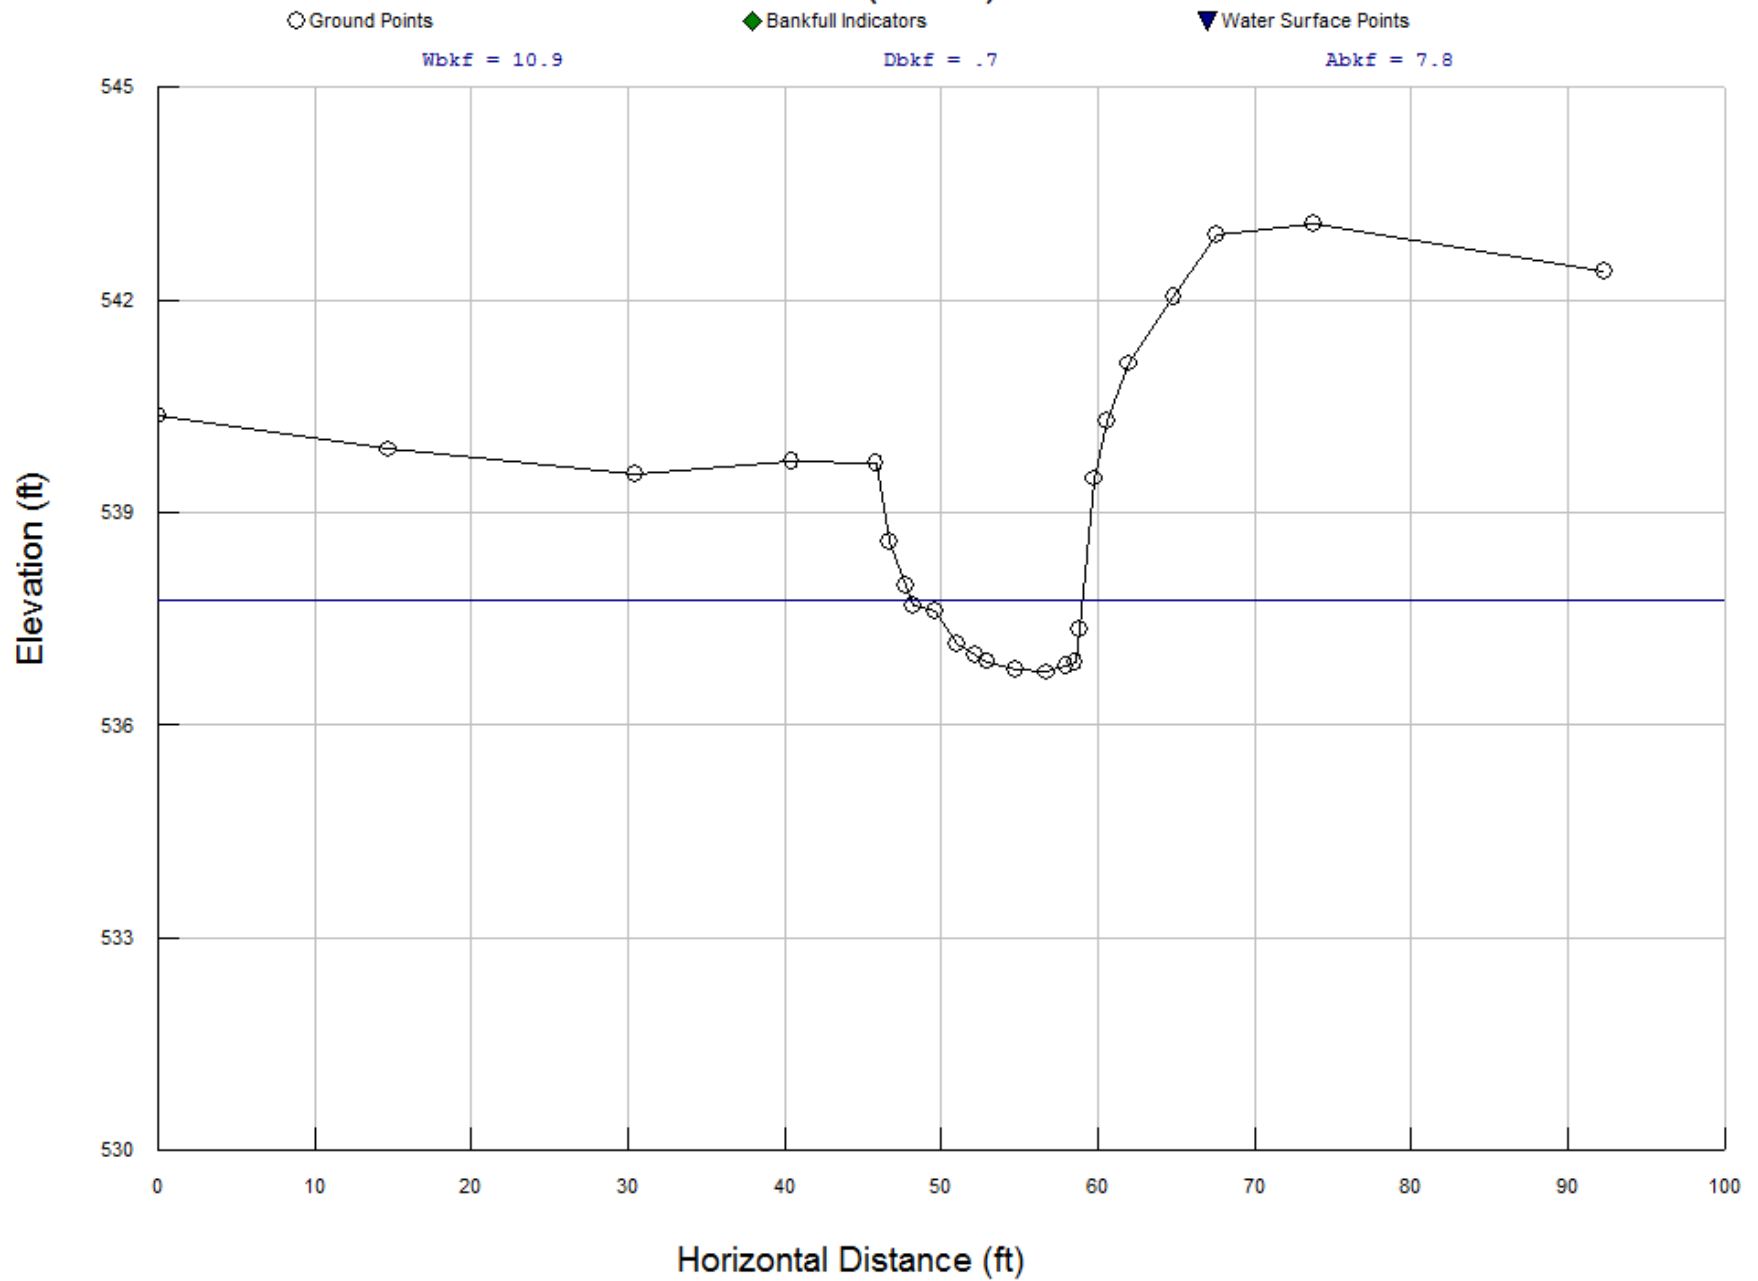
# UT1 XS7 (Riffle)

River Name: UT1  
 Reach Name: Reach 2 - Middle  
 Cross Section Name: XS7-Riffle  
 Survey Date: 06/10/11

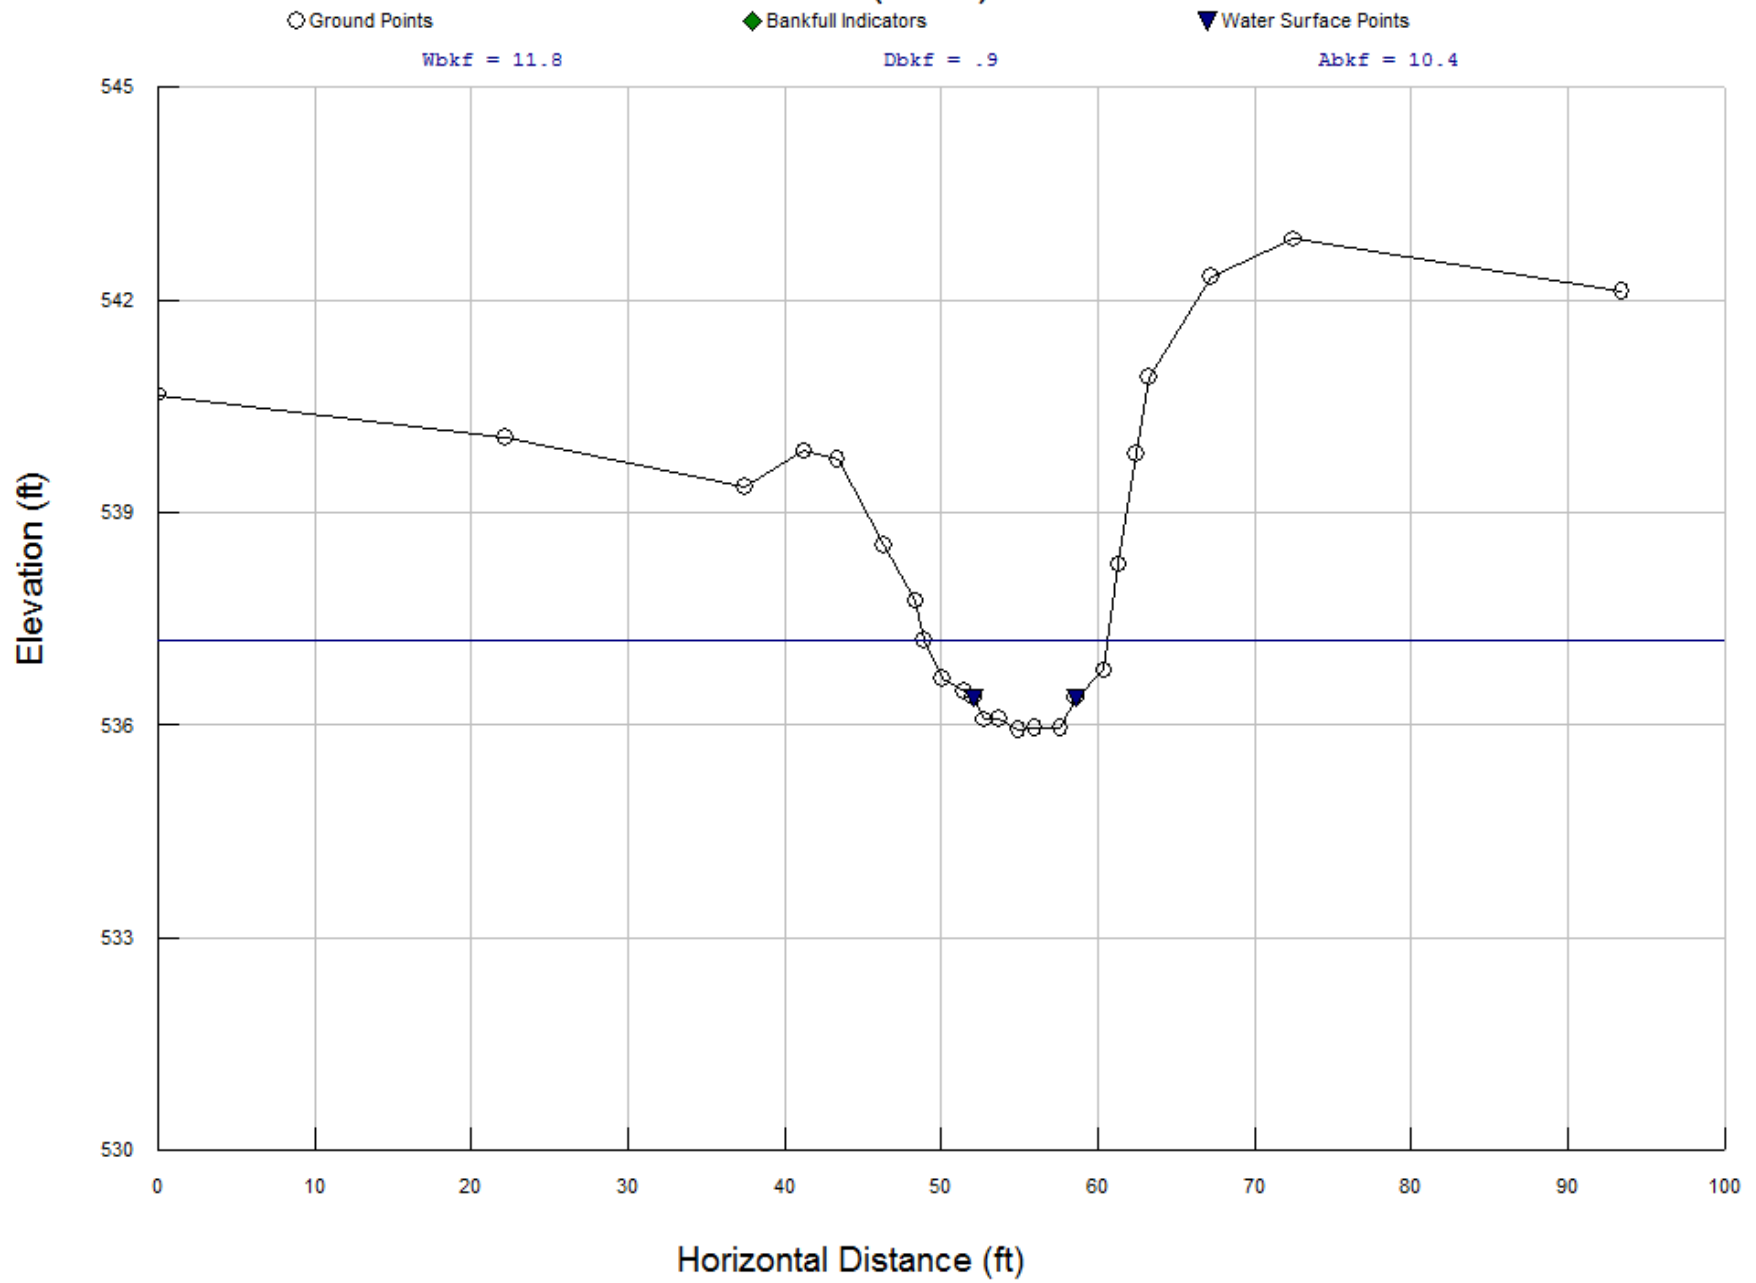
# UT1 XS8 (Pool)

River Name: UT1  
 Reach Name: Reach 2 - Middle  
 Cross Section Name: XS8-Pool  
 Survey Date: 06/10/11

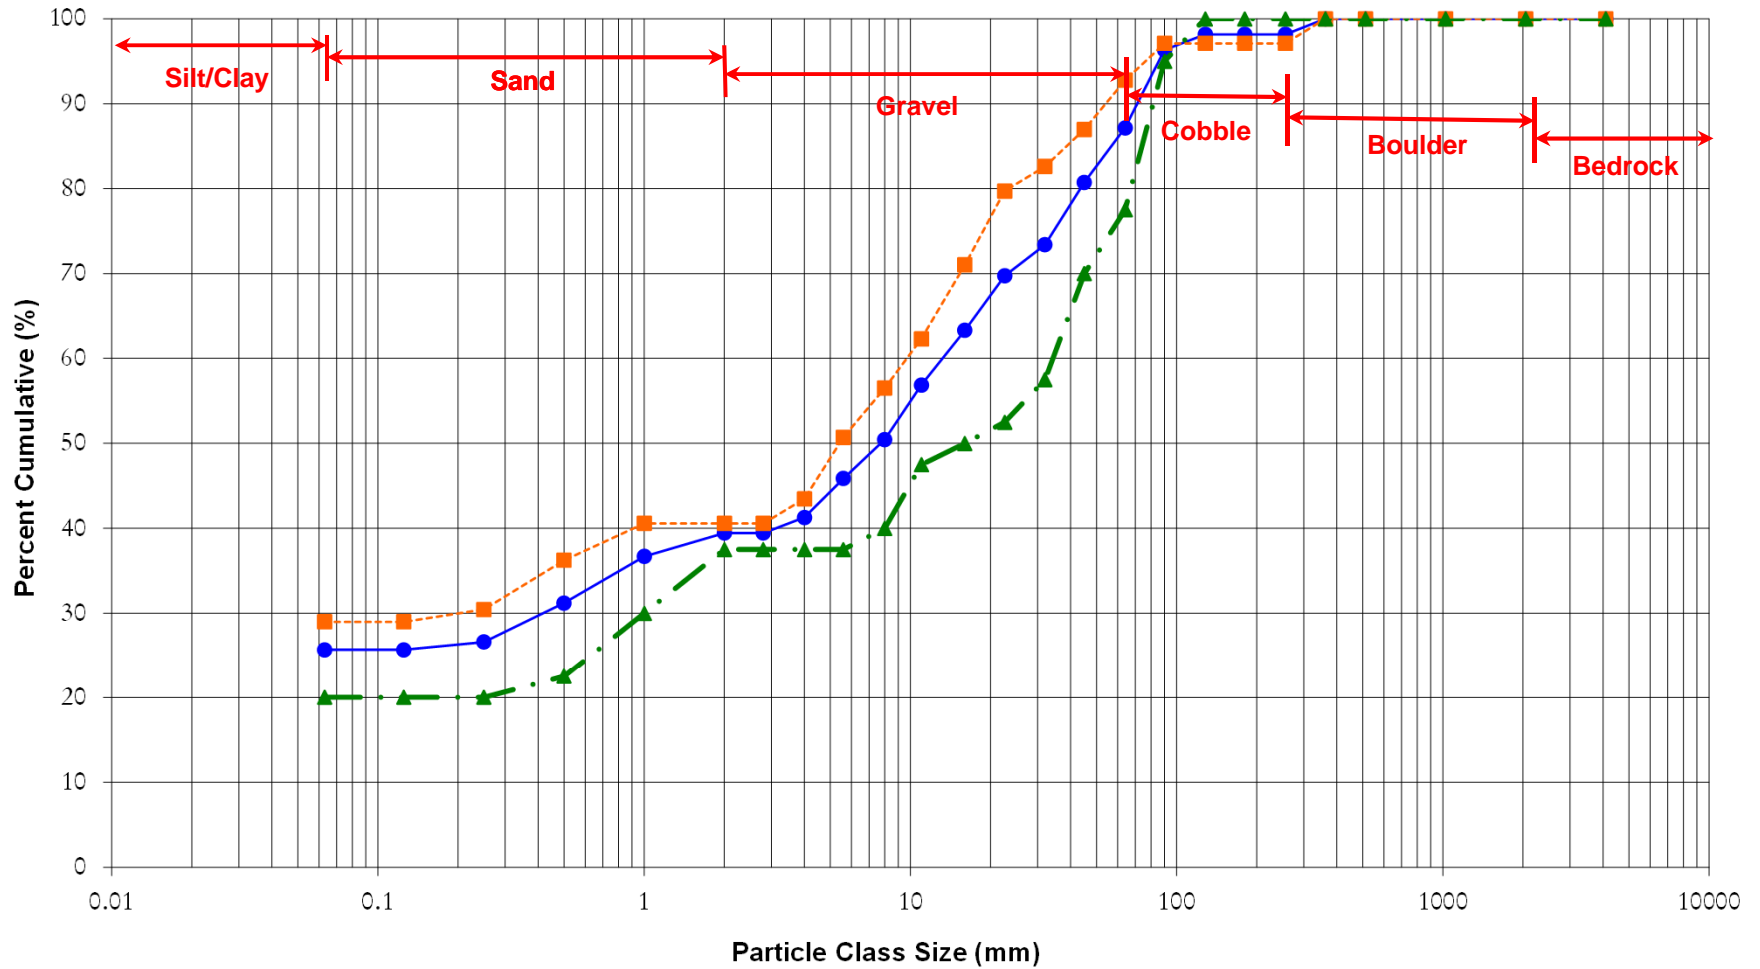
## Reach-Wide Pebble Count Particle Distribution

—●— Reach Summary    - - -■- - - Riffle Summary    - - -▲- - - Pool Summary

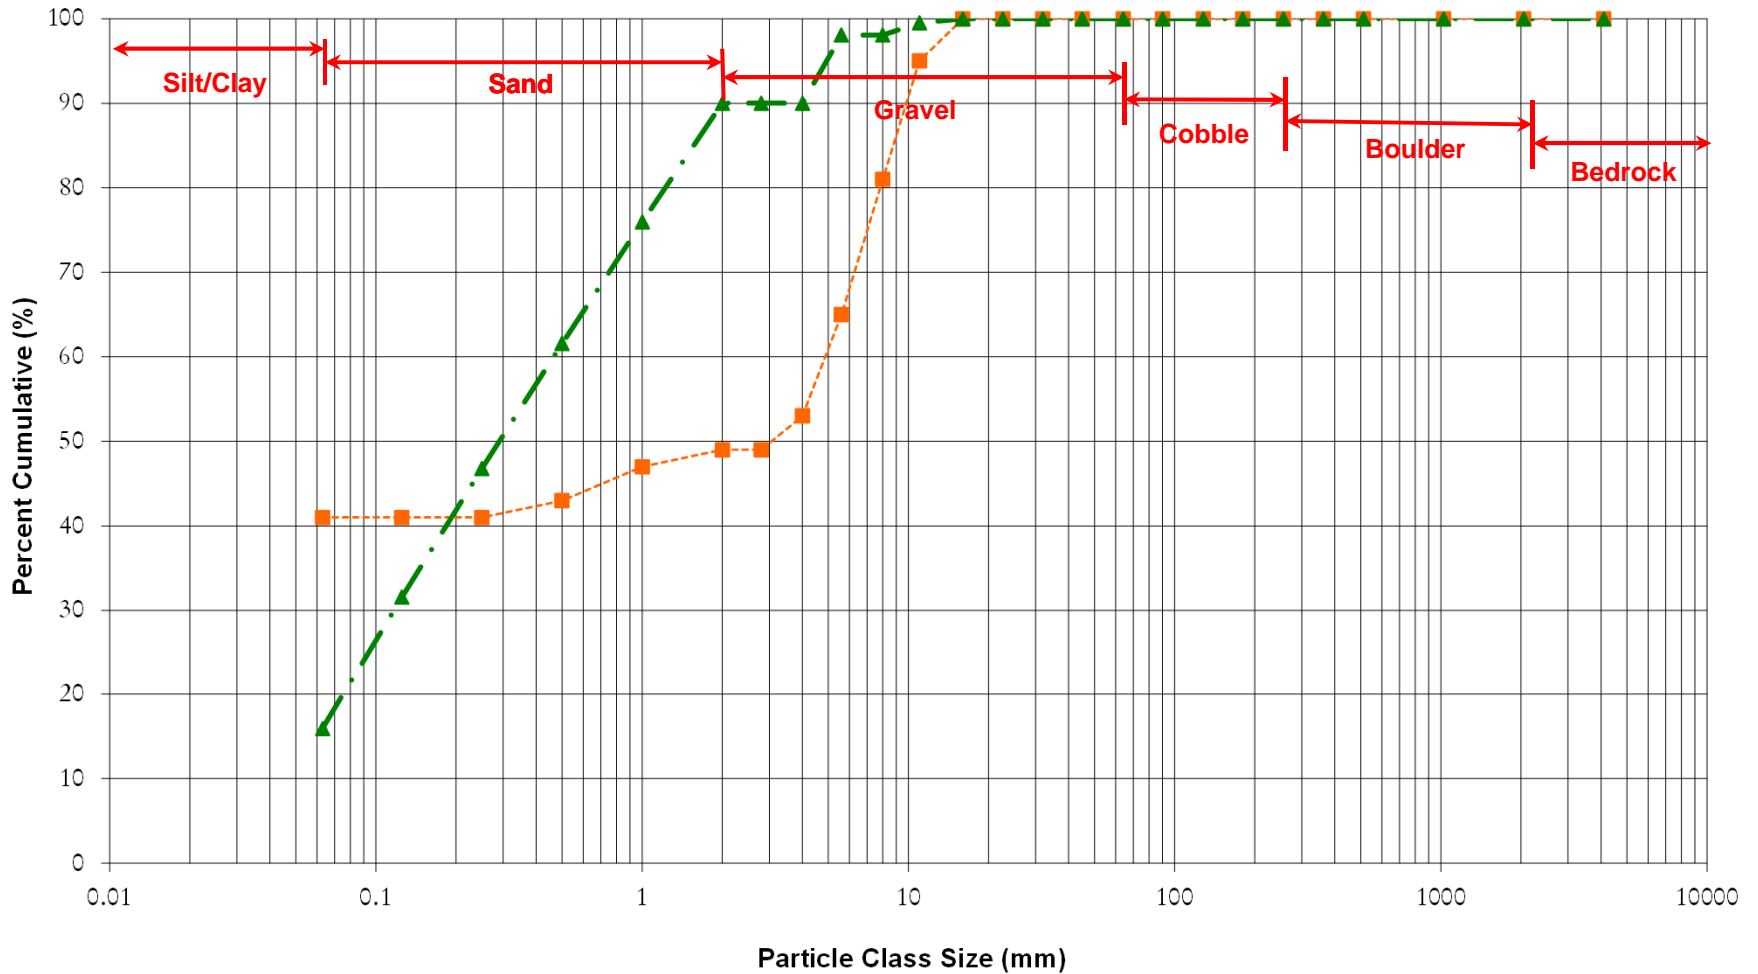
# UT1 - XS6 Riffle Pavement & Subpavement Particle Distribution

---■--- Pavement Summary    -▲- Subpavement Summary

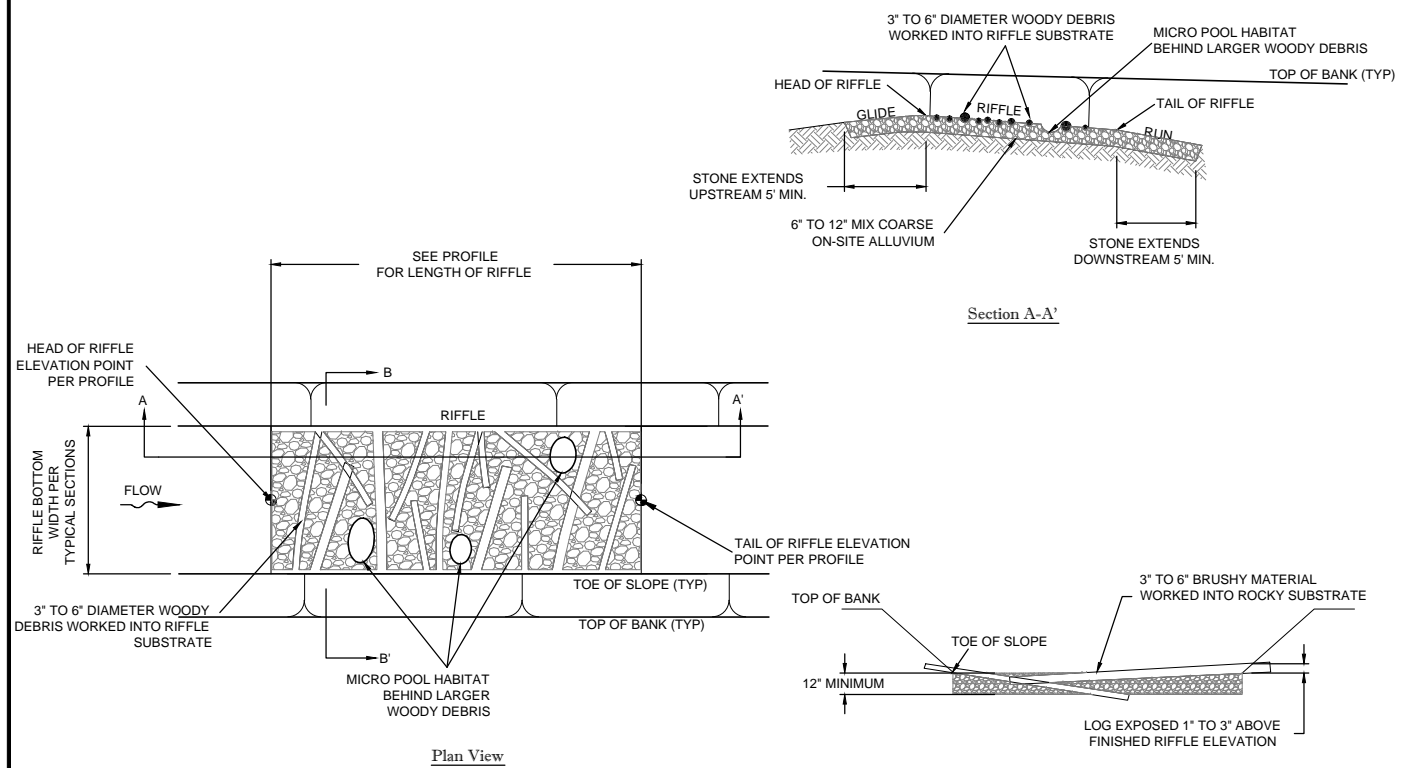
4  
5.1 Not to Scale **Woody Riffle** CR-4

- NOTES:**
- RIFFLE DIMENSIONS FROM TYPICAL SECTIONS.
  - SEE PROFILE FOR LENGTH AND SLOPE.

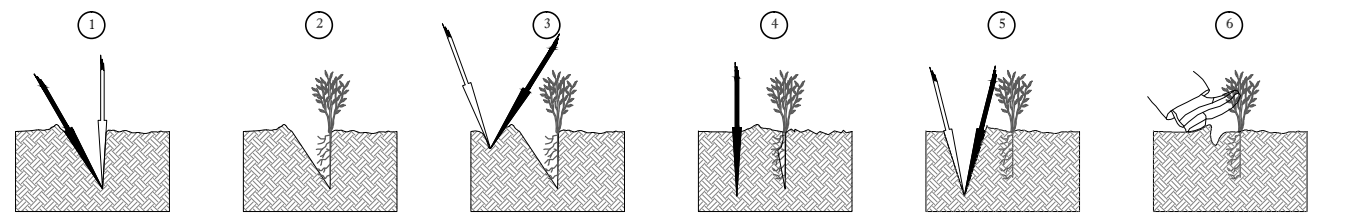
**1**  
 INSERT THE DIBBLE, OR SHOVEL, STRAIGHT DOWN INTO THE SOIL TO THE FULL DEPTH OF THE BLADE AND PULL BACK ON THE HANDLE TO OPEN THE PLANTING HOLE. (DO NOT ROCK THE SHOVEL BACK AND FORTH AS THIS CAUSES SOIL IN THE PLANTING HOLE TO BE COMPACTED, INHIBITING ROOT GROWTH.)

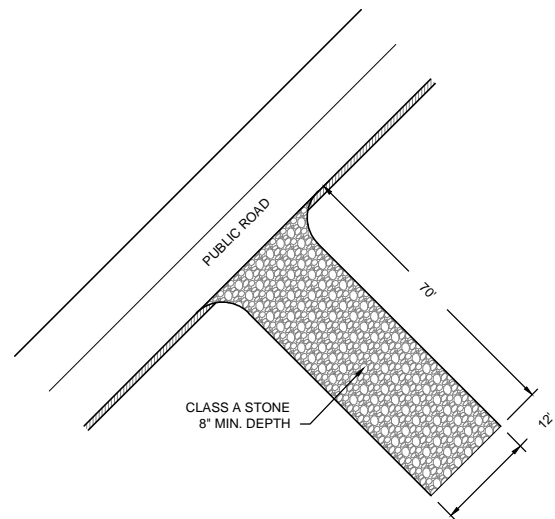
3  
5.7  
Construction Entrance  
Not to Scale

- NOTES:
1. PROVIDE TURNING RADIUS SUFFICIENT TO ACCOMMODATE LARGE TRUCKS.
  5. LOCATE CONSTRUCTION ENTRANCE AT ALL POINTS OF INGRESS AND EGRESS UNTIL SITE IS STABILIZED. PROVIDE FREQUENT CHECKS OF THE DEVICE AND TIMELY MAINTENANCE.
  6. MUST BE MAINTAINED IN A CONDITION WHICH WILL PREVENT TRACKING OR DIRECT FLOW OF MUD ONTO STREETS. PERIODIC TOP DRESSING WITH STONE WILL BE NECESSARY.
  7. ANY MATERIAL TRACKED ONTO THE ROADWAY MUST BE CLEANED IMMEDIATELY.
  8. USE CLASS A STONE OR OTHER COARSE AGGREGATE APPROVED BY THE ENGINEER.
  9. PLACE FILTER FABRIC BENEATH STONE.
