**Cross Creek  
Stream Restoration  
Cumberland County, North Carolina  
Mitigation Report**

NCEEP Project Number 105  
SCO Number 01-05460-01  
EEP Project Manager: Melonie Allen

**July 2006**

**CROSS CREEK STREAM RESTORATION  
STREAM MITIGATION REPORT**

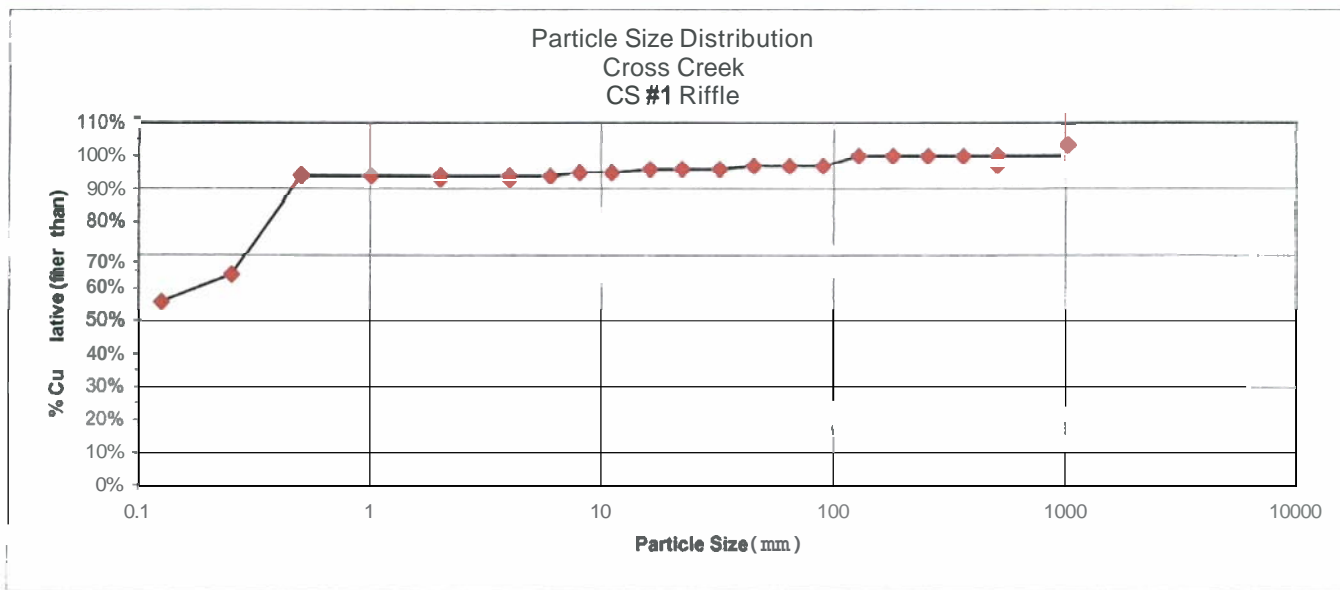
PEBBLE COUNT								
Site: Cross Creek						41512005		
Party: Amanda Todd and Russel Barbour						CS#1	Riffle	
		Particle Count						
Inches	Particle Silt/Clay	Millimeter < 0.062	S/C	Riffle		Total No.	Item %	% Cumulative
				56		56	56%	56%
.04 - .08	Very Fine	.062 - .125	S	0		0	0%	56%
	Fine	.125 - .25	A	8		8	8%	64%
	Medium	.25 - .50	N	30		30	30%	94%
	Coarse	50 - 1.0	D	0		0	0%	94%
	Very Coarse	1.0 - 2.0	S	0		0	0%	94%
.08 - .16	Very Fine	2.0 - 4.0		0		0	0%	94%
.16 - .22	Fine	4.0 - 5.7	G	0		0	0%	94%
.22 - .31	Fine	7 - 8.0	R	1		1	1%	95%
.31 - .44	Medium	8.0 - 11.3	A	0		0	0%	95%
.44 - .63	Medium	11.3 - 16.0	V	1		1	1%	96%
.63 - .89	Coarse	16.0 - 22.6	E	0		0	0%	96%
.89 - 1.26	Coarse	22.6 - 32.0	L	0		0	0%	96%

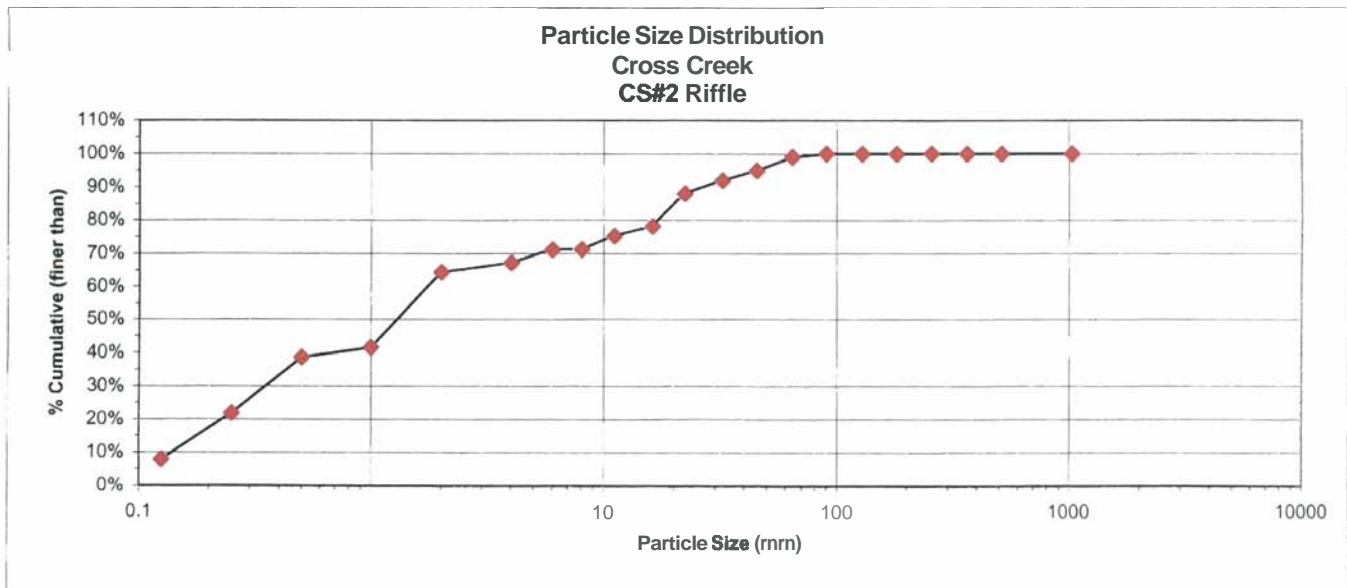
PEBBLE COUNT								
Site: Cross Creek						41512005		
Party: Amanda Todd and Russel Barbour						CS#2 Riffle		
Particle Count								
Inches	Particle	Millimeter		Riffle		Total No.	Item %	% Cumulative
	Silt/Clay	< 0.062	S/C	4		4	4%	4%
.04 - .08	Very Fine	.062 - .125	S	4		4	4%	8%
	Fine	.125 - .25	A	14		14	14%	22%
	Medium	.25 - .50	N	17		17	17%	39%
	Coarse	.50 - 1.0	D	3		3	3%	42%
	Very Coarse	1. - 2.0	S	23		23	23%	64%
.08 - .16	Very Fine	2.0 - 4.0		3		3	3%	67%
.16 - .22	Fine	4.0 - 5.7	G	4		4	4%	71%
.22 - .31	Fine	5.7 - 8.0	R	0		0	0%	71%
.31 - .44	Medium	8.0 - 11.3	A	4		4	4%	75%
.44 - .63	Medium	11.3 - 16.0	V	3		3	3%	78%
.63 - .89	Coarse	16.0 - 22.6	E	10		10	10%	88%
.89 - 1.26	Coarse	22.6 - 32.0	L	4		4	4%	92%

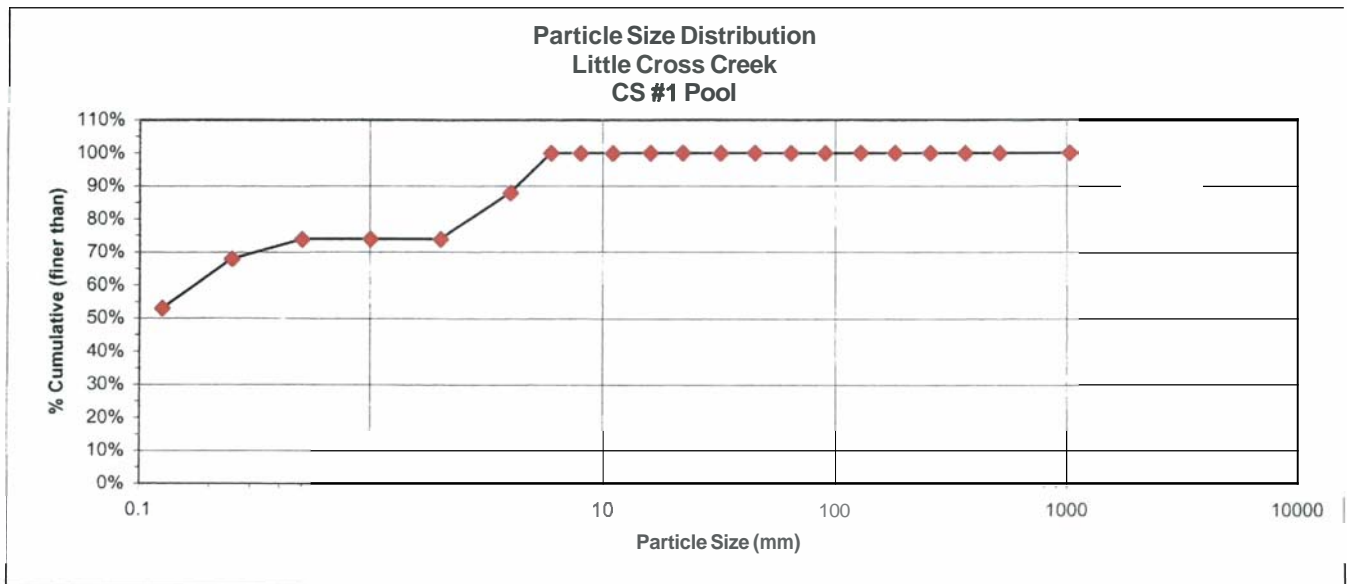
PEBBLE COUNT						4/5/2005		
Site: Little Cross Creek						CS#1 Pool		
Party: Amanda Todd and Russel Barbour						CS#1 Pool		
Inches	Particle	Millimeter	S/C	Particle Count		Total No.	Item %	% Cumulative
				Riffle				
	Silt/Clay	< 0.062	S/C	9		9	9%	9%
.04 - .08	Very Fine	.062 - .125	S	44		44	44%	53%
	Fine	.125 - .25	A	15		15	15%	68%
	Medium	.25 - .50	N	6		6	6%	74%
	Coarse	.50 - 1.0	D	0		0	0%	74%
	Very Coarse	1.0 - 2.0	S	0		0	0%	74%
.08 - .16	Very Fine	2.0 - 4.0		14		14	14%	88%
.16 - .22	Fine	4.0 - 5.7	G	12		12	12%	100%
.22 - .31	Fine	5.7 - 8.0	R	0		0	0%	100%
.31 - .44	Medium	8.0 - 11.3	A	0		0	0%	100%
.44 - .63	Medium	11.3 - 16.0	V	0		0	0%	100%
.63 - .89	Coarse	16.0 - 22.6	E	0		0	0%	100%
.89 - 1.26	Coarse	22.6 - 32.0	L	0		0	0%	100%

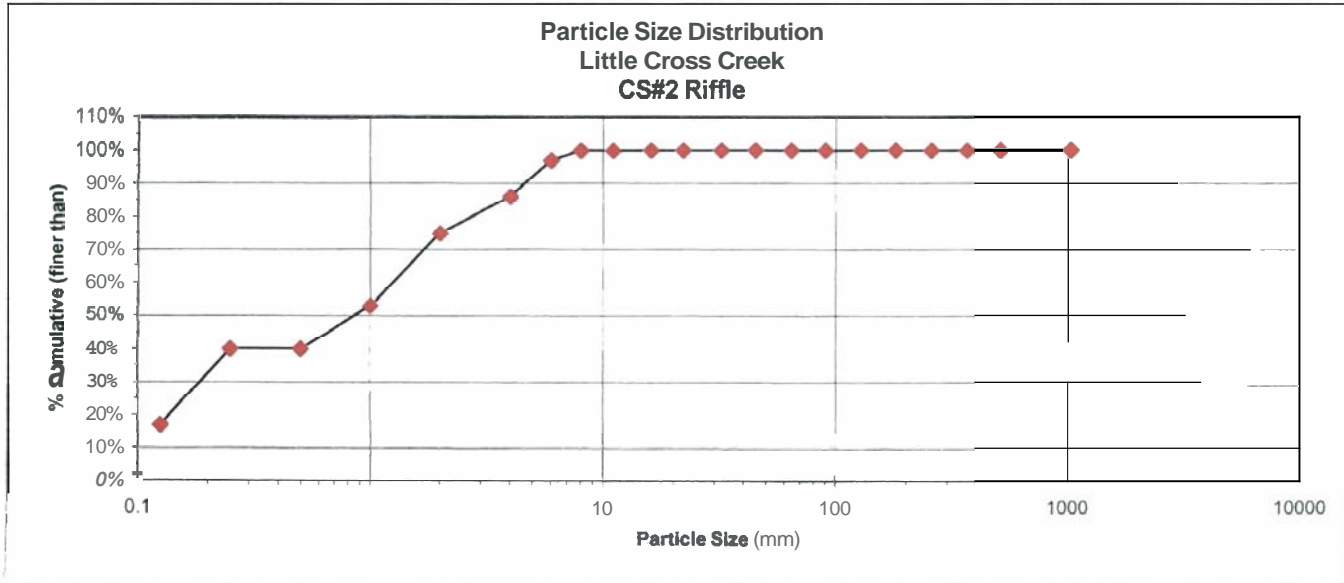
PEBBLE COUNT									
Site: Little Cross Creek						4/5/2005			
Party: Amanda Todd and Russel Barbour						CS#2		Riffle	
Particle Count									
Inches	Particle	Millimeter		Riffle		Total No.	Item %	% Cumulative	
	Silt/Clay	< 0.062	S/C	13		13	13%	13%	
.04 - .08	Very Fine	.062 - .125	S	4		4	4%	17%	
	Fine	.125 - .25	A	23		23	23%	40%	
	Medium	.25 - .50	N	0		0	0%	40%	
	Coarse	.50 - 1.0	D	13		13	13%	53%	
	Very Coarse	1.0 - 2.0	S	22		22	22%	75%	
.08 - .16	Very Fine	2.0 - 4.0		11		11	11%	86%	
.16 - .22	Fine	4.0 - 5.7	G	11		11	11%	97%	
.22 - .31	Fine	5.7 - 8.0	R	3		3	3%	100%	
.31 - .44	Medium	8.0 - 11.3	A	0		0	0%	100%	
.44 - .63	Medium	11.3 - 16.0	V	0		0	0%	100%	
.63 - .89	Coarse	16.0 - 22.6	E	0		0	0%	100%	
.89 - 1.26	Coarse	22.6 - 32.0	L	0		0	0%	100%
