**CUTAWHISKIE CREEK STREAM AND WETLAND RESTORATION SITE
2010 ANNUAL MONITORING REPORT (YEAR 3)**

**HERTFORD COUNTY, NORTH CAROLINA
NCEEP CONTRACT NO. D06066-A**

SITE LOCATION
CUTAWHISKIE CREEK
RESTORATION SITE
MONITORING REPORT

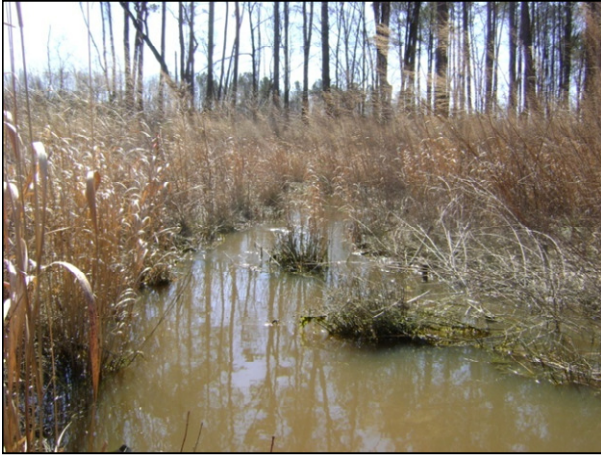
Photo 1. UT to Cutawhiskie Creek following a bankfull event. Water still persists above the top of bank and on the floodplain.

Table VI Hydrological (Bankfull) Verifications			
Cutawhiskie Creek Restoration Site – EEP Contract No. D06066-A			
Date of Data Collection	Date of Occurrence	Method	Photo Number
11-16-09	11-14-09	Photo documentation	See 2009 Monitoring Report
03-04-10	03-03-10	Photo documentation	1-2 (Appendix B)
11-18-10	09-28-10	Photo documentation	3 (Appendix B)

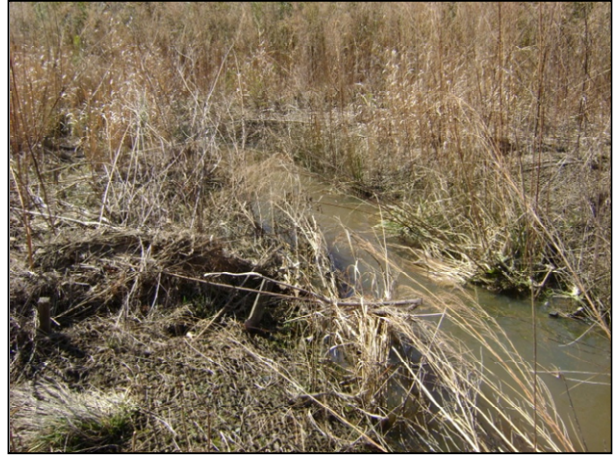
Photo 2. Floodplain wrack line.

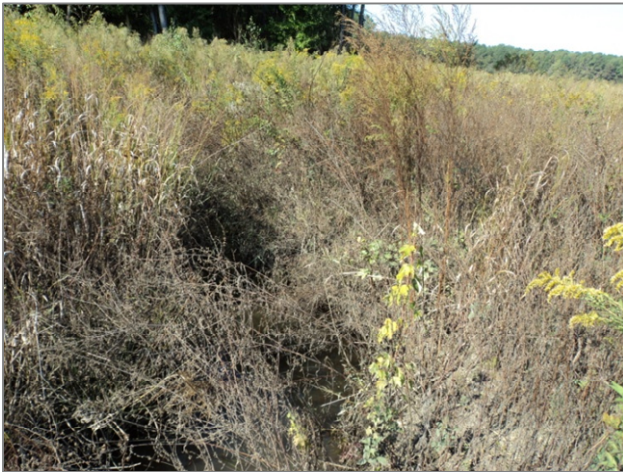
Photo 3. Hurricane Nicole produced 8-10 inches of rain over the region during an 8 hour period. Evidence of a large bankfull event was seen while checking monitoring gauges. Herbaceous vegetation adjacent to the channel showed signs of being matted down from water flow. Wrack lines were found pressed against erosion matting stakes and woody vegetation.
