MITIGATION PLAN

**Dales Creek Restoration Site
Buncombe County, North Carolina
DMS Project Number 100128
DEQ Contract 7910
USACE AID #: SAW-2019-00834
NCDWR #: 20190864 Version 1**

**French Broad River Basin
Cataloging Unit 06010105**

KCI Associates of North Carolina, PC
4505 Falls of Neuse Rd, Suite 400
Raleigh, NC 27609
(919) 783-9214

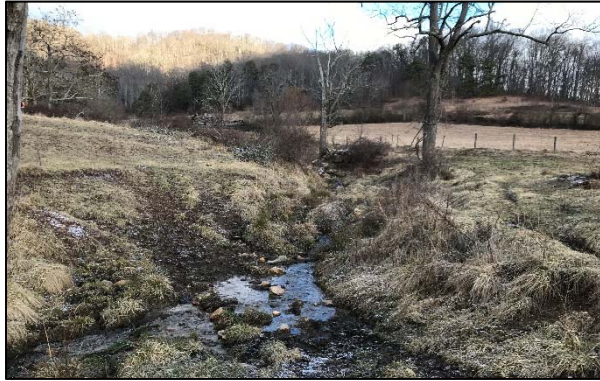
Photo 1: 2/5/18 - Looking at UT1-4 below UT2 confluence.

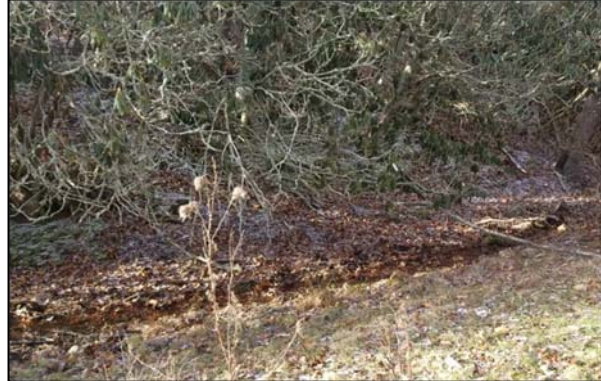
Photo 2: 2/5/18 - Looking at upstream portion of UT2.

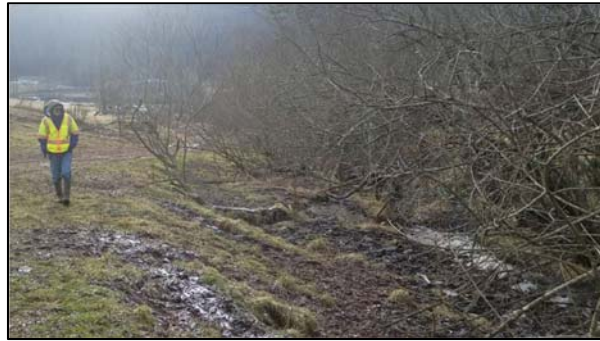
Photo 3: 2/5/18 - Looking downstream on UT1-3 above UT2 confluence.

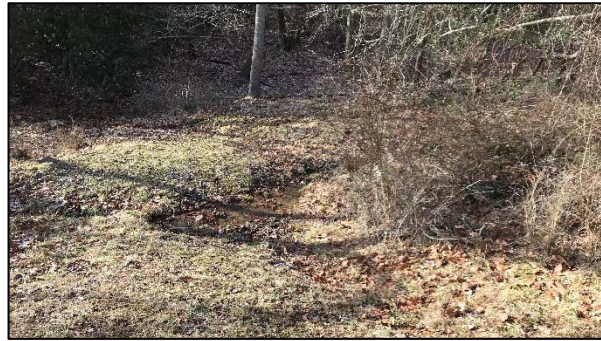
Photo 4: 2/5/18 - Looking at UT1-2.

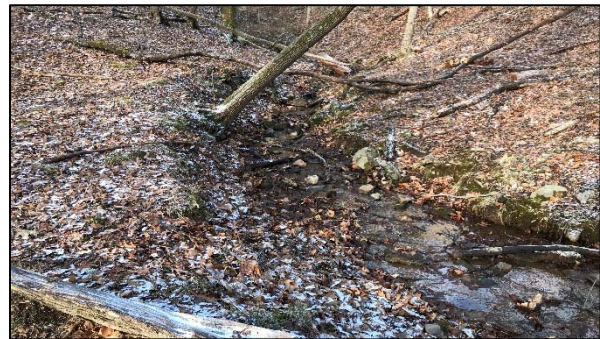
Photo 5: 2/5/18 - Looking at UT1-1.

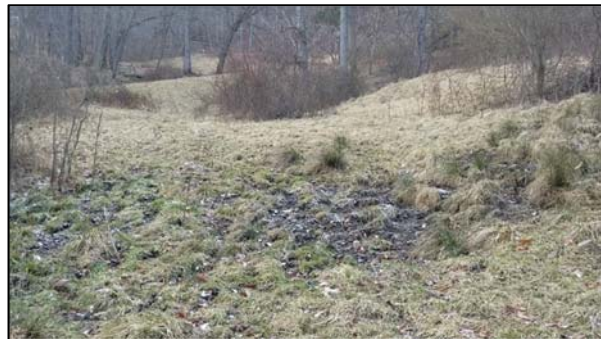
Photo 6: 2/5/18 - Looking at the wetland above UT4.

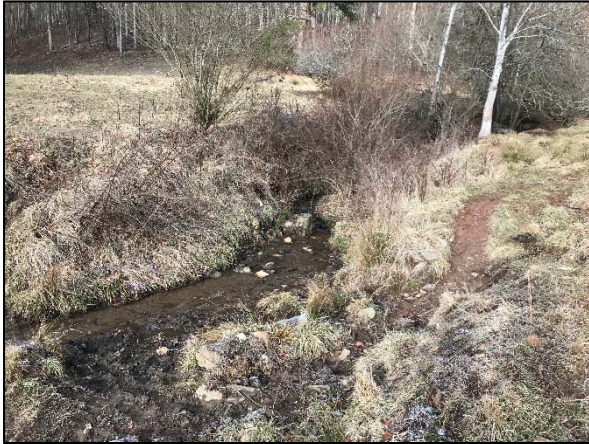
Photo 7: 2/5/18 - Cattle access to UT1-3.

Cattle impacts, vegetation removal, and channelization are among the causes that have reduced the functionality of the project streams and riparian buffers. The proposed project captures a large proportion of the project watershed's drainage routing and offers the opportunity to produce functional uplift at the site that would not otherwise occur within the near future.

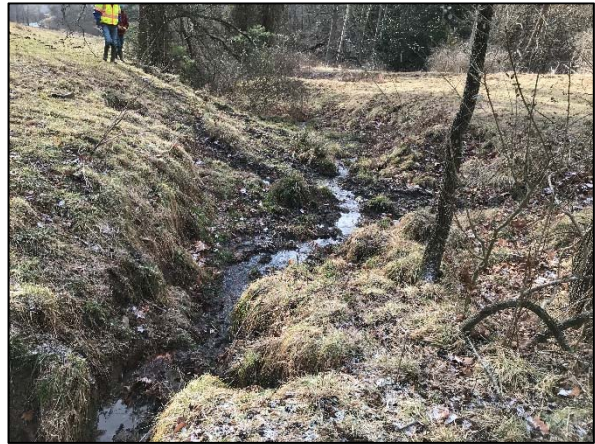
Photo 8: 2/5/18 - Cattle crossing along UT3.

UT3 begins at Station 300+00 and ends at Station 304+60 where it enters UT1. UT3 is the only reach requiring Restoration within this stream system. This is a steep channel that has undergone severe cattle impacts, and active headcuts are present as the bedform adjusts to this disturbance. The Restoration work will focus on restoring this headwater channel to a more natural step and cascade pool system. We will make use of cascade riffle structures to mimic the natural grade control that is found in the stable systems throughout the Newfound Creek watershed. The work will also include adjustments to dimension, pattern, and profile and the installation of woody debris structures to provide habitat niches throughout the stream. Special attention will be given to channel form where the cattle have destroyed the existing bed and banks and in the steeper portions of the channel as described here.

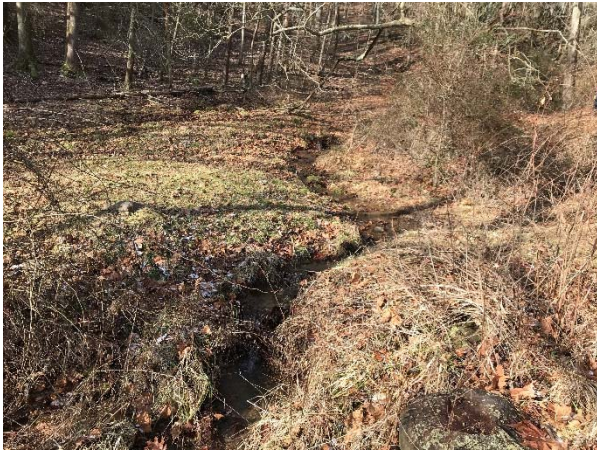
Photo 9: 2/5/18 - Looking at UT5-2.

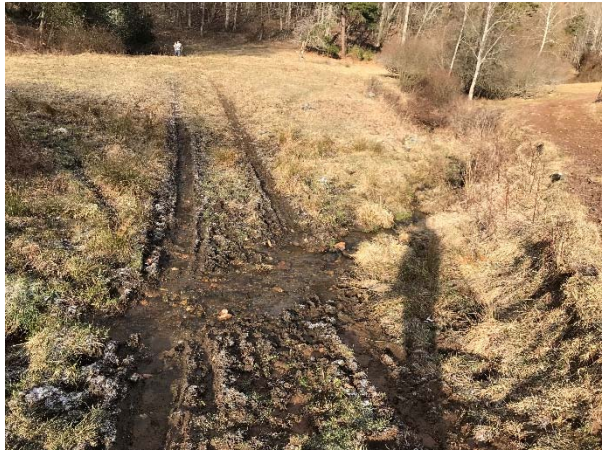
Photo 10: 2/5/18 – Looking at existing ford crossing at UT3.

In addition, one ford crossing will be rebuilt above the top of UT2 with stone protection and a boulder sill as shown in the project plan details. The ford crossing will be protected by a fence and gates and connect to livestock exclusion fencing upstream of the ford crossing to provide additional protection of UT2 from cattle. All other existing ford crossings will be eliminated. These crossing locations are shown on Figure 8.

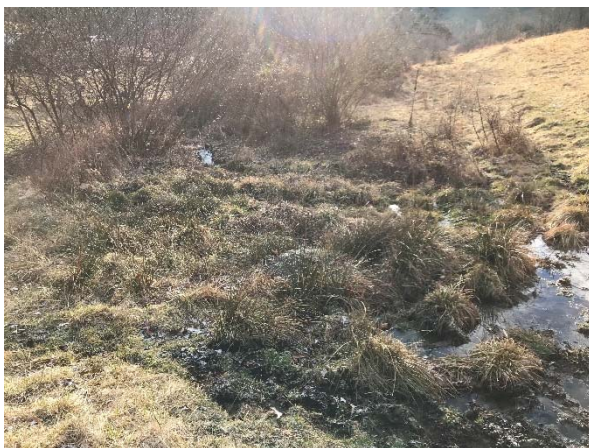
Photo 11: 2/5/18 - Looking at W3 at the confluence of UT1 and UT2.

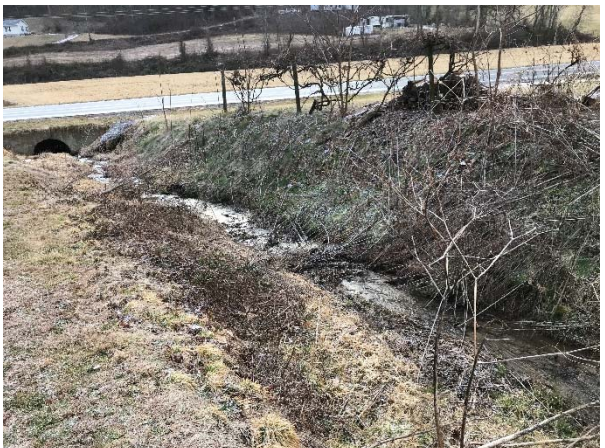
Photo 12: 2/5/18 - Looking at UT1 downstream of the project at Newfound Road.

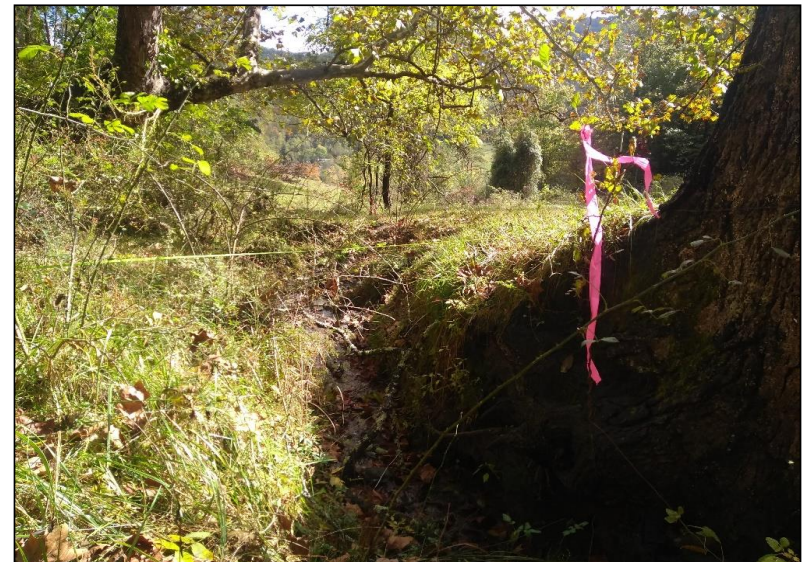
River Basin:	French Broad
Site	Dale's Creek
XS ID	UT3 XS A
Drainage Area (sq mi):	0.02
Date:	10/22/2019
Field Crew:	T. Seelinger, J. Sullivan

Station	Elevation
0.0	2364.25
7.0	2362.91
12.6	2358.38
21.2	2354.53
27.8	2354.61
32.7	2354.82
33.9	2354.71
35.0	2353.97
36.4	2352.11
37.3	2352.03
38.0	2352.20
38.5	2352.21
38.9	2352.10
39.8	2356.22
42.5	2356.64
51.4	2356.47
58.5	2356.67
66.3	2357.40

SUMMARY DATA	
Bankfull Elevation (ft):	2352.6
Bankfull Cross-Sectional Area (ft²):	1.2
Bankfull Width (ft):	2.9
Flood Prone Area Elevation (ft):	2353.1
Flood Prone Width (ft):	3.5
Max Depth at Bankfull (ft):	0.5
Mean Depth at Bankfull (ft):	0.4
W / D Ratio:	7.1
Entrenchment Ratio:	1.2
Bank Height Ratio:	4.9

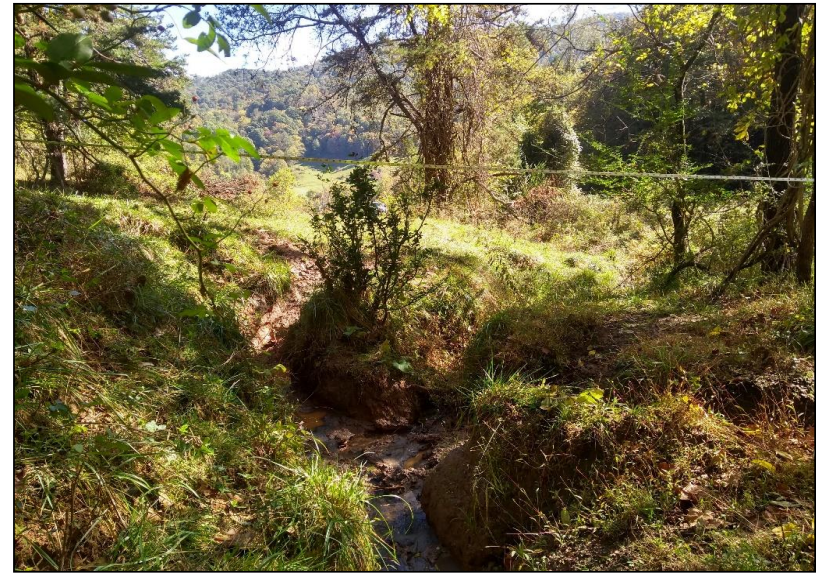
River Basin:	French Broad
Site	Dale's Creek
XS ID	UT3 XS B
Drainage Area (sq mi):	0.02
Date:	10/22/2019
Field Crew:	T. Seelinger, J. Sullivan

Station	Elevation
0.0	2353.76
4.8	2353.23
6.4	2351.47
7.4	2351.03
9.0	2350.77
10.4	2349.25
12.1	2348.40
13.0	2346.45
14.3	2346.43
14.7	2346.18
14.9	2346.45
15.2	2347.36
16.2	2348.52
17.6	2348.63
22.3	2348.83
29.0	2348.92
31.3	2349.48
34.9	2350.82
46.9	2350.78
54.6	2350.85

SUMMARY DATA	
Bankfull Elevation (ft):	2346.9
Bankfull Cross-Sectional Area (ft²):	1.0
Bankfull Width (ft):	2.2
Flood Prone Area Elevation (ft):	2347.7
Flood Prone Width (ft):	3.0
Max Depth at Bankfull (ft):	0.7
Mean Depth at Bankfull (ft):	0.5
W / D Ratio:	4.8
Entrenchment Ratio:	1.3
Bank Height Ratio:	3.1

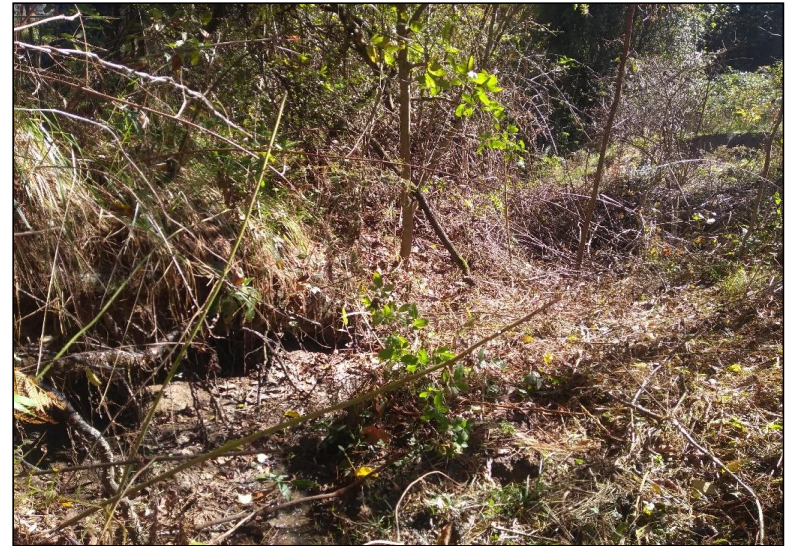
River Basin:	French Broad
Site	Dale's Creek
XS ID	UT3 XS C
Drainage Area (sq mi):	0.02
Date:	10/22/2019
Field Crew:	T. Seelinger, J. Sullivan

Station	Elevation
0.0	2346.68
9.6	2344.24
15.2	2343.26
19.2	2342.80
23.2	2342.72
29.4	2342.23
32.4	2341.77
36.0	2340.27
38.8	2339.59
41.3	2334.74
41.9	2334.80
42.7	2334.78
43.4	2334.81
43.6	2335.14
44.7	2335.31
45.8	2335.52
47.1	2336.29
50.0	2337.17
55.1	2339.51
57.8	2340.23
64.4	2340.46
68.7	2339.91
72.2	2339.36
77.6	2339.93
80.5	2341.37
89.5	2342.36
97.3	2343.75
104.9	2344.20

SUMMARY DATA	
Bankfull Elevation (ft):	2335.26
Bankfull Cross-Sectional Area (ft²):	1.2
Bankfull Width (ft):	3.4
Flood Prone Area Elevation (ft):	2335.8
Flood Prone Width (ft):	5.5
Max Depth at Bankfull (ft):	0.5
Mean Depth at Bankfull (ft):	0.3
W / D Ratio:	9.7
Entrenchment Ratio:	1.6
Bank Height Ratio:	1.0

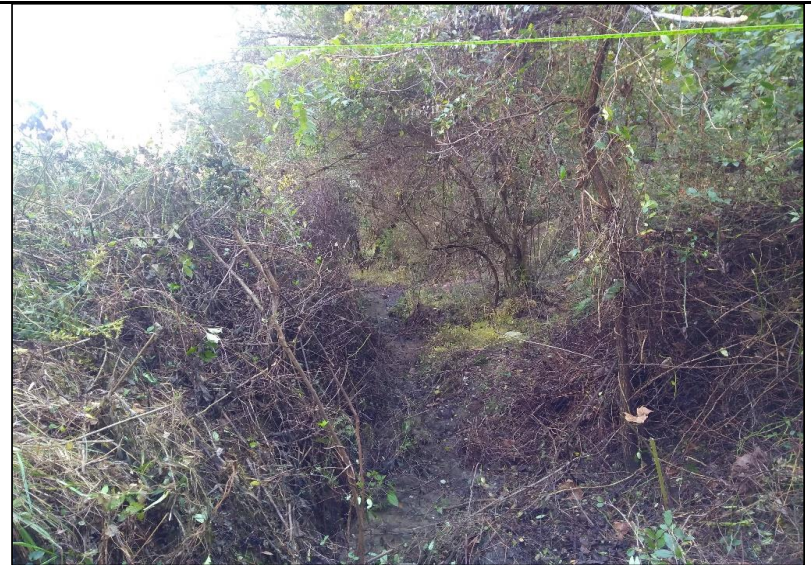
River Basin:	French Broad
Site	Dale's Creek
XS ID	UT3 XS D
Drainage Area (sq mi):	0.03
Date:	10/22/2019
Field Crew:	T. Seelinger, J. Sullivan

Station	Elevation
0.0	2334.91
7.5	2334.36
31.9	2333.20
40.1	2332.77
41.9	2332.69
45.3	2331.74
48.0	2330.69
50.2	2329.53
52.8	2328.43
54.5	2327.23
55.8	2324.87
56.5	2324.96
56.6	2324.93
57.0	2325.08
57.4	2325.63
58.3	2325.71
60.4	2325.90
63.3	2326.95
68.6	2330.55
72.2	2332.16
77.3	2332.75
81.6	2333.28
90.3	2334.03
96.8	2334.43

SUMMARY DATA	
Bankfull Elevation (ft):	2325.6
Bankfull Cross-Sectional Area (ft²):	1.1
Bankfull Width (ft):	2.0
Flood Prone Area Elevation (ft):	2326.4
Flood Prone Width (ft):	6.8
Max Depth at Bankfull (ft):	0.8
Mean Depth at Bankfull (ft):	0.5
W / D Ratio:	3.8
Entrenchment Ratio:	3.3
Bank Height Ratio:	1.1

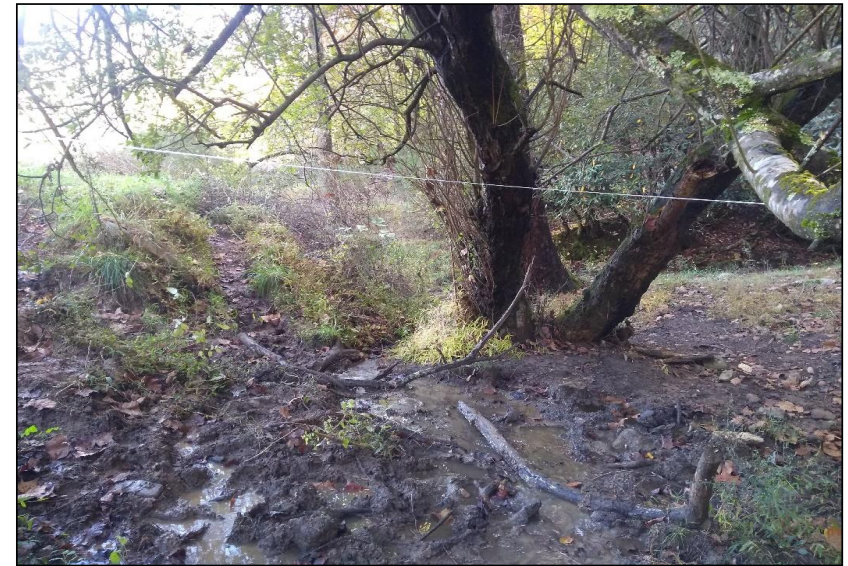
Station	Elevation
0.0	2327.33
11.3	2326.28
20.7	2325.63
25.3	2324.78
31.0	2321.15
32.8	2319.76
34.2	2319.32
35.7	2318.86
37.2	2318.92
38.8	2319.00
40.3	2319.16
41.7	2319.56
43.9	2319.55
45.6	2319.58
48.5	2321.74
53.1	2322.66
57.8	2324.73
69.0	2326.91
73.3	2327.35

SUMMARY DATA	
Bankfull Elevation (ft):	2319.3
Bankfull Cross-Sectional Area (ft²):	1.6
Bankfull Width (ft):	6.3
Flood Prone Area Elevation (ft):	2319.7
Flood Prone Width (ft):	12.6
Max Depth at Bankfull (ft):	0.4
Mean Depth at Bankfull (ft):	0.3
W / D Ratio:	24.6
Entrenchment Ratio:	2.0
Bank Height Ratio:	1.9

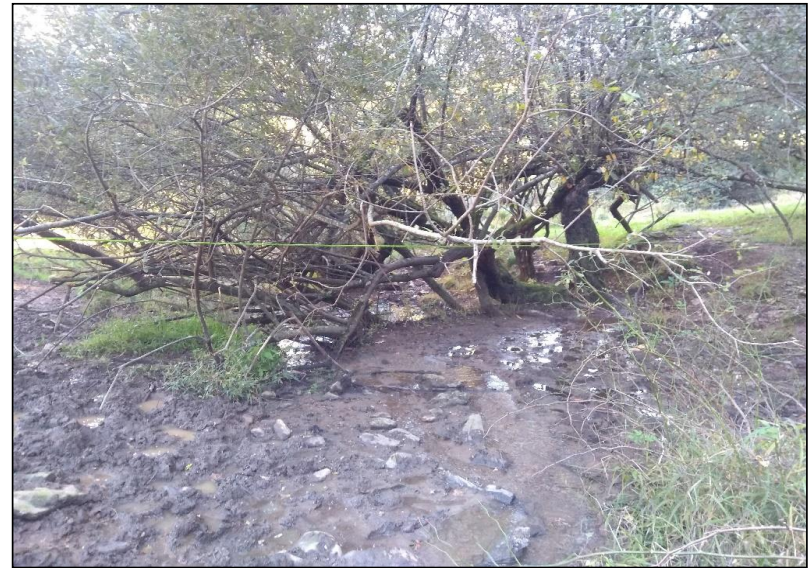
River Basin:	French Broad
Site	Dale's Creek
XS ID	UT1-3 XS F (Cattle Wallow)
Drainage Area (sq mi):	0.15
Date:	10/22/2019
Field Crew:	T. Seelinger, J. Sullivan

Station	Elevation
0.0	2311.38
8.8	2310.39
22.9	2309.50
24.9	2309.01
25.8	2308.80
27.4	2306.68
28.8	2305.67
30.1	2305.56
32.3	2305.12
34.1	2305.03
35.7	2304.95
37.8	2305.12
38.4	2304.94
39.7	2304.85
40.5	2304.83
41.2	2304.85
41.4	2304.99
43.1	2304.96
44.9	2304.97
47.0	2304.97
49.5	2304.97
53.0	2304.97
54.6	2305.67
59.8	2308.78
67.4	2310.25
72.0	2311.38

SUMMARY DATA	
Bankfull Elevation (ft):	2305.27
Bankfull Cross-Sectional Area (ft²):	6.3
Bankfull Width (ft):	22.2
Flood Prone Area Elevation (ft):	2305.7
Flood Prone Width (ft):	26.0
Max Depth at Bankfull (ft):	0.4
Mean Depth at Bankfull (ft):	0.3
W / D Ratio:	77.7
Entrenchment Ratio:	1.2
Bank Height Ratio:	1.7

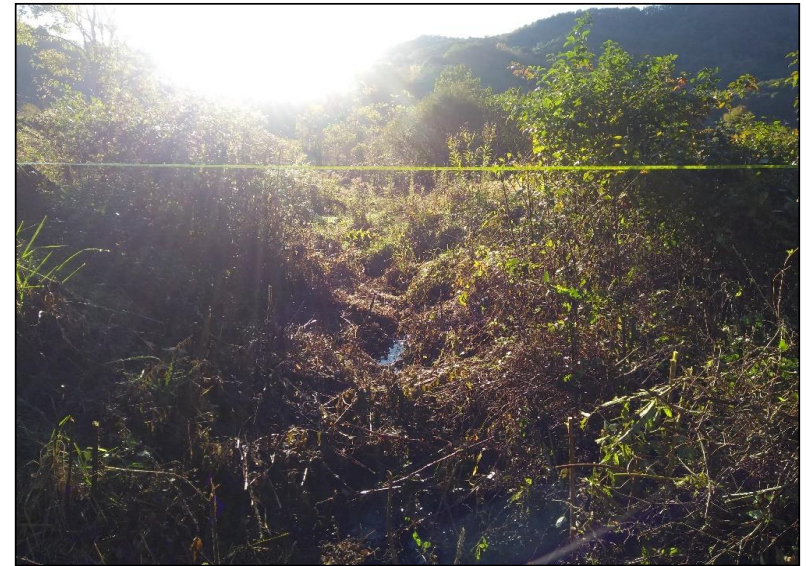
Station	Elevation
0.0	2293.27
2.1	2293.05
7.9	2290.57
12.3	2290.00
16.6	2289.65
22.3	2289.41
24.1	2289.44
26.8	2287.81
28.5	2287.11
30.0	2286.30
31.0	2285.36
31.6	2285.20
32.3	2285.21
32.7	2285.22
33.3	2285.43
34.1	2286.10
37.2	2287.95
39.2	2289.36
41.8	2289.48
43.9	2289.82
45.8	2290.19
47.4	2290.91
50.1	2292.09
52.9	2292.41
57.5	2292.52
62.9	2292.88

SUMMARY DATA	
Bankfull Elevation (ft):	2286.4
Bankfull Cross-Sectional Area (ft²):	3.5
Bankfull Width (ft):	4.6
Flood Prone Area Elevation (ft):	2287.5
Flood Prone Width (ft):	8.9
Max Depth at Bankfull (ft):	1.2
Mean Depth at Bankfull (ft):	0.8
W / D Ratio:	6.0
Entrenchment Ratio:	2.0
Bank Height Ratio:	3.8

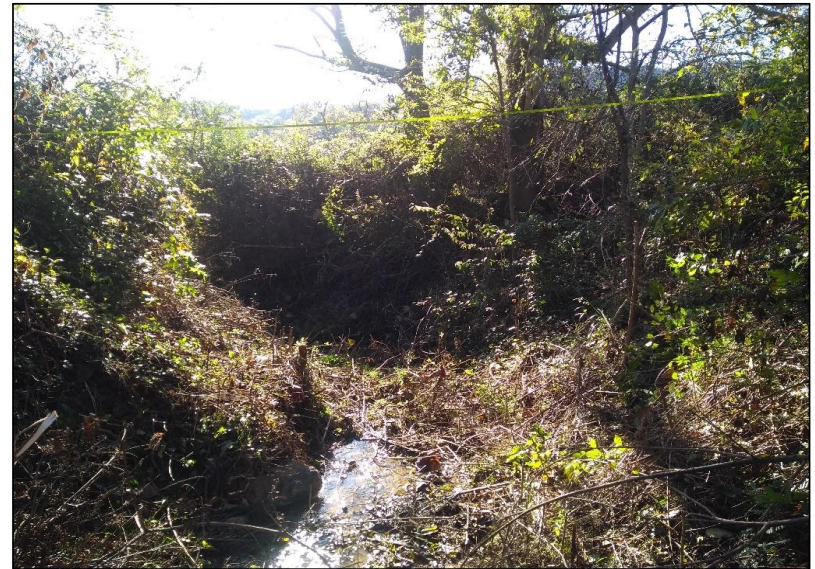
River Basin:	French Broad
Site	Dale's Creek
XS ID	UT1-4 XS H
Drainage Area (sq mi):	0.19
Date:	10/22/2019
Field Crew:	T. Seelinger, J. Sullivan

Station	Elevation
0.0	2279.06
6.4	2278.82
15.0	2276.24
20.5	2275.83
26.0	2276.20
28.8	2276.35
35.6	2276.46
44.0	2276.08
50.1	2275.89
51.7	2275.61
53.4	2274.04
57.0	2270.84
57.7	2269.90
58.6	2269.78
59.8	2269.46
60.5	2269.63
61.4	2269.86
62.4	2269.85
64.2	2270.44
65.8	2270.88
67.0	2272.18
73.9	2276.44
78.5	2278.84
80.6	2280.06
82.1	2280.30
84.7	2280.62
90.5	2281.58
98.4	2283.38
103.7	2284.86

SUMMARY DATA	
Bankfull Elevation (ft):	2270.5
Bankfull Cross-Sectional Area (ft²):	4.3
Bankfull Width (ft):	7.0
Flood Prone Area Elevation (ft):	2271.5
Flood Prone Width (ft):	10.1
Max Depth at Bankfull (ft):	1.0
Mean Depth at Bankfull (ft):	0.6
W / D Ratio:	11.5
Entrenchment Ratio:	1.4
Bank Height Ratio:	6.0

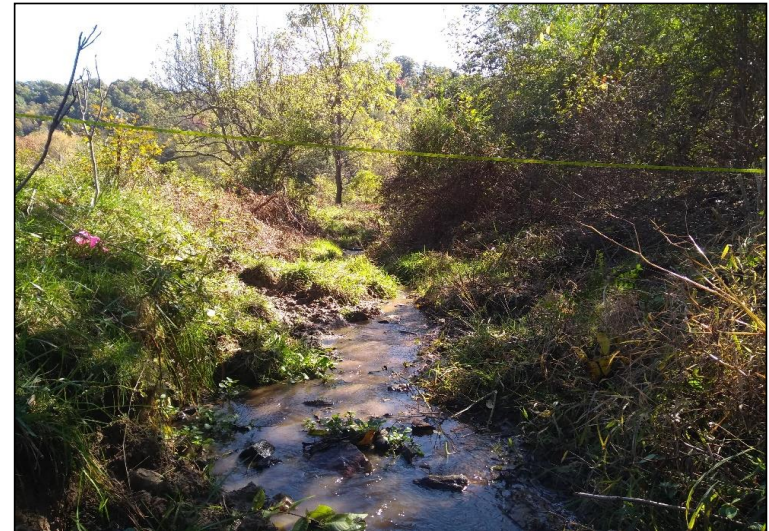
Station	Elevation
0.0	2258.74
11.3	2257.50
14.9	2256.84
17.6	2256.10
19.8	2254.77
21.3	2254.11
23.4	2253.71
24.4	2253.11
26.5	2252.69
28.0	2251.59
29.6	2251.26
30.2	2251.10
30.7	2249.27
31.4	2249.07
31.9	2249.07
32.3	2249.20
32.7	2249.20
33.5	2249.19
34.8	2249.28
35.3	2249.63
36.7	2249.84
37.8	2249.95
38.4	2250.57
41.6	2251.12
43.9	2251.58
45.4	2251.64
49.6	2251.75
51.9	2252.16
55.7	2253.24
59.2	2253.94

SUMMARY DATA	
Bankfull Elevation (ft):	2250.1
Bankfull Cross-Sectional Area (ft²):	5.3
Bankfull Width (ft):	7.5
Flood Prone Area Elevation (ft):	2251.2
Flood Prone Width (ft):	12.3
Max Depth at Bankfull (ft):	1.1
Mean Depth at Bankfull (ft):	0.7
W / D Ratio:	10.8
Entrenchment Ratio:	1.6
Bank Height Ratio:	1.4

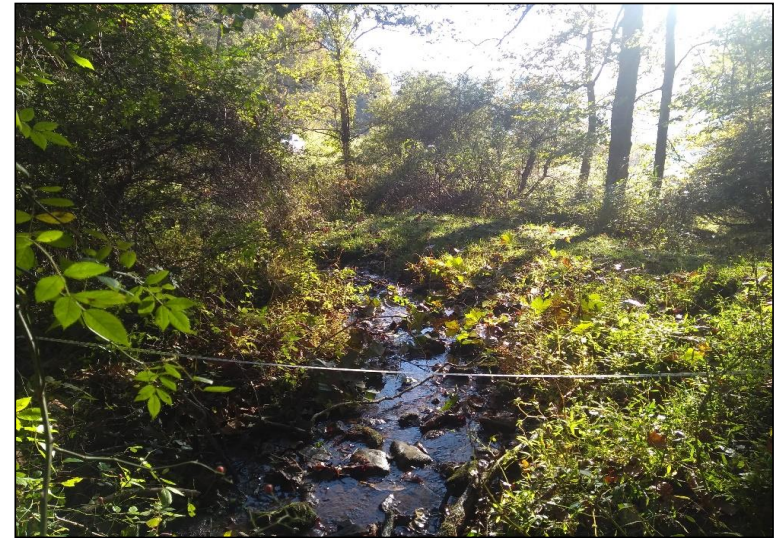
River Basin:	French Broad
Site	Dale's Creek
XS ID	UT1-2 XS Reference 1
Drainage Area (sq mi):	0.11
Date:	10/22/2019
Field Crew:	T. Seelinger, J. Sullivan

Station	Elevation
0.0	2334.96
4.1	2334.80
8.7	2333.17
10.6	2332.74
11.9	2332.77
12.9	2332.56
13.5	2332.17
14.2	2332.23
17.0	2332.04
18.8	2332.20
21.0	2333.06
23.0	2333.65
27.5	2333.94
30.2	2333.85
34.2	2333.97

SUMMARY DATA	
Bankfull Elevation (ft):	2332.7
Bankfull Cross-Sectional Area (ft²):	3.4
Bankfull Width (ft):	7.7
Flood Prone Area Elevation (ft):	2333.3
Flood Prone Width (ft):	13.7
Max Depth at Bankfull (ft):	0.6
Mean Depth at Bankfull (ft):	0.4
W / D Ratio:	17.4
Entrenchment Ratio:	1.8
Bank Height Ratio:	1.0

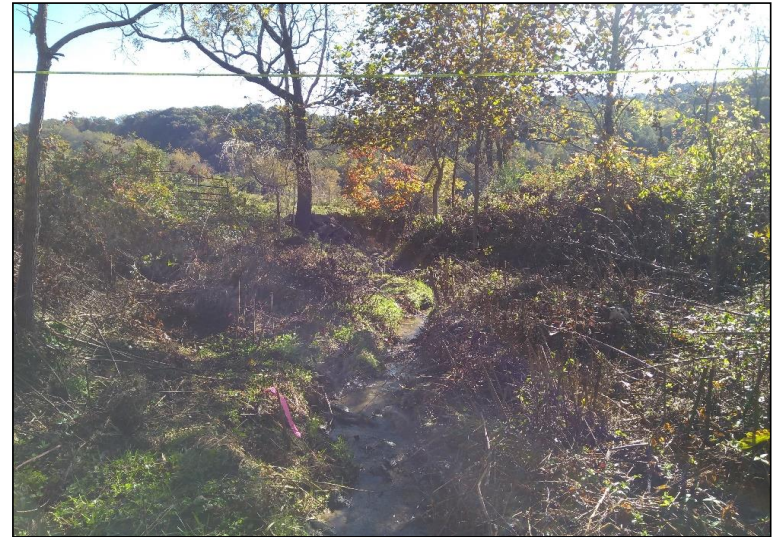
River Basin:	French Broad
Site	Dale's Creek
XS ID	UT1-3 XS Reference 2
Drainage Area (sq mi):	0.19
Date:	10/22/2019
Field Crew:	T. Seelinger, J. Sullivan

Station	Elevation
0.0	2272.16
3.7	2271.87
6.0	2271.53
7.2	2271.07
9.8	2268.91
13.0	2266.48
14.8	2266.50
15.7	2266.38
16.0	2265.86
17.4	2265.45
17.7	2265.56
18.1	2265.38
18.9	2265.31
20.0	2265.36
20.6	2266.40
22.2	2266.47
24.1	2267.11
26.4	2268.01
28.0	2269.07
32.7	2270.82
38.8	2273.29
39.8	2274.44
41.5	2275.08
46.2	2275.20
52.0	2275.52

SUMMARY DATA	
Bankfull Elevation (ft):	2266.4
Bankfull Cross-Sectional Area (ft²):	4.1
Bankfull Width (ft):	5.1
Flood Prone Area Elevation (ft):	2267.5
Flood Prone Width (ft):	13.3
Max Depth at Bankfull (ft):	1.1
Mean Depth at Bankfull (ft):	0.8
W / D Ratio:	6.3
Entrenchment Ratio:	2.6
Bank Height Ratio:	1.0

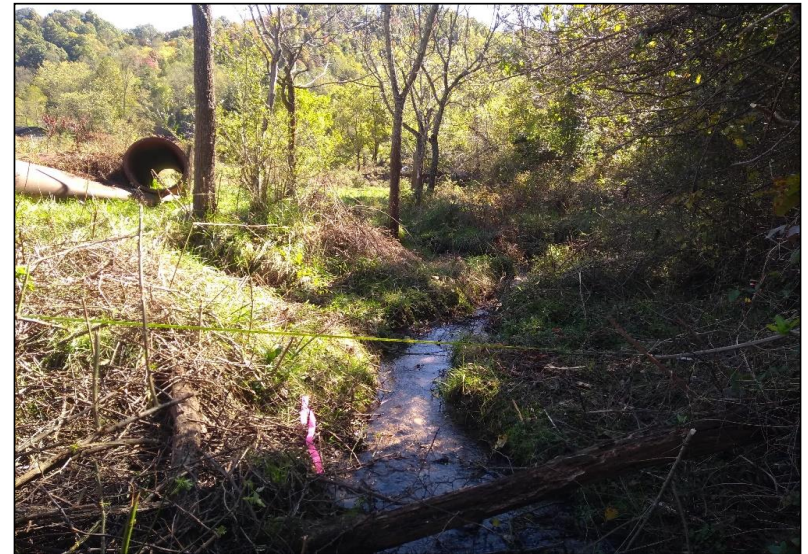
River Basin:	French Broad
Site	Dale's Creek
XS ID	UT1-4 XS Reference 3
Drainage Area (sq mi):	0.21
Date:	10/22/2019
Field Crew:	T. Seelinger, J. Sullivan

Station	Elevation
0.0	2247.77
4.5	2247.50
10.3	2246.64
16.8	2245.93
23.6	2245.28
27.6	2244.90
32.1	2244.66
35.8	2243.89
39.5	2243.06
41.7	2242.72
42.6	2242.37
44.4	2241.93
45.0	2241.77
45.6	2241.80
46.3	2241.73
46.8	2241.81
47.3	2242.48
48.0	2242.57
49.6	2242.70
52.9	2242.82
53.9	2243.35
54.8	2244.69
56.2	2245.41

SUMMARY DATA	
Bankfull Elevation (ft):	2242.7
Bankfull Cross-Sectional Area (ft²):	3.8
Bankfull Width (ft):	7.8
Flood Prone Area Elevation (ft):	2243.7
Flood Prone Width (ft):	17.4
Max Depth at Bankfull (ft):	1.0
Mean Depth at Bankfull (ft):	0.5
W / D Ratio:	16.1
Entrenchment Ratio:	2.2
Bank Height Ratio:	1.0

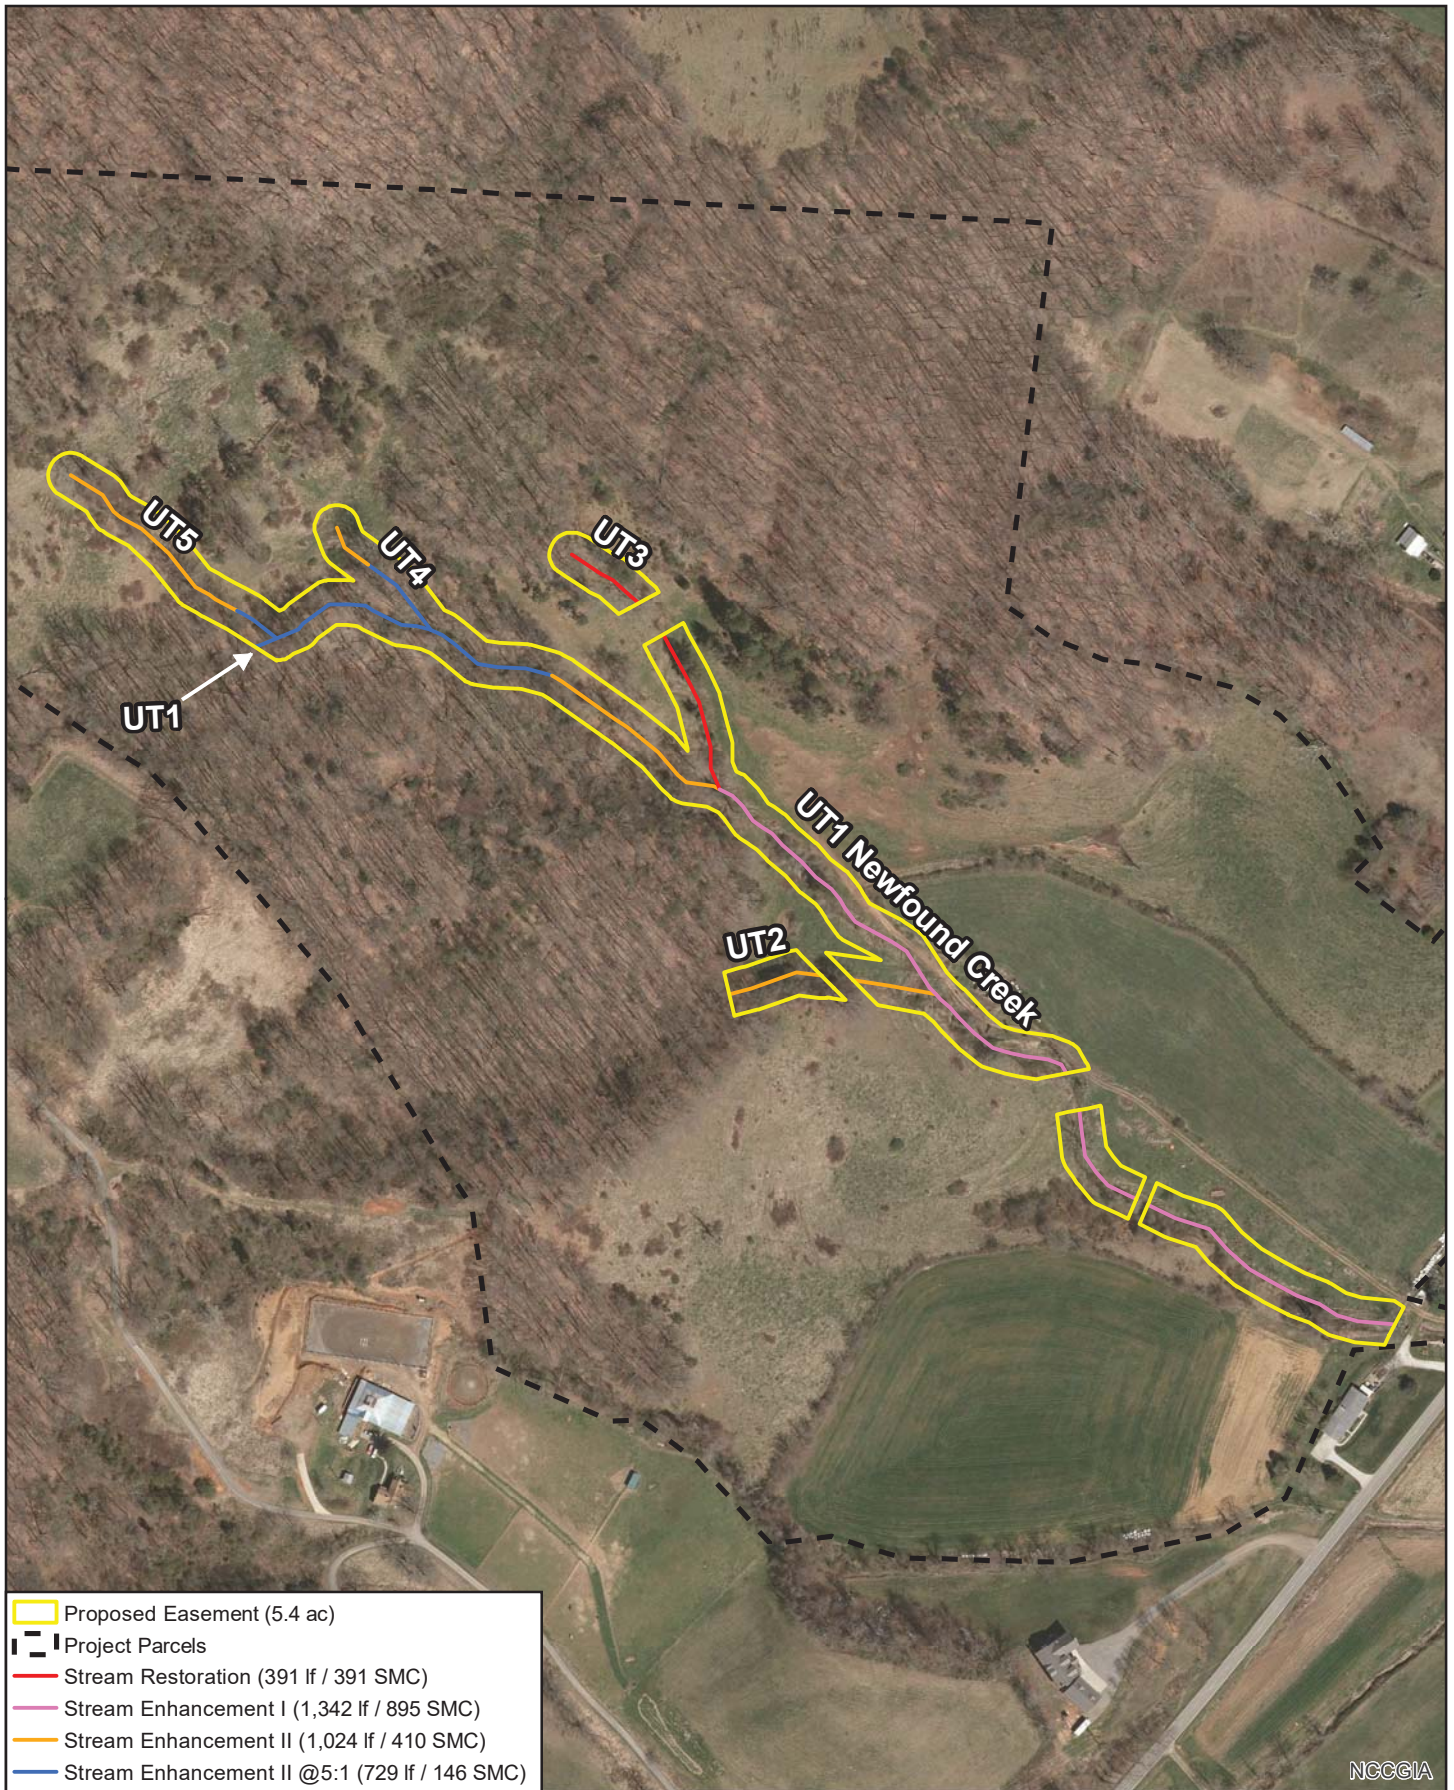
Figure 11

**FIGURE 11. PROPOSED MITIGATION TYPE AND EXTENT
DALES CREEK RESTORATION SITE
BUNCOMBE COUNTY, NC**
