RESTORATION PLAN

DANIELS FARM WETLAND RESTORATION SITE *Franklin County, North Carolina*

October 2003

*Prepared by: KCI Associates of North Carolina
4601 Six Forks Road, Suite 200
Raleigh, North Carolina 27609*

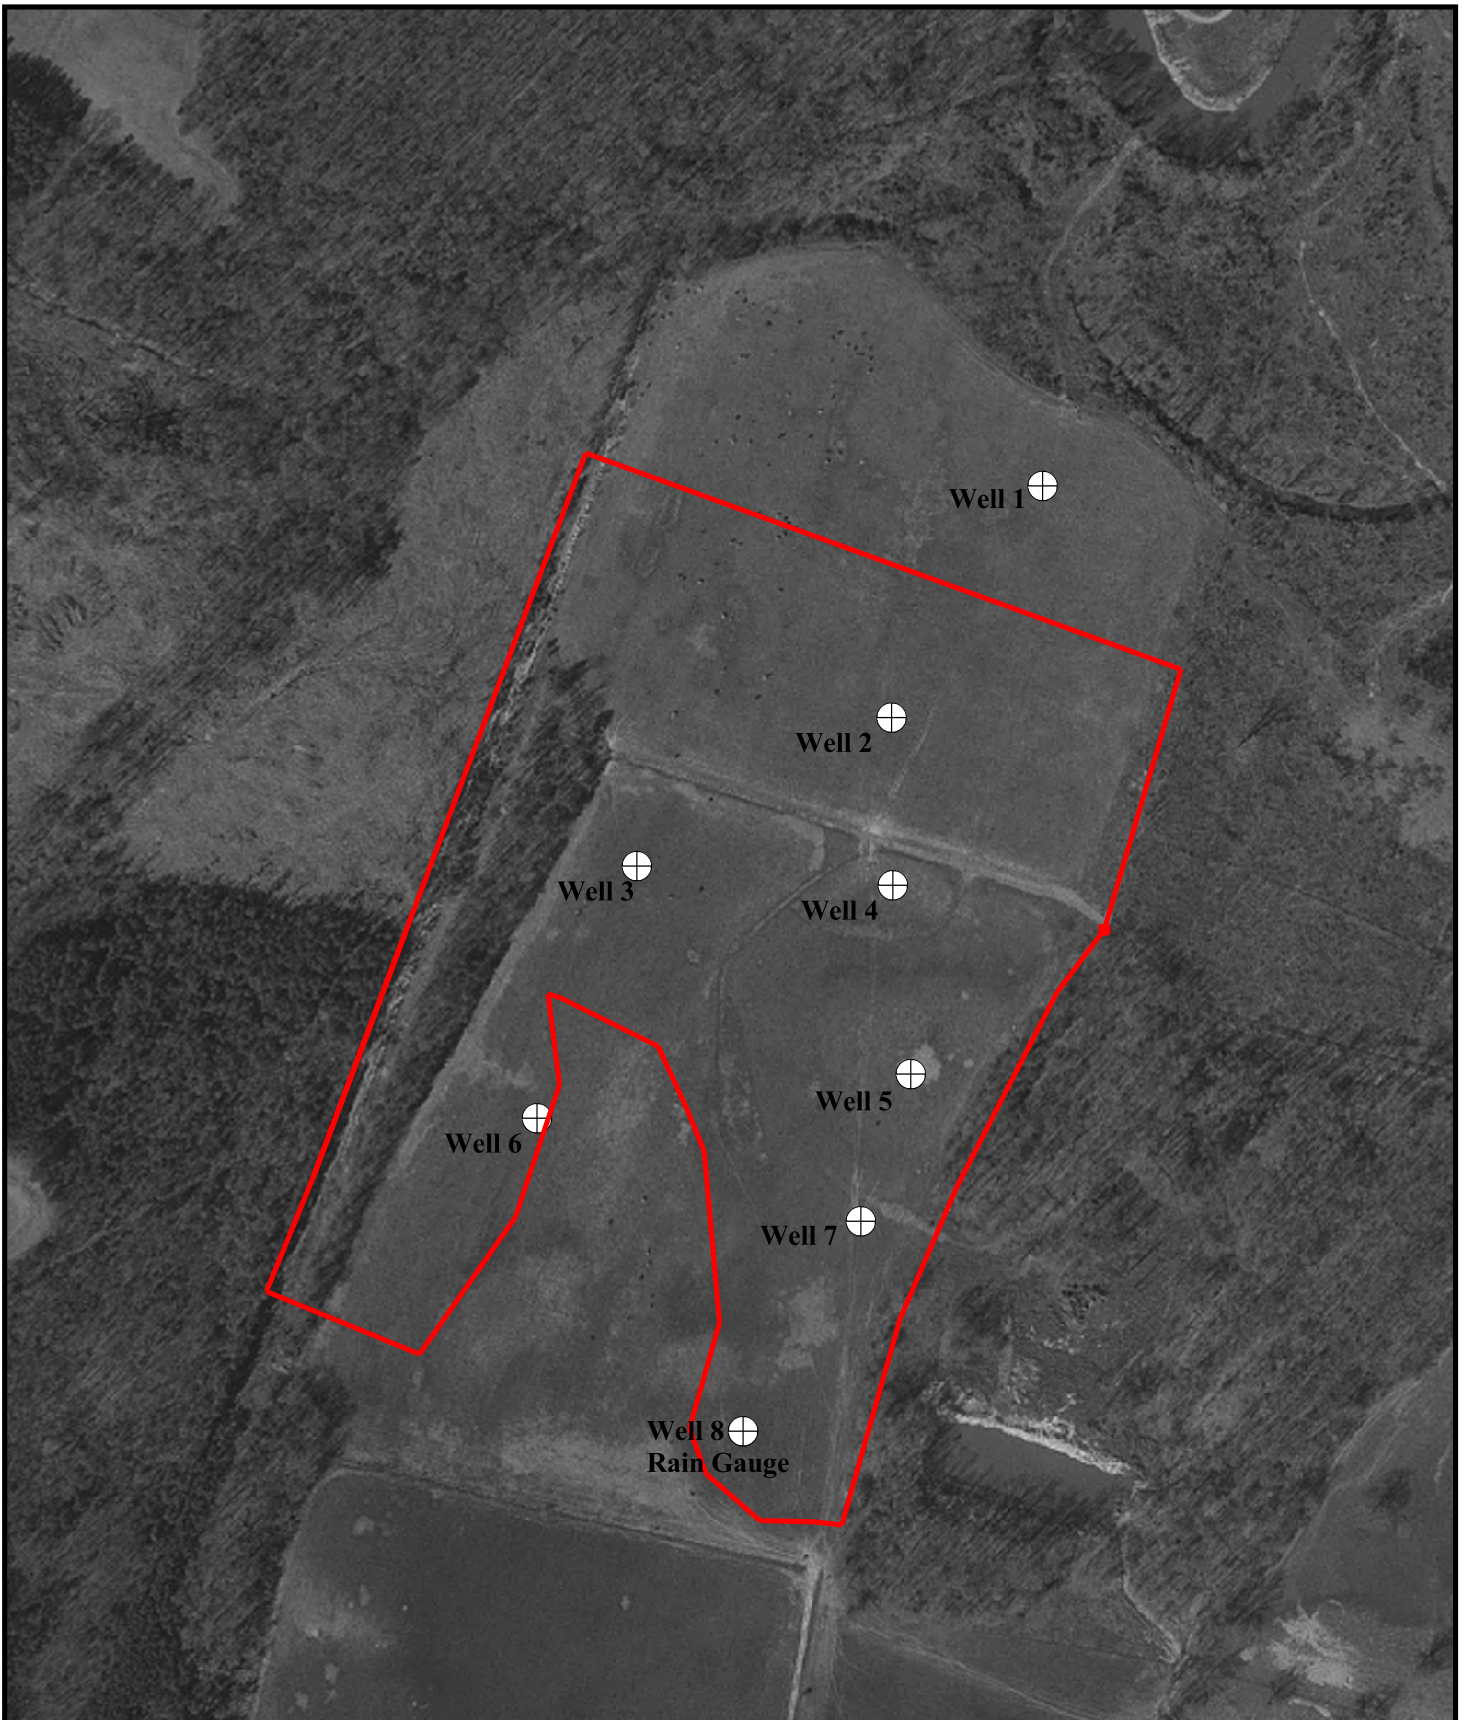
Figure 5. GW Monitoring Gauges

Well 1 is located north of the proposed restoration boundary near a sharp drop in slope away from the site. This drop appears to help drain the area quickly after rain events, even though well 1 is situated in Wahee soils which are classified as being somewhat poorly drained and slowly permeable. This results in many days of inundation within a foot of the surface, but few for periods of prolonged time (**Table 1**).

Well 2 is located within the site boundary north of the large lateral drainage ditch that flows west to east across the site. The area slopes slightly from north to south, toward the drainage ditch. Well 2 was placed in the Roanoke soil series, which is classified as being poorly drained and

Well 6 is further south and just upgradient of well 3 near the seep that creates the western border of the project site. Due to high elevation and close proximity to the seep, well 6 exhibits quick drainage compared with monitoring points found within the Roanoke series.

Well 8 is located inside the south east corner of the project site boundary in an area distinguished by a conglomeration of soils found on the project site, including Altavista, Augusta and Toisnot. Toisnot is a poorly drained, slowly permeable soil that causes this area to pond during rain events and keeps groundwater level consistently at or near the surface for extended periods following precipitation events.

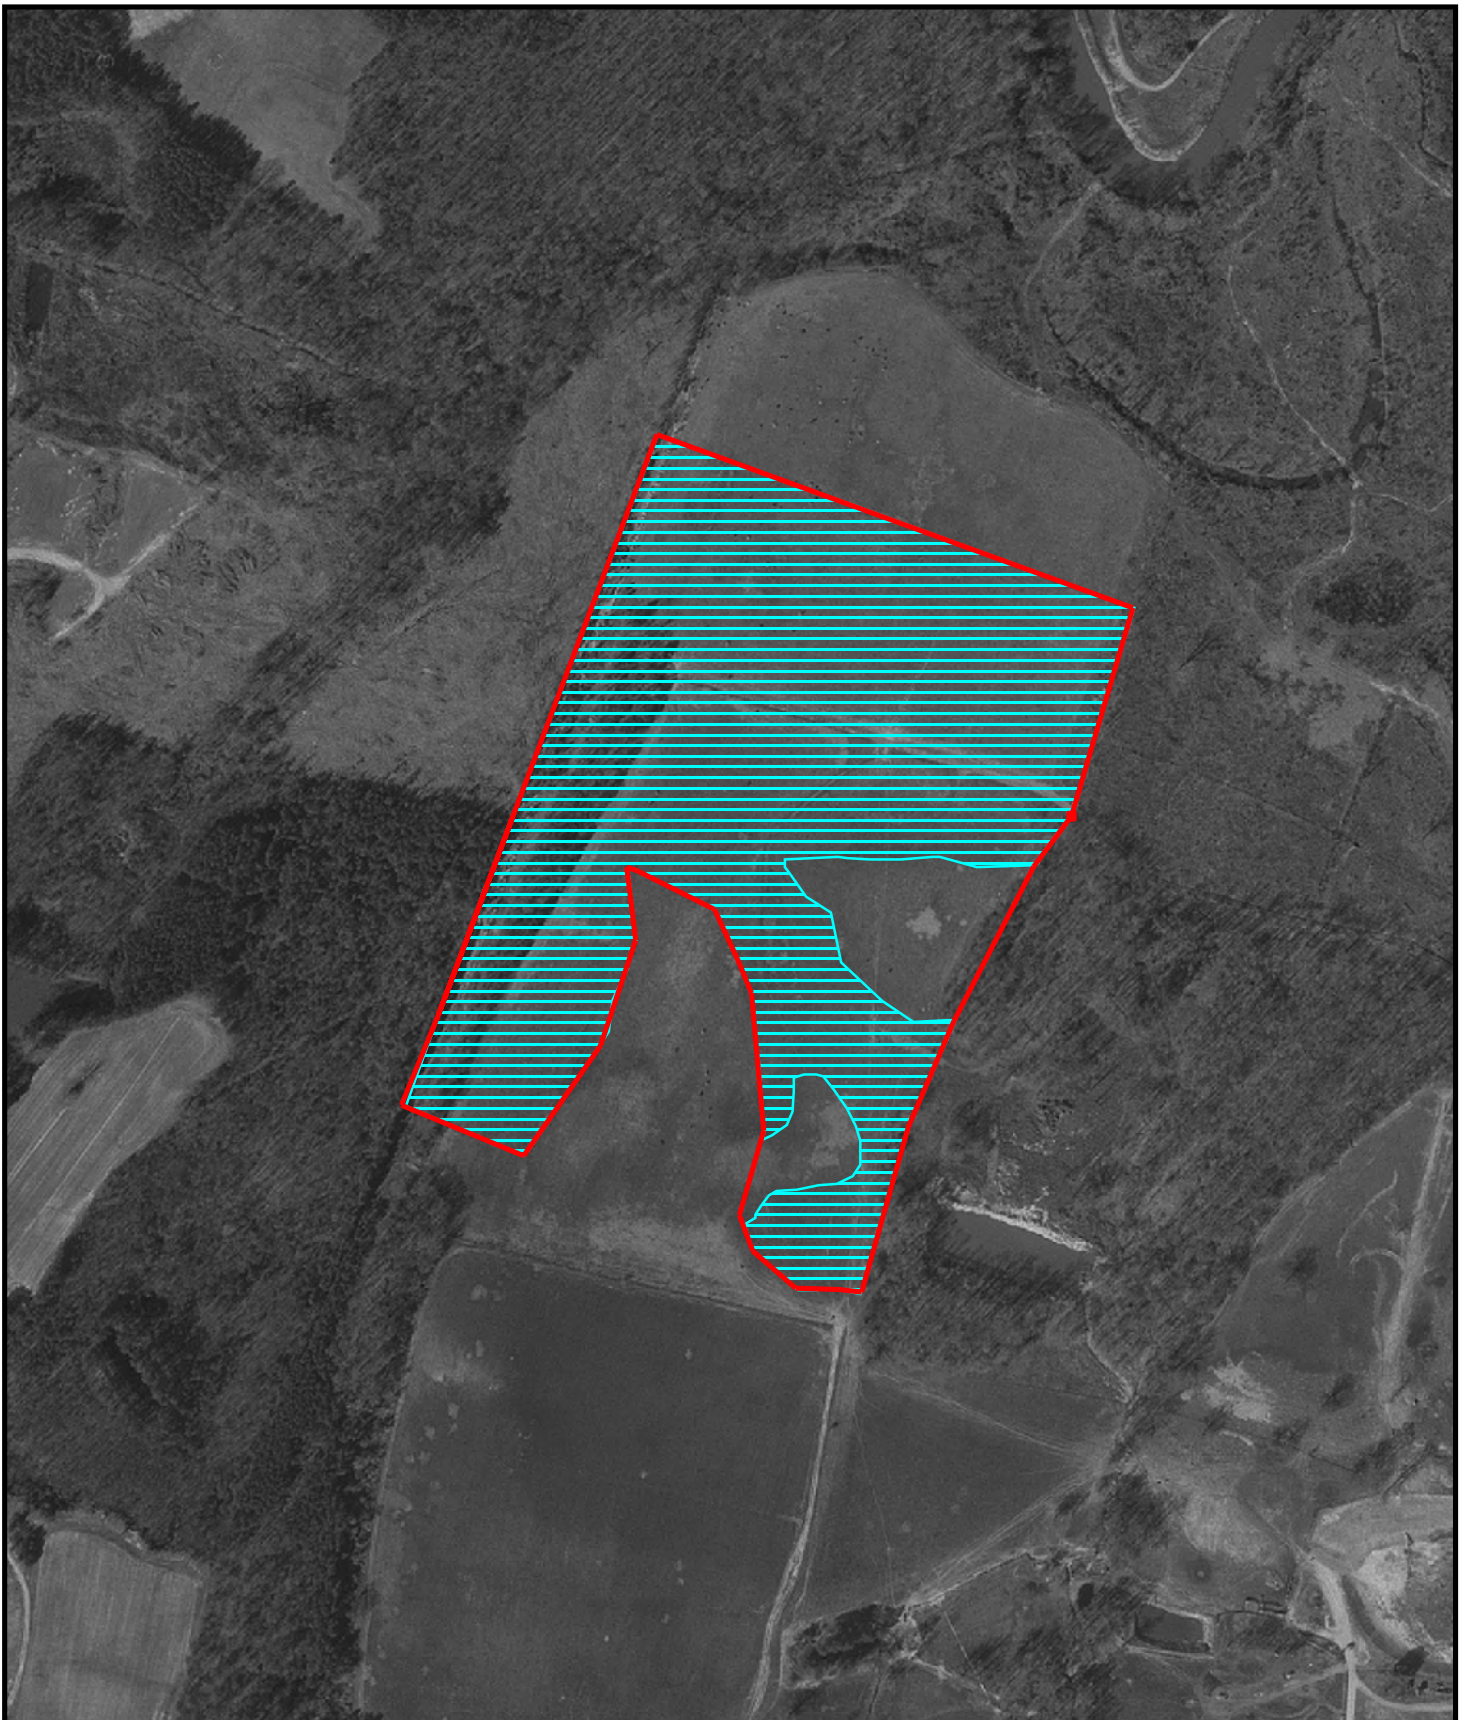
Figure 7. Limits of Hydric Soils

The Franklin County Soil Survey has classified the soils underlying the site as Altavista sandy loam, (59A). However, our findings (**Appendix E**) indicate that the Roanoke and Toisnot hydric soils comprise approximately 89 percent of the site, while Altavista, Augusta and other non-hydric inclusions cover approximately 11 percent of the site (**Figure 7**). All of these soil series are formed in alluvial sediments and are commonly found on terraces adjacent to better-drained soils. The following sections describe each soil series, in detail. The basic soil properties of each series are summarized in **Table 2**.

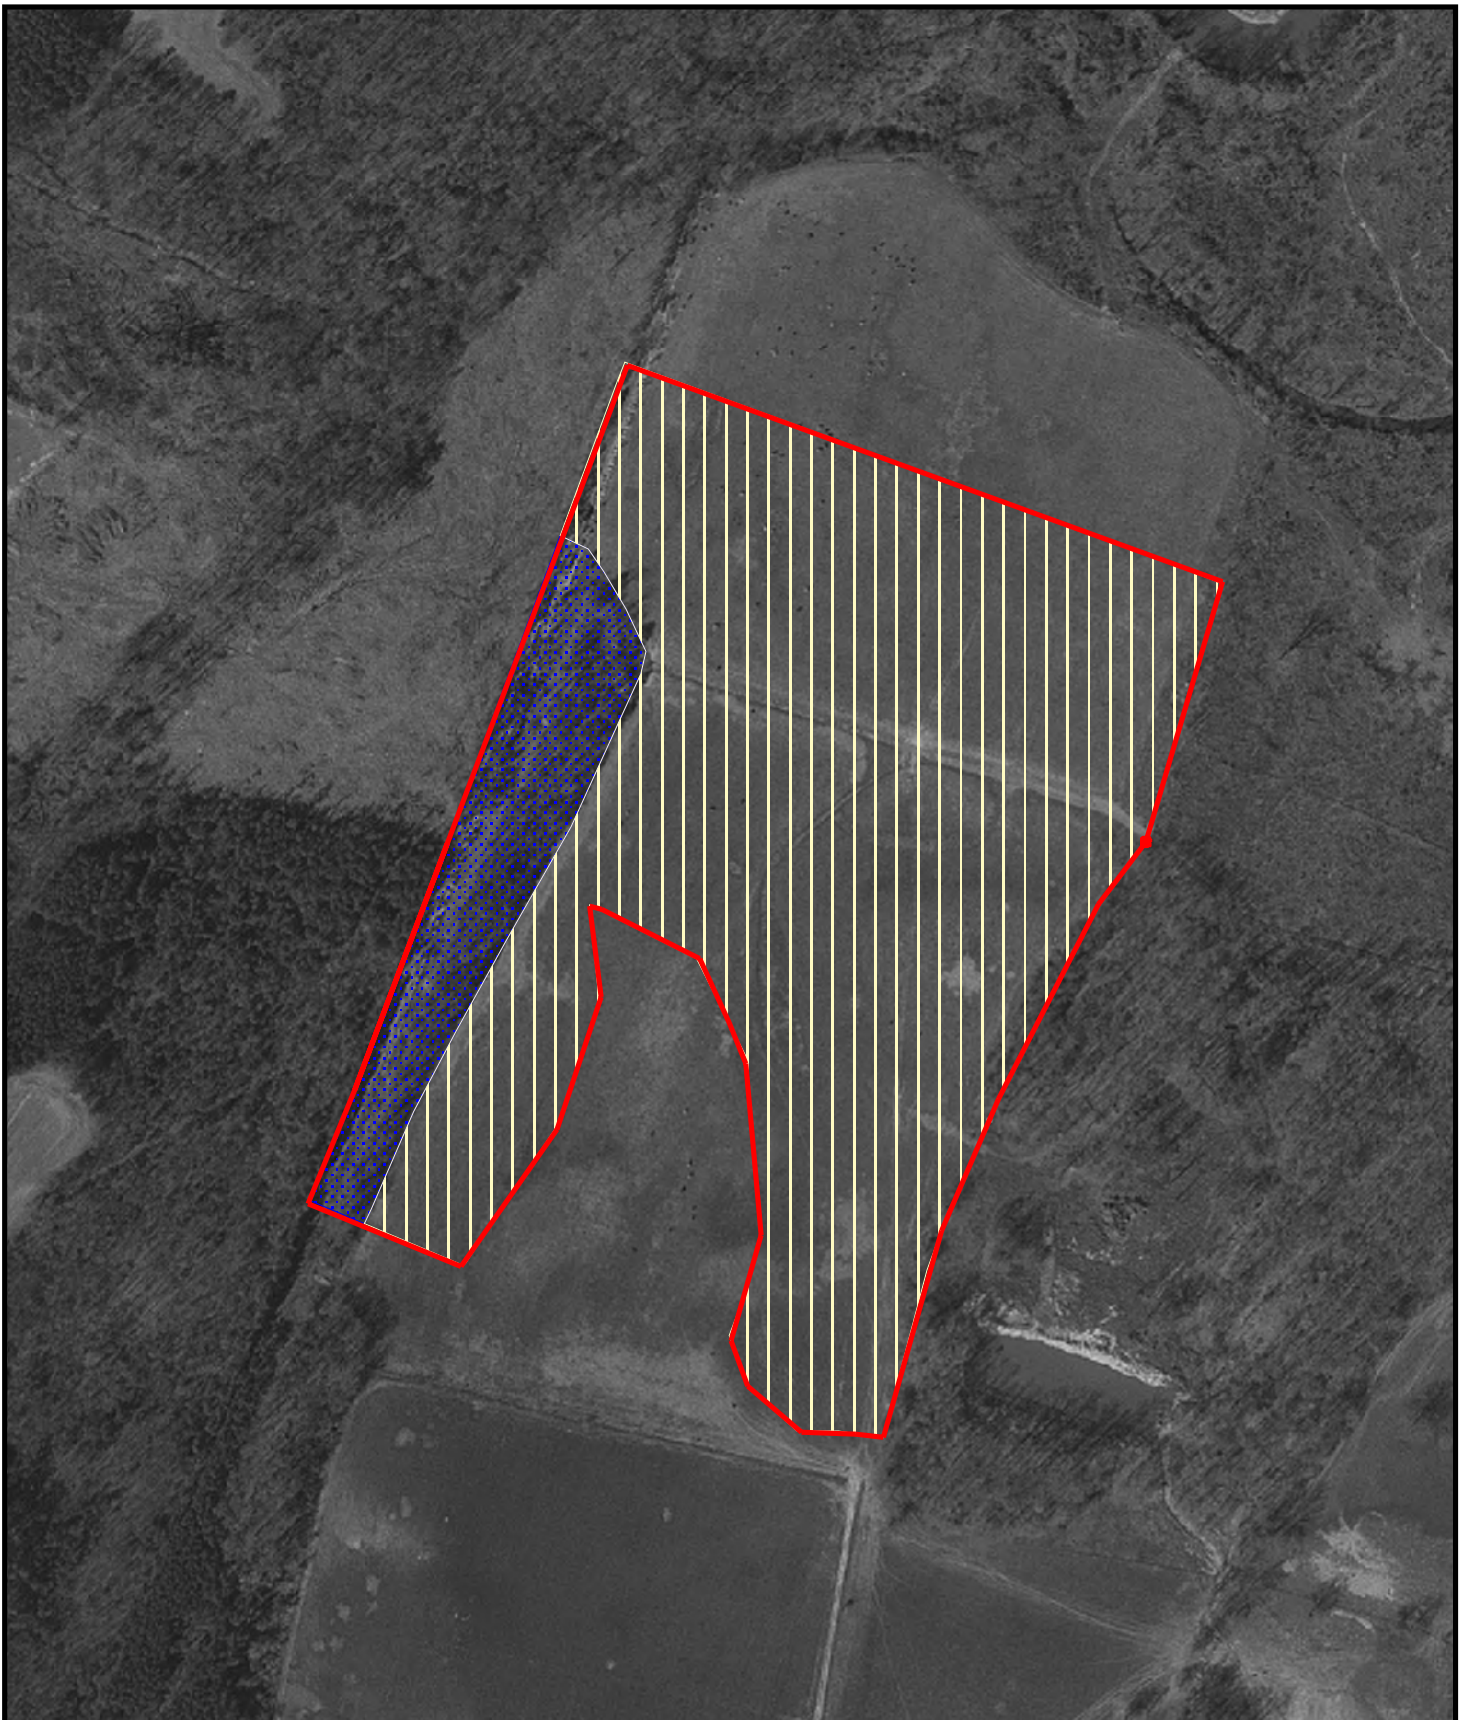
Figure 8. Existing Communities

Agriculture occupies the majority of the site, with pasture being the primary land use. Ditches are found around the perimeter of the agricultural fields to enhance drainage of water from the site and make the land more suitable for farming. Utilization of the site for agriculture has had significant impacts on the site. Ditches and grassed waterways have been created or enhanced to promote drainage through, around and off of the site to allow crop production on prior converted wetland areas. Clearing of the site has removed virtually all of the natural vegetative communities. All existing agricultural land, or 89% of the site, has been classified as prior converted wetland. The remaining 11% of the land should also qualify for restoration due to drainage and filling activities.

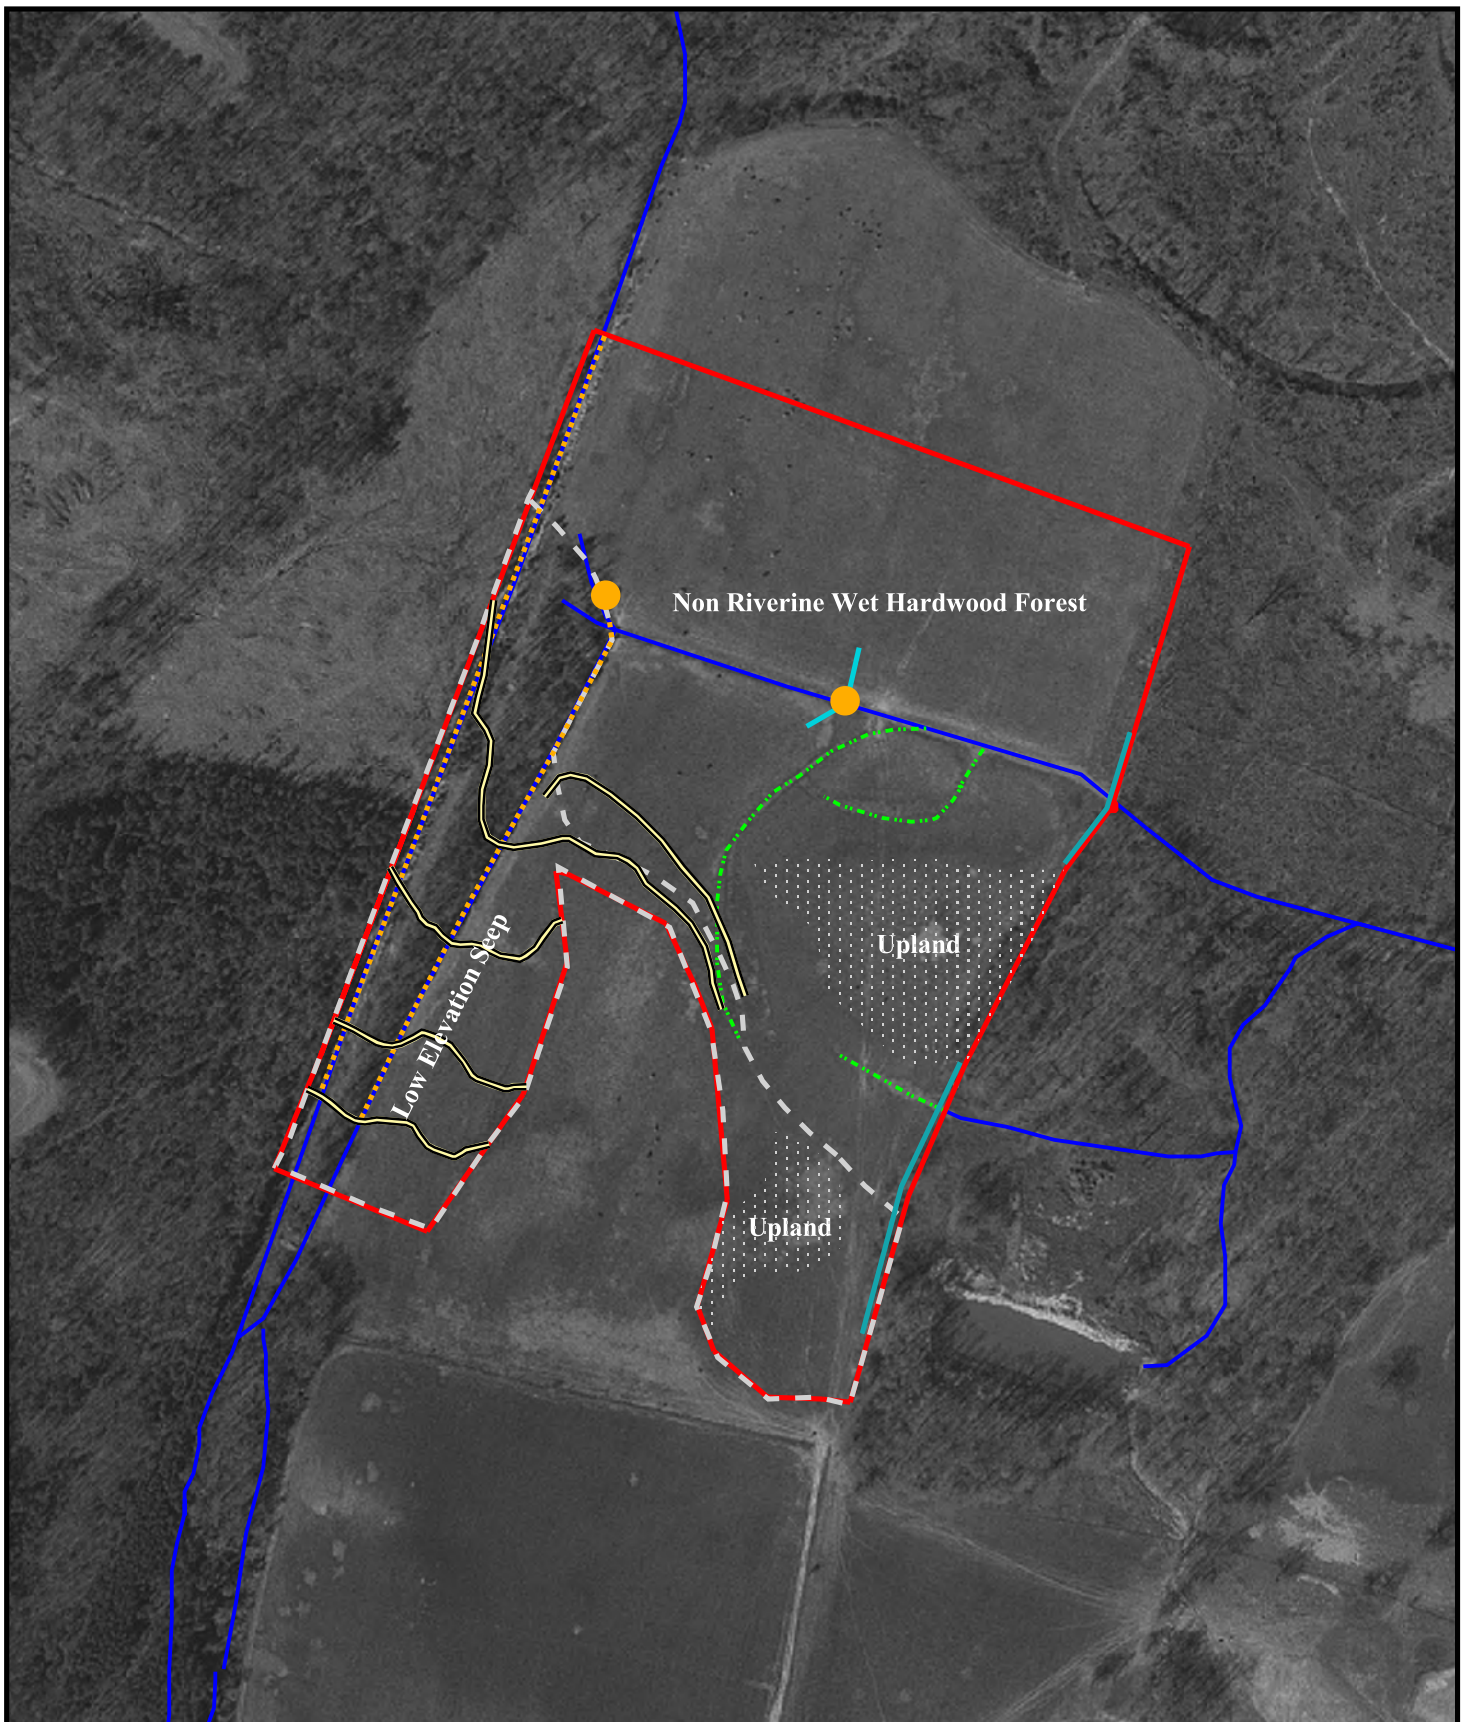
Figure 9. Restoration Activities

- Filling the primary drainage ditch along the western site boundary
- Filling the farm drainage ditch along the western site boundary
- Plugging the lateral ditch with a ditch plug
- Filling the grassed waterways
- Removing ditch spoil from wooded areas to restore natural seepage patterns
- Placing water diversion features, where appropriate, to redistribute the surface hydrology
- Placing restrictive berms, where appropriate, to reduce runoff and enhance infiltration
- Recreating microtopography across the site to enhance surface water retention and storage, and to provide amphibian breeding habitat where possible
- Disking the ground surface to reduce compaction from pastured cattle
- Re-vegetating the site with Low Elevation Seep and Nonriverine Wet Hardwood Forest species

Ditch Removal: Approximately two drainage ditches and three grassed waterways found on the site currently enhance the removal of seepage waters and precipitation. This drainage network will be filled or plugged as appropriate as part of restoration activities.

Fill Removal and Micro-topography Enhancement: Dredge spoils from ditching will be removed and replaced on the site to expose buried hydric soils and establish micro-topographic variations to enhance the retention of water from seepage and precipitation.

Redistribution of Surface Water: Water Diversion Features will be placed at planned contour intervals to enhance the retention of water from seepage and precipitation and to counteract the damage due to farm practices that promote soil disturbance, manipulation and ditching. The water diversion features will simulate a mature forest condition by diffusing surface water rather than concentrating sheet flow into erosive channels.
