Daniels Farm #1  
Wetland Restoration Site  
Franklin County, North Carolina

Tar-Pam 03020101  
Contract # AW03005

**Monitoring Report  
Year 4**

November 2007

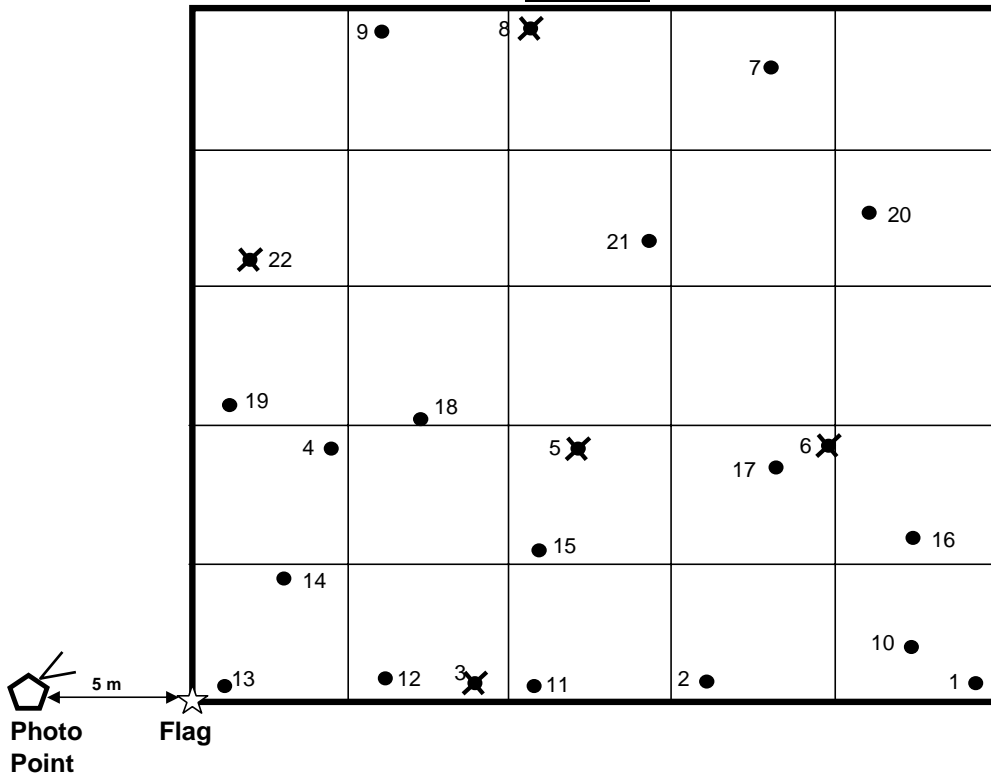
## Plot Map

ID	Species	Height (m)	Collar Diameter (cm)	Comments (insect damage, disease, browsing)
1	Laurel Oak ( <i>Quercus laurifolia</i> )	1.5	1.8	healthy
2	Swamp Chestnut Oak ( <i>Quercus michauxii</i> )	1.6	3.5	healthy
3	Swamp Black Gum ( <i>Nyssa sylvatica</i> )			dead
4	Swamp Chestnut Oak ( <i>Quercus michauxii</i> )	2.0	2.9	healthy
5	Swamp Black Gum ( <i>Nyssa sylvatica</i> )			dead
6	Swamp Chestnut Oak ( <i>Quercus michauxii</i> )			dead
7	Laurel Oak ( <i>Quercus laurifolia</i> )	1.4	1.6	healthy
8	Laurel Oak ( <i>Quercus laurifolia</i> )			dead
9	Laurel Oak ( <i>Quercus laurifolia</i> )	0.8	0.9	healthy
10	Green Ash ( <i>Fraxinus pennsylvanica</i> )	1.7	2.1	healthy
11	Swamp Chestnut Oak ( <i>Quercus michauxii</i> )	1.3	1.0	healthy
12	Swamp Chestnut Oak ( <i>Quercus michauxii</i> )	1.5	1.9	healthy
13	Cherrybark Oak ( <i>Quercus pagoda</i> )	1.5	1.5	healthy
14	Overcup Oak ( <i>Quercus lyrata</i> )	1.6	2.6	healthy

15	Overcup Oak ( <i>Quercus lyrata</i> )	1.7	2.4	healthy
16	Green Ash ( <i>Fraxinus pennsylvanica</i> )	1.7	2.2	healthy
17	Overcup Oak ( <i>Quercus lyrata</i> )	1.7	3.7	healthy
18	Overcup Oak ( <i>Quercus lyrata</i> )	1.5	2.5	healthy
19	Swamp Chestnut Oak ( <i>Quercus michauxii</i> )	0.3	0.3	resprout from the base
20	Overcup Oak ( <i>Quercus lyrata</i> )	1.7	3.3	healthy
21	Overcup Oak ( <i>Quercus lyrata</i> )	1.9	2.6	healthy
22	Overcup Oak ( <i>Quercus lyrata</i> )			dead

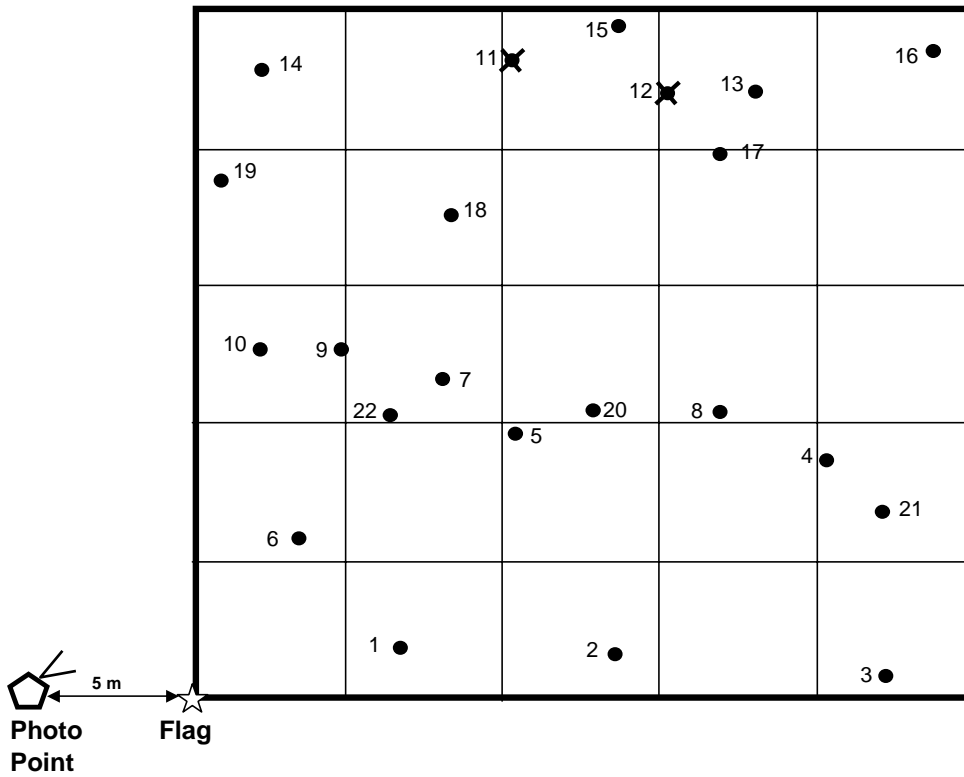
## Plot Map

ID	Species	Height (m)	Collar Diameter (cm)	Comments (insect damage, disease, browsing)
1	Willow Oak ( <i>Quercus phellos</i> )	0.9	1.7	healthy
2	Willow Oak ( <i>Quercus phellos</i> )	0.8	1.2	healthy
3	Willow Oak ( <i>Quercus phellos</i> )	1.0	1.4	healthy
4	Swamp Black Gum ( <i>Nyssa sylvatica</i> )	0.6	1.2	healthy
5	Swamp Chestnut Oak ( <i>Quercus michauxii</i> )	0.7	0.8	healthy
6	Swamp Black Gum ( <i>Nyssa sylvatica</i> )	0.8	1.3	healthy
7	Swamp Chestnut Oak ( <i>Quercus michauxii</i> )	1.9	2.1	healthy
8	Willow Oak ( <i>Quercus phellos</i> )	2.6	3.4	healthy
9	Swamp Chestnut Oak ( <i>Quercus michauxii</i> )	2.1	2.4	healthy
10	Swamp Black Gum ( <i>Nyssa sylvatica</i> )	0.8	2.1	healthy
11	Swamp Black Gum ( <i>Nyssa sylvatica</i> )			dead
12	Swamp Chestnut Oak ( <i>Quercus michauxii</i> )			dead
13	Swamp Black Gum ( <i>Nyssa sylvatica</i> )	0.9	2.6	healthy
14	Laurel Oak ( <i>Quercus laurifolia</i> )	0.5	0.8	healthy

15	Swamp Chestnut Oak ( <i>Quercus michauxii</i> )	1.6	1.9	healthy
16	Overcup Oak ( <i>Quercus lyrata</i> )	1.7	2.8	healthy
17	Green Ash ( <i>Fraxinus pennsylvanica</i> )	2.1	3.1	healthy
18	Overcup Oak ( <i>Quercus lyrata</i> )	1.9	4.2	healthy
19	Overcup Oak ( <i>Quercus lyrata</i> )	1.4	1.9	healthy
20	Cherrybark Oak ( <i>Quercus pagoda</i> )	0.9	1.0	healthy
21	Cherrybark Oak ( <i>Quercus pagoda</i> )	0.4	0.7	healthy
22	Overcup Oak ( <i>Quercus lyrata</i> )	0.9	1.1	healthy

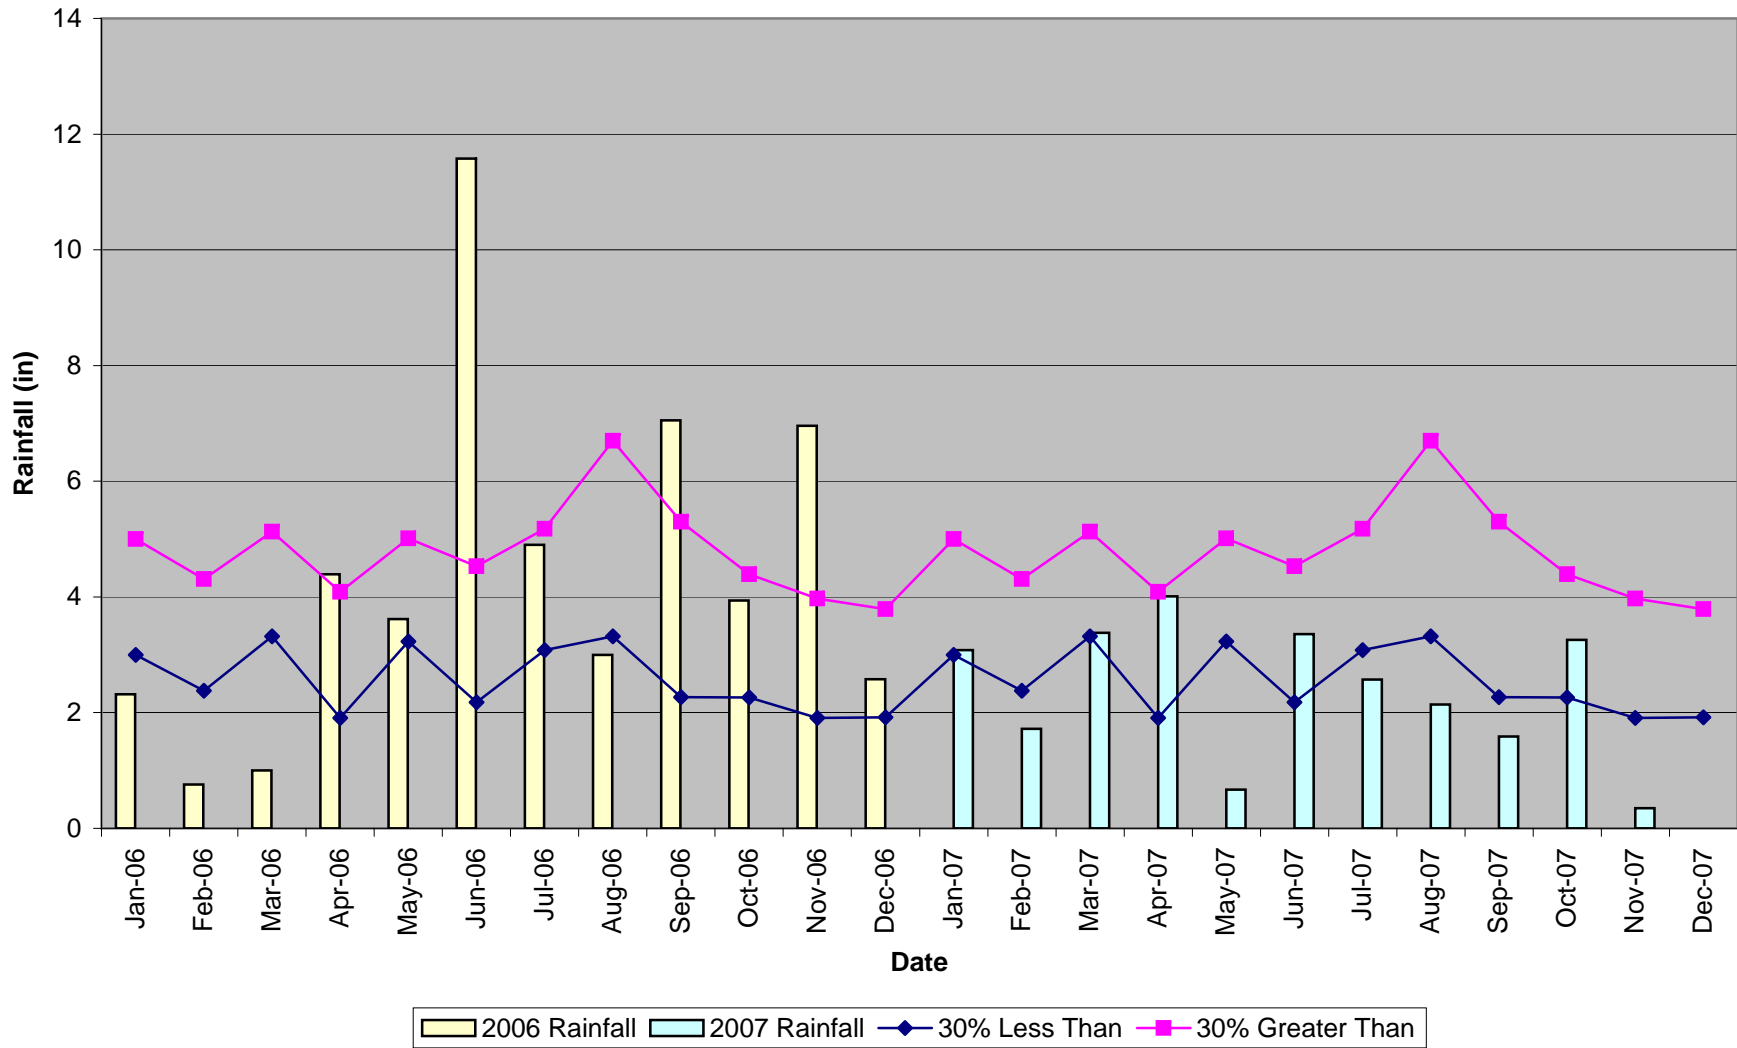
**Daniels Property 30-70 Percentile Graph 2006-2007**  
**Louisburg, NC Monthly Rainfall**

Site climatic data for the 2007 growing season were analyzed in comparison to historical data to determine whether 2007 was a normal year in terms of climatic conditions. This step is as a precursor to validating the results of the wetland monitoring. The historical data were collected from the NRCS, Water and Climate Center, "Climate Analysis for Wetlands by County" website. This evaluation concluded that 2007 was a below average year for rainfall during the growing season. The rainfall data from 2007 indicates that every month was below the 30<sup>th</sup> percentile of average rainfall for each month (Appendix B). The piedmont of North Carolina experienced an exceptional drought during the 2007 growing season. This is reflected in the shorter hydroperiod for the site when compared to previous monitoring data. The fact that the project site maintained wetland hydrology during this drought illustrates how strong the groundwater influence is.

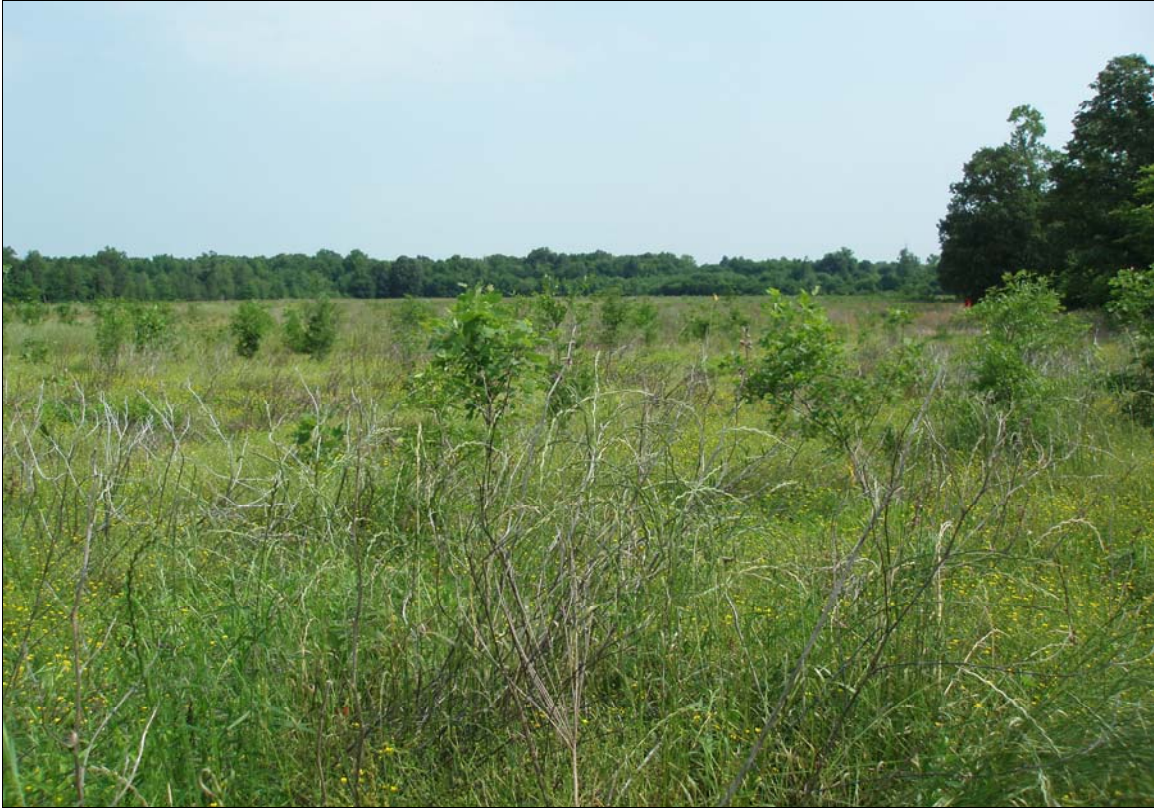
Photo Location 1: View looking toward vegetation plot #8 identified by flag. 5/30/07 - MY04

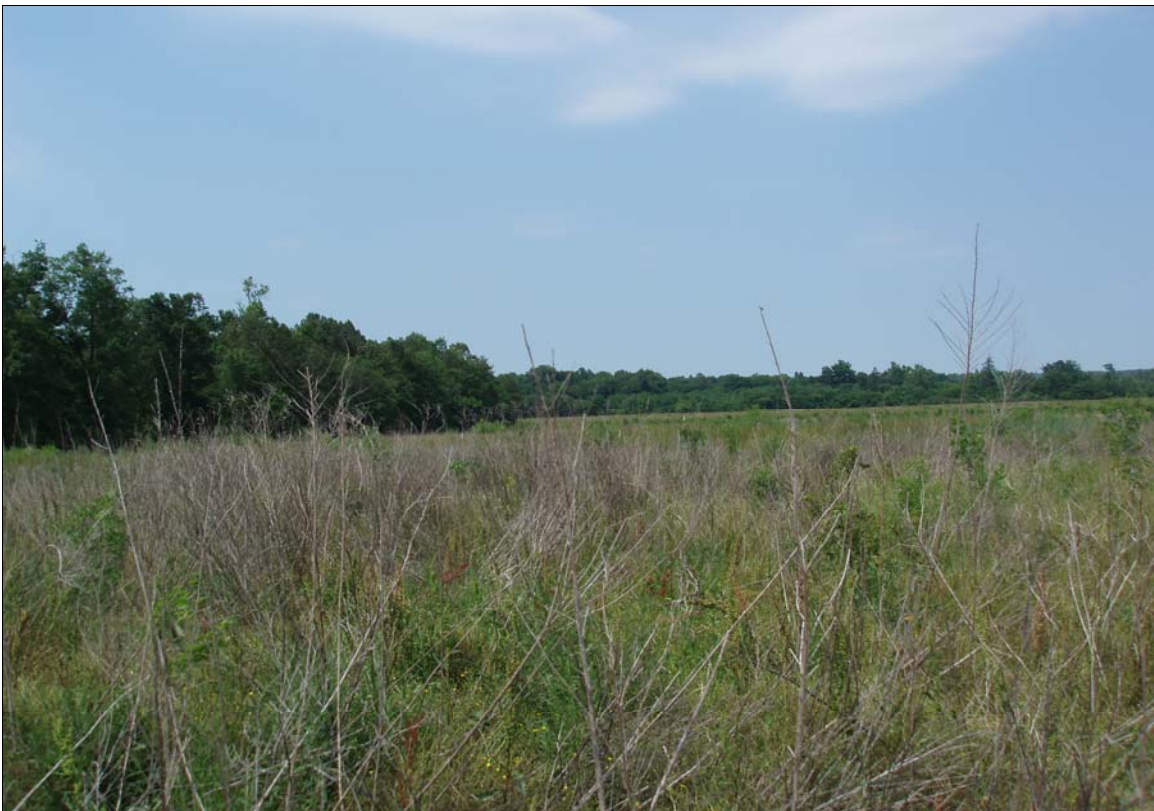
Photo Location 2: View looking toward vegetation plot #1. 5/30/07 - MY04

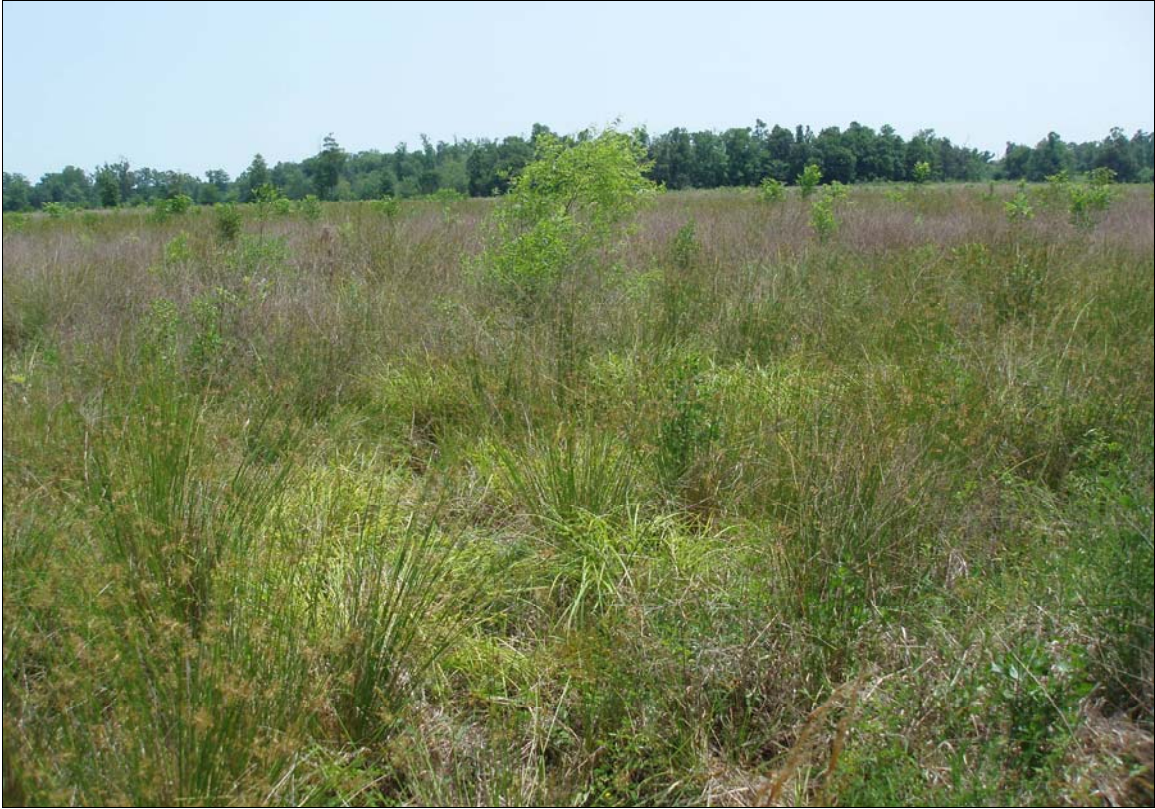
Photo Location 3: View looking toward vegetation plot #4. 5/30/07 - MY04

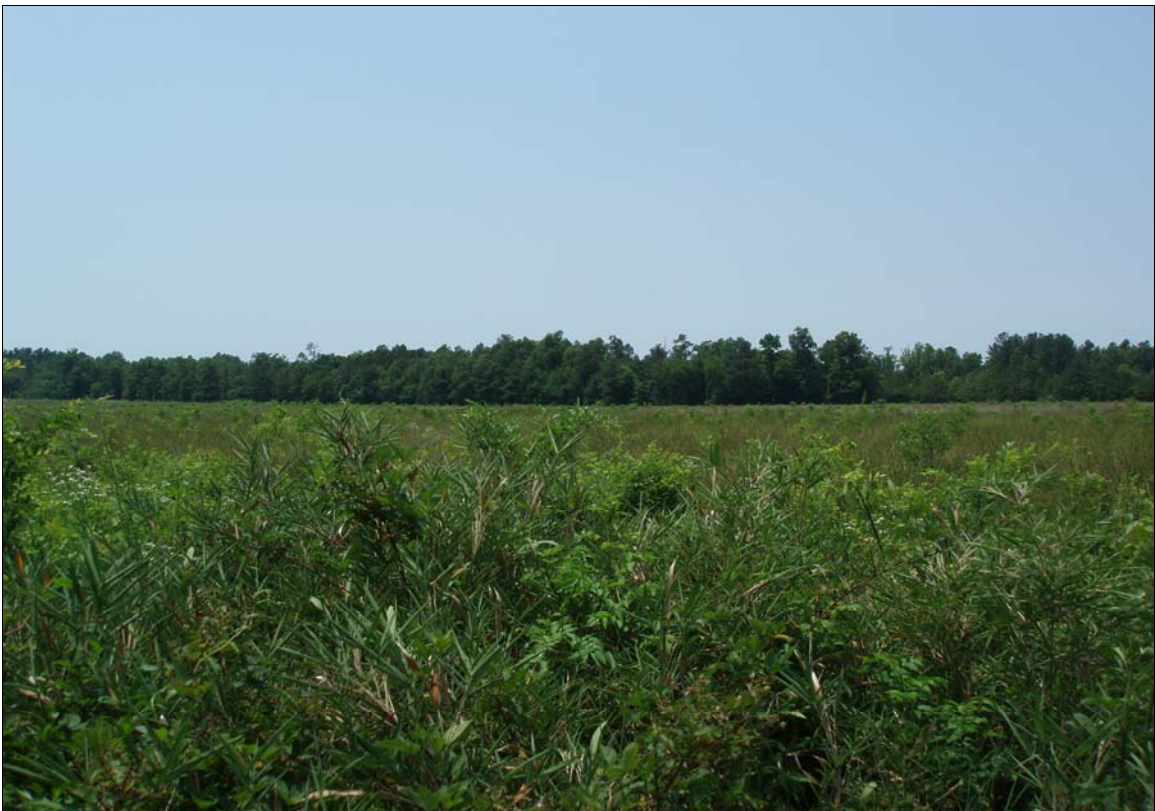
Photo Location 4: View looking toward vegetation plot #5. 5/30/07 - MY04

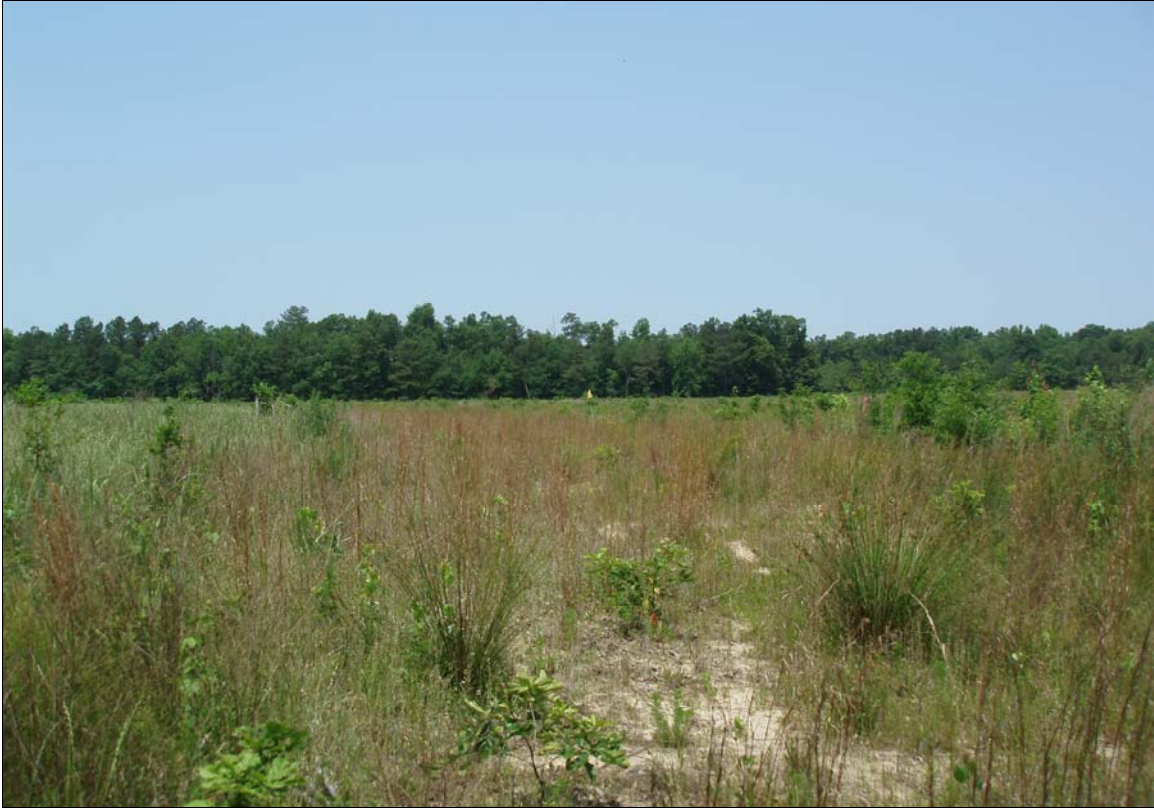
Photo Location 5: View looking toward vegetation plot #6 identified by the yellow flag. The upland area shown to the left of the yellow flag is non-wetland. 5/30/07 - MY04
