**Daniels Farm #2 Wetland Restoration Site  
Franklin County, North Carolina**

***Wetland Restoration Plan***

**Contract No. D05025**

**North Carolina Ecosystem Enhancement Program**

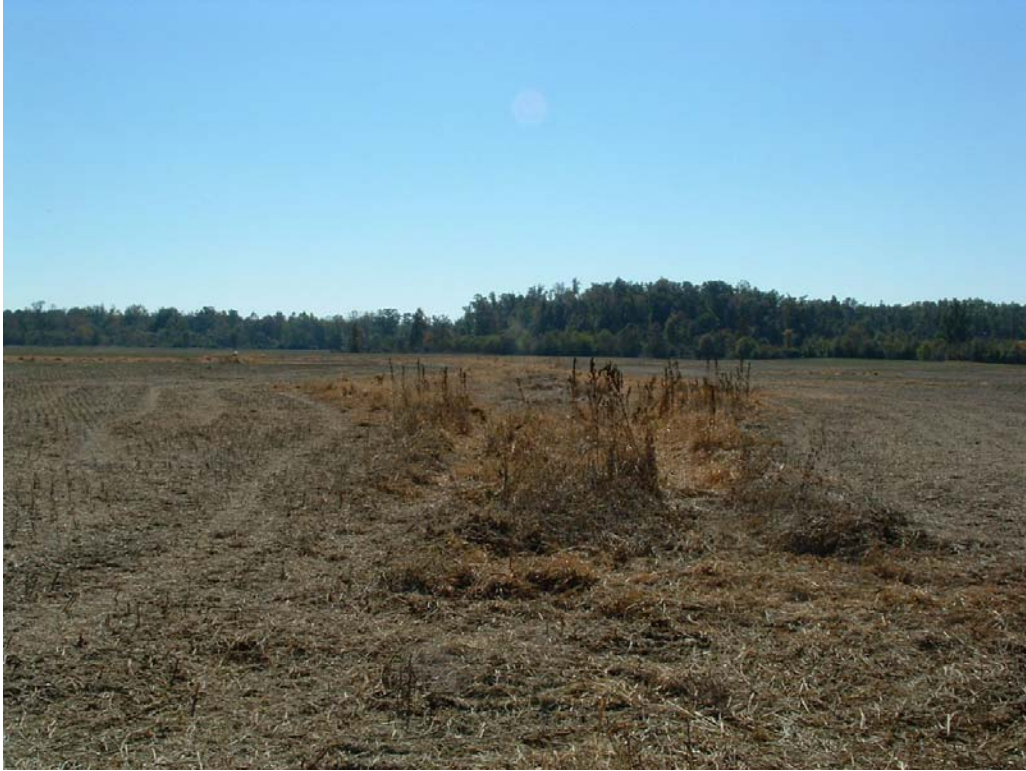
Restoration Site #1: Top of agricultural field looking south toward unknown tributary to the Tar River.

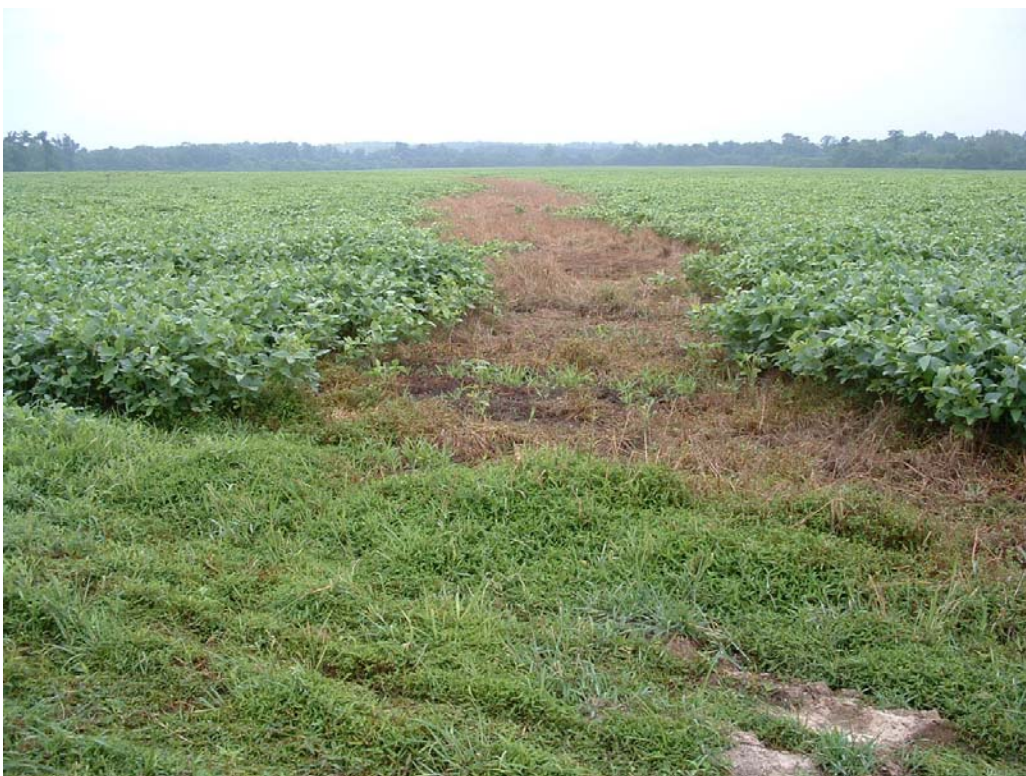
Restoration Site #1: Bottom of site where grassed waterway exits, crosses dirt road and enters unknown tributary to the Tar River.

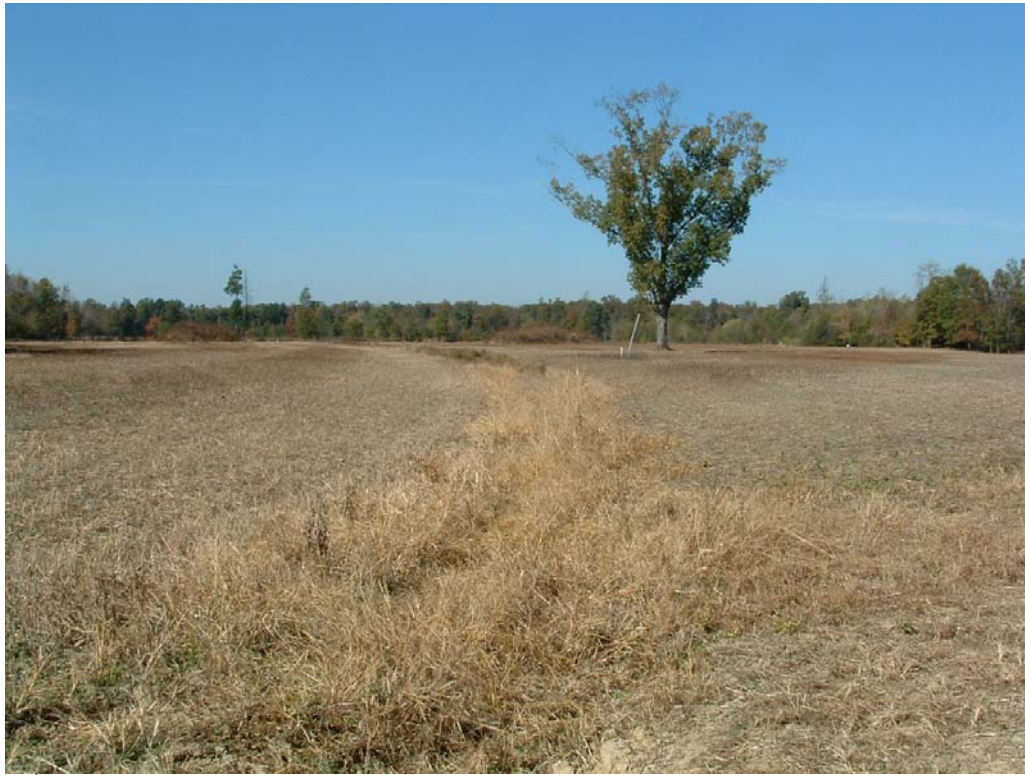
Directly east of agricultural field where the ditch drains into the unknown tributary of the Tar River (Restoration Wetland #2).

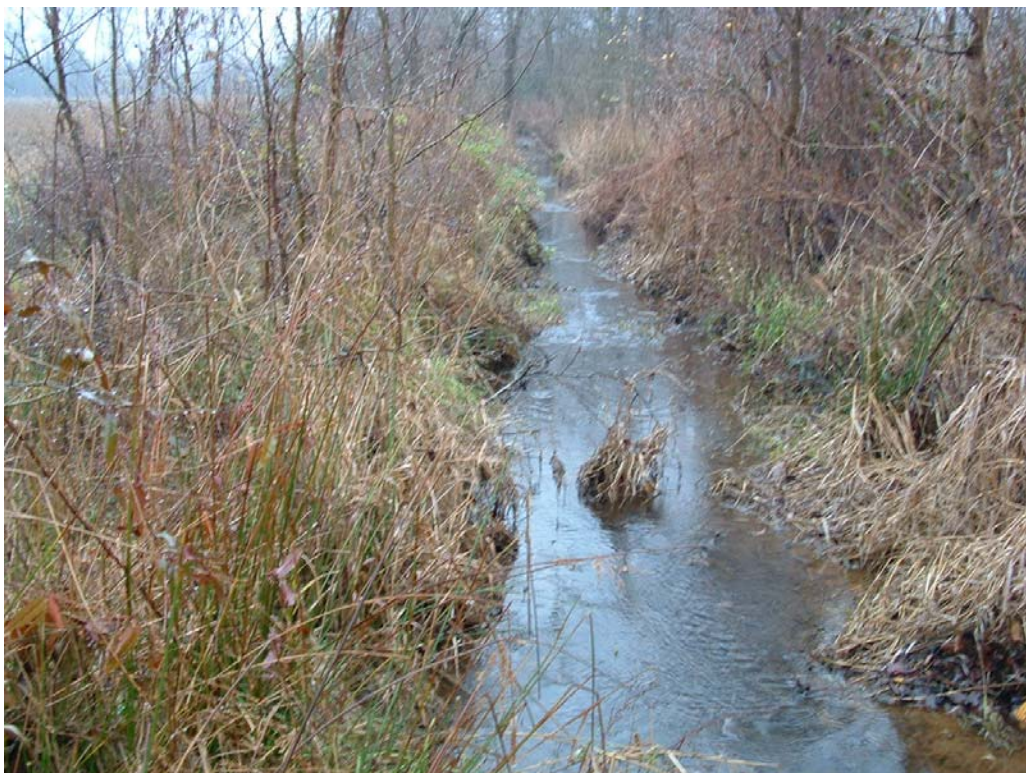
Looking downstream (east) along Ditch #2 that will be filled during the restoration project. Restoration Wetland #2 is on either side of this ditch.

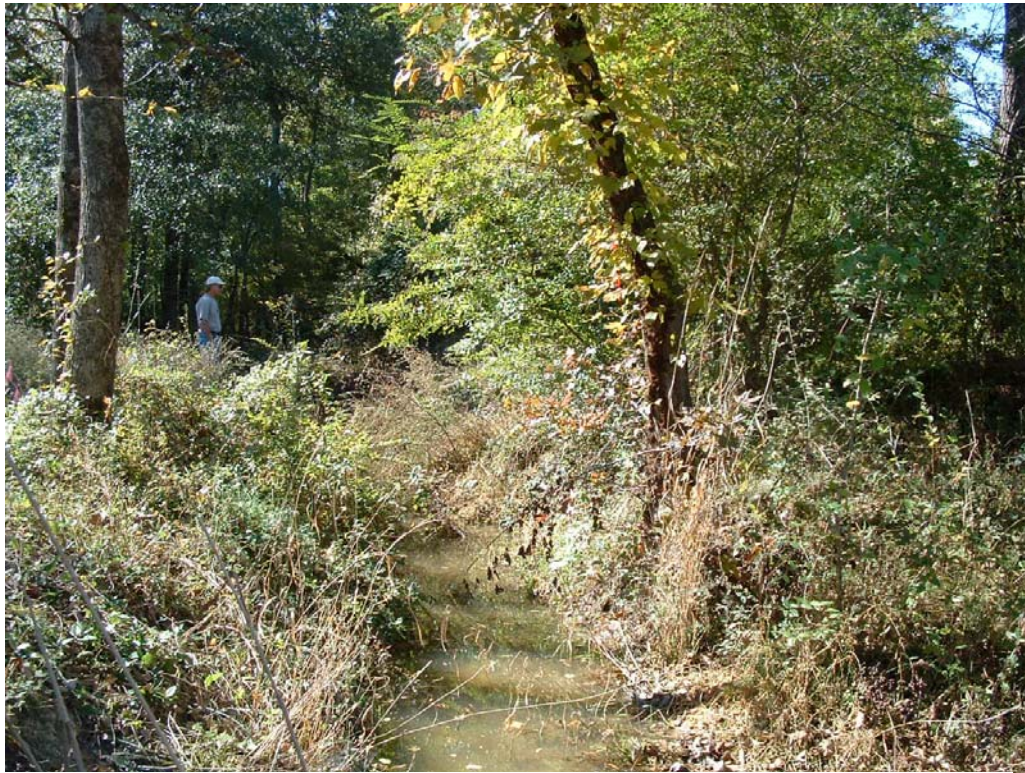
Looking upstream (south) along unnamed tributary to the Tar River, upstream of the confluence with Ditch #2.

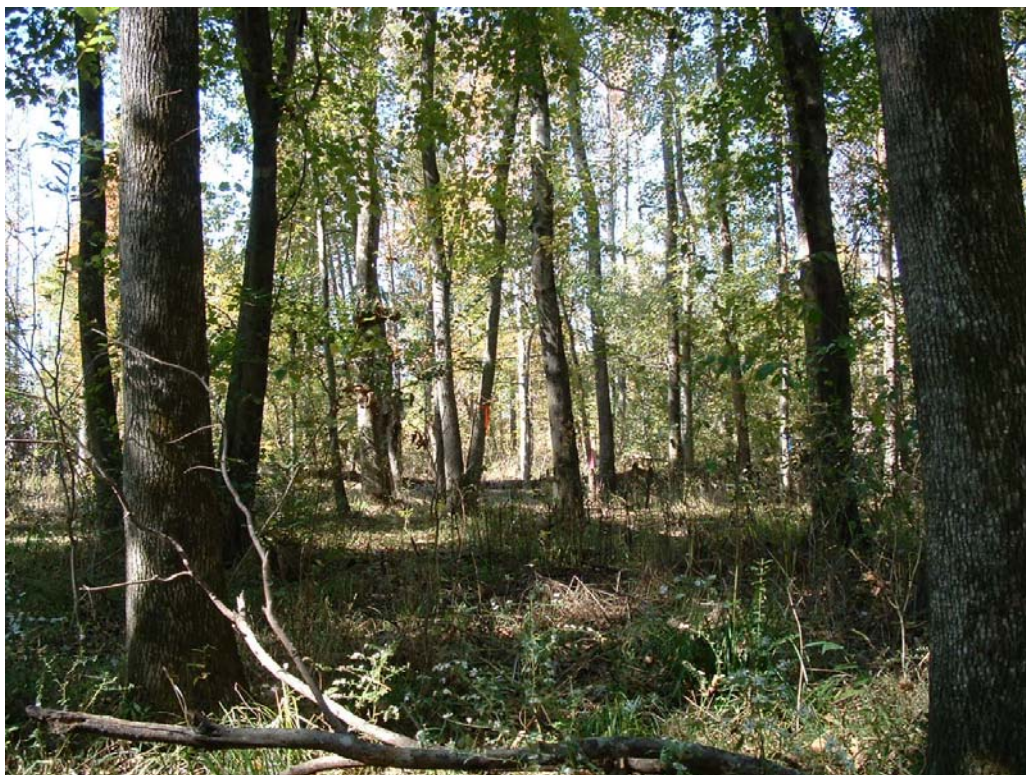
Enhancement Site #3: Forested wetland area contains mature wetland vegetation, but could benefit from hydrologic enhancements.

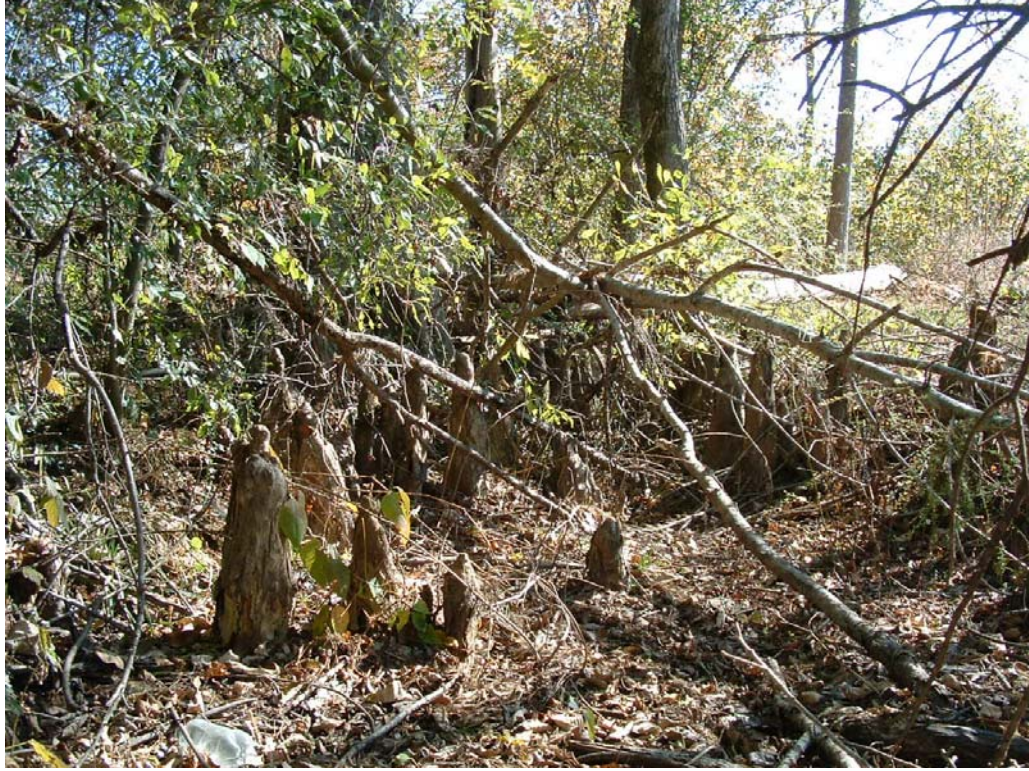
Cypress knees in Enhancement Wetland #3.

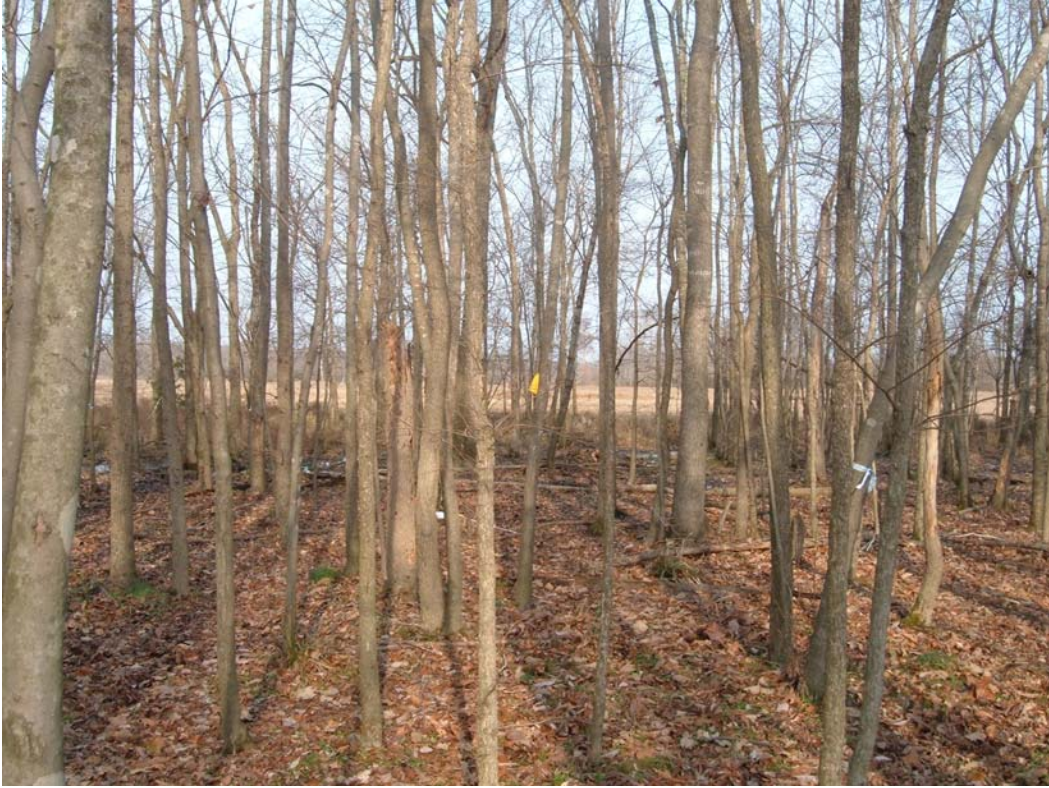
Reference wetland looking north (Restoration Wetland #2 in background).

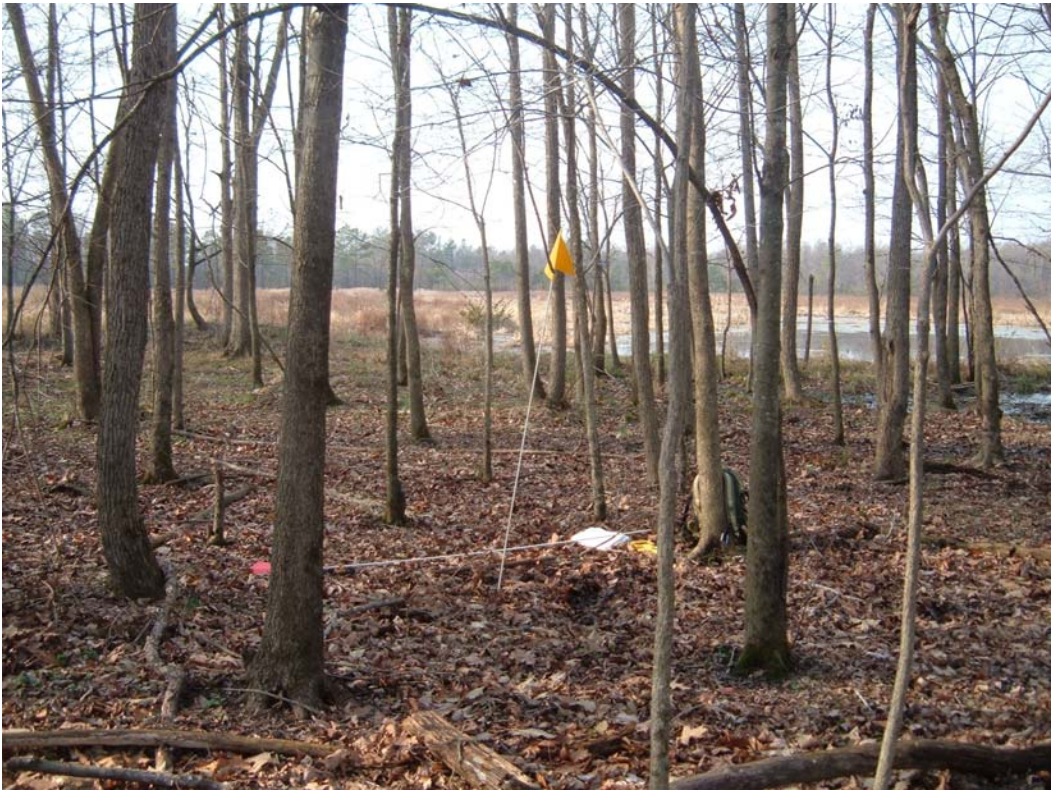
Reference wetland looking west toward the Daniels I Restoration Project.
