Daniels Farm #2
Wetland Restoration Site
Franklin County, North Carolina

Tar-Pam 03020101
Contract # D05025

**Monitoring Report
Year 3**

December 2008

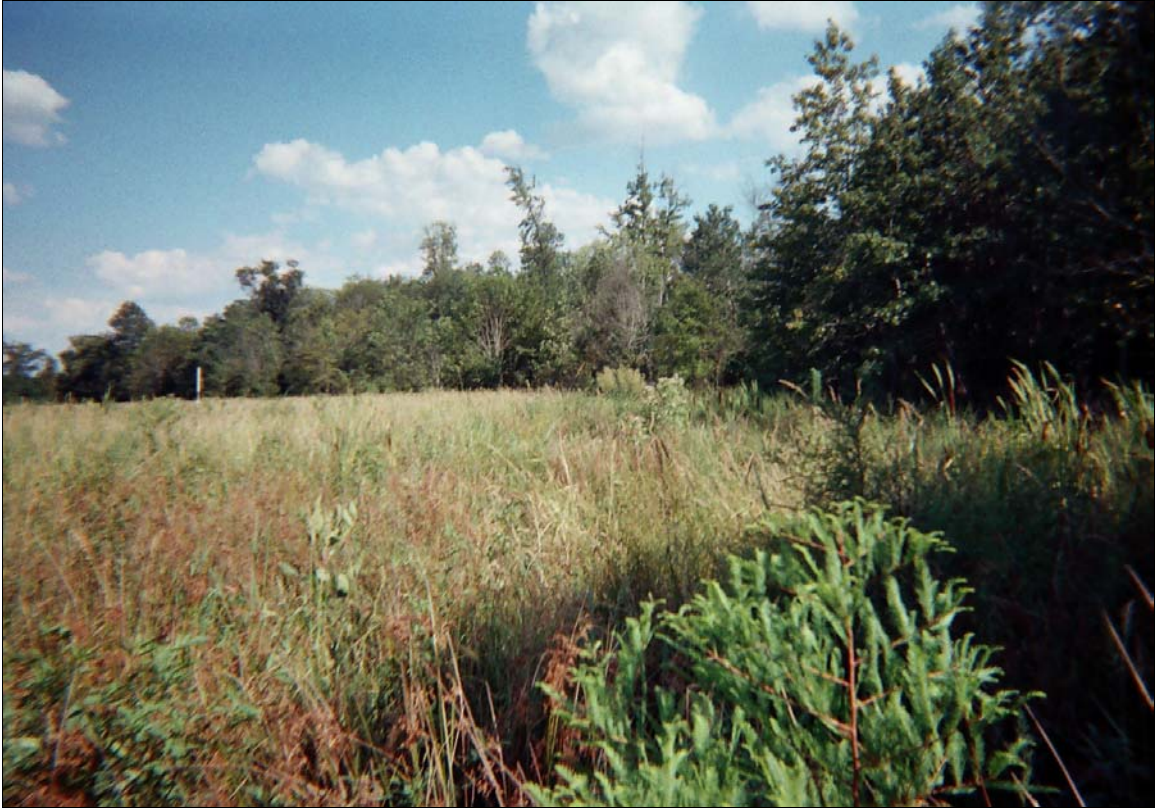
Photo Point 3A: View looking east toward Vegetation Plot # 5. 8/8/08 – MY03

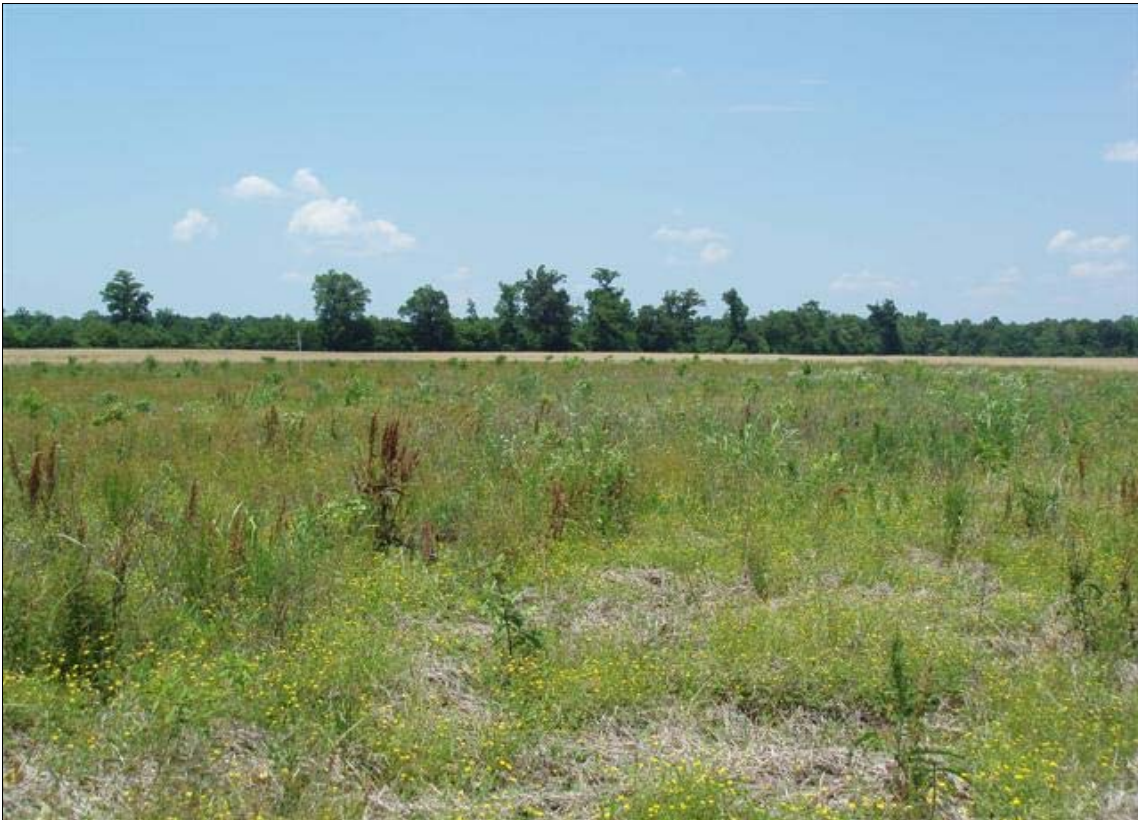
Photo Point 6A: View looking northwest toward Vegetation Plot #6. 8/8/08 – MY03
