ANNUAL REPORT FOR 1999

Dowd Dairy Farm Mitigation Site
Bladen County
Project No. 8.1241802
TIP No. R-2204 WM

Prepared By:
Natural Systems Unit &
Roadside Environmental Unit
North Carolina Department of Transportation
December 1999

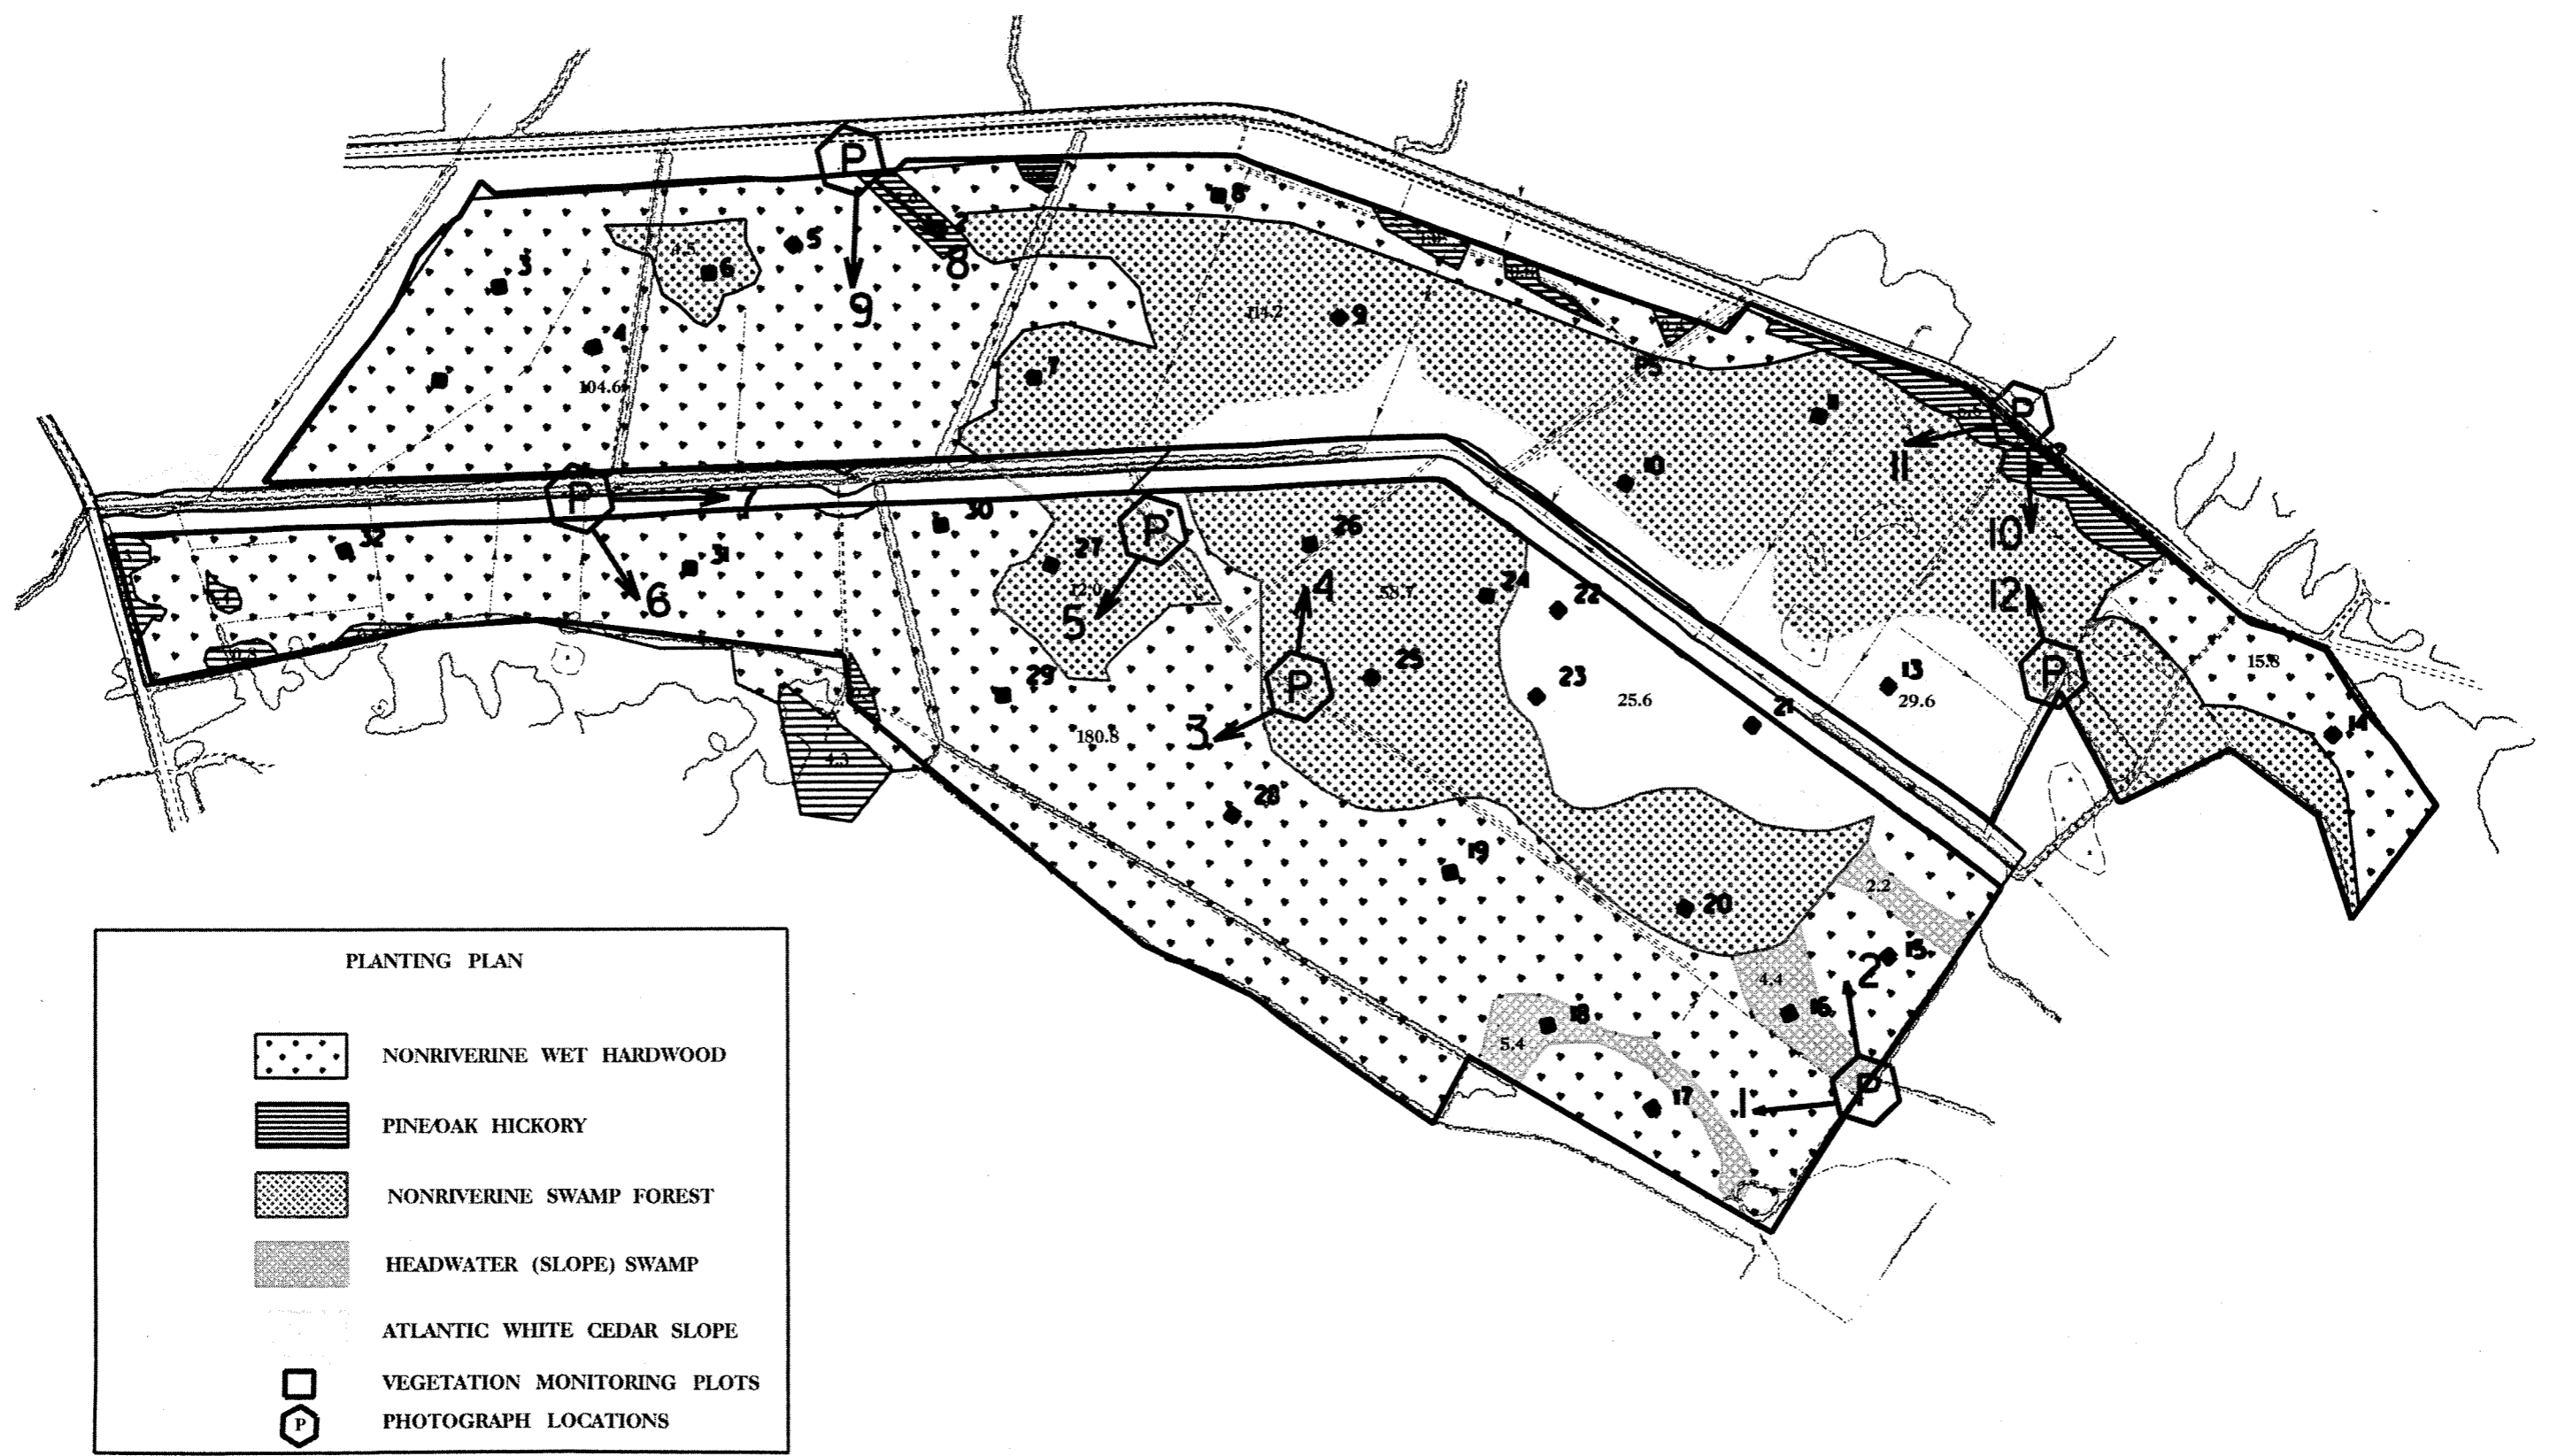
PHOTO AND VEGETATION PLOT LOCATIONS

DOWD DAIRY FARM MITIGATION PLANTING PLAN PHASE I
