ANNUAL REPORT FOR 2001

**DOWD DAIRY FARM MITIGATION SITE
BLADEN COUNTY
PROJECT NO. 8.1241802
TIP NO. R-2204WM**

Prepared By:
Natural Systems Unit & Roadside Environmental Unit
North Carolina Department of Transportation
December 2001

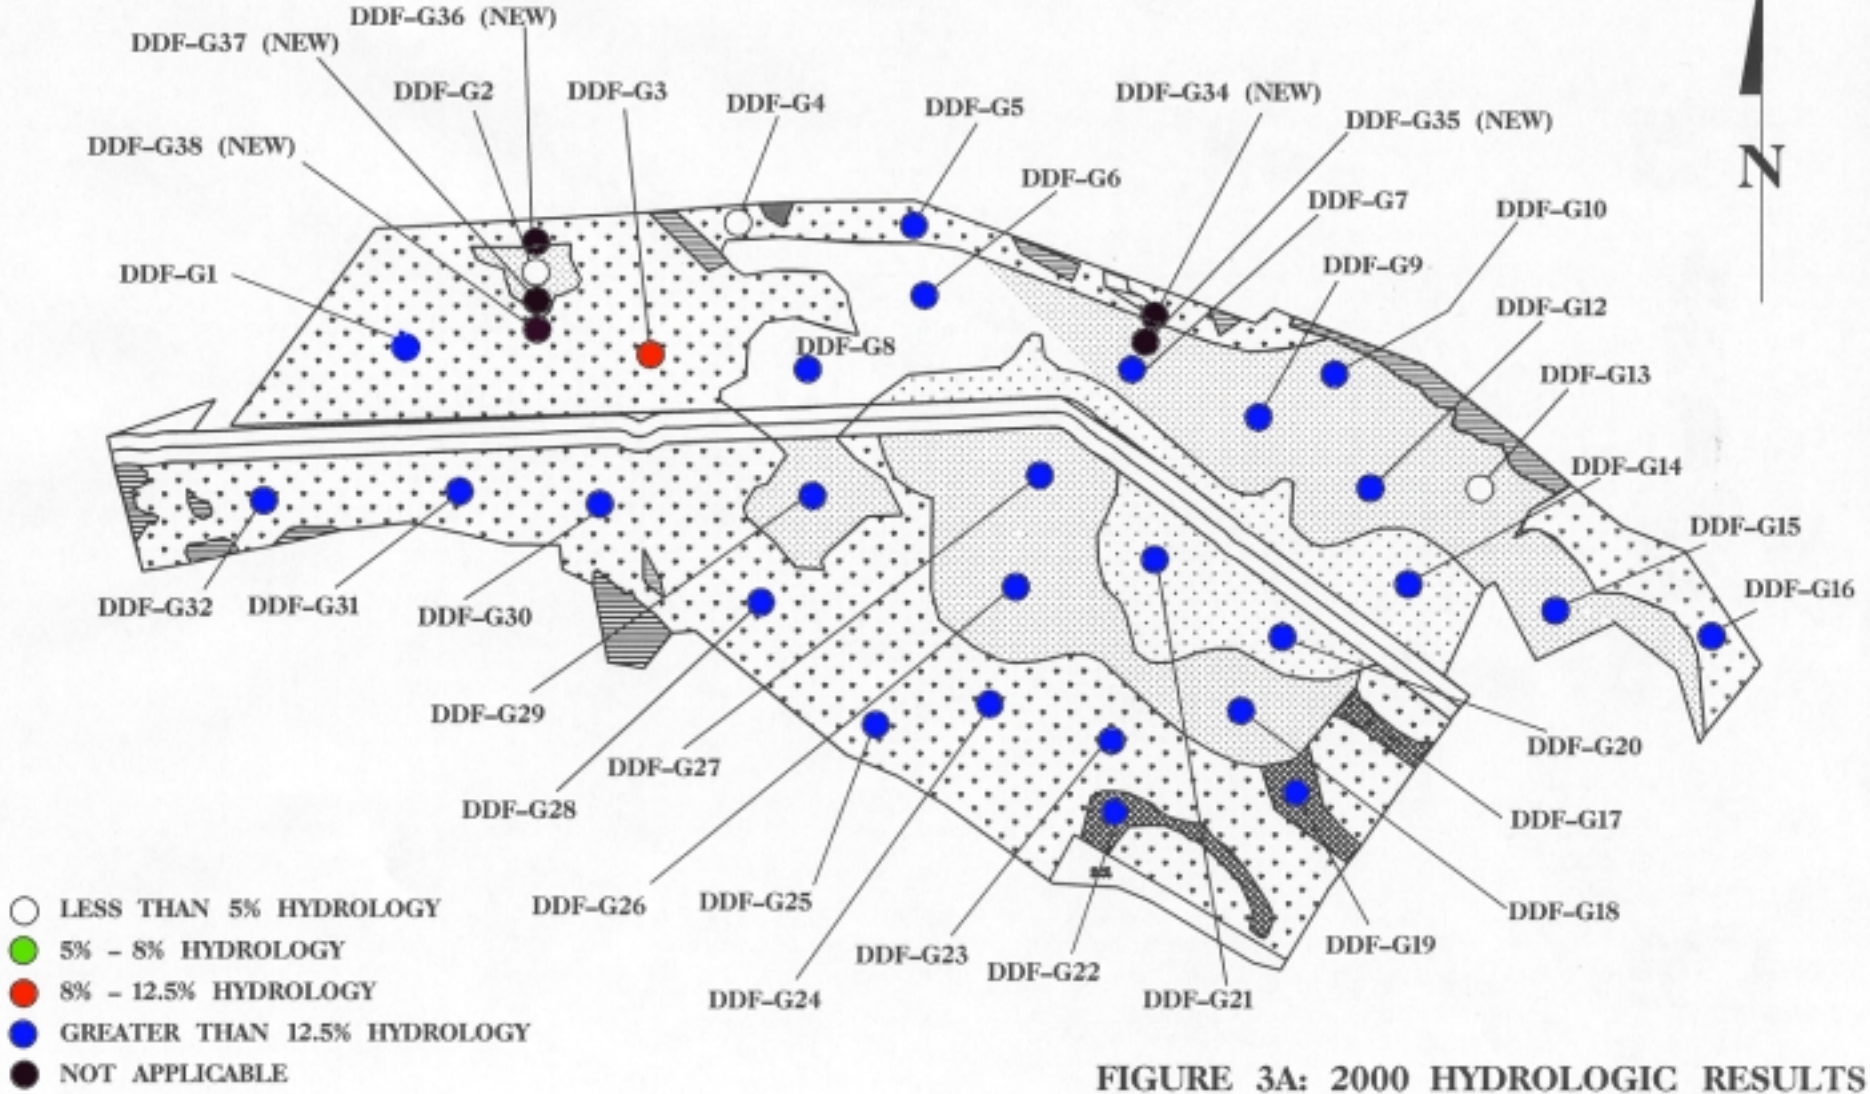
FIGURE 3A: 2000 HYDROLOGIC RESULTS

Figure 4A is a graphical representation of the hydrologic monitoring results for the year 2000 and Figure 4B gives the same information for the year 2001. A blue dot represents wetland hydrology for more than 12.5% of the season; a red

dot indicates hydrology between 8% and 12.5%; a green dot represents hydrology between 5% and 8%.

During the time period from March through November 2000, twenty-seven of the thirty-one gauges met jurisdictional hydrologic success of at least 12.5% during the growing season. Conversely, only three gauges met hydrology of less than 5% of the growing season.

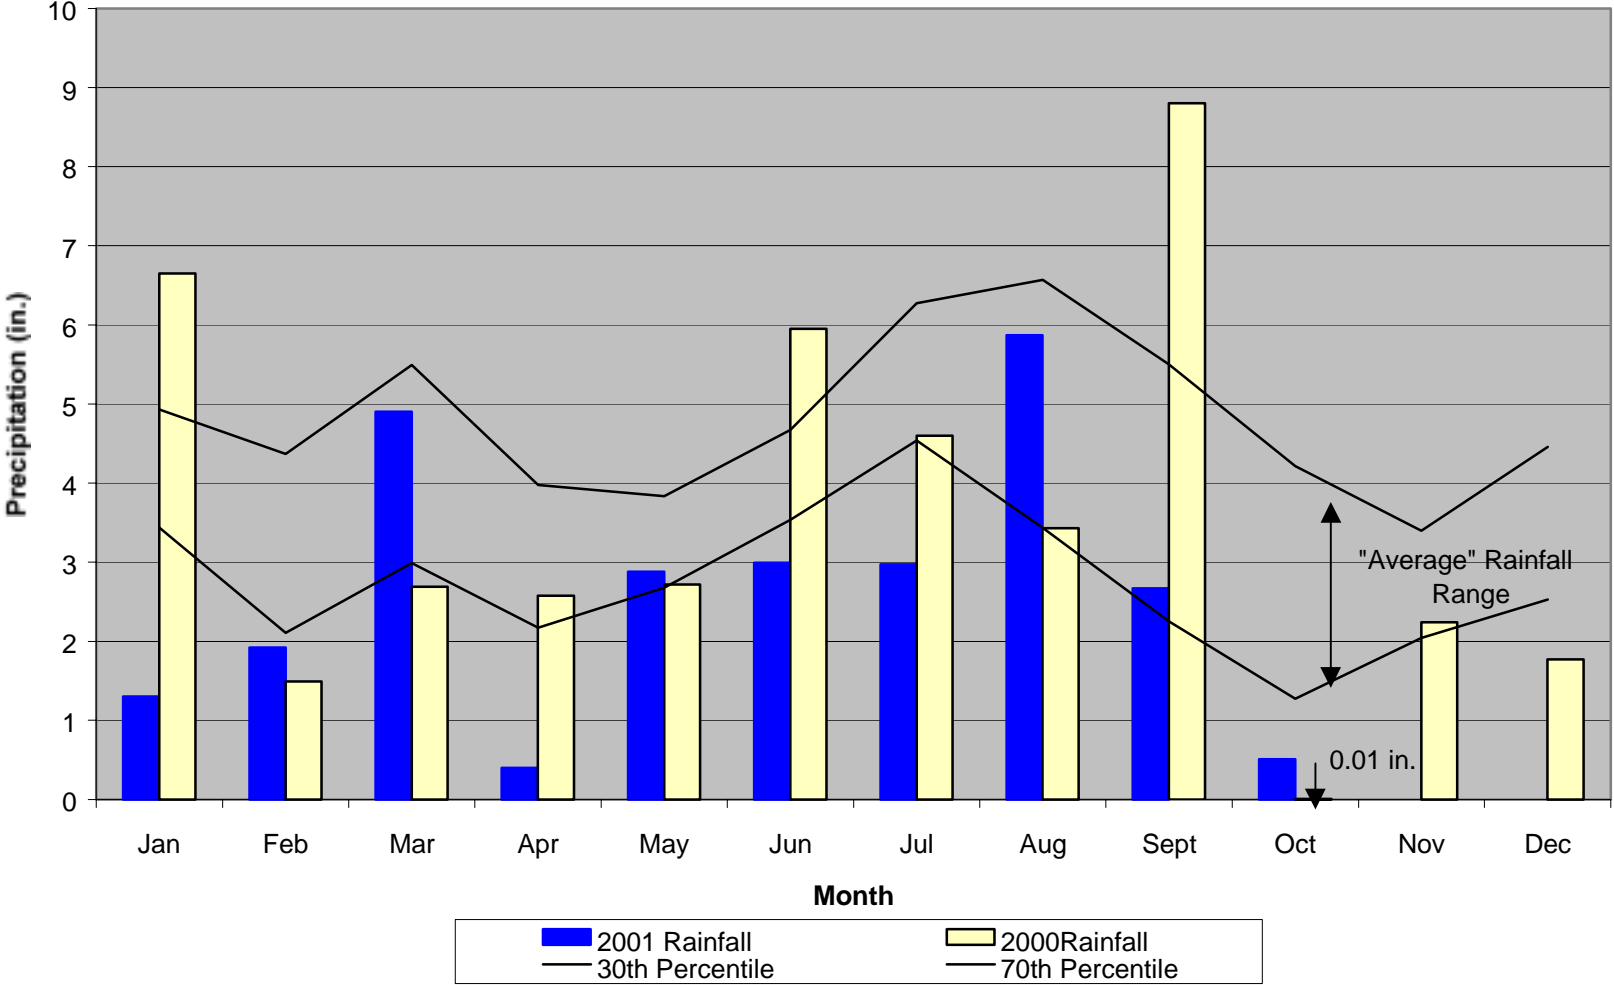
**FIGURE 4: Dowd Dairy 30-70 Percentile Graph
Bladen County**

Figure 5 represents an examination of the local climate in comparison with historical data in order to determine whether 2001 was “average” in terms of climate conditions. The two lines represent the 30th and 70th percentiles of monthly precipitation for William O. Huske L&D, NC. The bars are monthly rainfall totals for 2000 and 2001. The historical data was collected from the National Climatic Data Center while the recent rainfall was provided by the State Climate Office of North Carolina. Because of data availability, the 2001 rainfall encompasses precipitation through November. The 2002 annual monitoring report will include a 30-70 percentile graph with the monthly rainfall from December 2001.

The months of March and August 2001 were considered “average”. The remaining months for 2001 were considered below average.

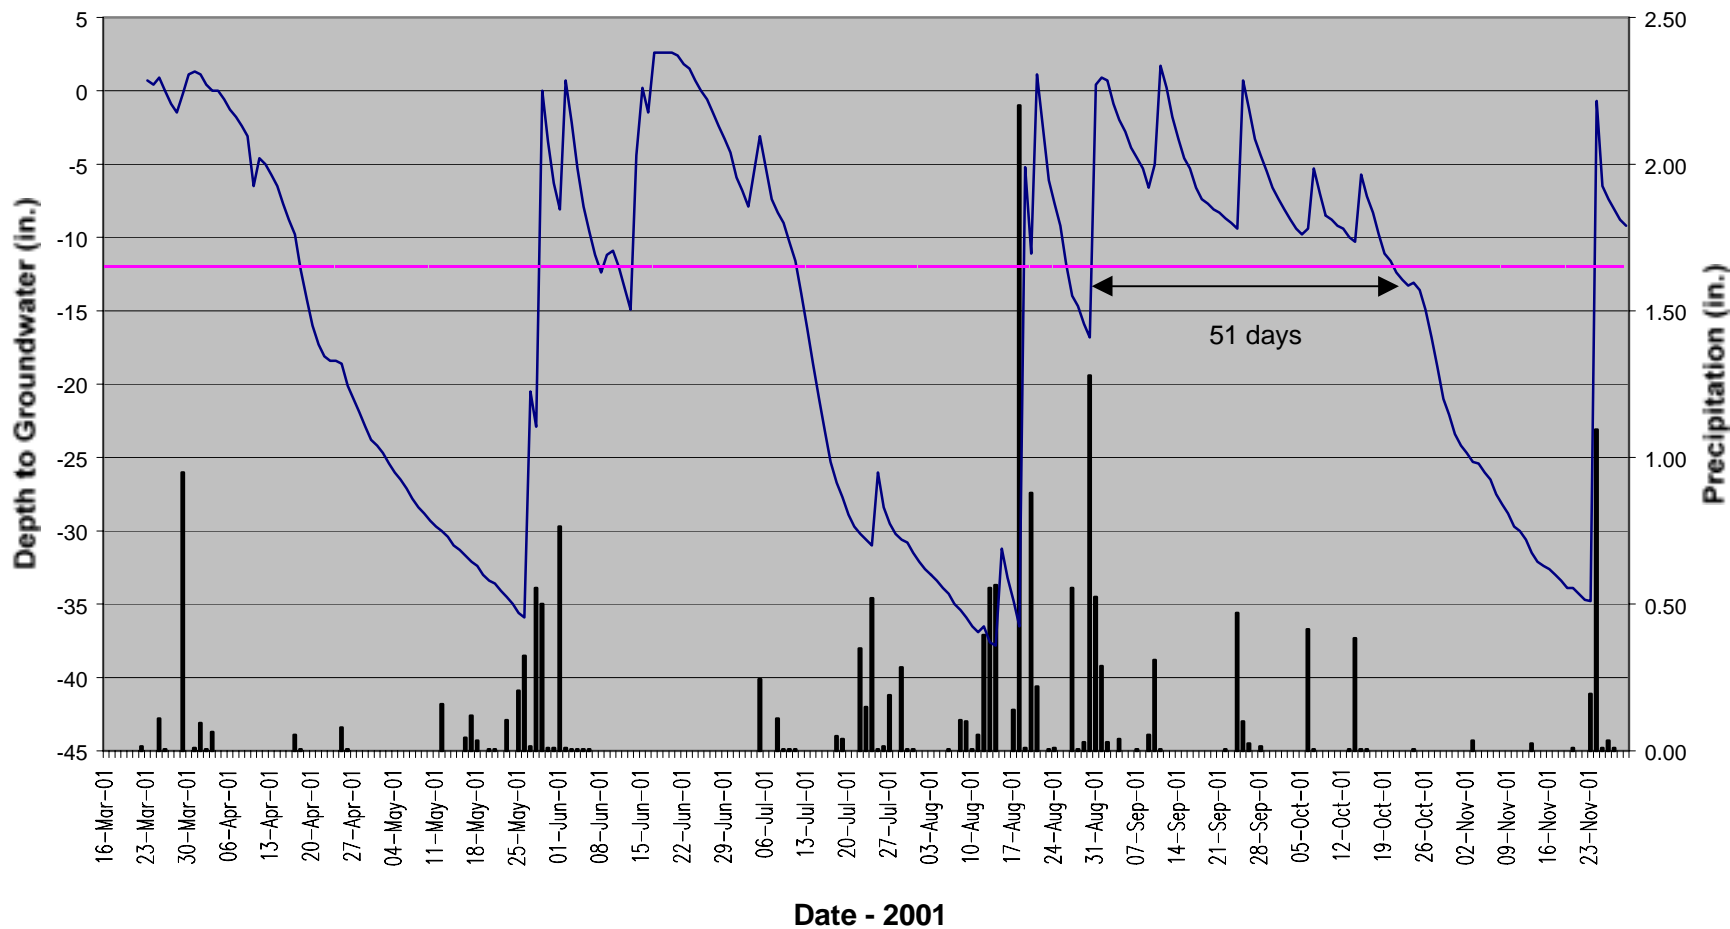
Dowd Dairy Farm - Gauge G1

Appendix A contains a plot of the groundwater depth for each monitoring gauge. Data determined to be erroneous was omitted; therefore, some gaps appear in the plots. Precipitation events are included on each graph as bars. The rainfall plotted is the daily rainfall recorded by rain gauges located on the site. It must be noted that several gauges continued to be problematic throughout the growing season and were eventually replaced.

Appendix A contains a plot of the groundwater depth for each monitoring gauge. The maximum number of consecutive days is noted on each graph.

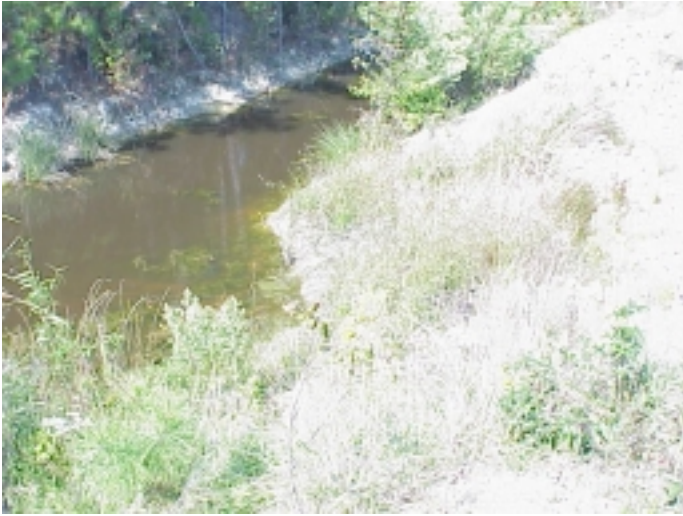
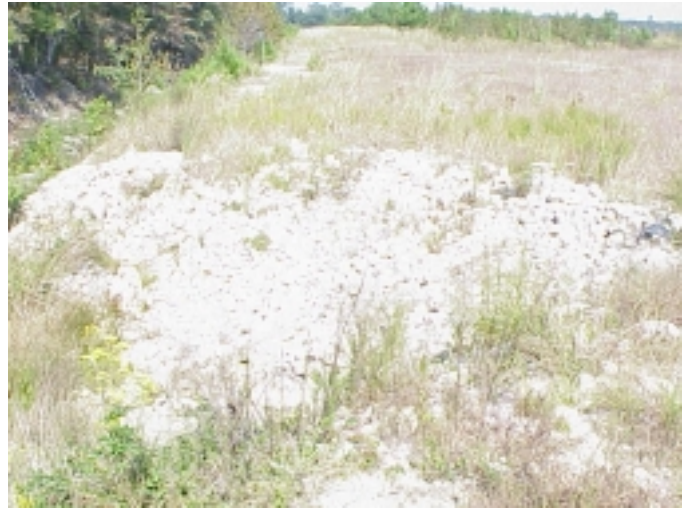
Note: Photos 13 and 14 are of rock plug at end of filled main ditch.
