ANNUAL REPORT FOR 2003

**Dowd Dairy Farm Mitigation Site
Bladen County
Project No. 8.1241802
TIP No. R-2204WM**

Prepared By:
Office of Natural Environment & Roadside Environmental Unit
North Carolina Department of Transportation
December 2003

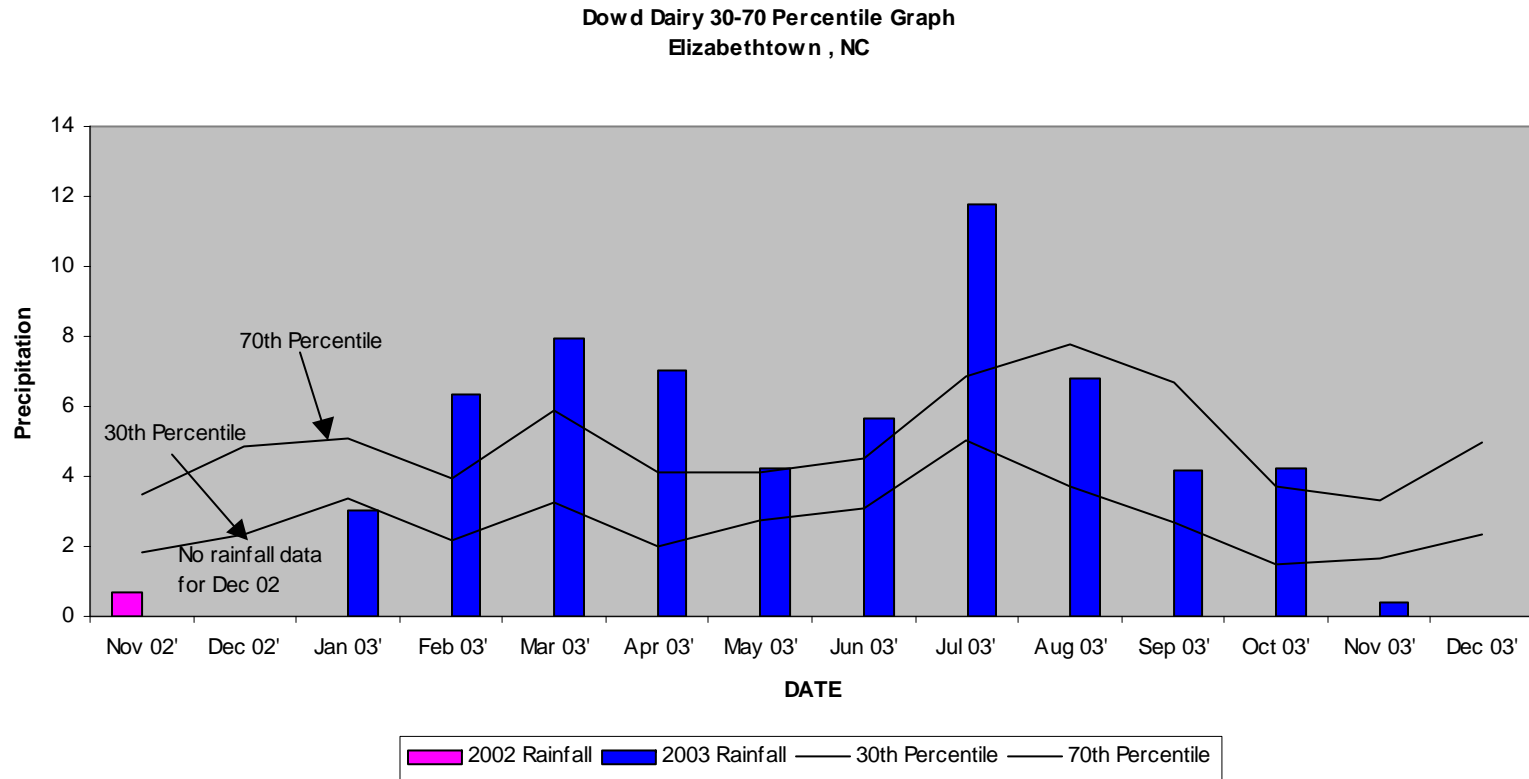
FIGURE 4. 30-70 PERCENTILE GRAPH

Figure 4 represents an evaluation of the local climate in comparison with historical data in order to determine whether 2003 was “average” in terms of climate conditions. The two lines represent the 30th and 70th percentiles of monthly precipitation for Elizabethtown, NC. The bars are monthly rainfall totals for 2002 and 2003. The historical data was collected from the State Climate Office of North Carolina.

For the 2003-year, February, March, April, June, July, and October experienced above average rainfall. The months of November (02’), January and November recorded below average rainfall for the site. May, August, and September experienced average rainfall. The rainfall data for November 2002 was not included in the graph. Overall, 2003 experienced an average to above average rainfall year.

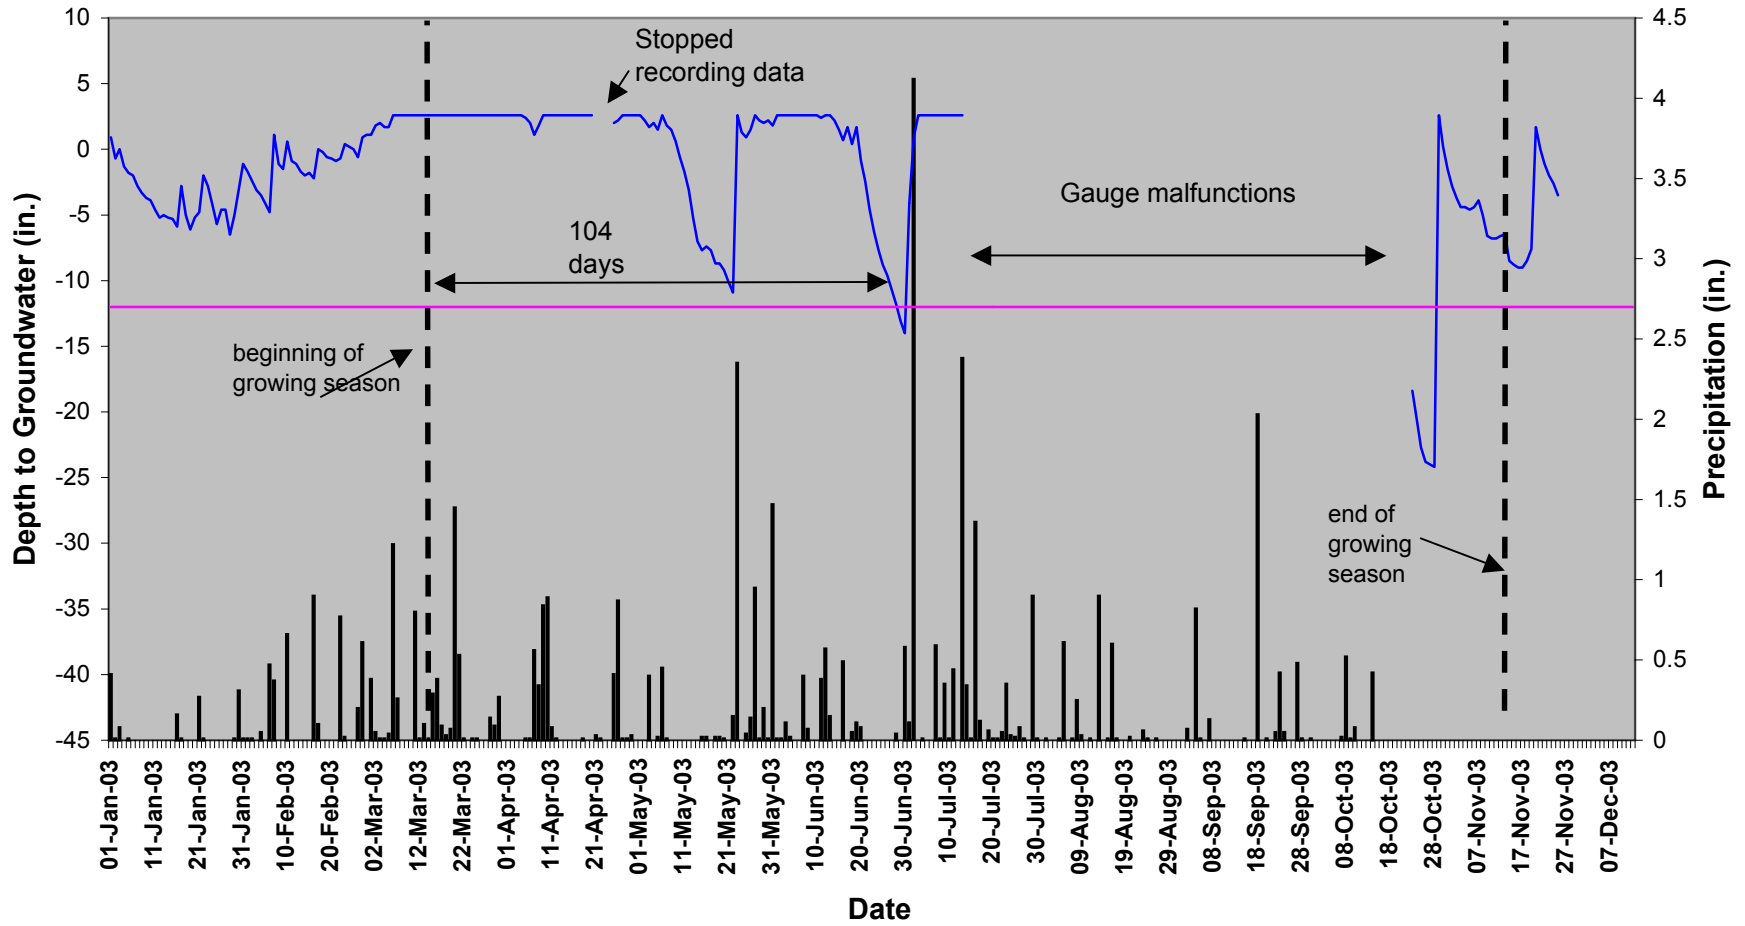
Dowd Dairy Farm - Gauge G1

Appendix A contains a plot of the groundwater depth for each monitoring gauge. Daily rainfall is included on each graph as bars (recorded by rain gauges located on the site). The maximum number of consecutive days that the groundwater was within 12 inches of the surface is noted on each graph.
