ANNUAL REPORT FOR 2004

**Dowd Dairy Farm Mitigation Site
Bladen County
Project No. 8.1241802
TIP No. R-2204WM**

Prepared By:
Office of Natural Environment & Roadside Environmental Unit
North Carolina Department of Transportation
December 2004

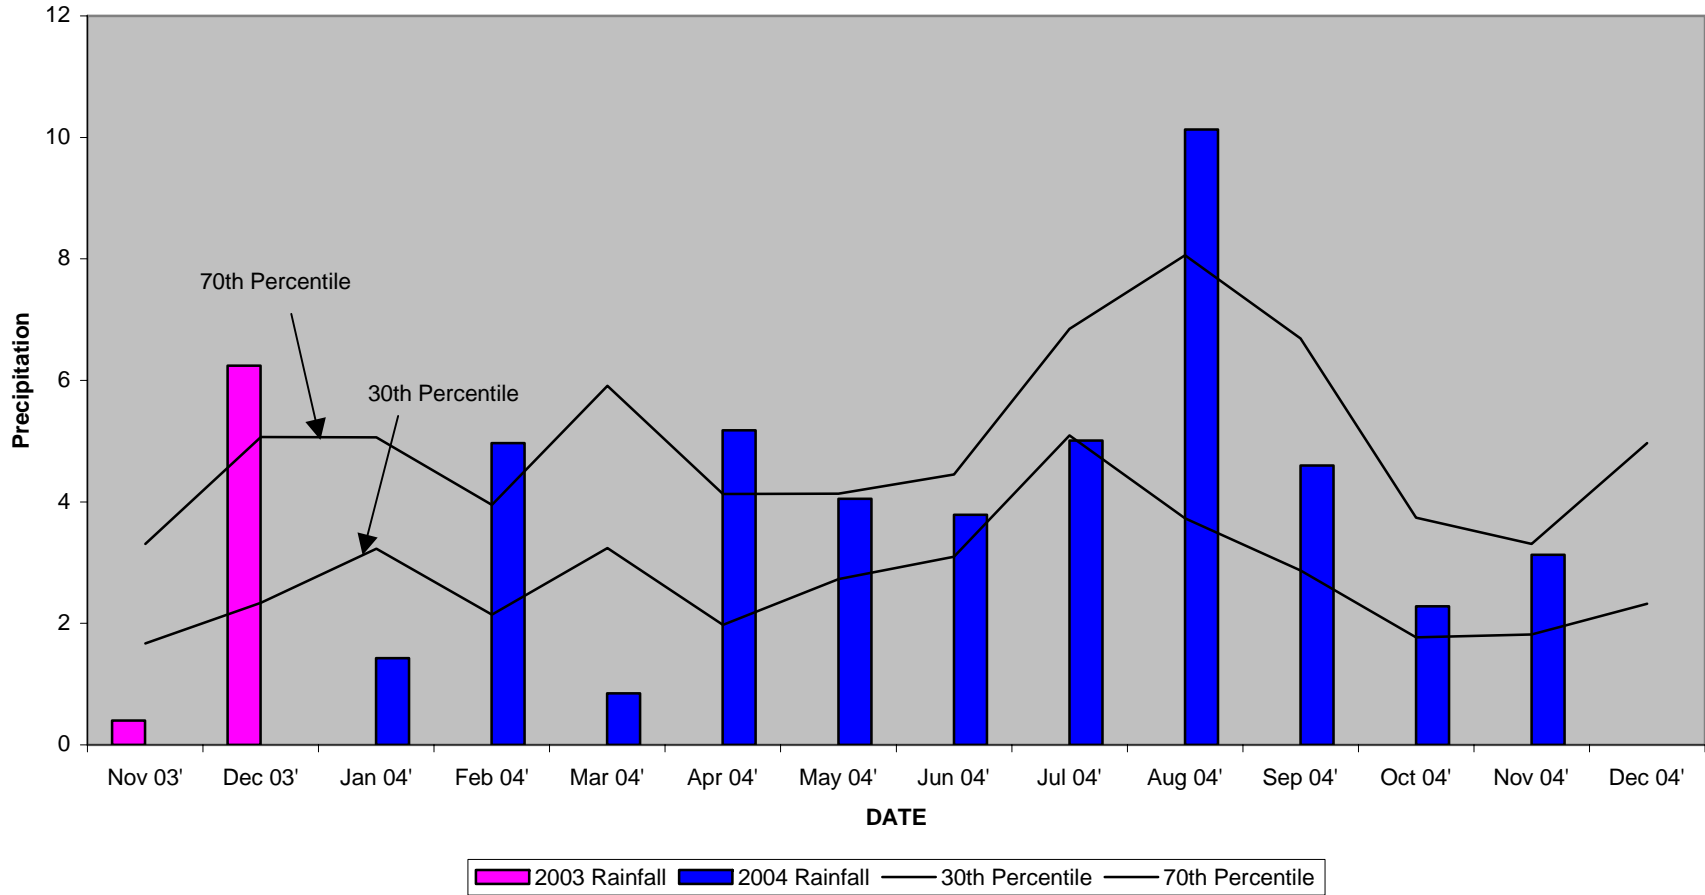
FIGURE 4. 30-70 PERCENTILE GRAPH

Figure 4 provides an evaluation of the local climate in comparison with historical data in order to determine whether 2004 was “average” in terms of climate conditions. The two lines represent the 30th and 70th percentiles of monthly precipitation for Elizabethtown, NC. The bars are monthly rainfall totals for 2003 and 2004. The historical data was collected from the State Climate Office of North Carolina.

For the 2004-year, December (03'), February, April, and August experienced above average rainfall. The months of November (03'), January and March recorded below average rainfall for the site. May, June, July, September, October, and November experienced average rainfall. Overall, 2004 experienced an average rainfall year.

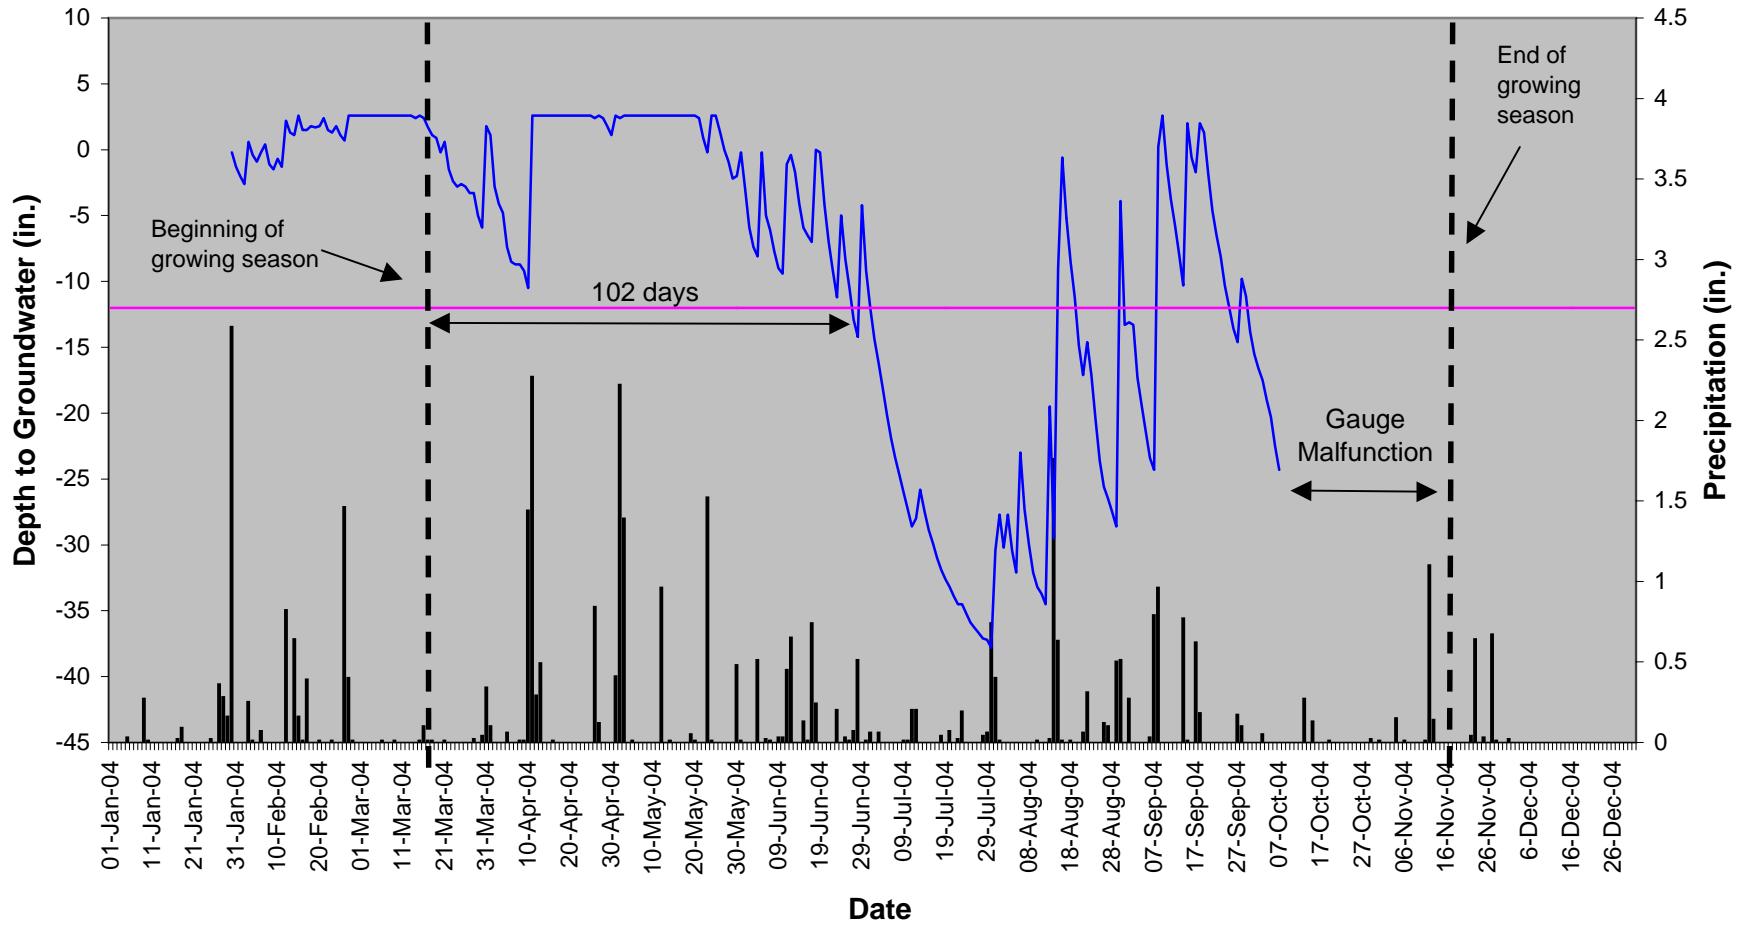
Dowd Dairy Farm - Gauge G1

Appendix A contains a plot of the groundwater depth for each monitoring gauge. Daily rainfall is included on each graph as bars (recorded by rain gauges located on the site). The maximum number of consecutive days that the groundwater was within 12 inches of the surface is noted on each graph.

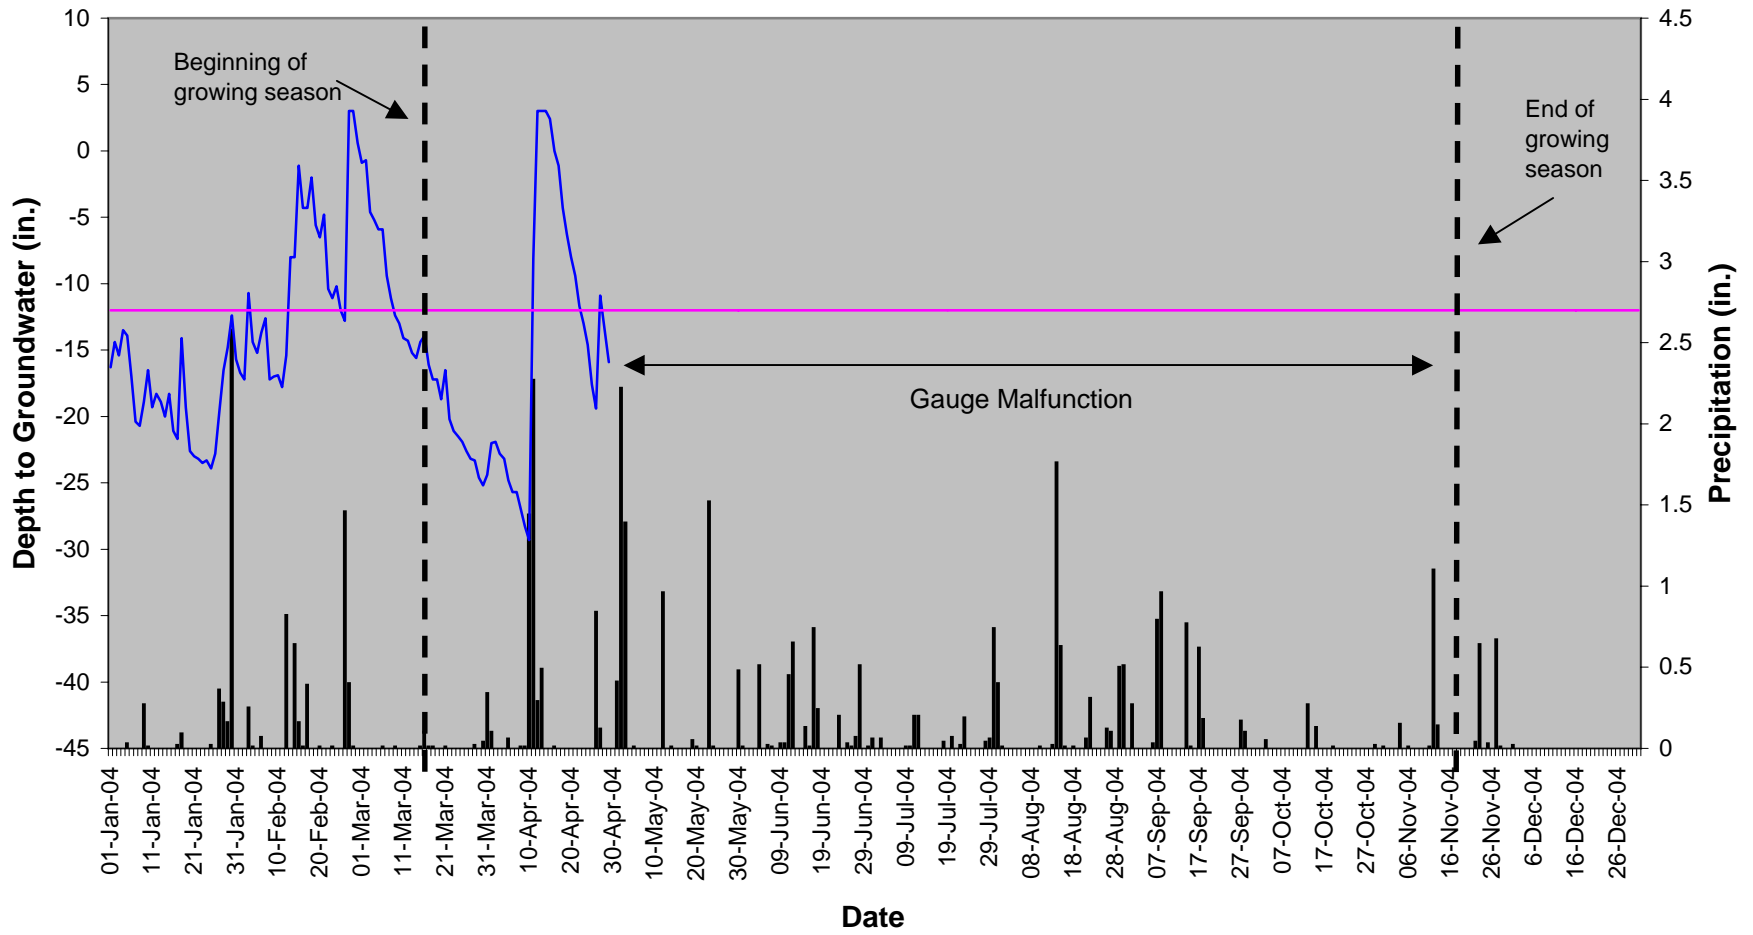
Dowd Dairy Farm - Gauge G2

It should also be noted that the following gauges malfunctioned during the 2004-growing season: G2, G6, G18, G22, G29, G30. These interruptions prevented accurate determinations of the percentage of the growing season that the site met the saturation criteria.

The majority of the gauges not meeting the criteria are located in the northwest portion of the subject property. These gauges include G2 (5%), G4 (2.9%) & G36 (2%). It is likely that the perimeter canal that is located adjacent to these gauges likely caused them to fail.
