**BASELINE MONITORING
DOCUMENT AND AS-BUILT
BASELINE REPORT
FINAL**

DRY CREEK MITIGATION SITE

Durham County, NC

DMS Project Number 97082

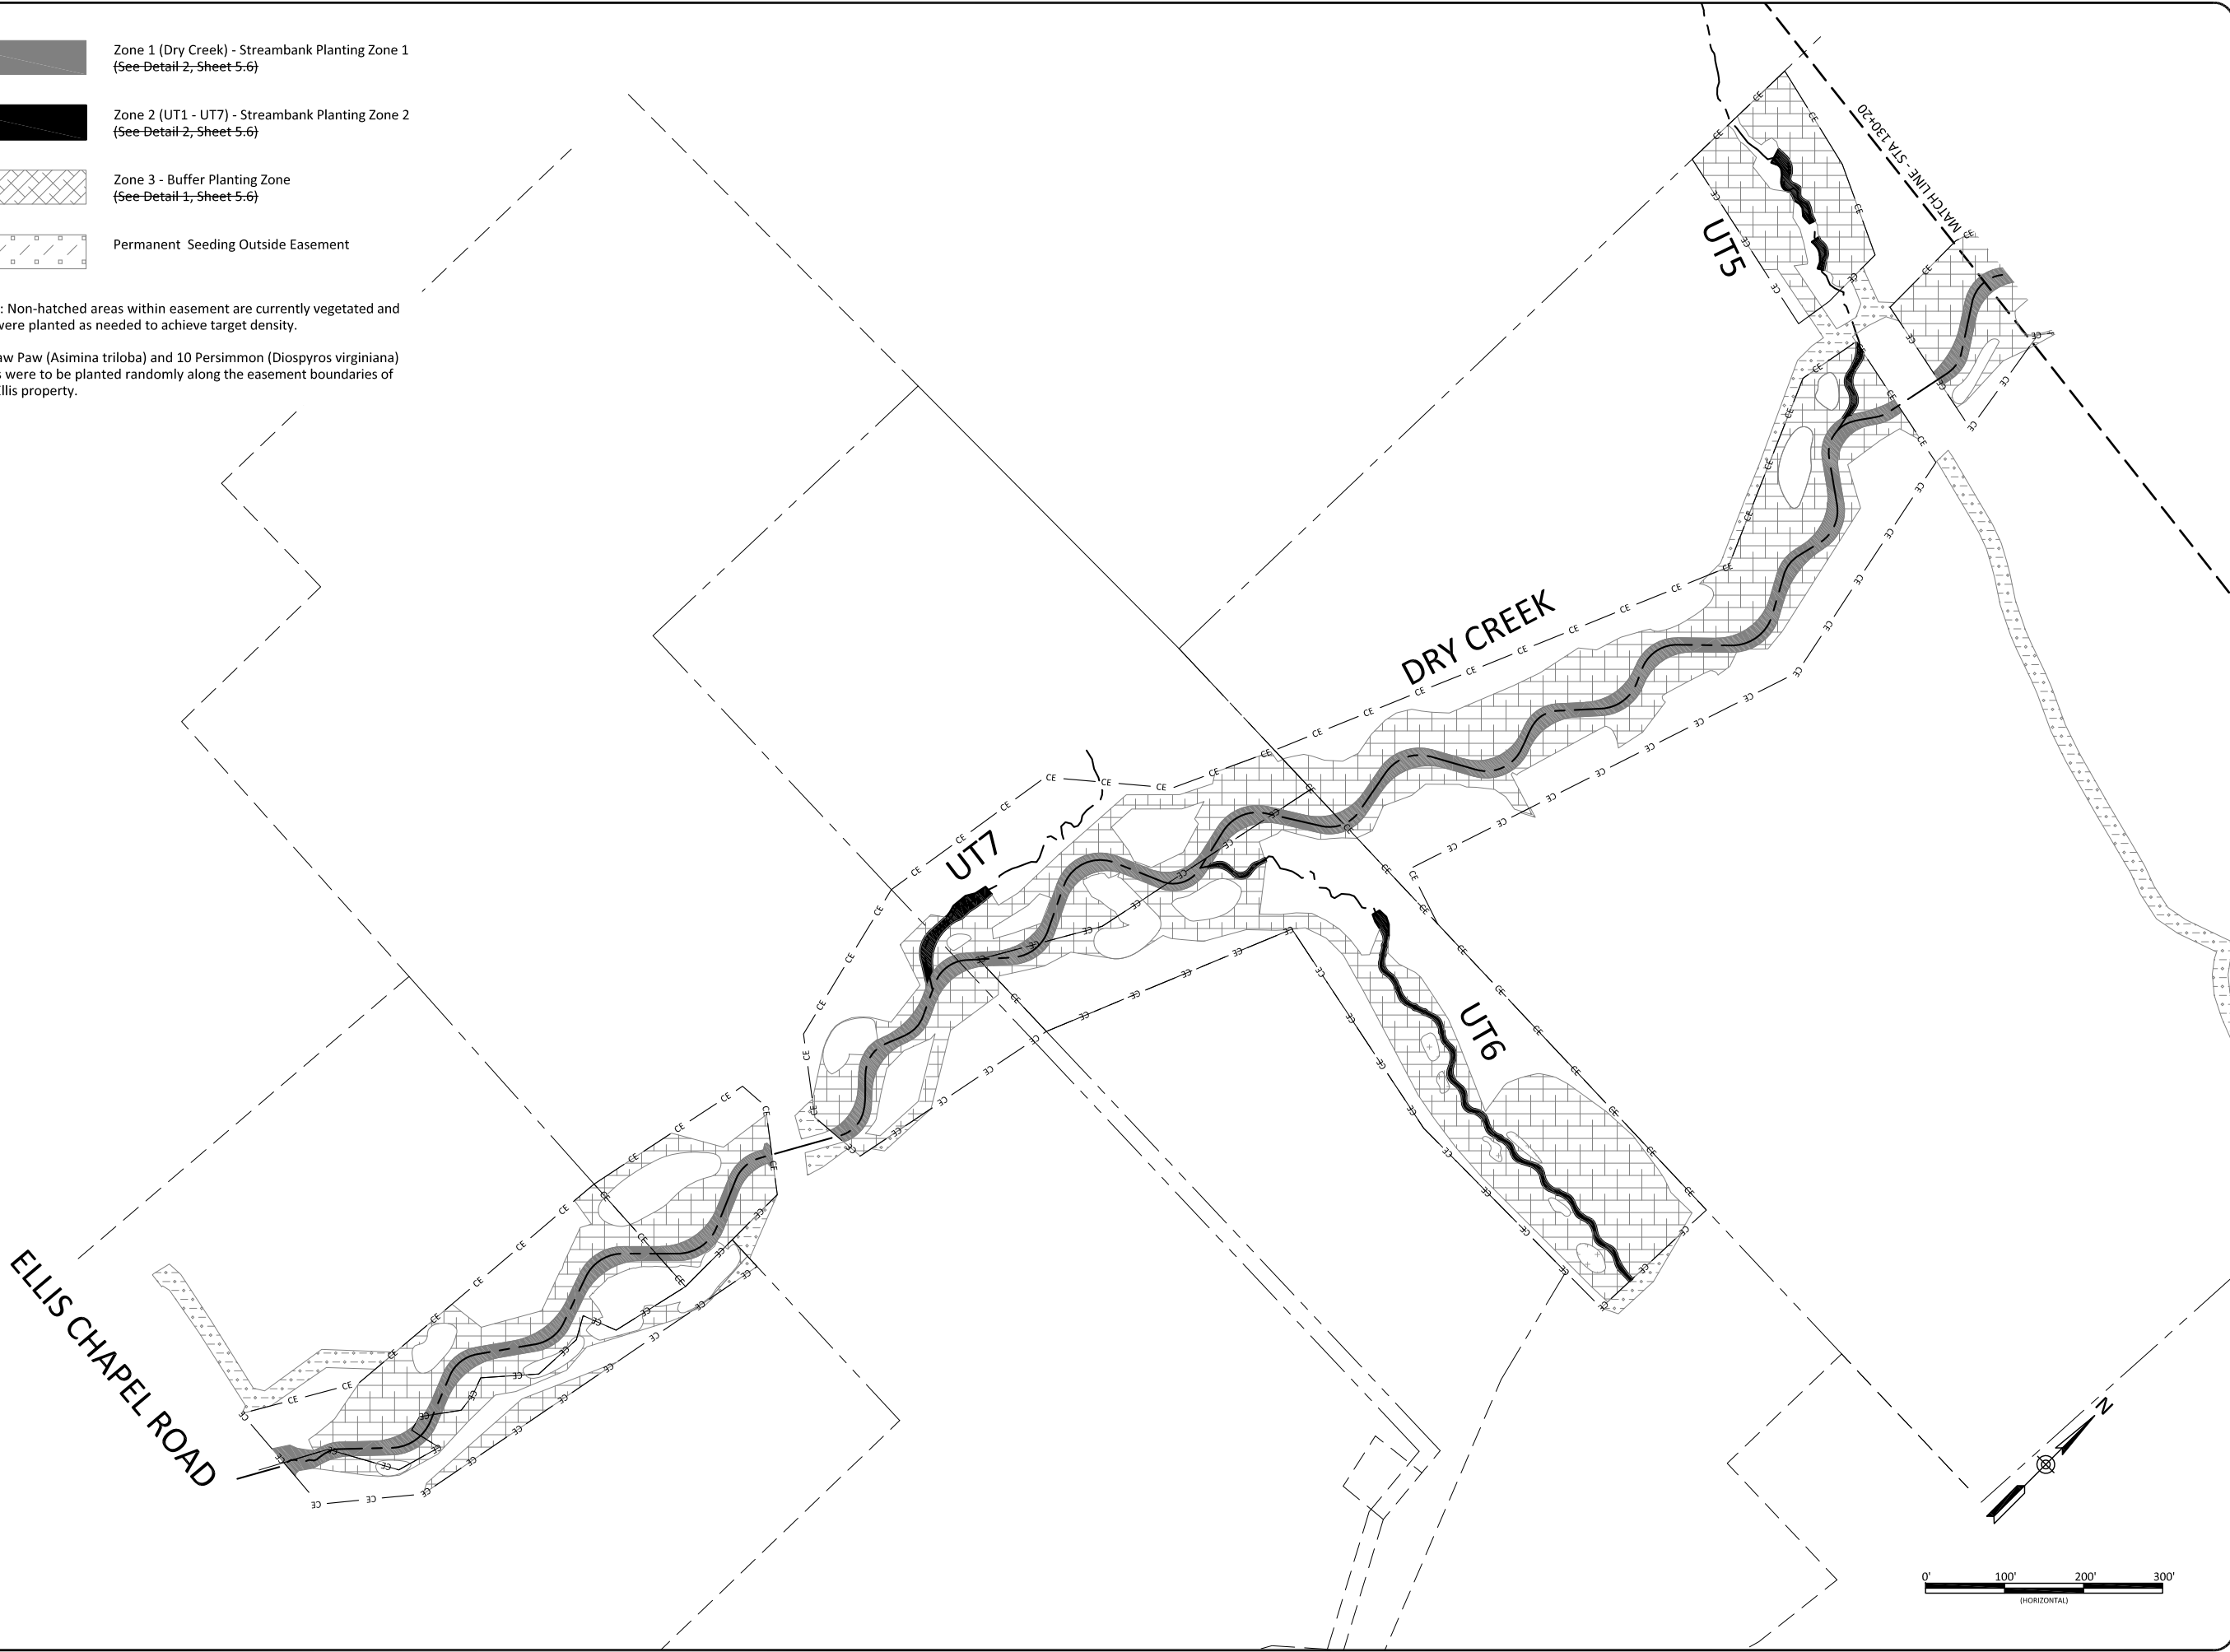
Dry Creek Mitigation Site
Durham County, NC
Planting Plan

- Notes:
1. Note: Non-hatched areas within easement are currently vegetated and but were planted as needed to achieve target density.
 2. 10 Paw Paw (*Asimina triloba*) and 10 Persimmon (*Diospyros virginiana*) trees were to be planted randomly along the easement boundaries of the Ellis property.
