**MONITORING YEAR 2
ANNUAL BUFFER REPORT
FINAL**

DRY CREEK MITIGATION SITE

Durham County, NC
NCDEQ Contract No. 6827
DMS ID No. 97082
NCDWR Project No. 2016-0369
RFP No. 16-006477

DRY CREEK MITIGATION SITE
Monitoring Year 2 Report

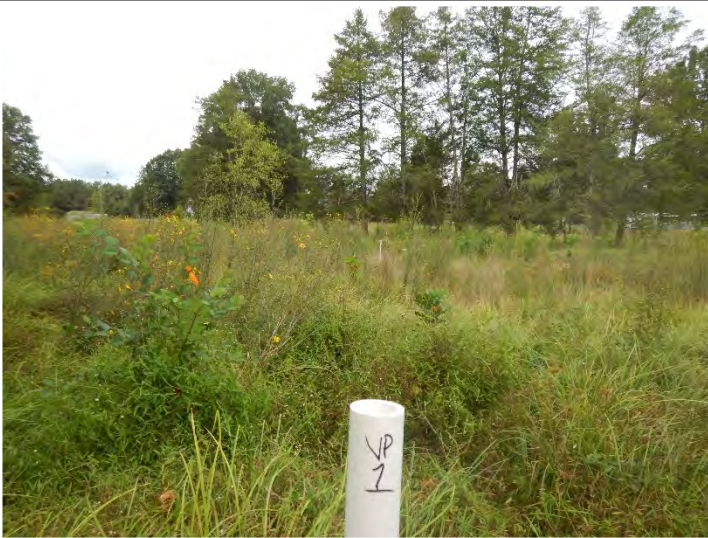
VEG PLOT 1 (9/16/2021)

Plot	Success Criteria Met *	Tract Mean
Vegetation Plot 1	Yes	57%
Vegetation Plot 2	Yes	
Vegetation Plot 3	Yes	
Vegetation Plot 4	Yes	
Vegetation Plot 5	No	
Vegetation Plot 6	No**	
Vegetation Plot 7	No**

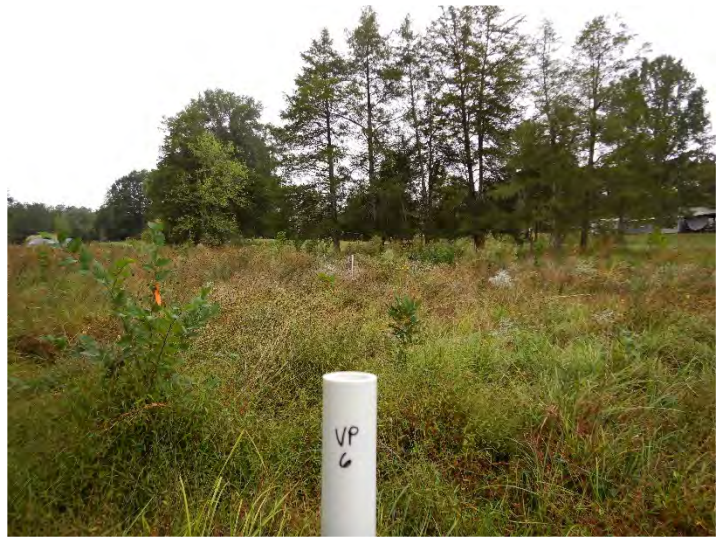
VEG PLOT 6 (10/6/2021)

**Vegetation Plot 6 and 7 meet the final success criteria for MY5 of 260 stems per acre when including volunteers.
