# Duke Swamp Wetland and Stream Restoration Plan Gates County, North Carolina

**FINAL REPORT**

**Project Number D06065-A**

Design Report Prepared by Baker Engineering NY, Inc.

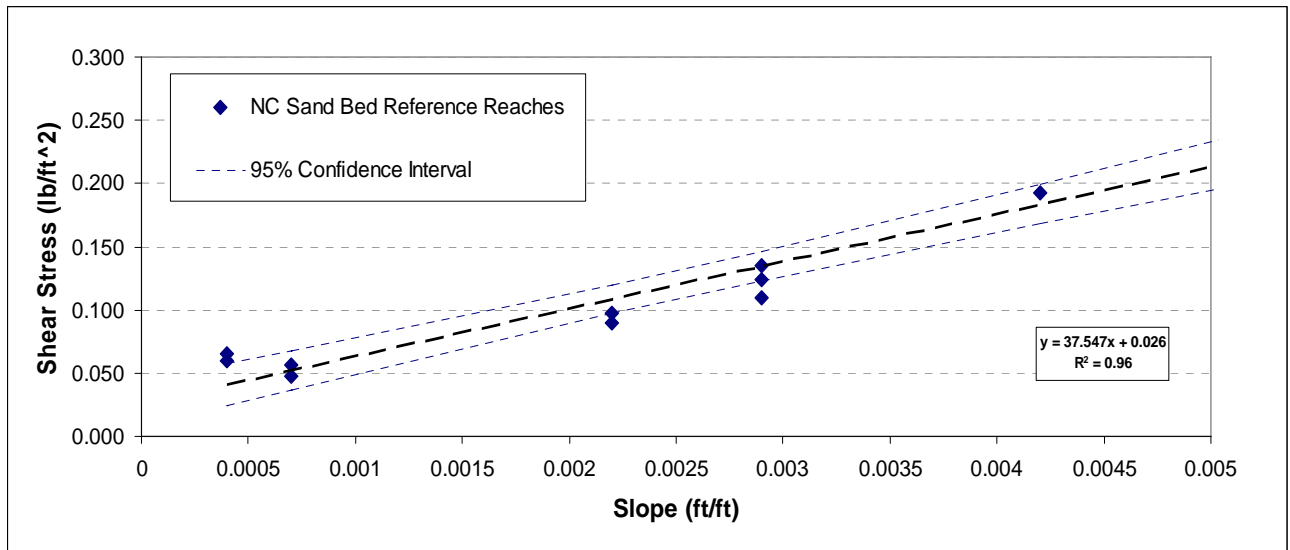
**Figure 2.1**

Bankfull Shear Stress Versus Channel Slope for Coastal Plain Reference Reaches.

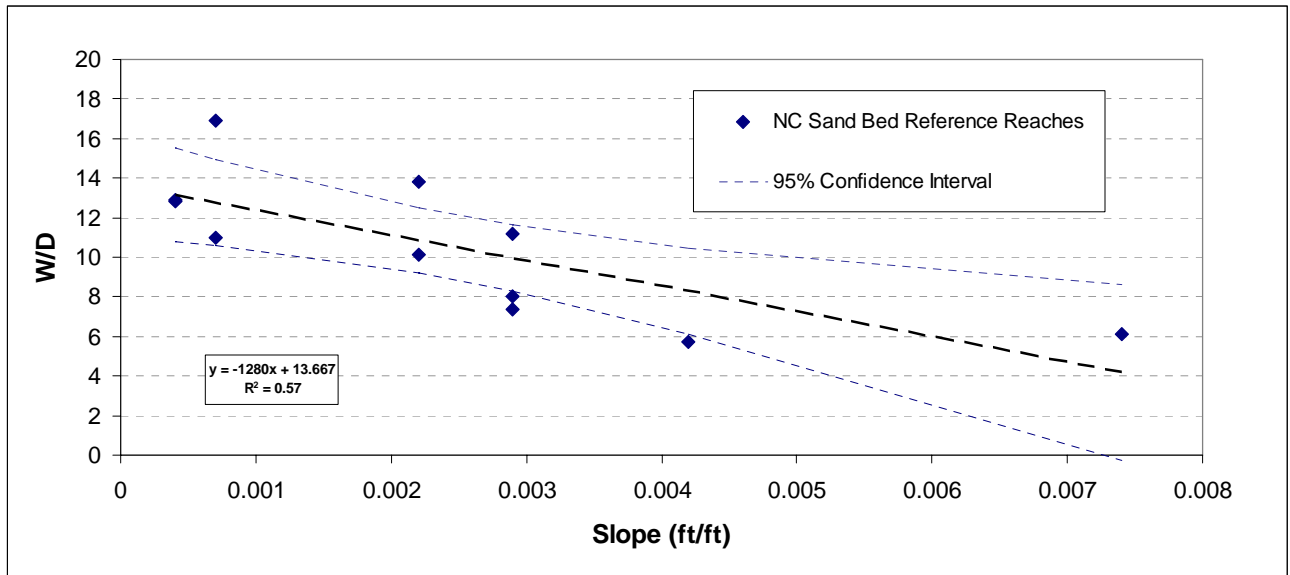
**Figure 2.3**

As an additional check of stream design stability, the design width-to-depth ratios (W/D) are plotted against slope and compared with data from sand-bed reference reaches in the Coastal Plain. Data collected on sand-bed systems in the Coastal Plain of North Carolina indicate a strong correlation between W/D and slope, with W/D decreasing as channel slope increases. The design W/D ratios are compared with reference reach data in Figure 2.3, which shows bankfull W/D ratio versus channel slope. If the design points for the design reaches fall within the range of W/D values shown for reference reaches under similar slope conditions, it is even more likely that the design dimensions of the restored channels will remain stable.

Width-to-depth Ratio (W/D) and Channel Slope for Coastal Plain Reference Reaches.

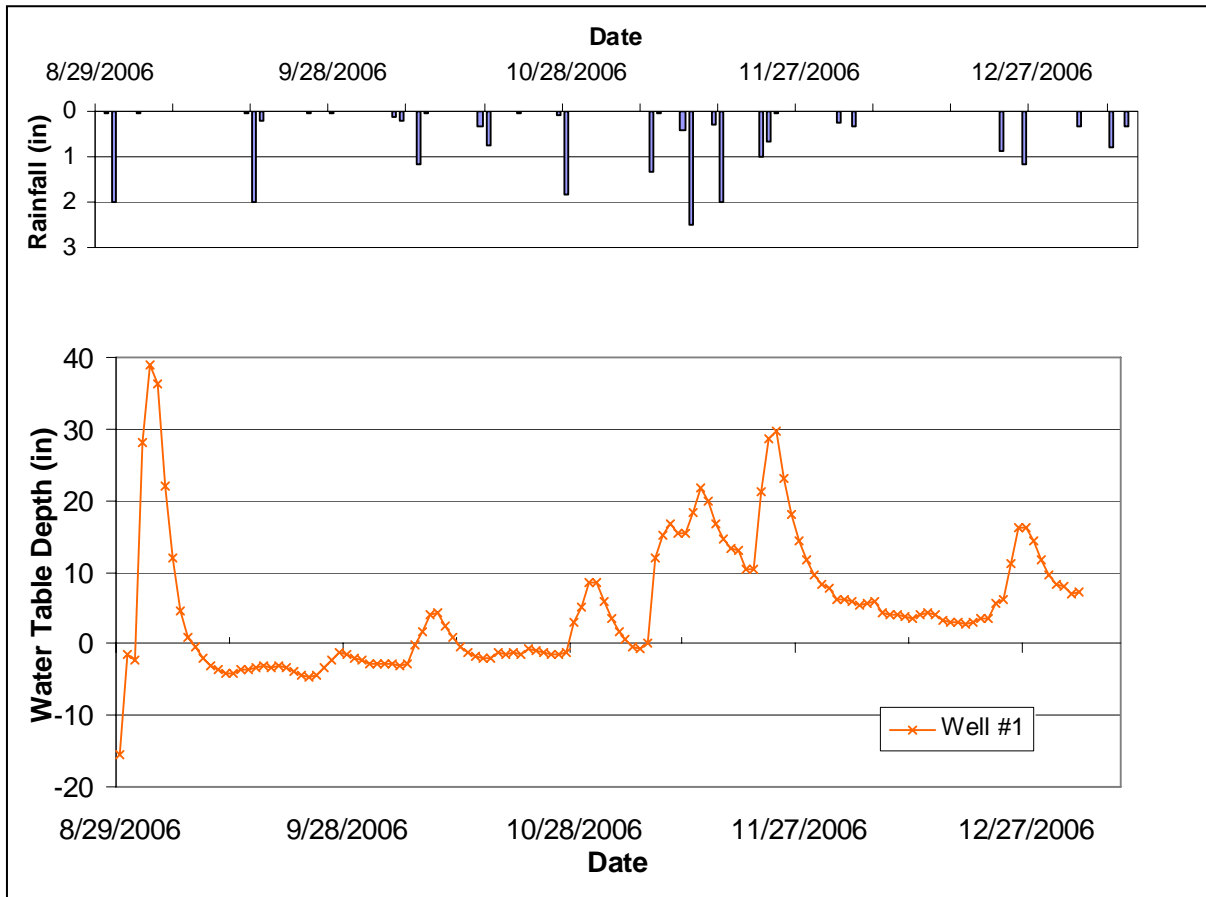
**Figure 7.2**

Water Table Depths Recorded in a Monitoring Well Installed within the Reference Site.

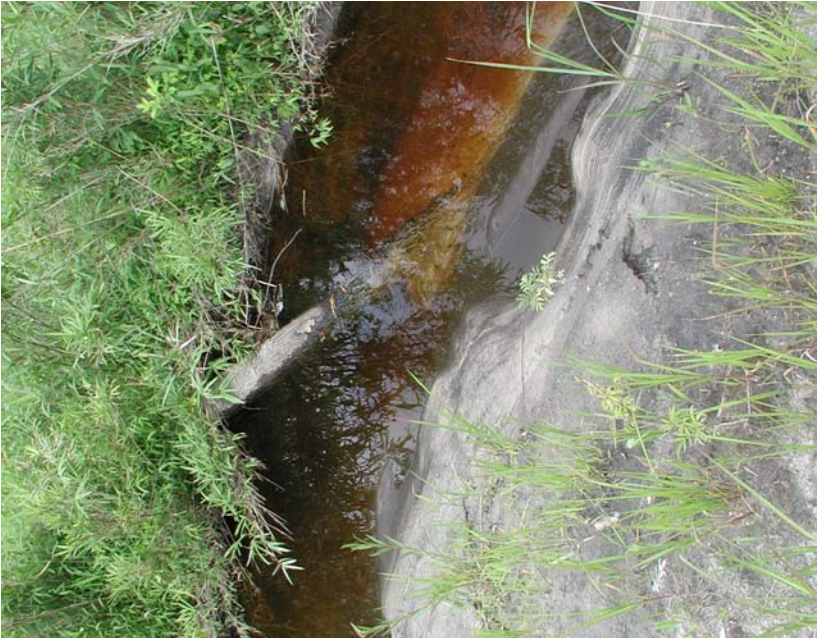
**Log Vane**

There are a variety of in-stream structural elements used in restoration. Exhibit 2.7 illustrates a few typical structures. These elements are comprised of natural materials such as stone, wood, and live vegetation. Their shape and location works with the flow dynamics to reinforce, stabilize, and enhance the function of the stream channel. In-stream structures provide three primary functions: grade control, stream bank protection, and habitat enhancement.

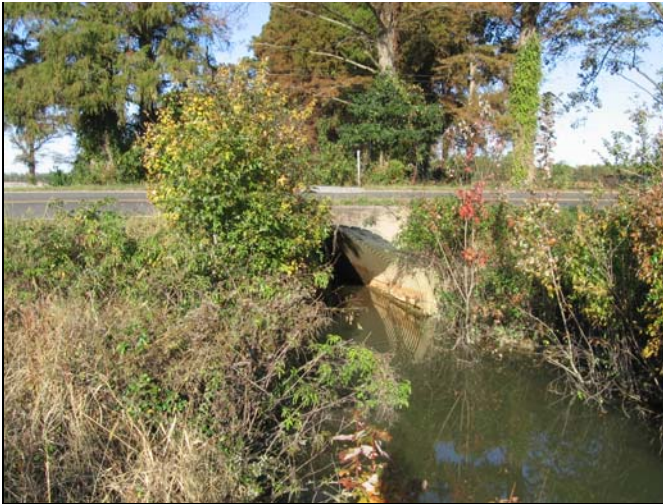
Culvert crossing under Kellogg Fork Rd (SR 1320) at beginning of project reach UT1.

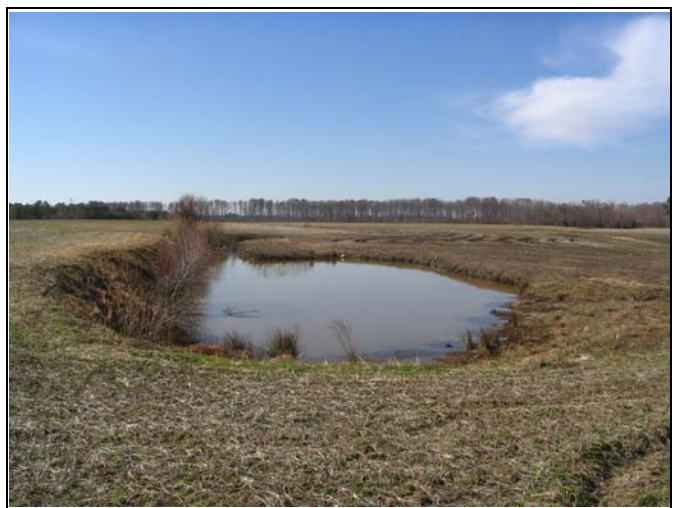
Looking at Pond #2 lacking bank vegetation and buffer protection.

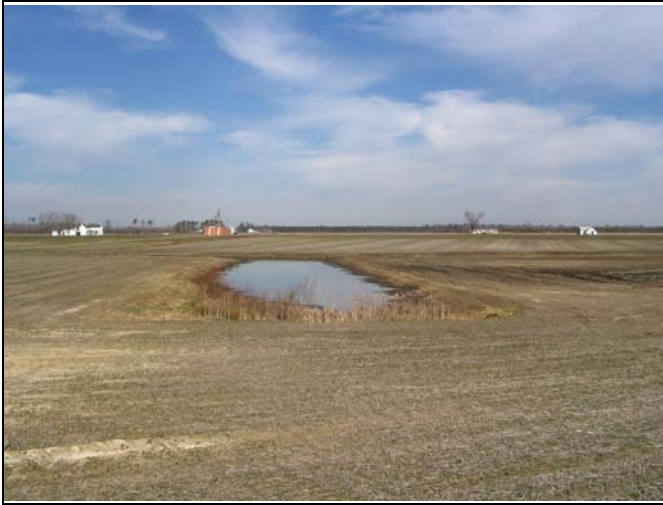
Looking at Pond #3 lacking bank vegetation and buffer protection.

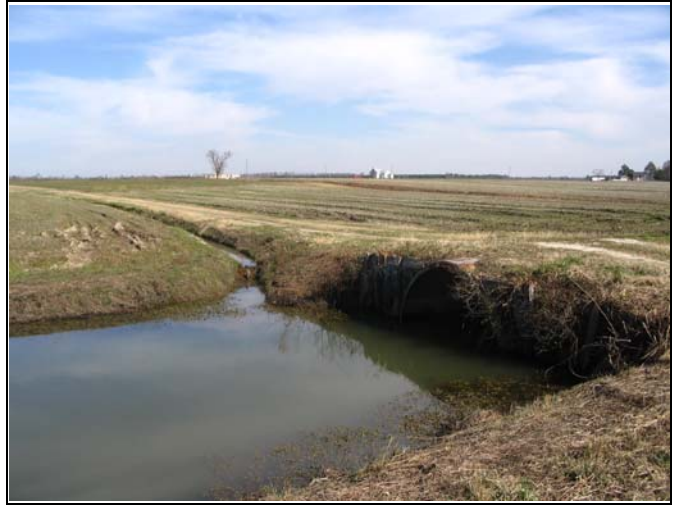
Farm access road at existing culvert crossing. Drainage ditch to be tied into proposed UT1.

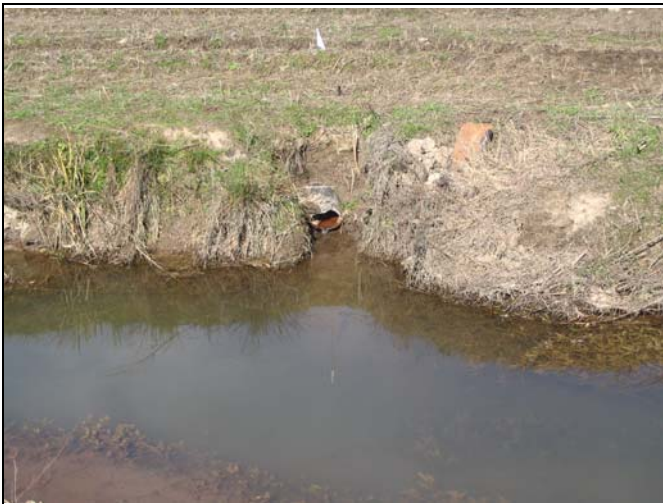
Example of existing drain tile to remain and tie into proposed stream and wetland areas.

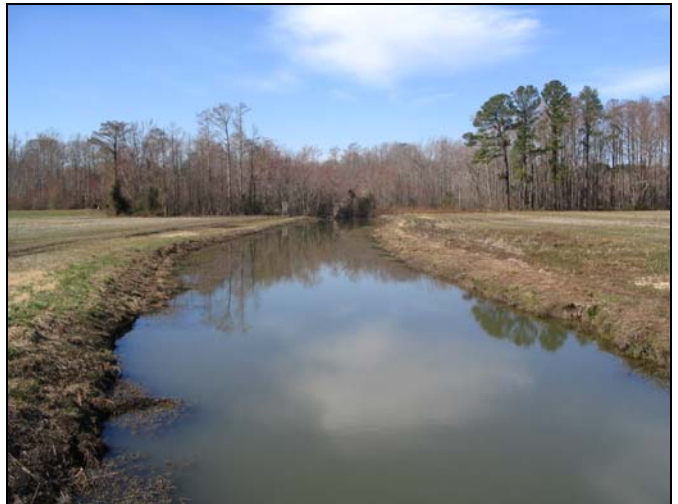
Looking downstream towards woodline at overly widened UT1 channel.

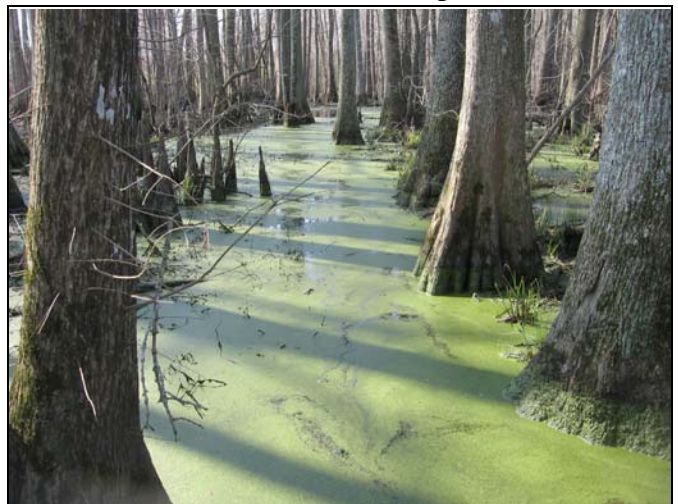
Looking downstream at UT2 backwater and excessive duckweed near beginning of reach.

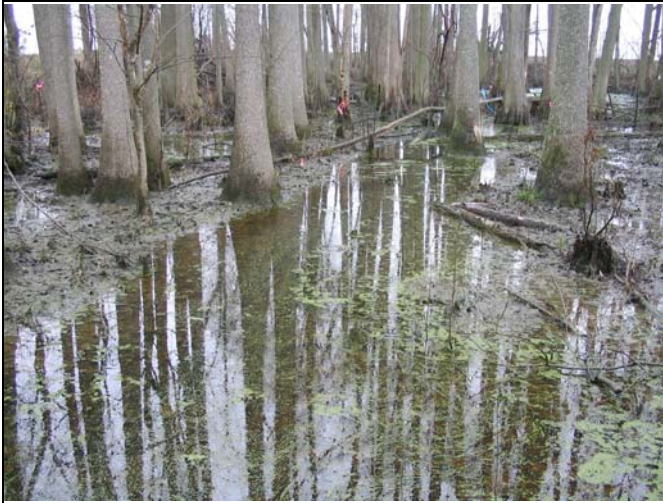
Looking upstream at backwater conditions along UT2 channel.

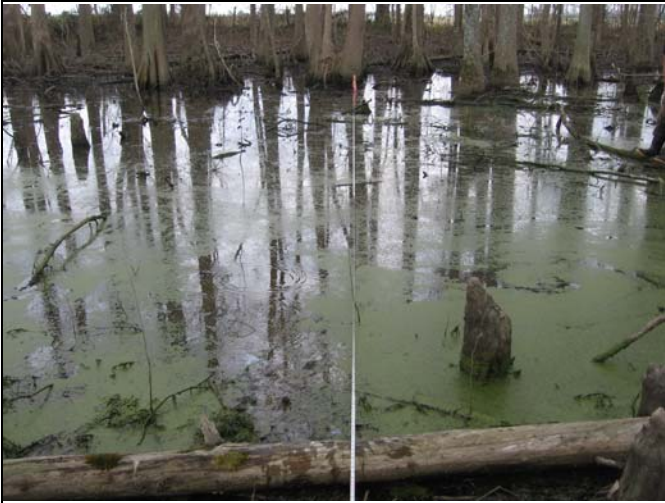
UT2 backwater located at cross-section 7, approximate Sta. 11+80.

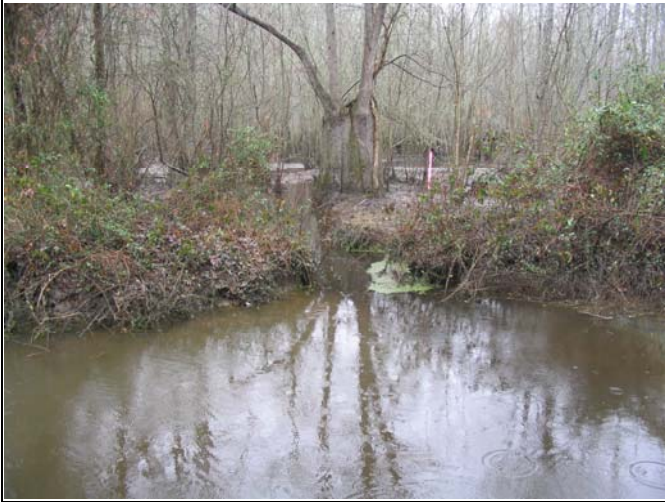
Looking upstream at UT2 backwater effects before confluence with UT1.
