STREAM AND WETLAND MITIGATION PLAN

DUTCHMANS CREEK SITE WAKE COUNTY, NORTH CAROLINA

The North Carolina Department of Transportation
Raleigh, North Carolina

July 1997

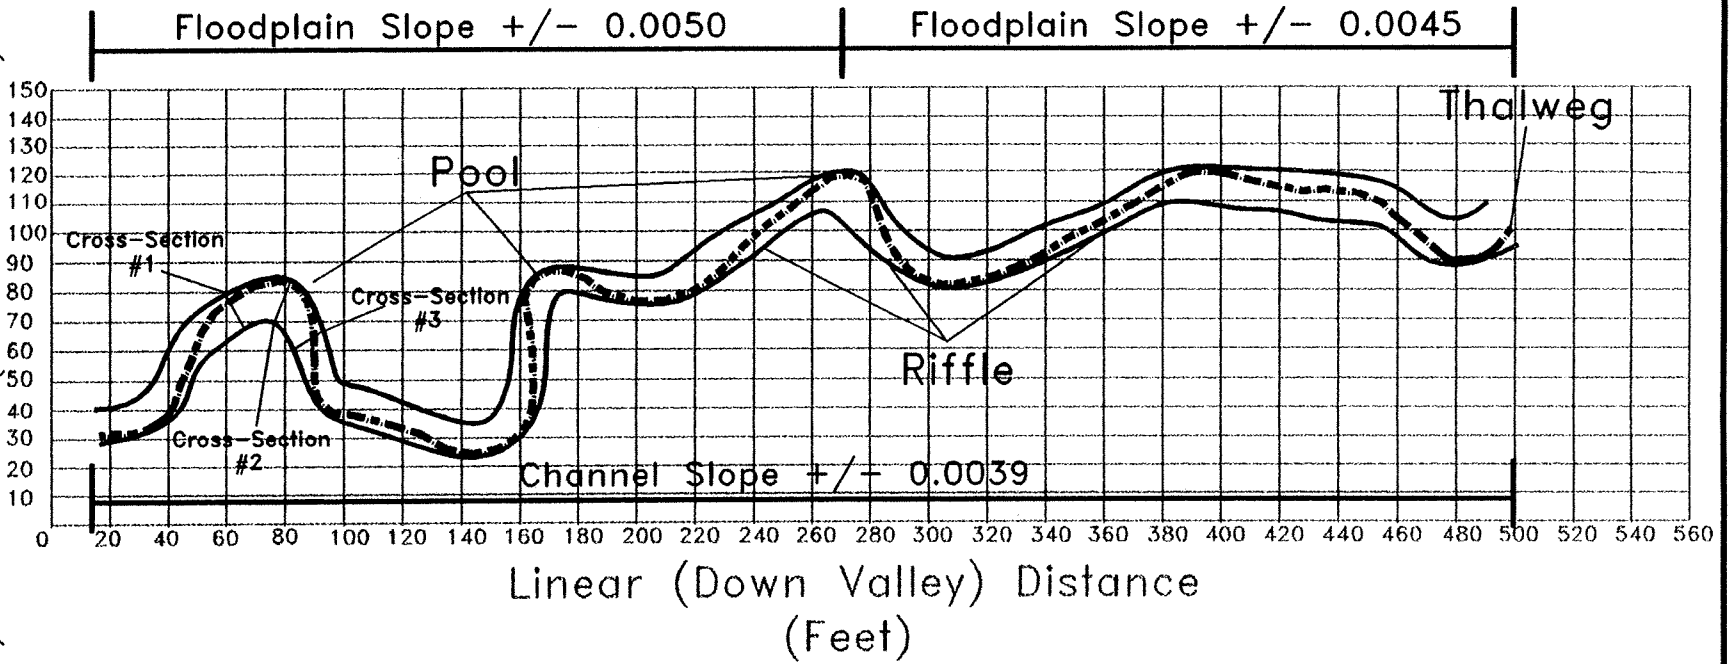
Drawn By:	Figure: 15
Checked By:	Project: ER96021.15
Scale:	Date: JUNE 1997

Typical Cross-Section 1, Reference

Typical Cross-Section 2, Reference

Typical Cross-Section 3, Reference

BANKFULL CHANNEL CROSS-SECTIONS
REFERENCE
WAKE COUNTY, NORTH CAROLINA

The Dutchmans Creek channel was designed under potentially stable conditions for an existing bankfull discharge of approximately 600 cubic feet/second [CFS]). The target cross-sectional areas averaged 3 m² (32 ft²) with a meandering channel slope of approximately 0.0039 (rise/run). Assuming that the valley slope averages 0.0051, a sinuosity averaging 1.3 will maintain a stable stream slope designed to transport sediment loads from point bar to point bar (sands) and within the thalweg (silts/clays) with reduced potential for bank erosion. However, increased sediment from the developing watershed may overwhelm the natural transport capacity of this reference stream channel. The design channel also supports a substrate composed of a mix of cobble and gravel with coarse to medium sands deposited on intermittent point (sand) bars.

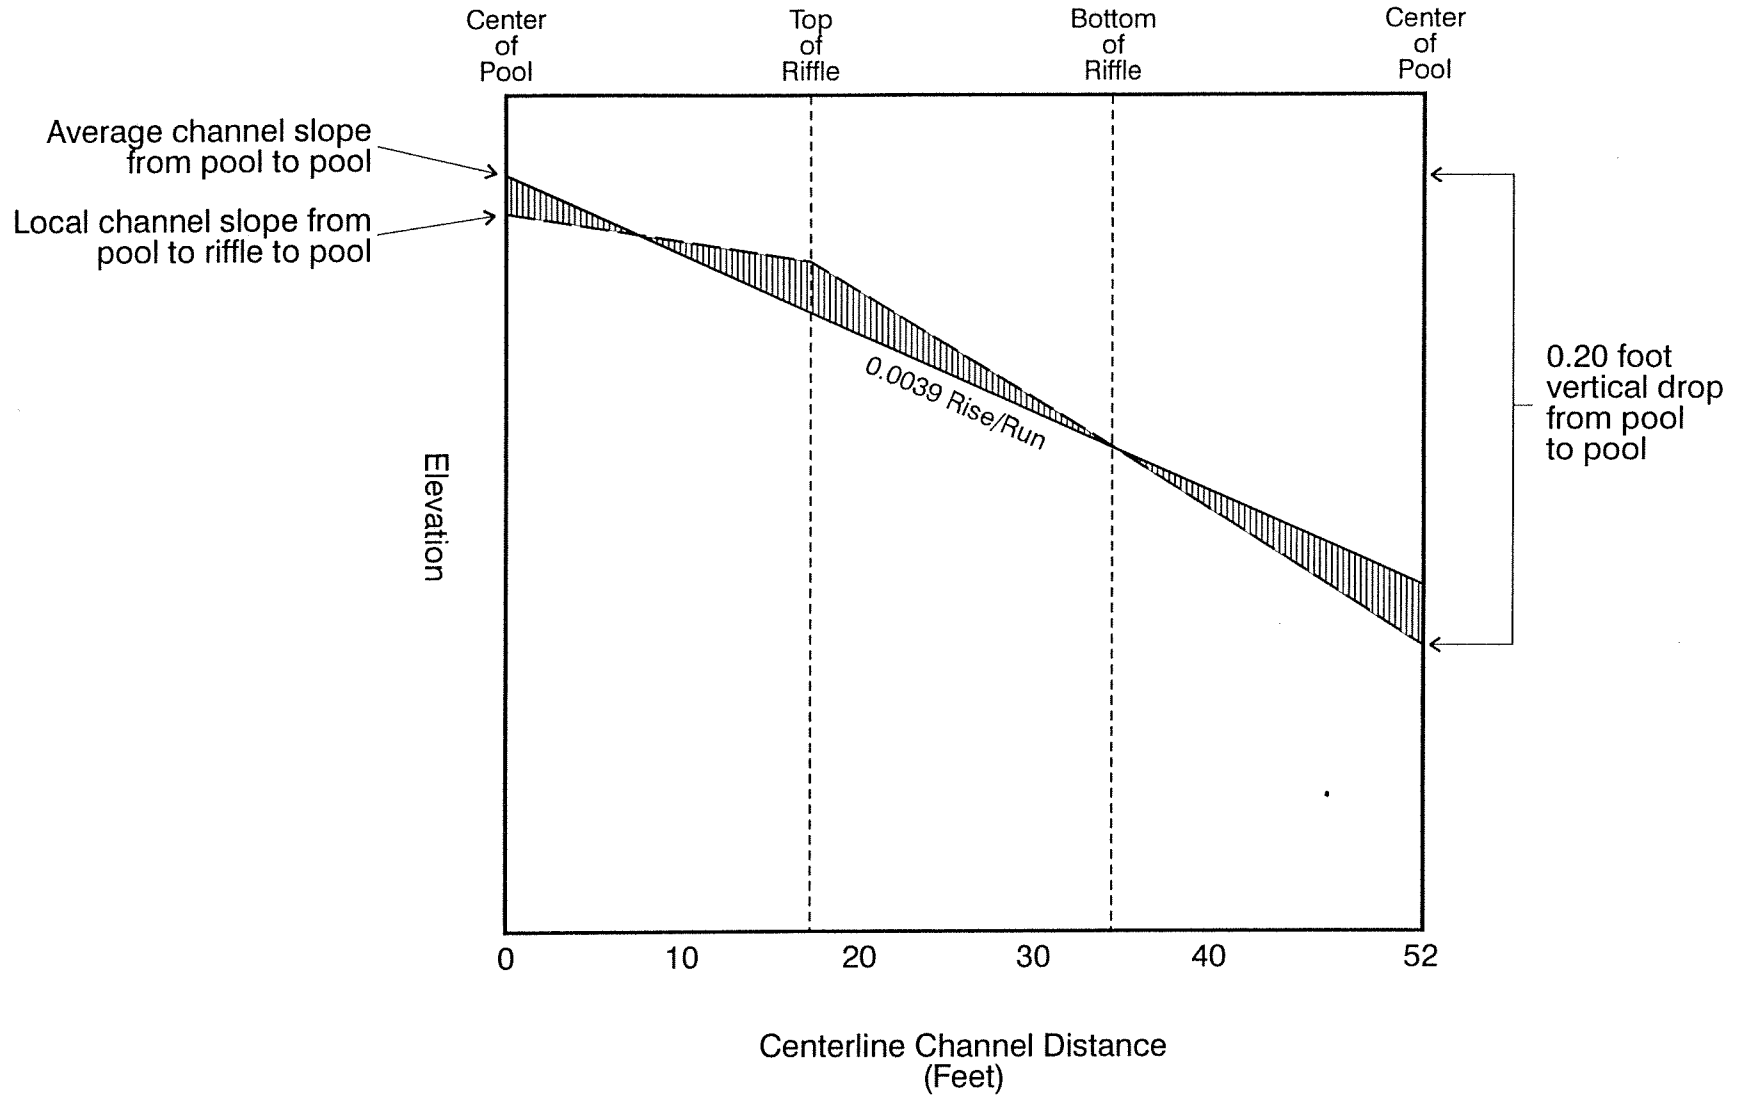
Figure:	16-2
Project:	ER96021.15
Date:	July 1997

Conceptual Depiction of Stream Channel Slope
Dutchman's Creek Mitigation Site
Wake County, North Carolina

The channel will be constructed to the dimensions depicted in three cross-sections in Figure 17. The cross-sections contain a thalweg to accommodate base flows and vary in width and depth based on location within each meander sequence. The slope within each meander sequence (from riffle to pool to riffle) will vary based on these cross-sections (Figure 16-2), but total slope within each meander wavelength will remain relatively constant at 0.0039 rise/run.
