ANNUAL REPORT FOR 2004

Dutchman's Creek Mitigation Site
Wake County
Project No. 8.U401721
TIP No. R-2000 WM

Prepared By:
Office of Natural Environment & Roadside Environmental Unit
North Carolina Department of Transportation
December 2004

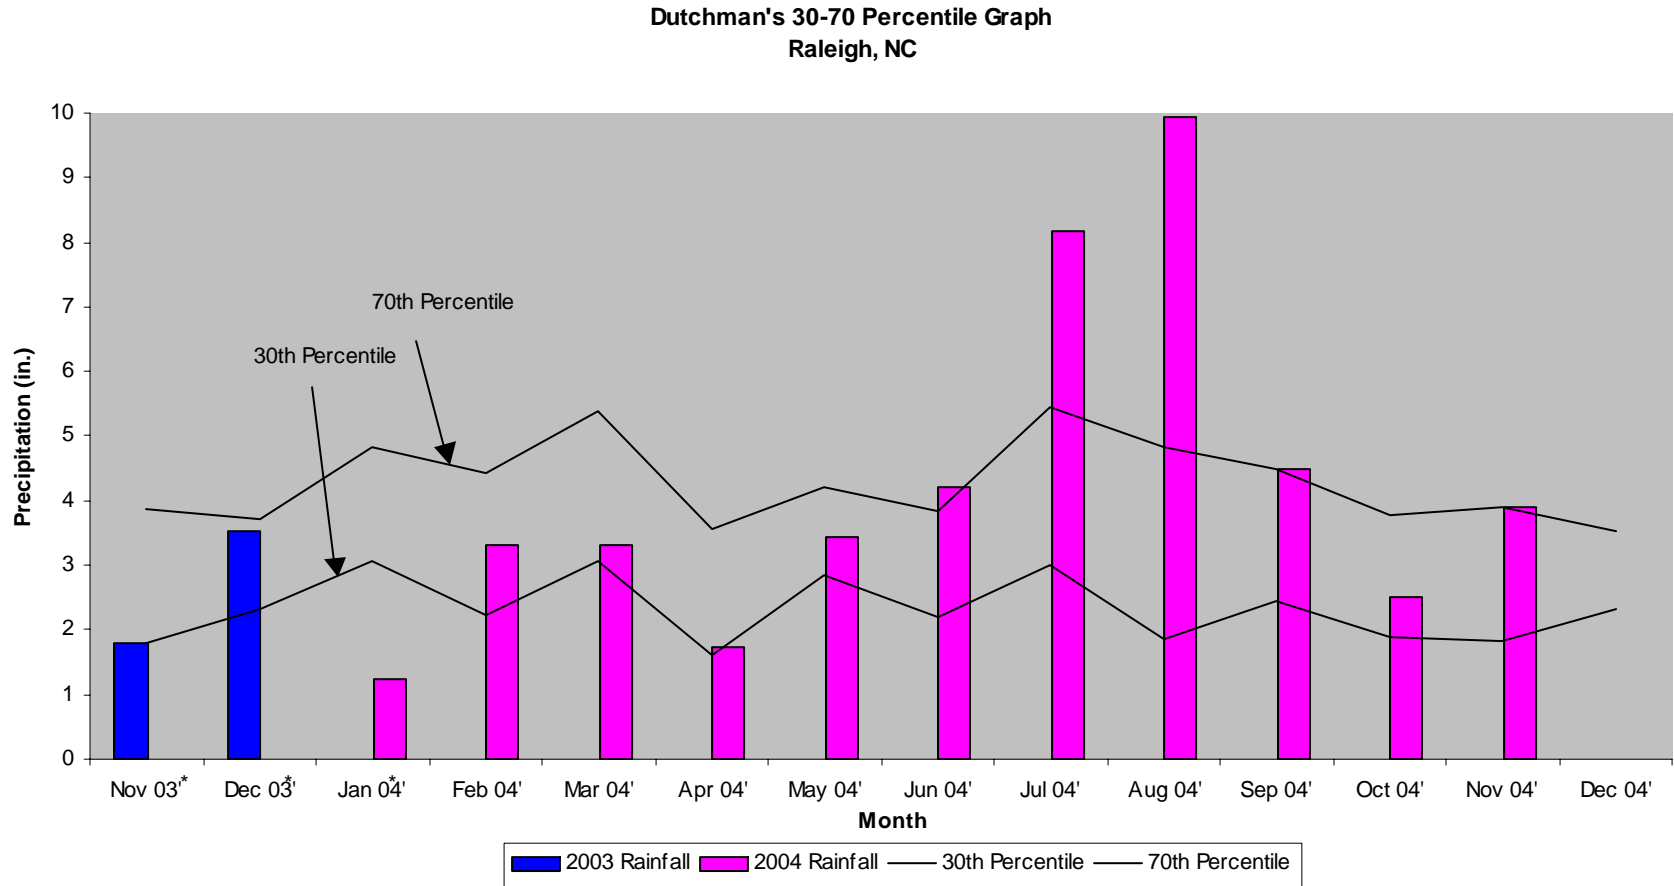
FIGURE 4: 30-70 Percentile Graph

Figure 4 provides an evaluation of the local climate in comparison with historical data in order to determine whether 2004 was “average” in terms of climate conditions. The two lines represent the 30th and 70th percentiles of monthly precipitation for Raleigh. The bars are the monthly rainfall totals for November 2003 through November 2004. The NC State Climate Office provided historical data from the Raleigh/Durham weather station.

Months with below average rainfall include January and April. November (03'), December (03'), February, March, May, and October experienced average rainfall. The months of June, July, August, September, and October all experienced above average rainfall for the year. Overall, the site experienced average to above average rainfall in 2004.

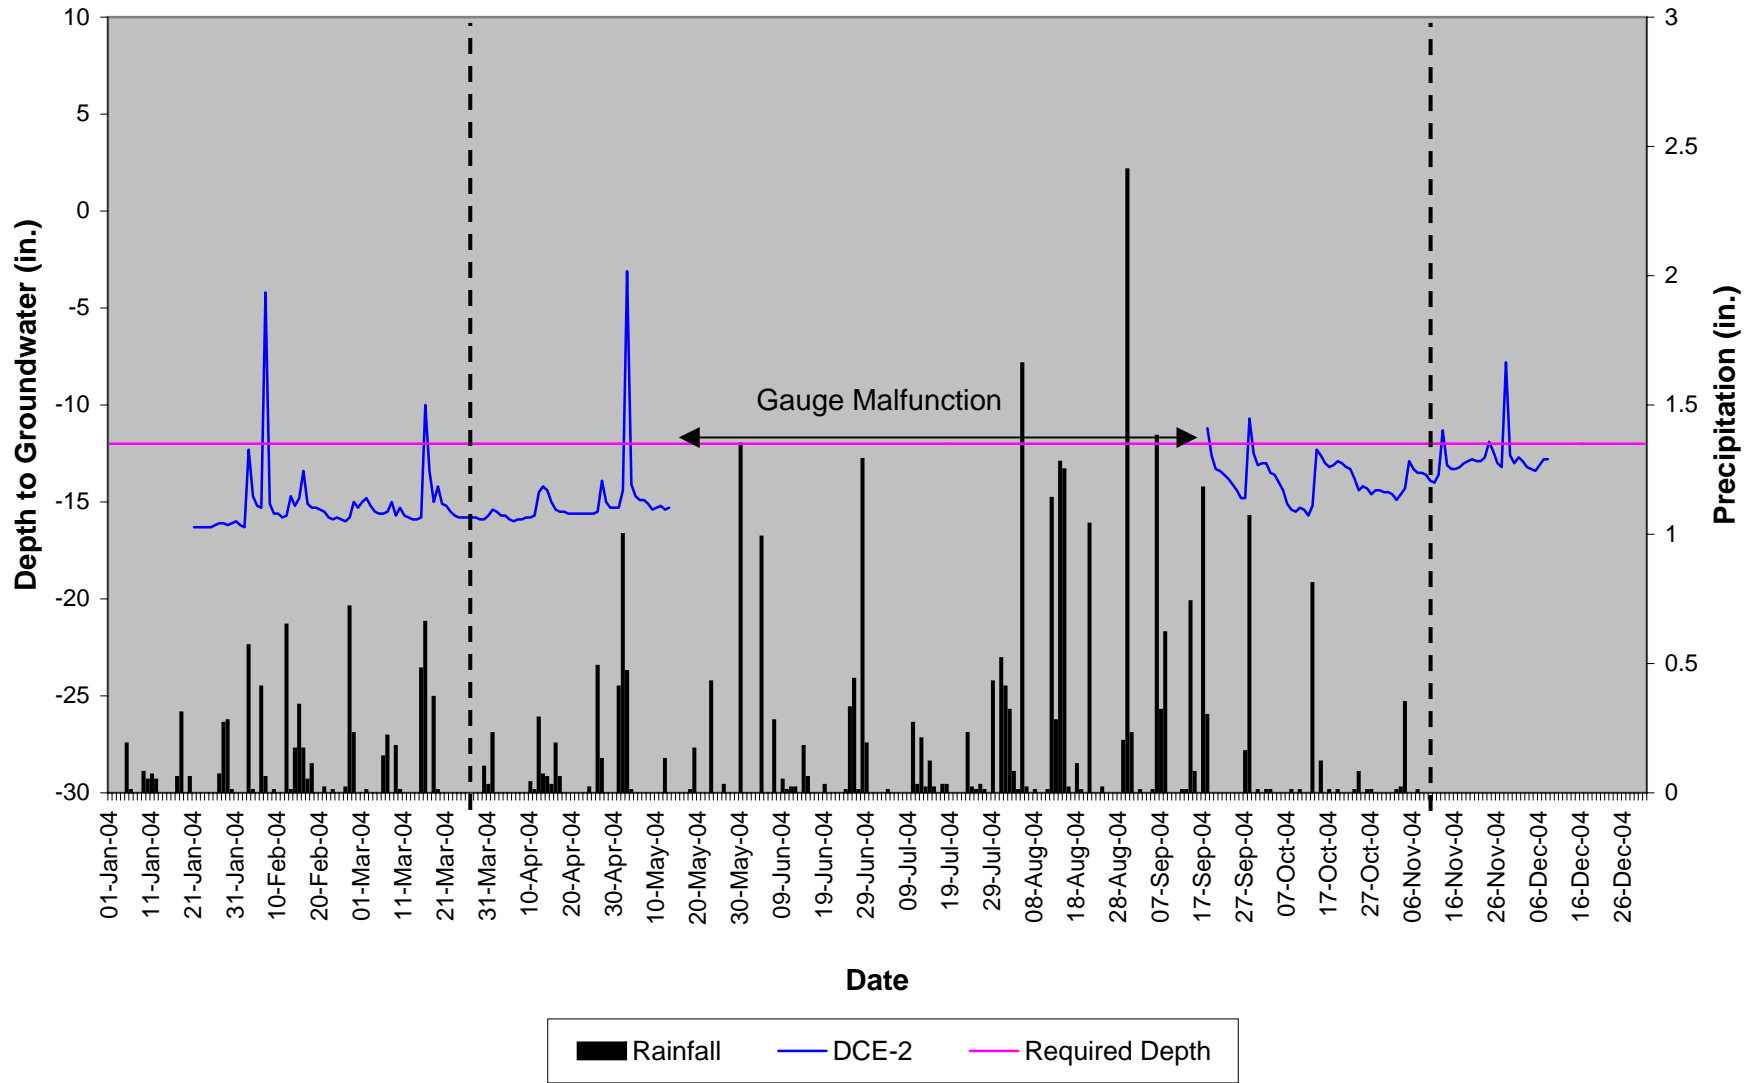
Dutchman's Creek DCE-2

Appendix A contains a plot of the groundwater depth for each monitoring well. If the gauge shows saturation for greater than 5% of the growing season, the maximum number of consecutive days is noted on each graph. The individual precipitation events are shown on the monitoring well graphs as bars.

- Gauge DCE-2 malfunctioned during the period from May 14 - September 17.

Monitoring Well	<5%	5-8%	8-12.5%	>12.5%	Actual %	Success Dates
DC-1+				×	39.1	March 26-May 11 Aug 13-Nov 10
DC-2+				×	20.0	March 26-May 10 Oct 12-Nov 10
DC-3	×				2.2	
DC-4+				×	27.0	March 26-May 26
DC-6+				×	27.0	March 31-May 26 July 18-Sept 17
DC-7	×				.4	
DCE-1	×				1.3	
DCE-2	×				.4
