ANNUAL REPORT FOR 2005

**Dutchman's Creek Mitigation Site
Wake County
EEP Project No. 121
NCDOT Project No. 8.U401721
TIP No. R-2000 WM**

January 2006

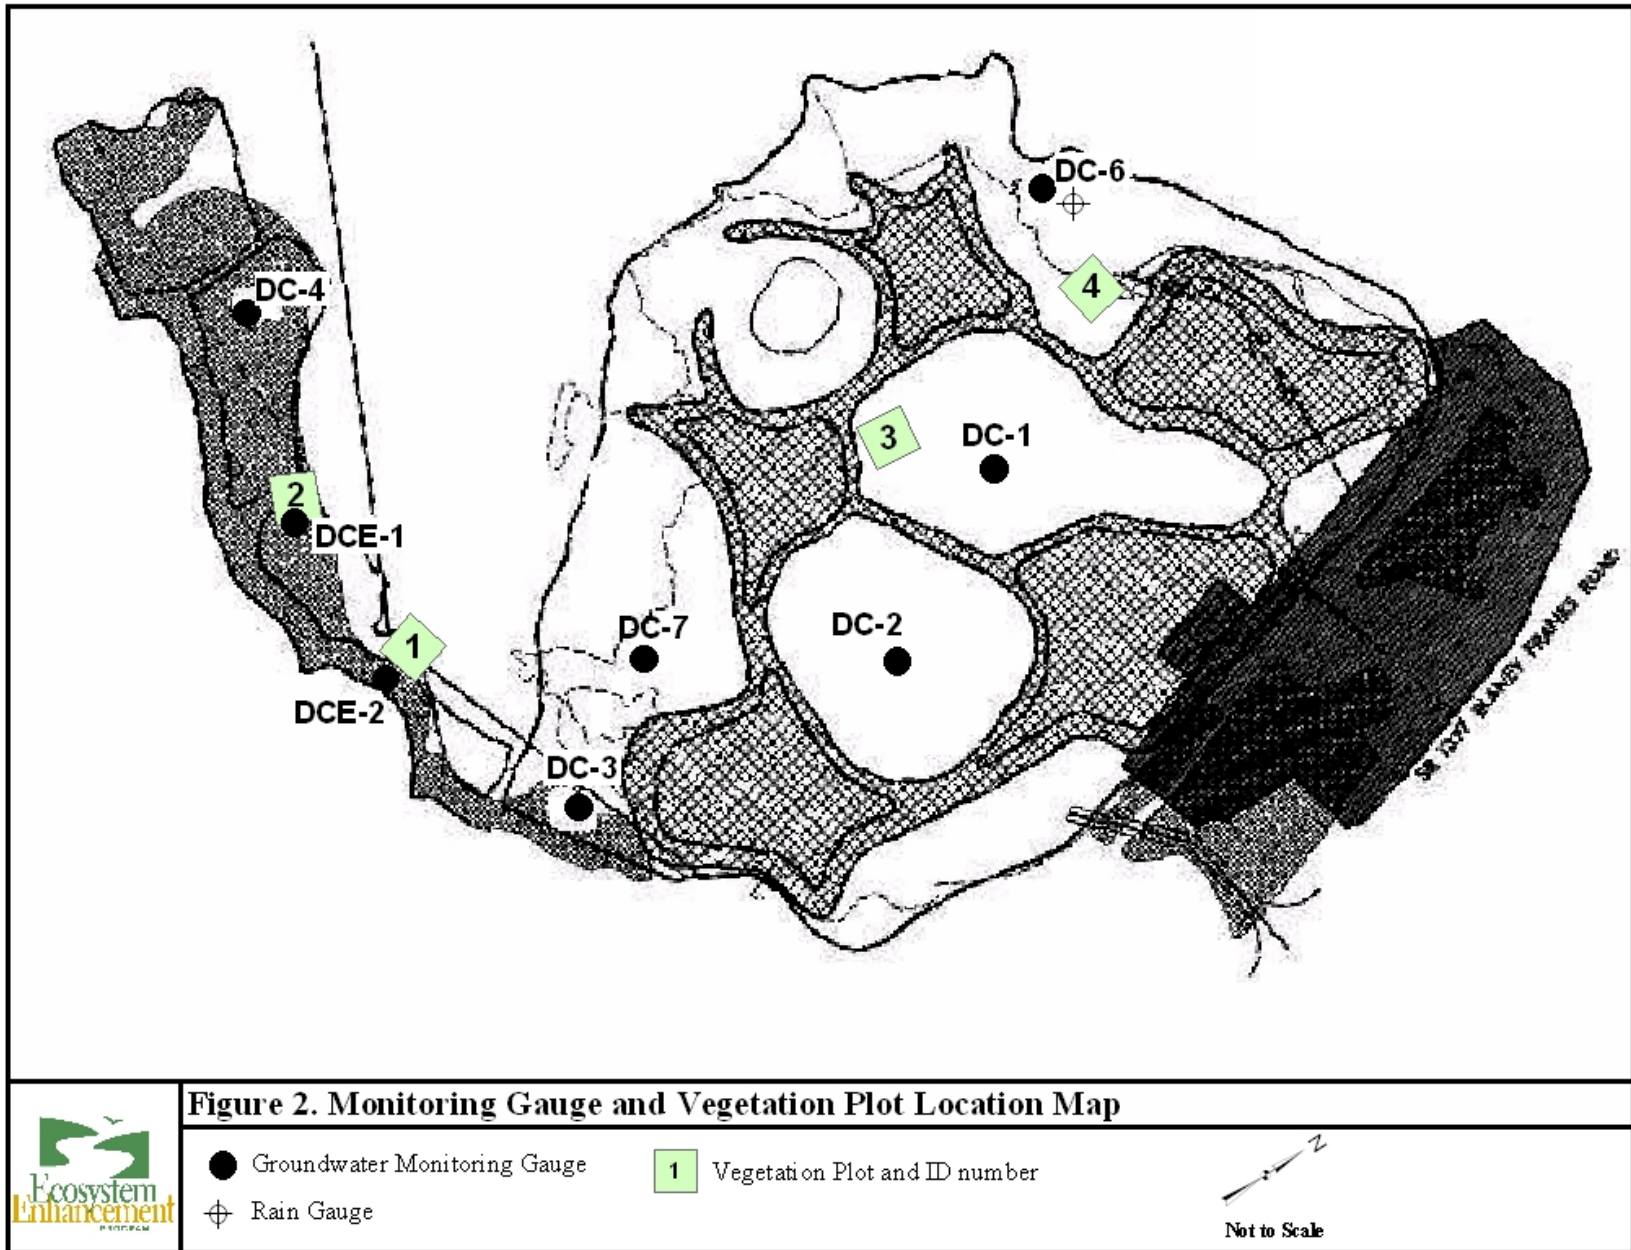
Figure 2. Monitoring Gauge and Vegetation Plot Location Map

In March of 2001, six groundwater-monitoring gauges were installed across the site (Figure 2). An additional groundwater gauge was installed in March 2002 based on an onsite agency review meeting. In April of 2003, two additional groundwater gauges were installed between gauges DC-3 and DC-4. After the 2003 monitoring season, the DC-5 gauge was not included in the monitoring results. The 2004 monitoring report fails to indicate why the monitoring of DC-5 was stopped. Currently, eight groundwater gauges and a rain gauge are used to monitor hydrology on the site. The automatic monitoring gauges record daily readings of groundwater depth.
