**DYE BRANCH STREAM  
RESTORATION PLAN**

**TOWN OF MOORESVILLE  
IREDELL COUNTY, NORTH CAROLINA**

**NORTH CAROLINA  
ECOSYSTEM ENHANCEMENT PROGRAM**

**OCTOBER 2005**

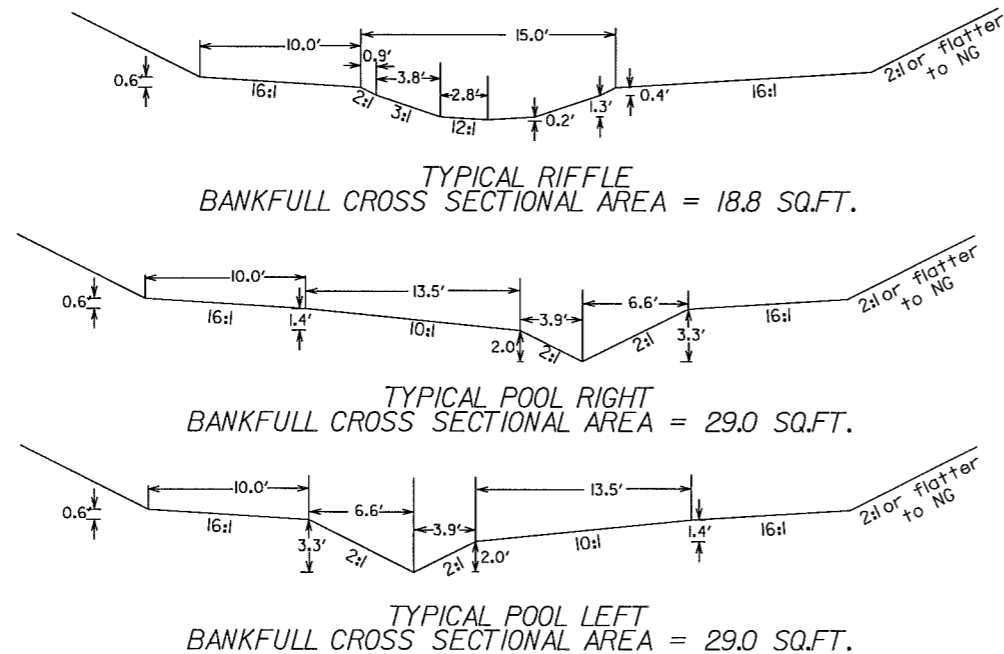
### DYE BRANCH - LOWER REACH (26+85 to 37+70)

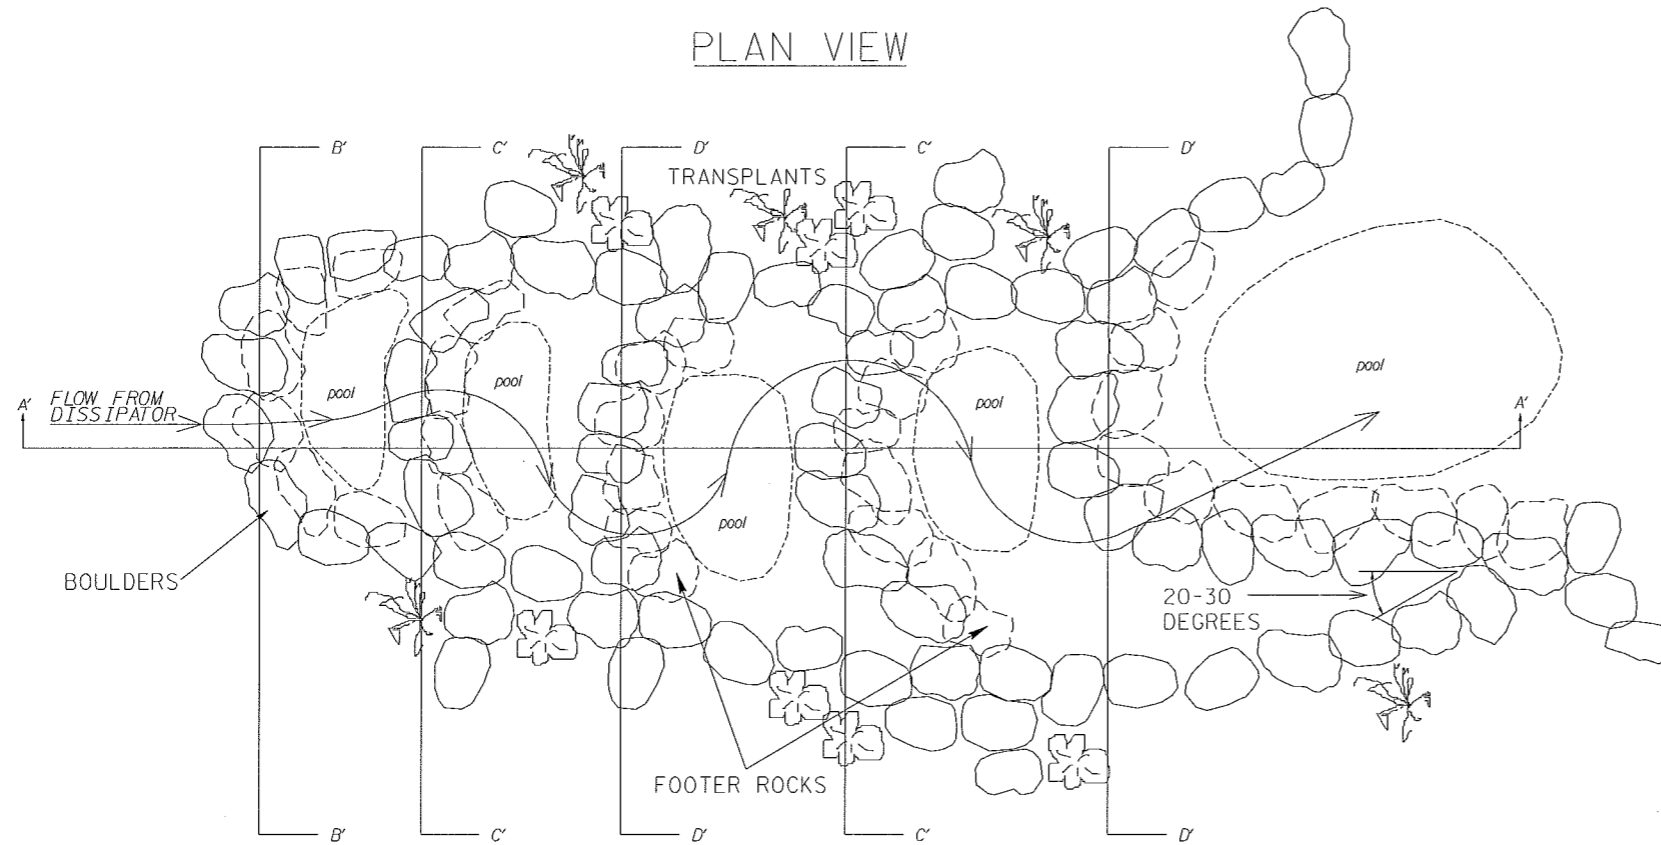
NOTE: BOULDERS SHOULD BE NATIVE QUARRIED ROCK OR LOCALLY SHOT ROCK, ANGULAR AND OBLONG WITH APPROXIMATE MINIMUM DIMENSIONS OF 4' X 3' X 2' FOR DYE BRANCH.

ROCKS SHOULD FIT TIGHTLY WITH MINIMAL SPACES

H = 0.3'  
 MAXIMUM DROP PER STEP = 1.0'  
 BACKFILL BEHIND STEPS WITH 3" WASHED STONE

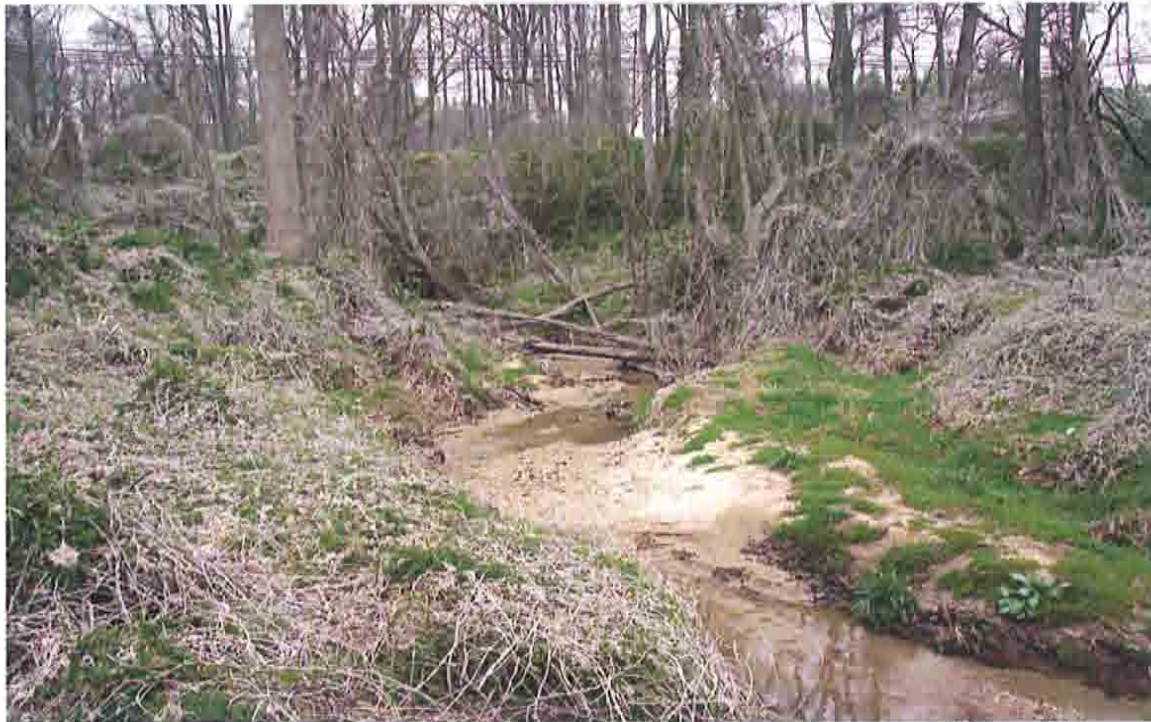
Debris in Dye Branch upper reach. Approximately 50 feet downstream of Center Ave.

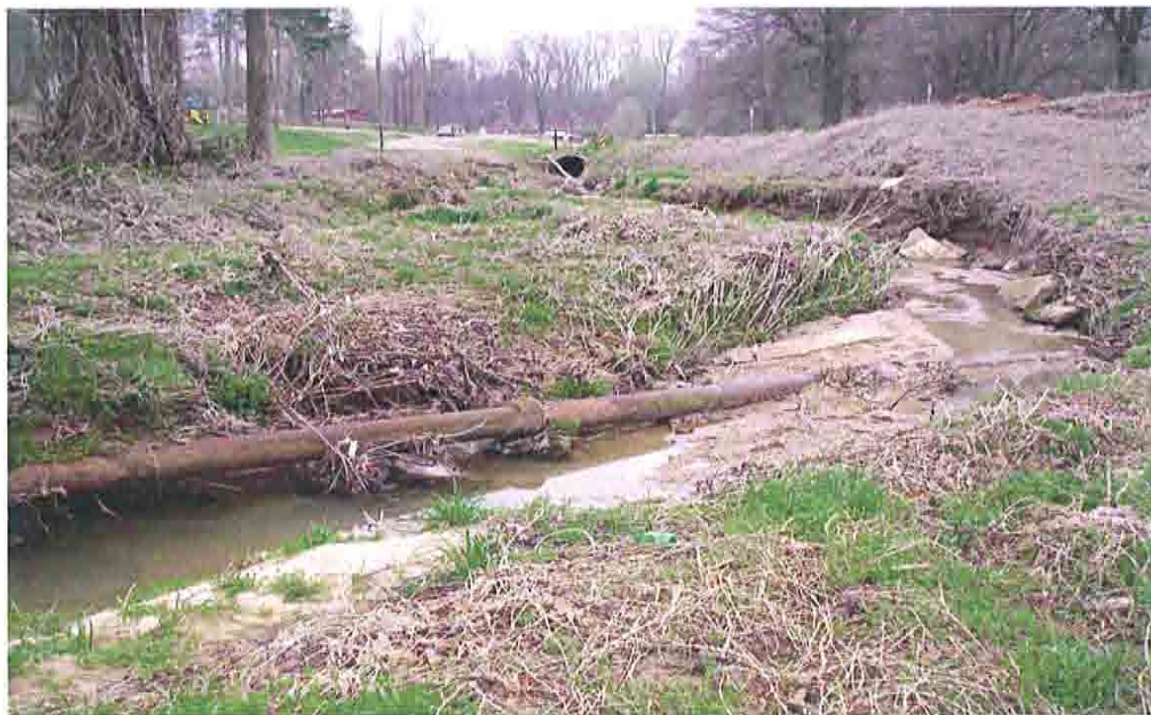
Old pipe in Dye Branch upper reach. Approximately 80 feet upstream of Mclelland Street culvert.

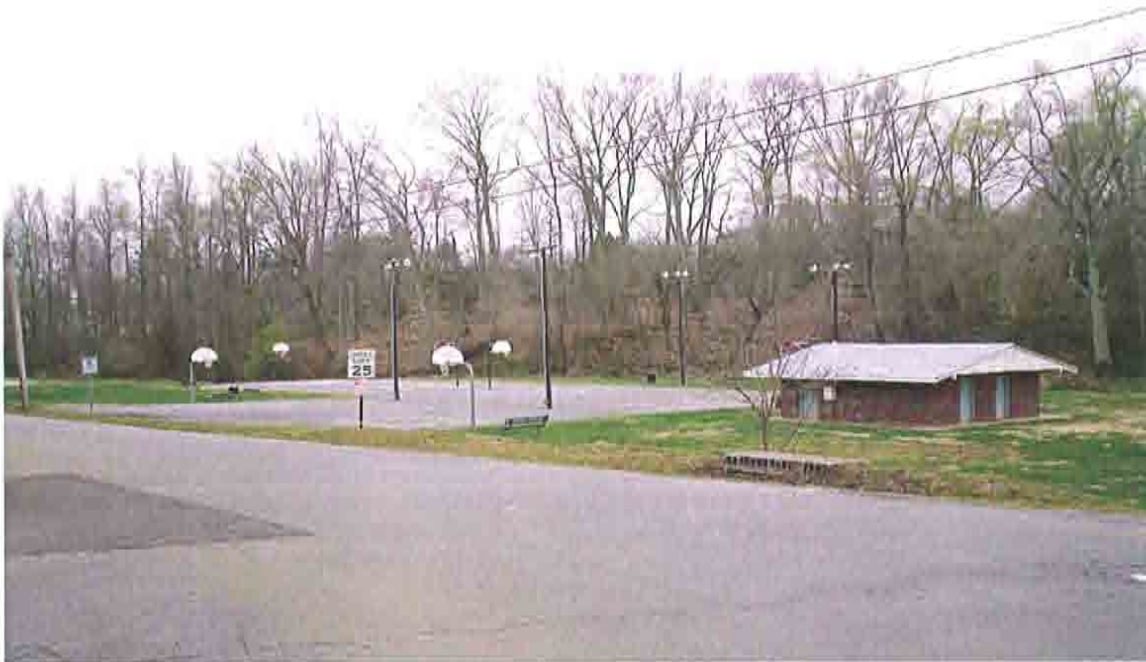
Existing basketball courts along middle reach of Dye Branch. Proposed area for channel relocation.

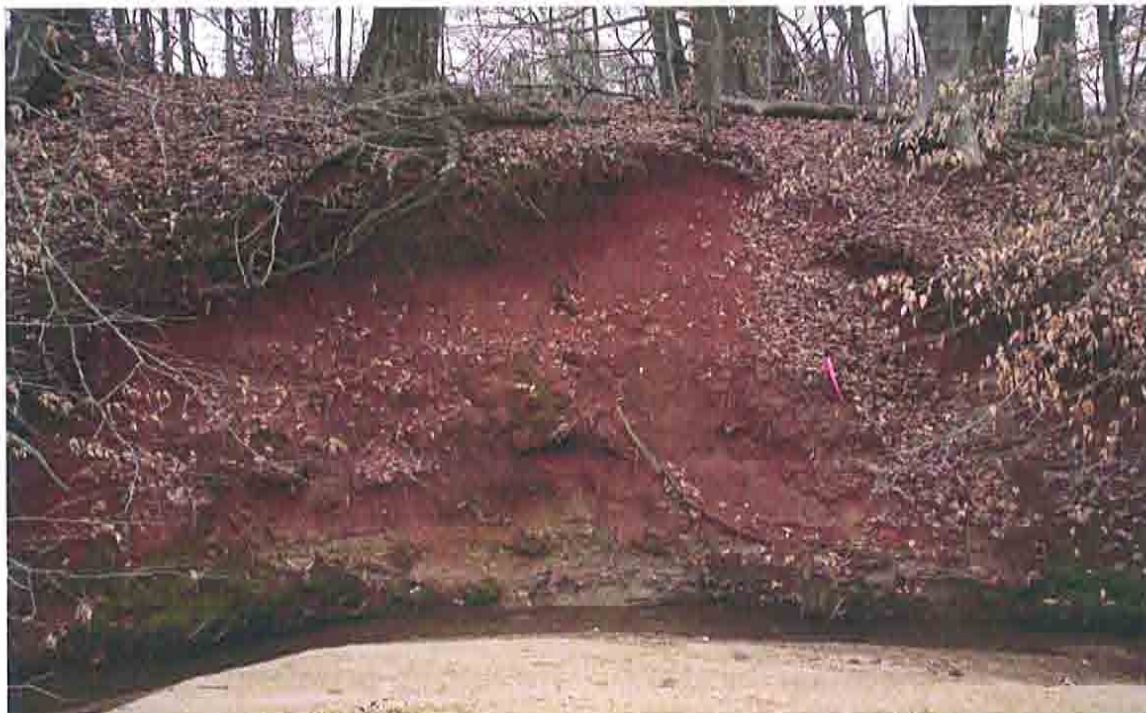
Eroded banks along western side of basketball courts. Dye Branch middle reach.

Dye Branch flows in close proximity to downtown Mooresville. The substantial amount of impervious surface and lack of vegetation throughout the watershed has contributed to the flashy flood conditions and actively eroding streambanks of the existing stream channel. Little to no riparian buffer exists along the stream within the project area, which has further exacerbated the destabilization of the stream.

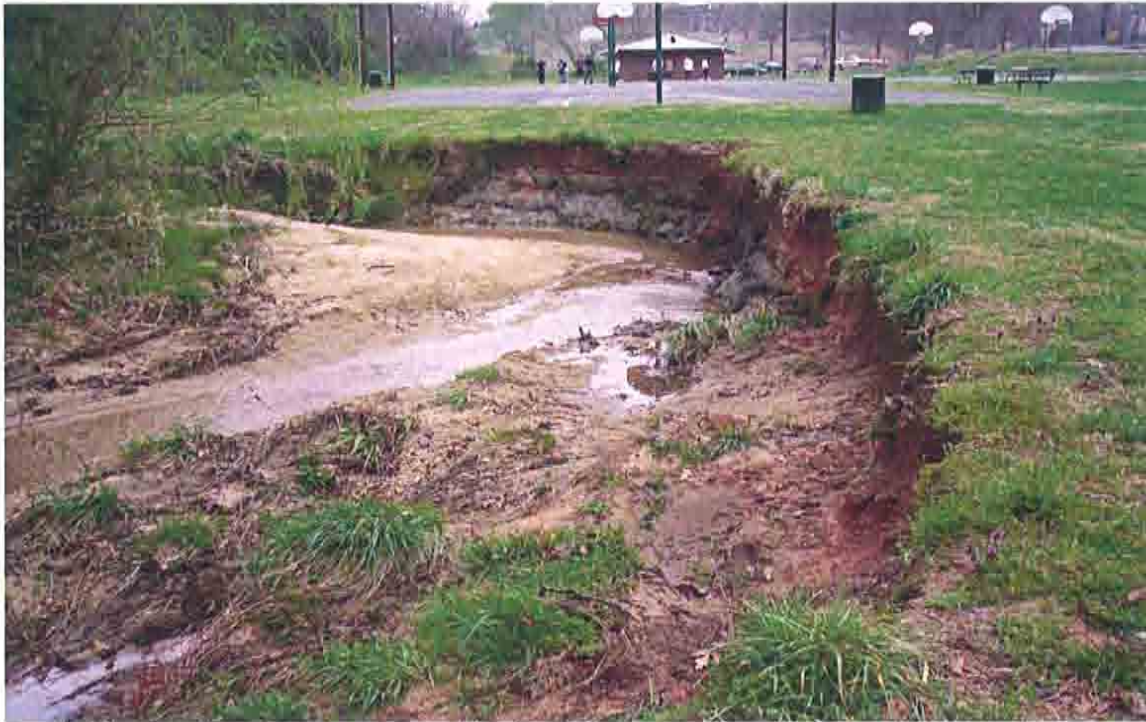
Eroded banks along southern end of basketball courts. Dye Branch middle reach.

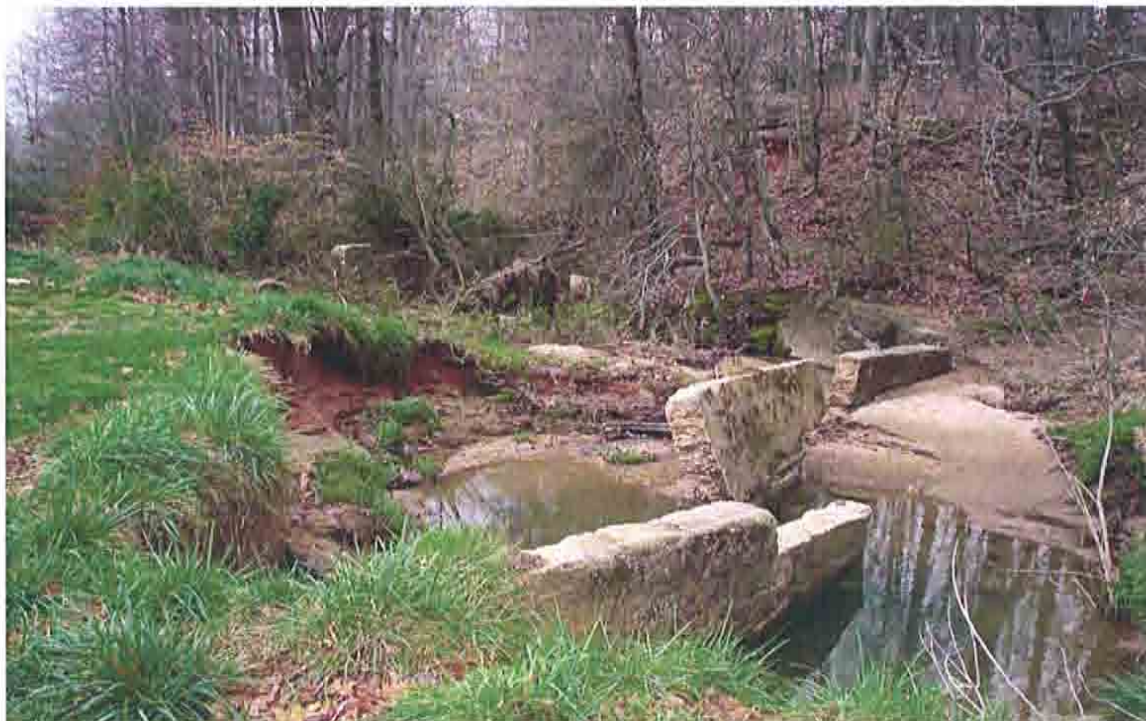
Concrete in stream on western side of basketball courts. Dye Branch middle reach looking downstream.

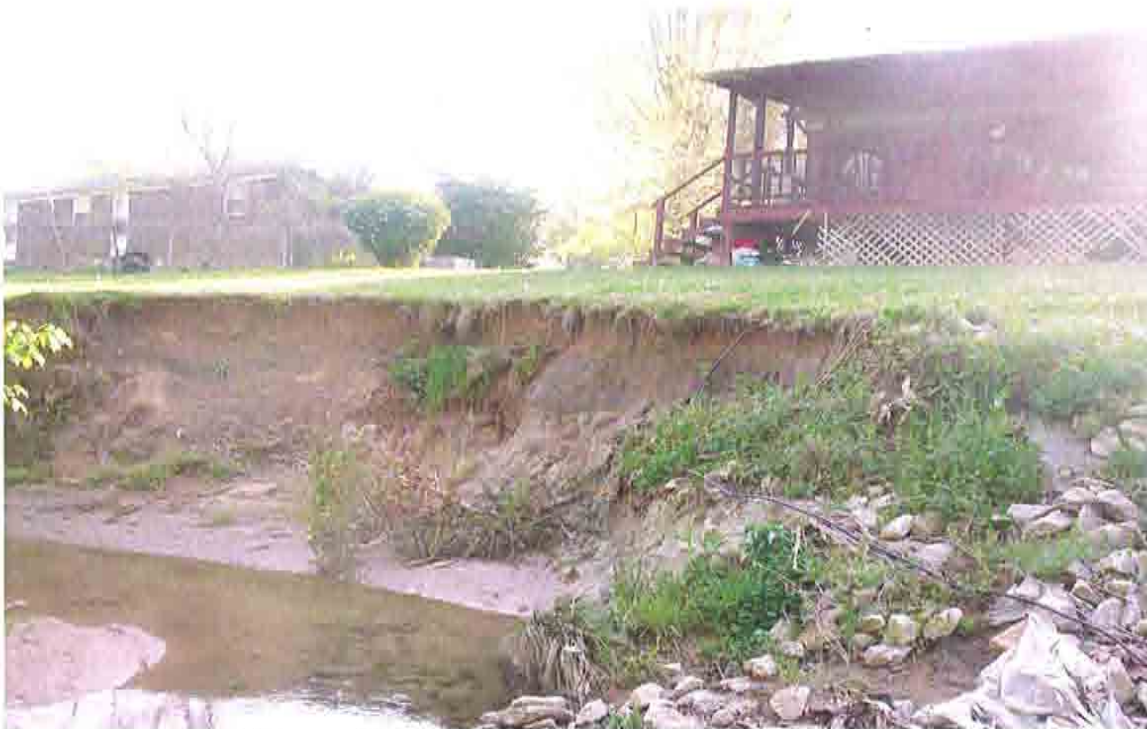
Eroded bank near Cabarrus Street, Dye Branch lower reach.

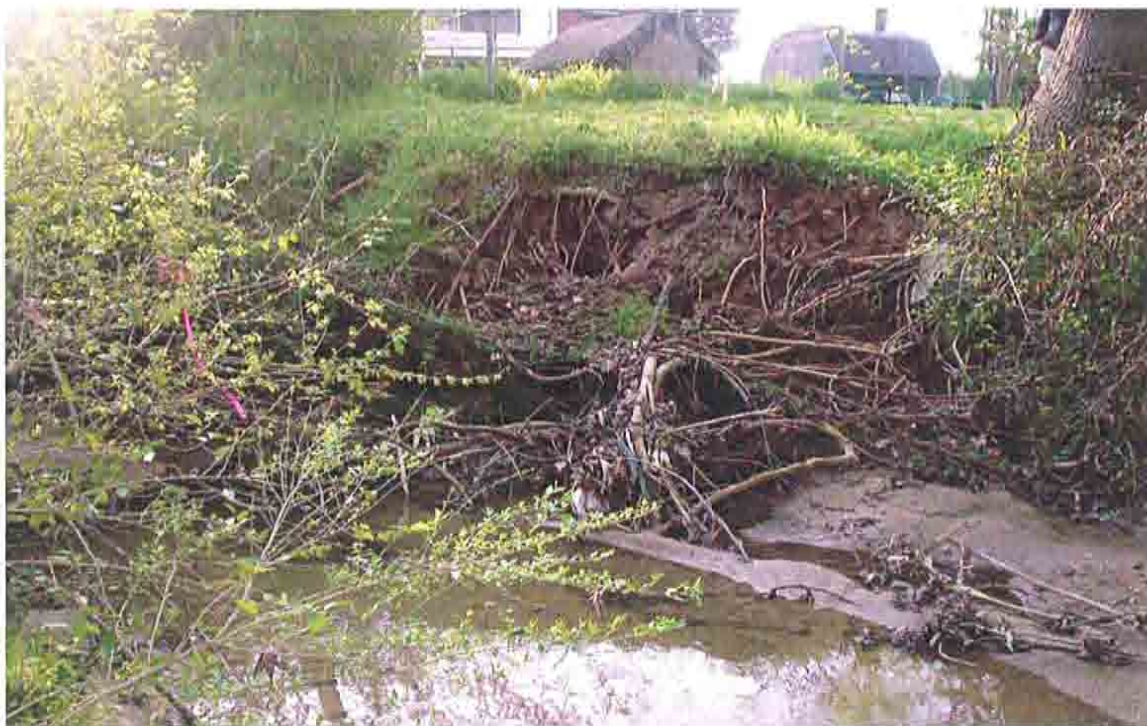
Eroded bank along last house before project ending boundary, Dye Branch lower reach.

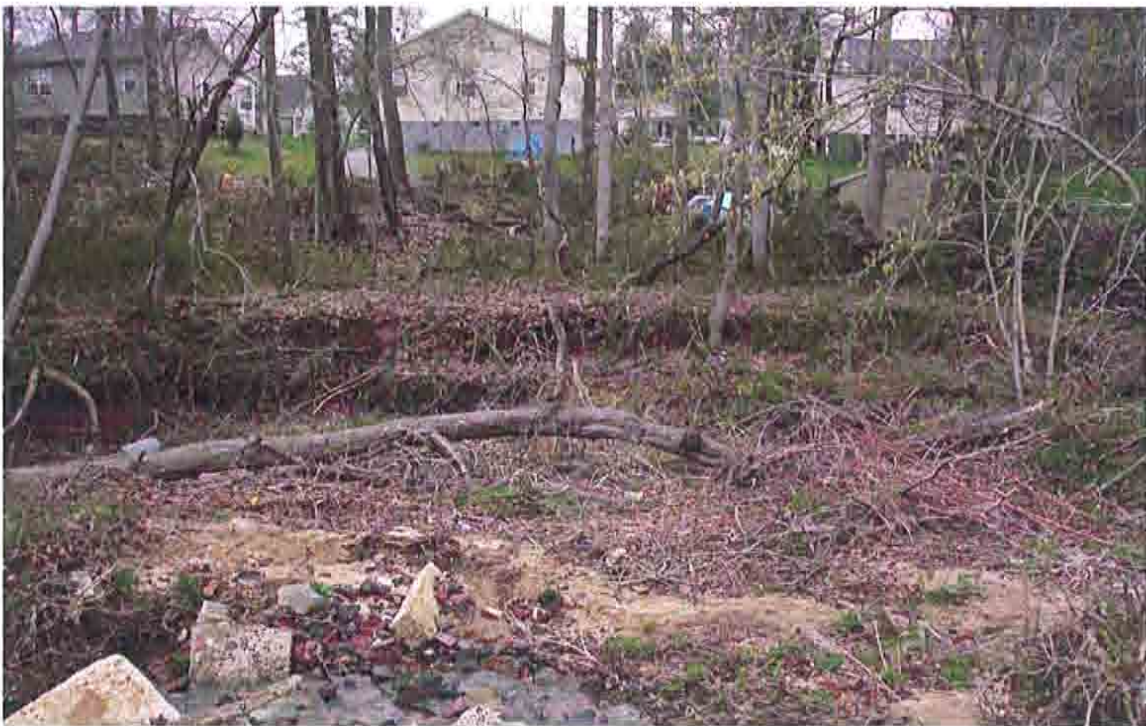
Photo Point 5. View looking at washout area approximately 50 ft. downstream of Cabarrus Avenue.
