**East Tarboro Canal Stream Restoration Project
Edgecombe County
North Carolina**

**CU: 03020103
SCO# 030603101
EEP Project No. 123**

**Year 2 Monitoring Report
November 15, 2009**

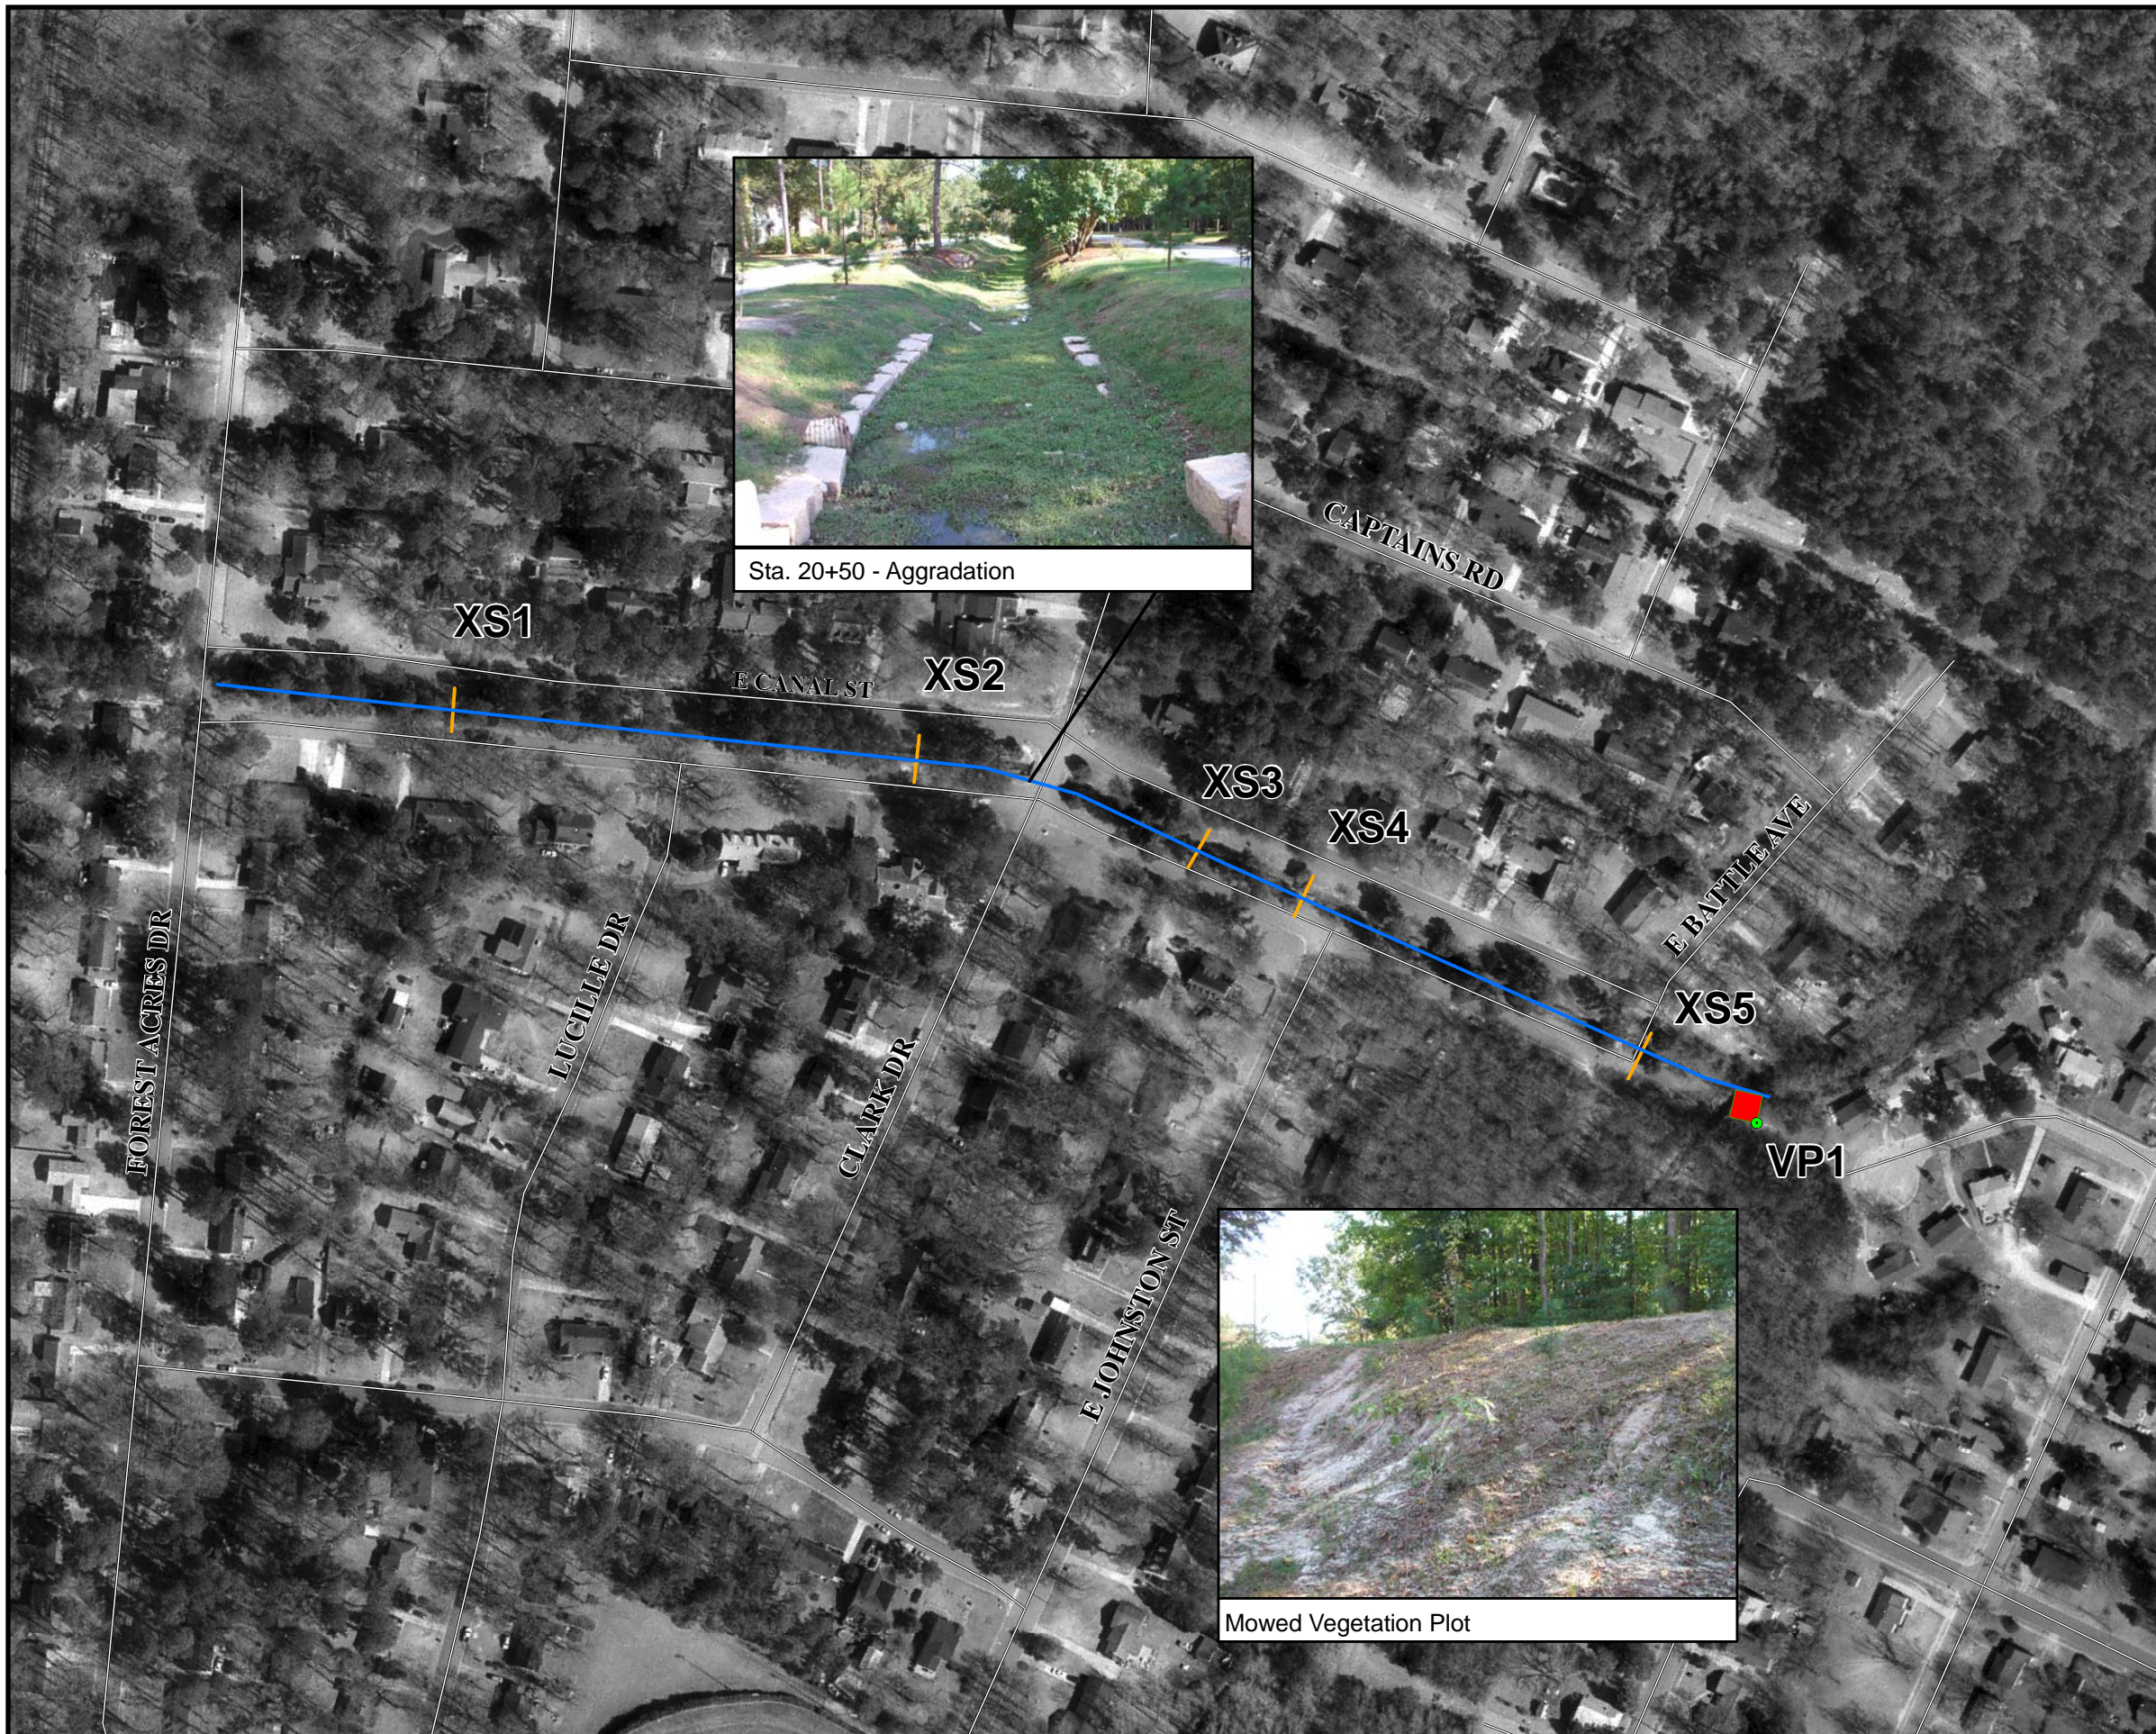
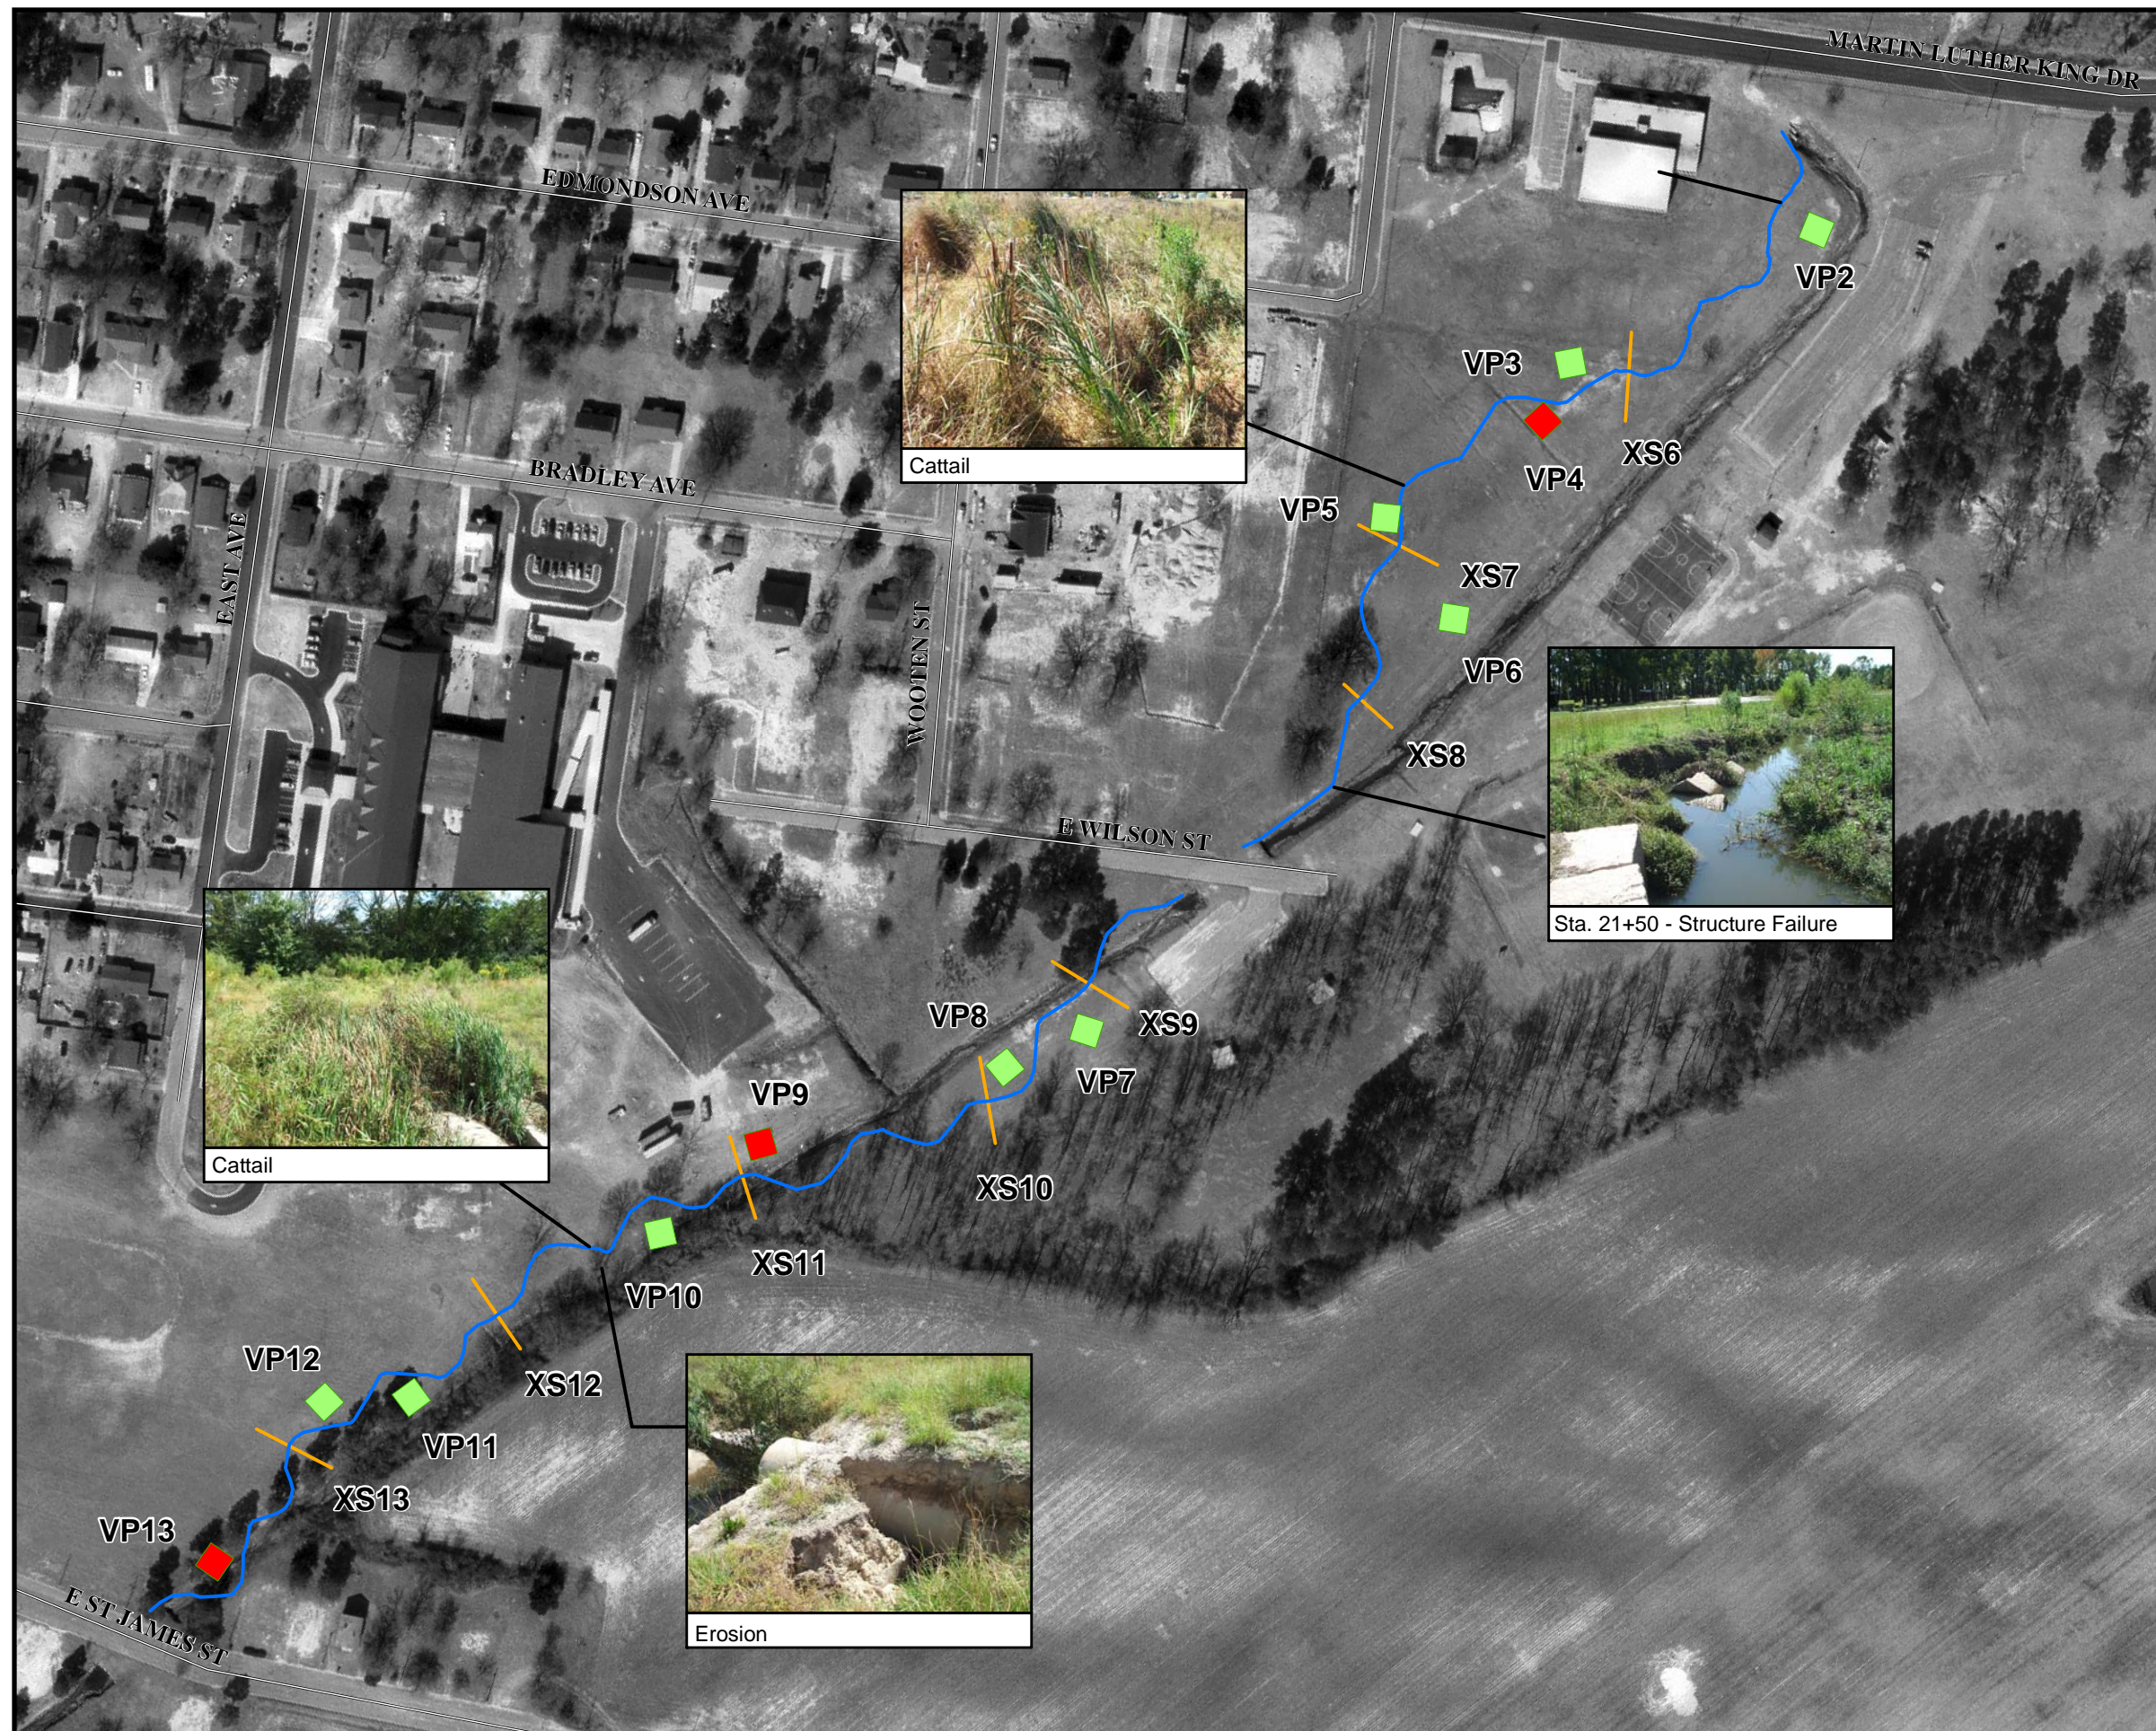
FIGURE 2a

Overall the East Tarboro Canal Stream Restoration Site is performing adequately. Channel dimension and pattern are similar to as-built conditions with the exception of the structure failure at station 21+50 and sediment erosion, both identified on Figure 2. Upon review of channel longitudinal profile, cross sections, and designed dimensions, both Reach 1 and Reach 2 channel profiles appear to be holding grade and maintaining bedform features. Stream reaches at East Tarboro Canal are stable and are showing few signs of instability. Reach 2 has a structure that is in need of immediate attention. Photos and location of these areas are shown in Figure 2.

Current Conditions Plan View
Reach 1

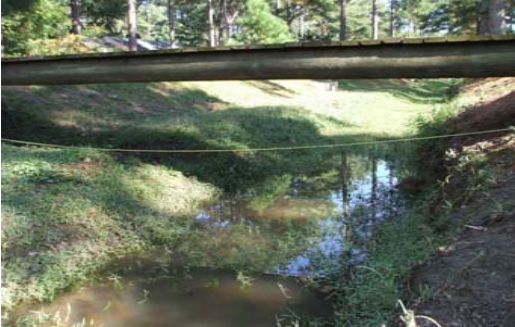
Photo of Cross-Section #1 - Looking Downstream

AsBuilt	2008	2009	2010	2011	2012
Area	13.72	11.5	13.40			
Width	10.26	13.3	13.60			
Mean Depth	1.34	0.9	1.00			
Max Depth	1.90	1.8	2.00			
W/D	7.66	14.8	13.90

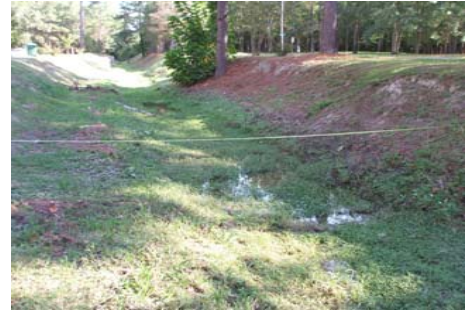
Photo of Cross-Section #3 - Looking Downstream

AsBuilt	2008	2009	2010	2011	2012
Area	14.78	14.30	14.20			
Width	11.62	10.90	11.20			
Mean Depth	1.27	1.30	1.30			
Max Depth	1.76	1.80	2.00			
W/D	9.15	8.40	8.80

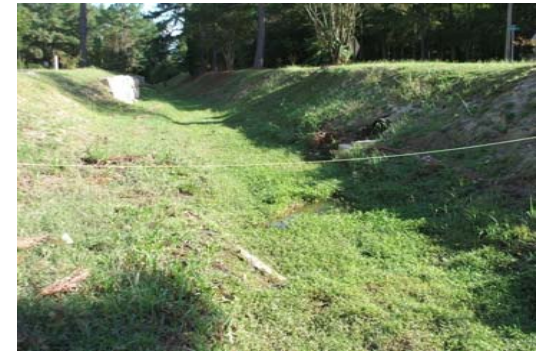
Photo of Cross-Section #4 - Looking Downstream

AsBuilt	2008	2009	2010	2011	2012
Area	12.05	12.60	12.03			
Width	11.04	10.90	14.48			
Mean Depth	1.09	1.20	0.83			
Max Depth	1.70	2.20	2.13			
W/D	10.13	9.40	17.40

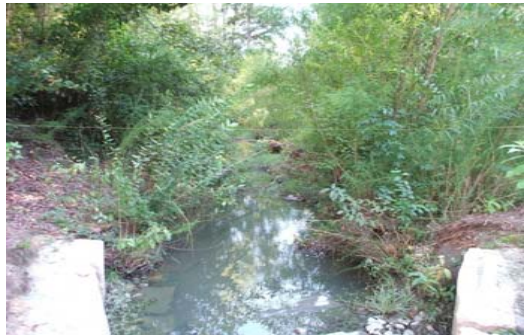
Photo of Cross-Section #5 - Looking Downstream

AsBuilt	2008	2009	2010	2011	2012
Area	16.42	25.60	15.33			
Width	11.63	13.00	10.08			
Mean Depth	1.41	2.80	1.52			
Max Depth	2.44	2.00	1.74			
W/D	8.25	6.60	6.60

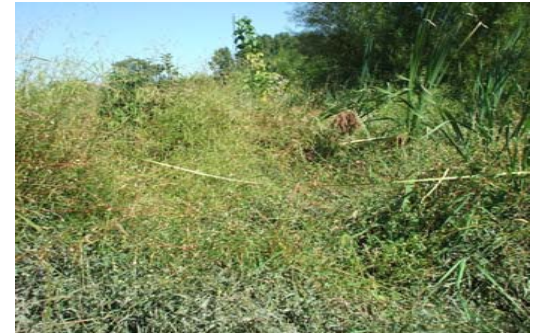
Photo of Cross-Section #6 - Looking Downstream

East Tarboro Canal 2009 Cross Section 6 - Reach 2

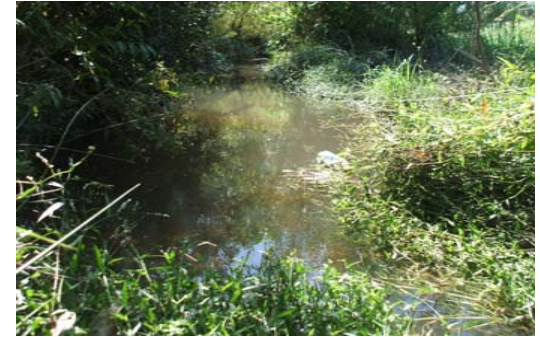
Photo of Cross-Section #7 - Looking Upstream

AsBuilt	2008	2009	2010	2011	2012
Area	31.22	30.00	19.60			
Width	22.54	26.80	23.54			
Mean Depth	1.39	1.10	0.83			
Max Depth	3.50	4.20	3.72			
W/D	16.22	23.90	29.00

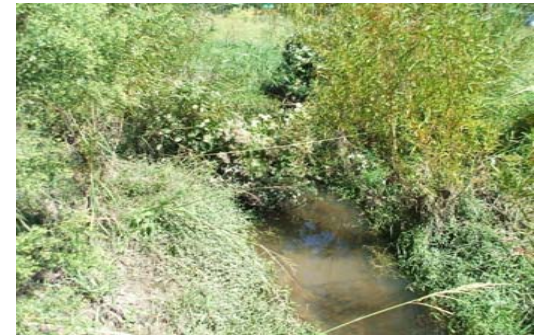
Photo of Cross-Section #8 - Looking Downstream

AsBuilt	2008	2009	2010	2011	2012
Area	22.99	12.10	14.30			
Width	20.60	12.70	15.13			
Mean Depth	1.12	1.00	0.95			
Max Depth	2.60	3.00	2.61			
W/D	18.39	13.30	16.00

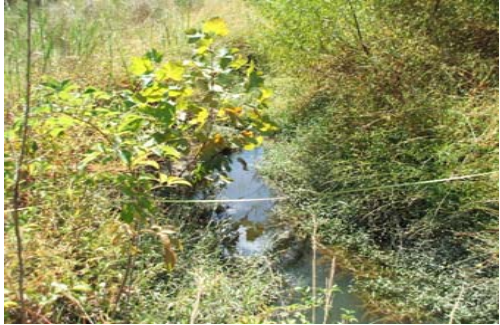
Photo of Cross-Section #9 - Looking Downstream

AsBuilt	2008	2009	2010	2011	2012
Area	27.34	22.11	23.30			
Width	19.36	34.70	14.00			
Mean Depth	1.41	0.50	1.70			
Max Depth	3.21	4.90	3.30			
W/D	13.73	66.90	8.40

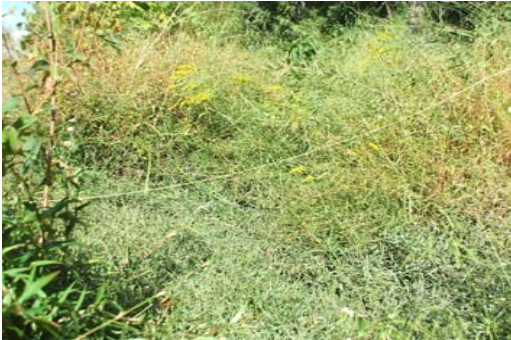
Photo of Cross-Section #10 - Looking Downstream

AsBuilt	2008	2009	2010	2011	2012
Area	25.78	21.60	19.96			
Width	20.60	22.70	19.52			
Mean Depth	1.25	1.00	1.02			
Max Depth	2.63	2.90	2.66			
W/D	16.48	23.80	19.10

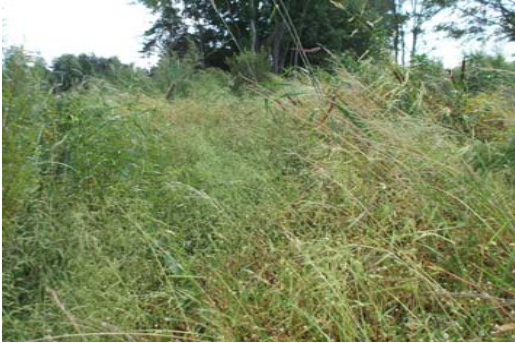
Photo of Cross-Section #11 - Looking Downstream

AsBuilt	2008	2009	2010	2011	2012
Area	26.71	18.20	18.07			
Width	18.93	15.10	18.77			
Mean Depth	1.41	1.20	0.96			
Max Depth	2.68	2.90	2.94			
W/D	13.43	12.60	19.50

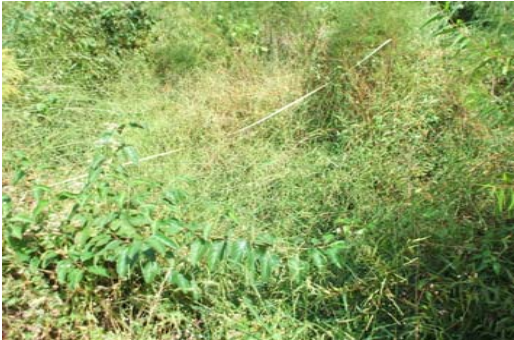
Photo of Cross-Section #12 - Looking Downstream

AsBuilt	2008	2009	2010	2011	2012
Area	24.83	12.90	14.28			
Width	18.13	15.60	17.98			
Mean Depth	1.37	0.80	0.79			
Max Depth	2.52	2.30	2.18			
W/D	13.23	18.90	22.60

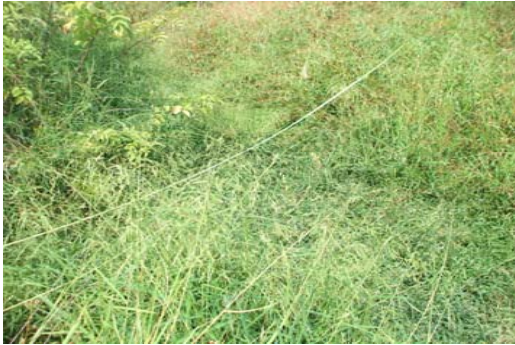
Photo of Cross-Section #13 - Looking Downstream

AsBuilt	2008	2009	2010	2011	2012
Area	26.73	13.50	11.43			
Width	21.52	9.60	10.99			
Mean Depth	1.24	1.40	1.04			
Max Depth	2.96	2.70	2.26			
W/D	17.35	6.90	10.60

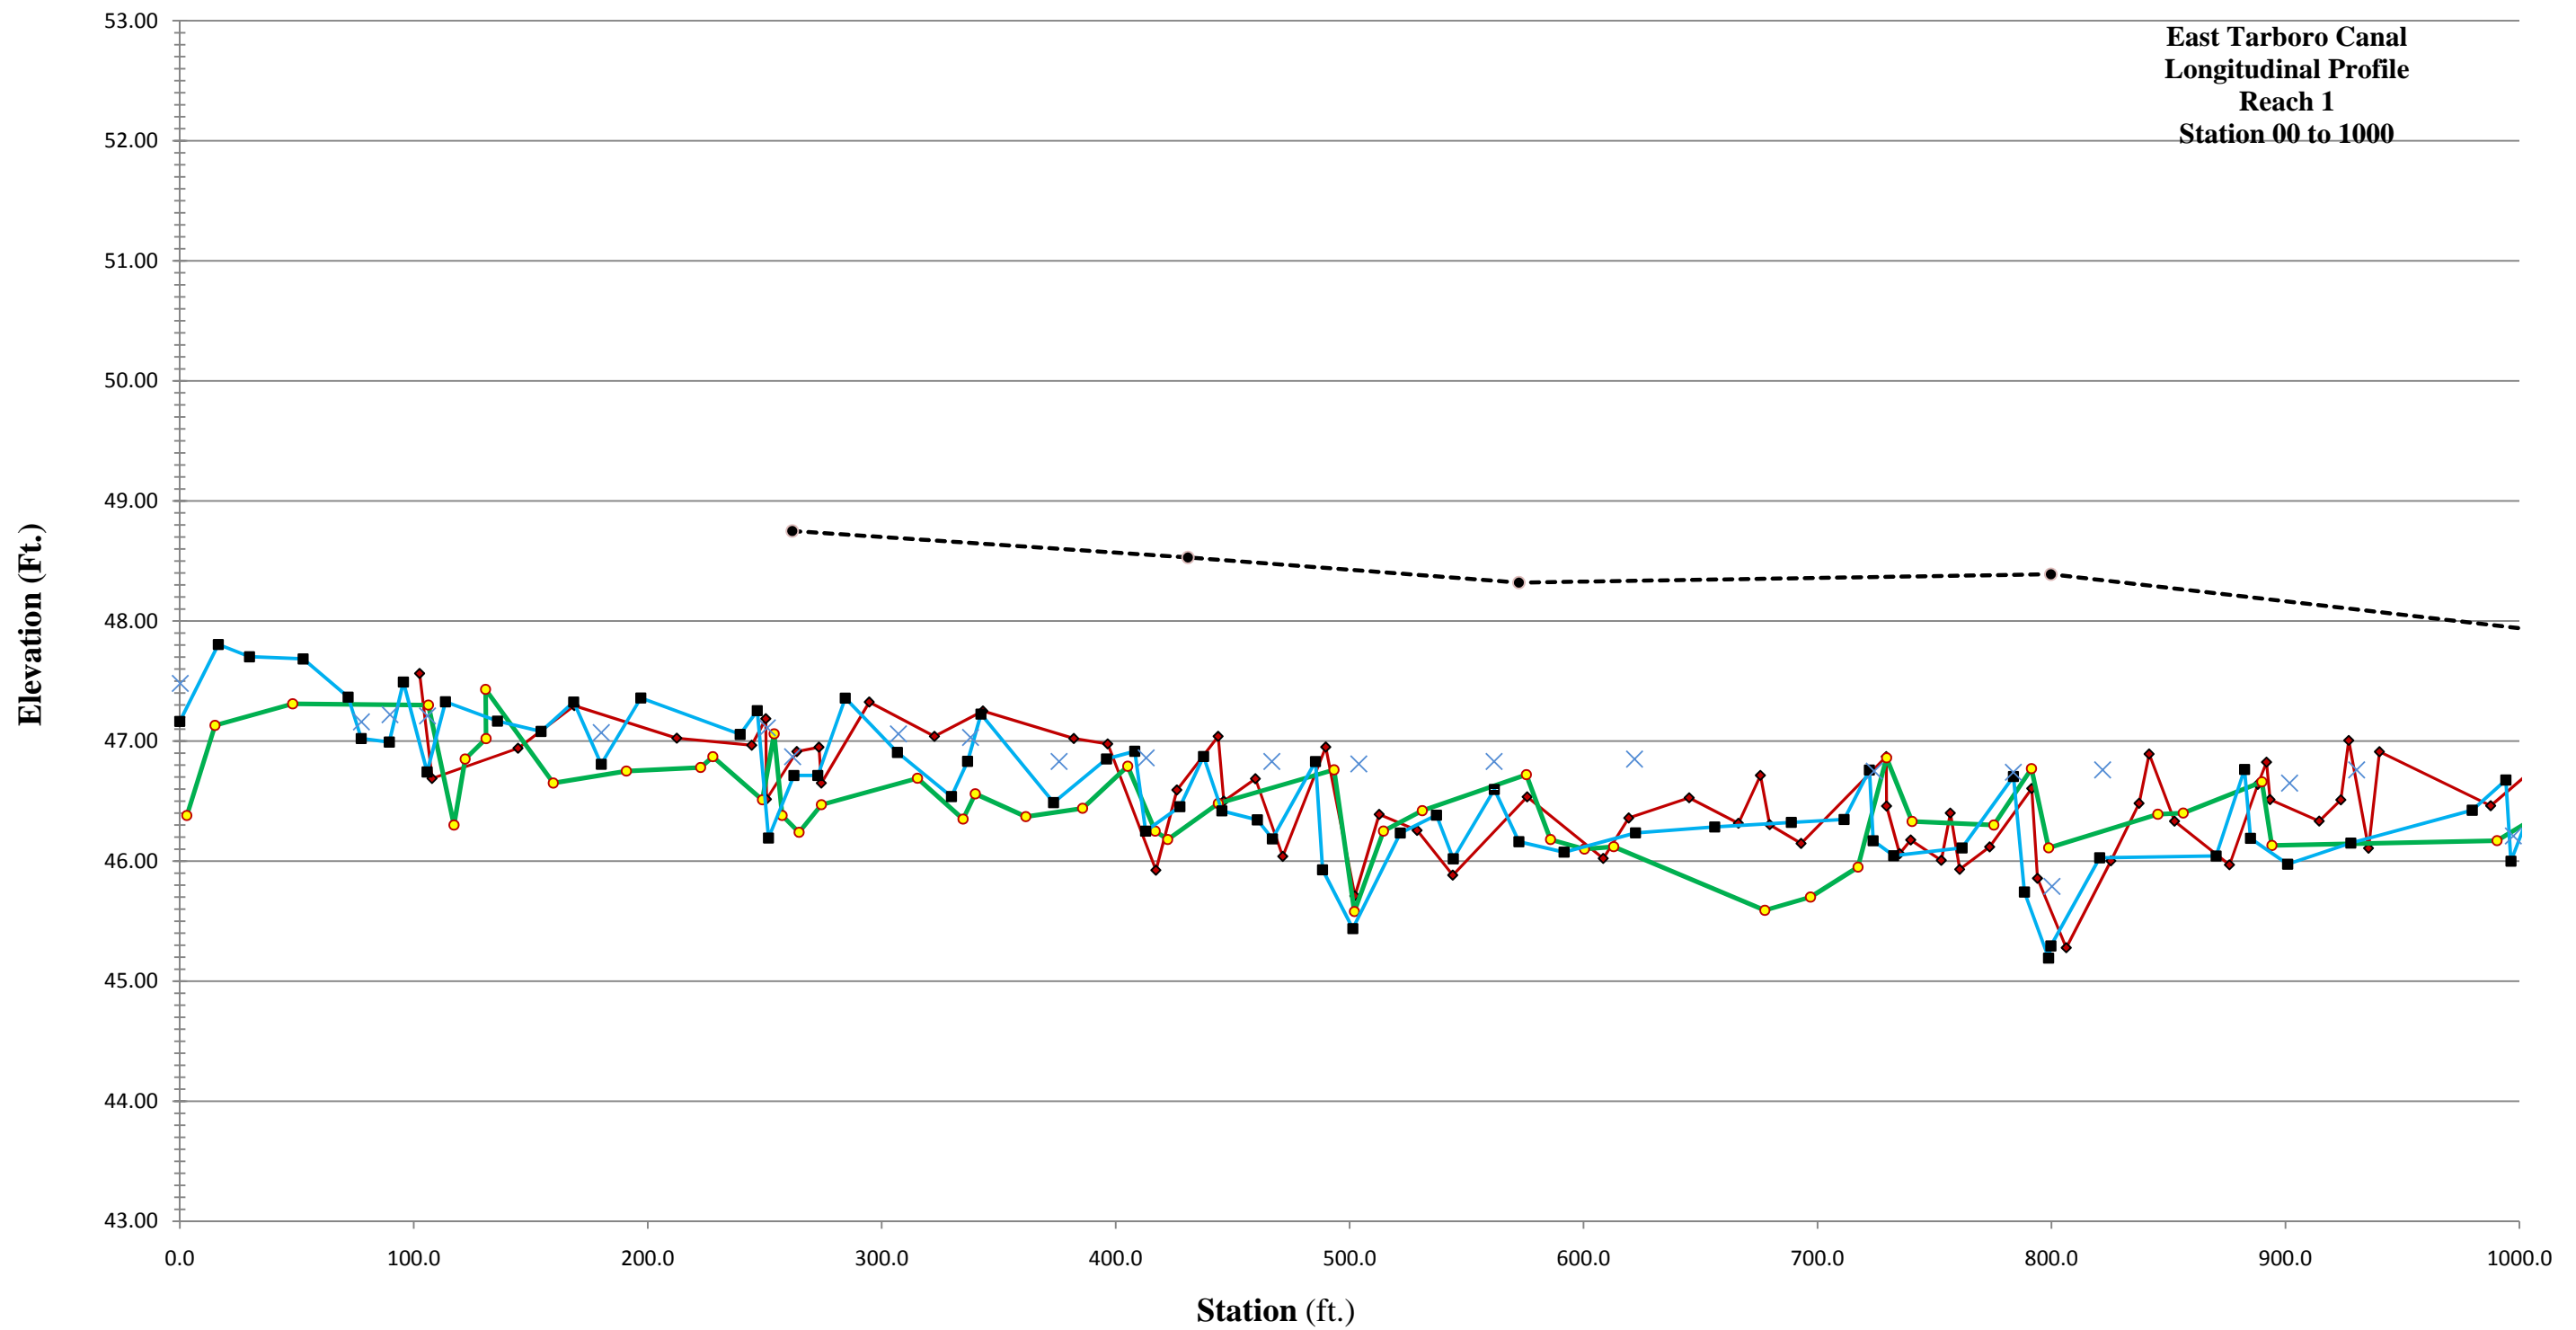
East Tarboro Canal
Longitudinal Profile
Reach 1
Station 00 to 1000

◆ 2008 Thalweg ● As-Built ■ 2009 Thalweg - - ● - - 2009 Bankfull × 2009 Water Surface

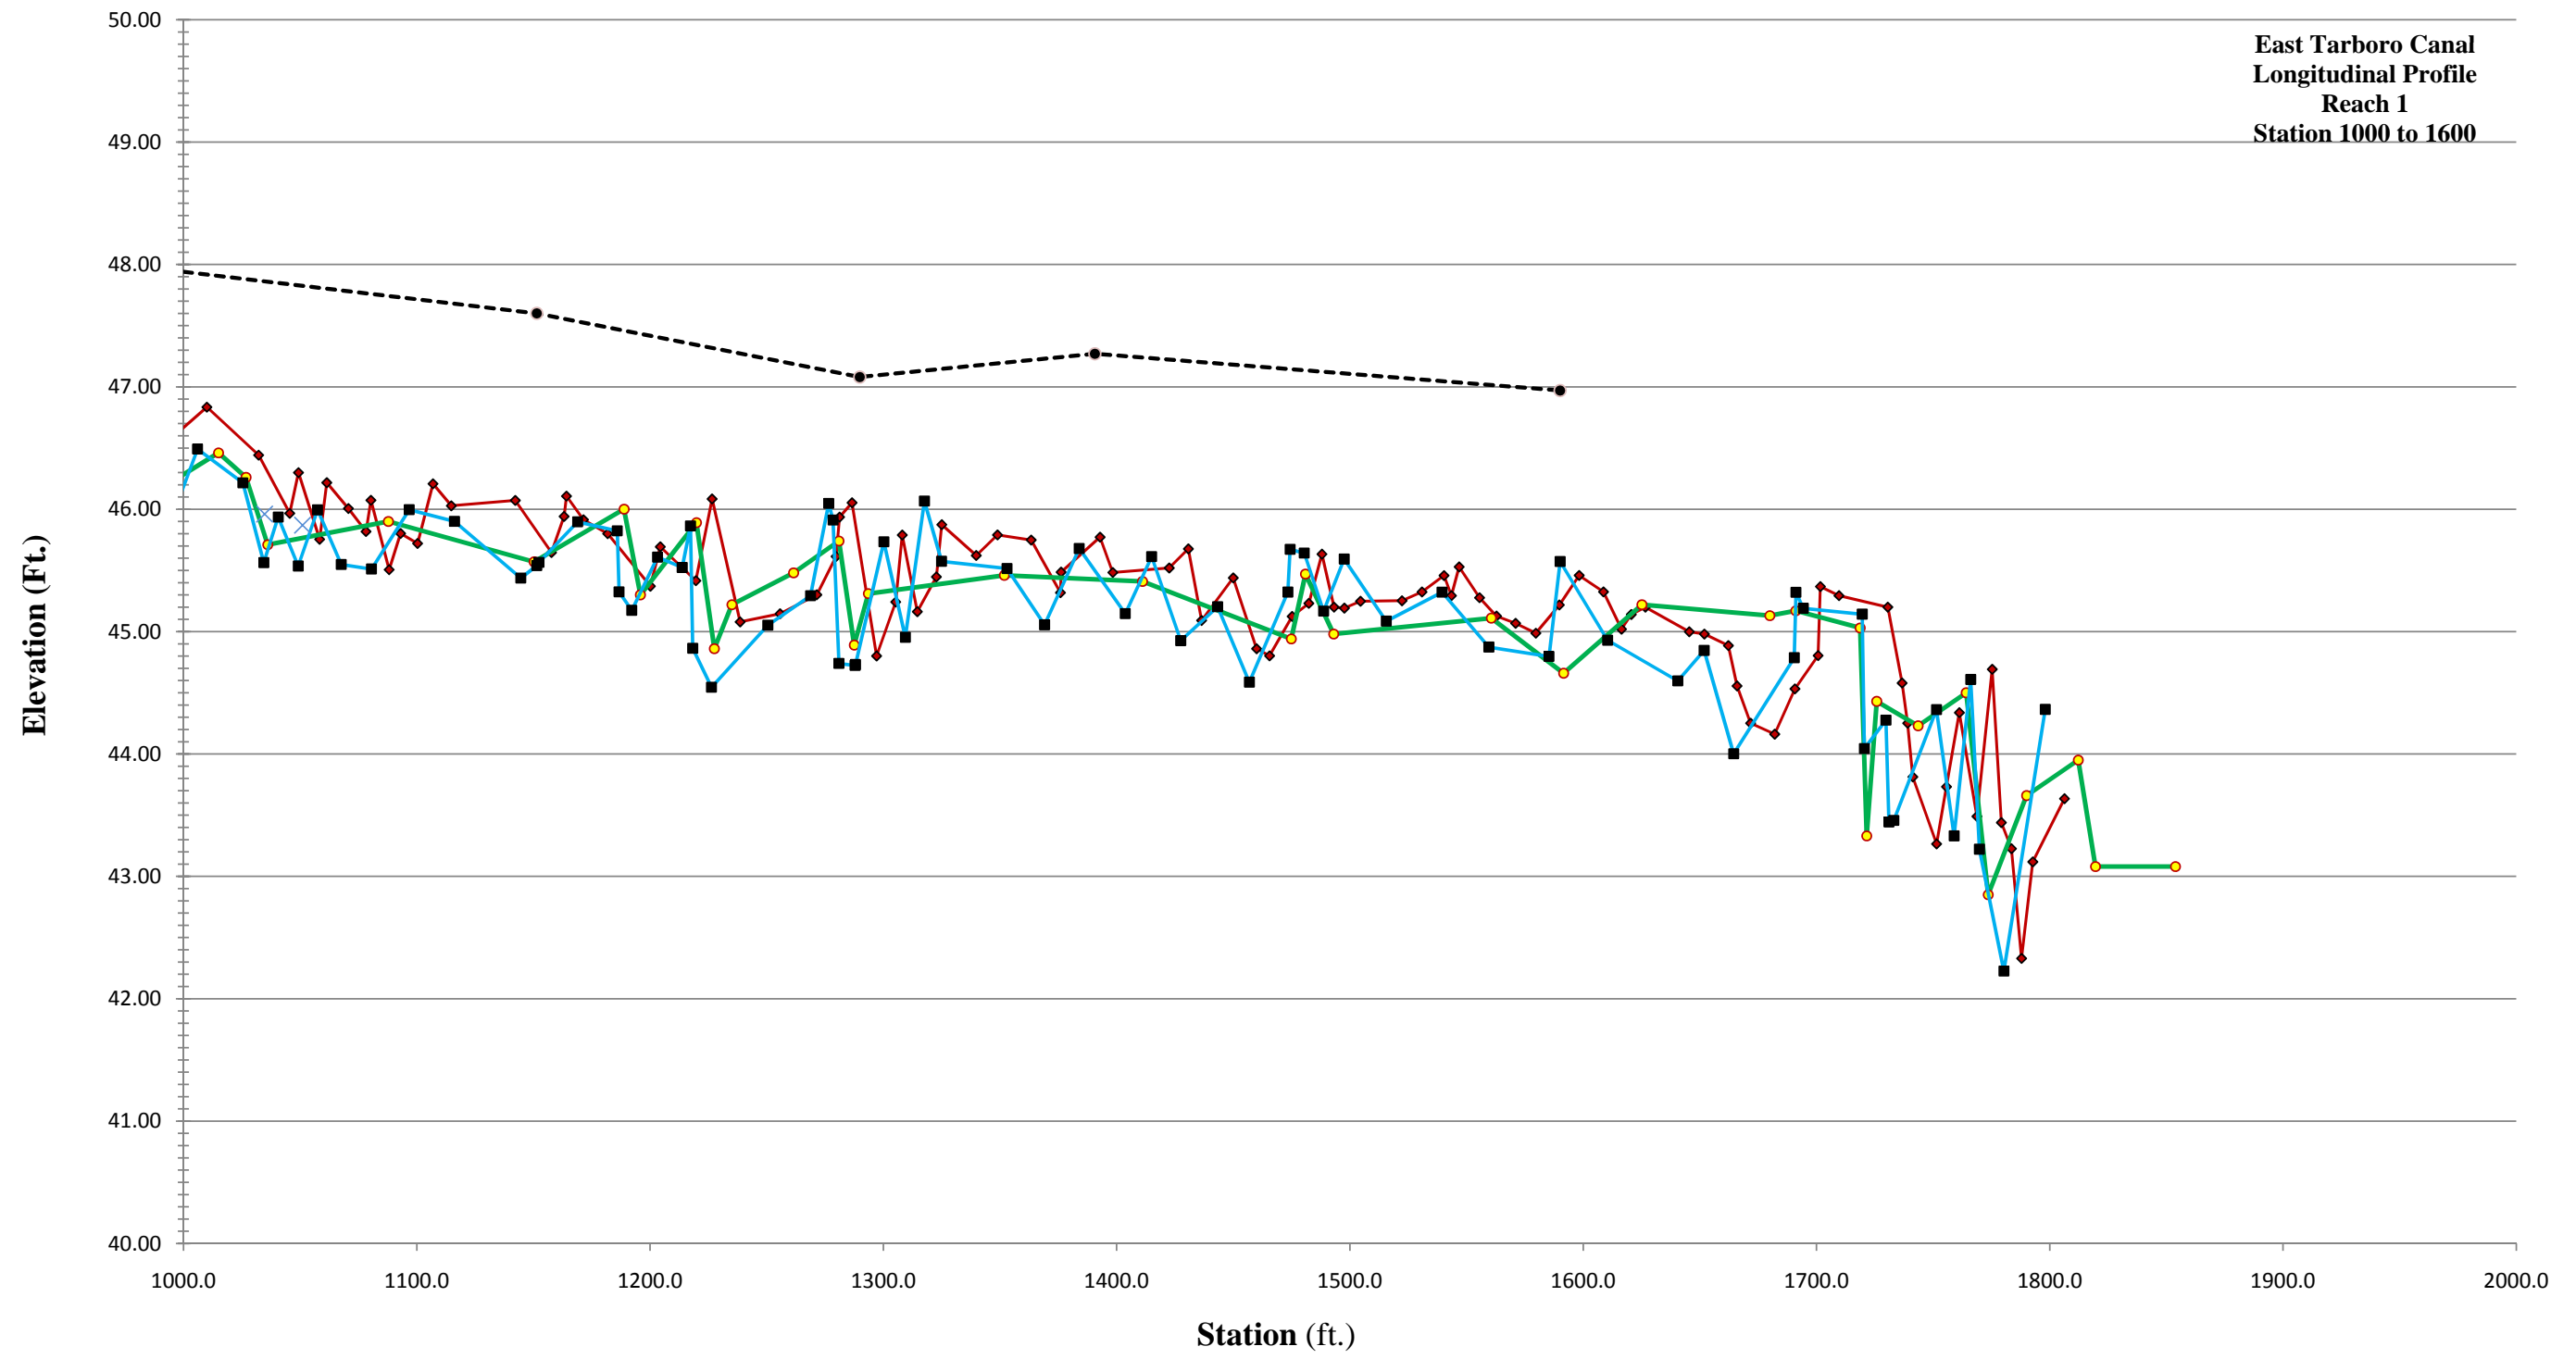
East Tarboro Canal
Longitudinal Profile
Reach 1
Station 1000 to 1600

2008 Thalweg As-Built 2009 Thalweg 2009 Bankfull 2009 Water Surface

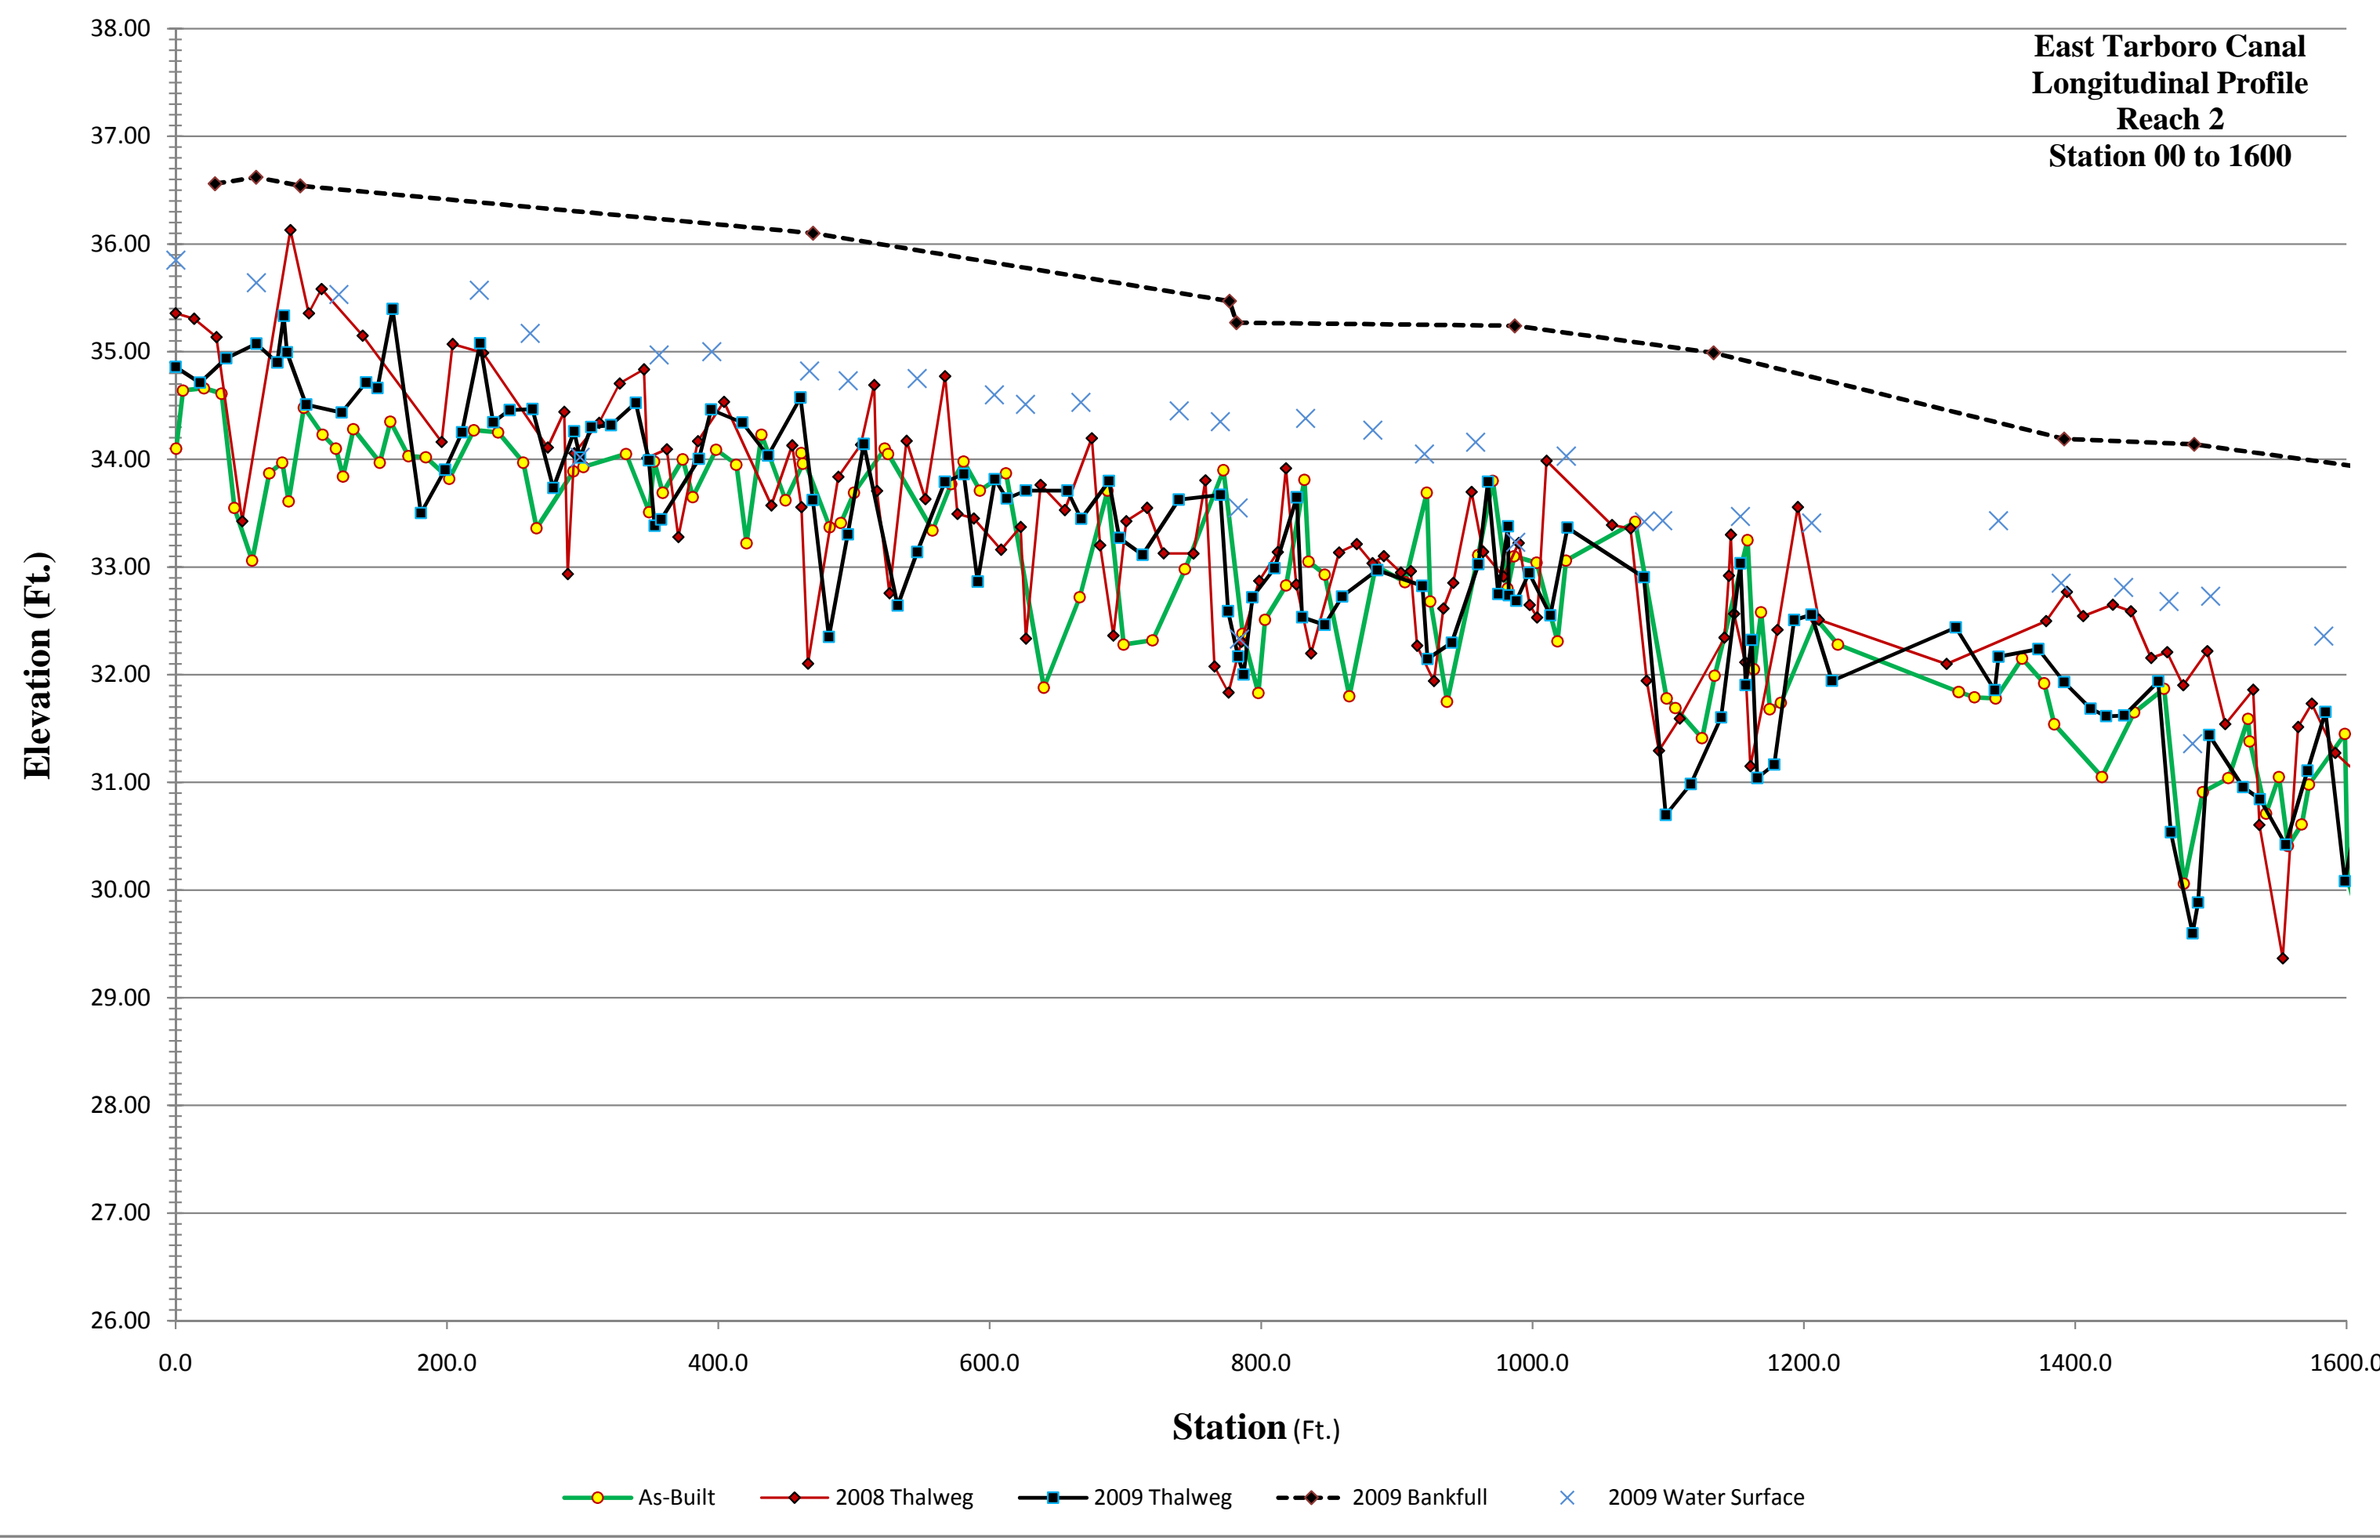
**East Tarboro Canal
Longitudinal Profile
Reach 2
Station 00 to 1600**

As-Built 2008 Thalweg 2009 Thalweg 2009 Bankfull 2009 Water Surface
