**East Tarboro Canal Stream Restoration Project
Edgecombe County
North Carolina**

**CU: 03020103
SCO# 030603101
EEP Project No. 123**

**Year 2 Monitoring Report
November 15, 2009**

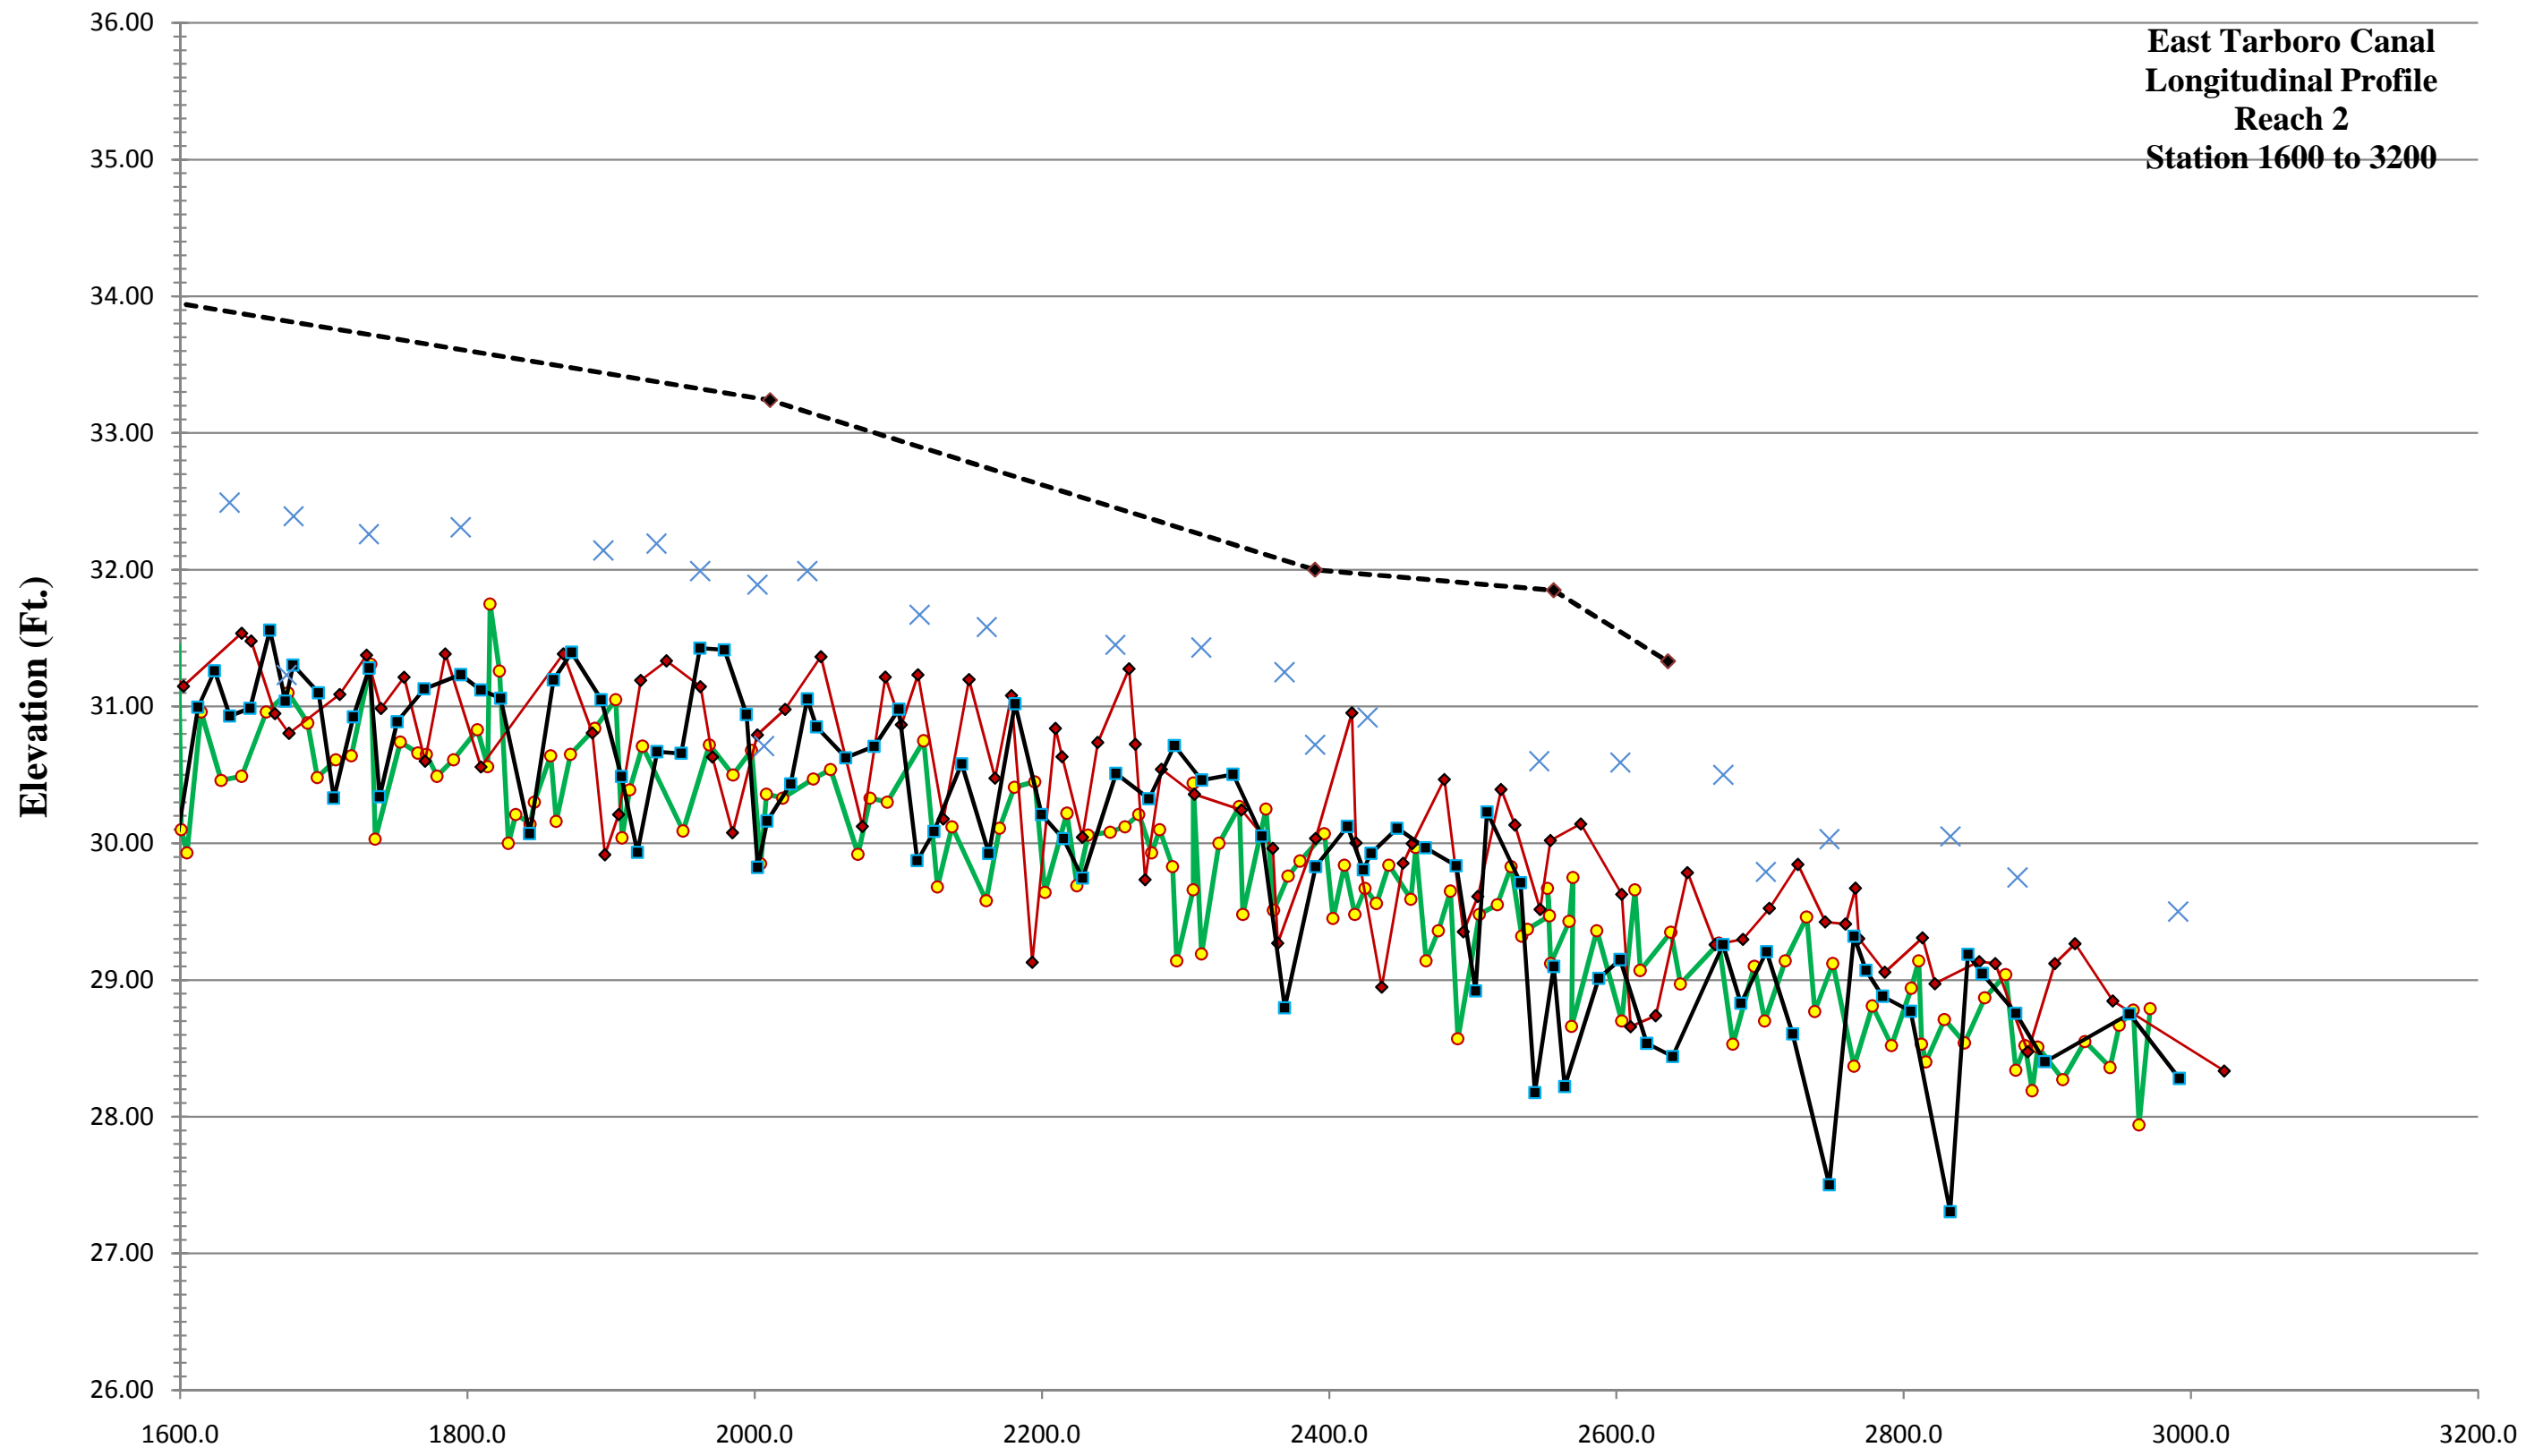
**East Tarboro Canal
Longitudinal Profile
Reach 2
Station 1600 to 3200**

As-Built 2008 Thalweg 2009 Thalweg 2009 Bankfull 2009 Water Surface

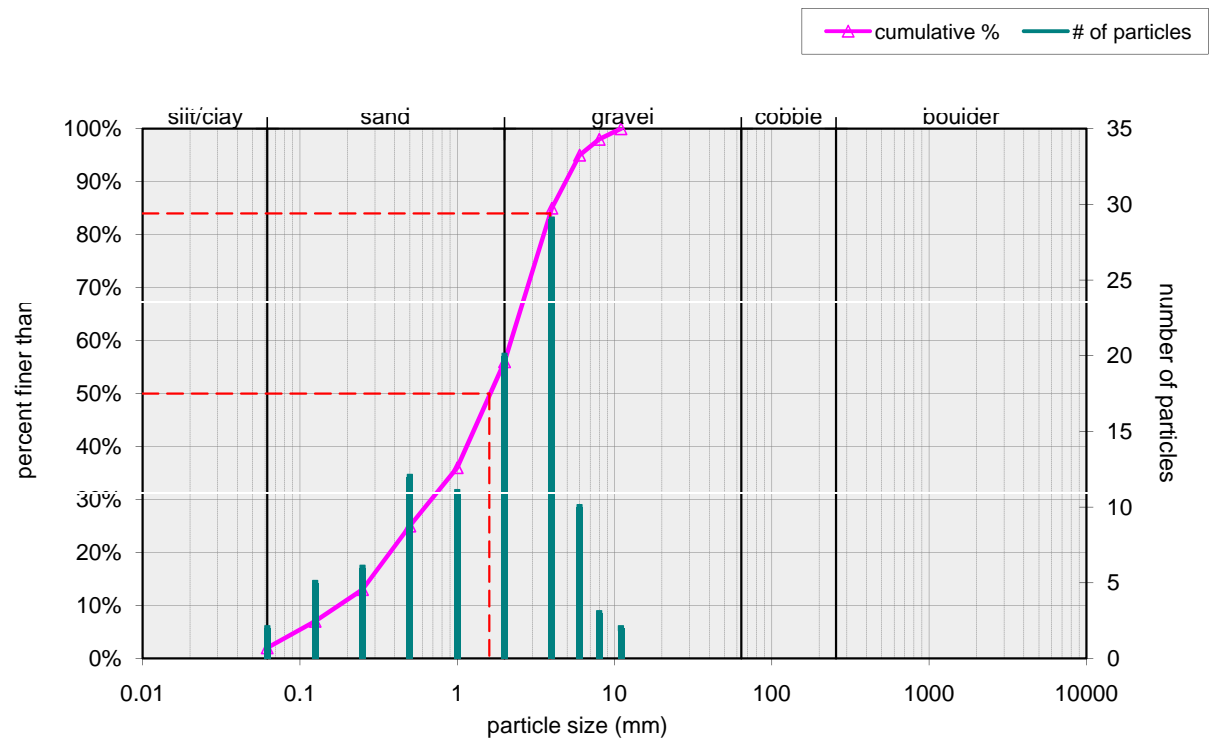
Cross Section 13

Size (mm)		Size Distribution		Type	
D16	0.3	mean	1.1	silt/clay	2%
D35	0.94	dispersion	3.9	sand	54%
D50	1.6	skewness	-0.16	gravel	44%
D65	2.5			cobble	0%
D84	3.9			boulder	0%
D95	6
