Mitigation Plan  
Edwards-Johnson Mitigation Project  
Johnston County, North Carolina  
FINAL VERSION

NCDEQ DMS Project Identification # 97080  
NCDEQ DMS Contract # 6825  
Neuse River Basin (Cataloging Unit 03020201)  
USACE Action ID Number: SAW-2016-00883  
Contracted Under RFP # 16-006477

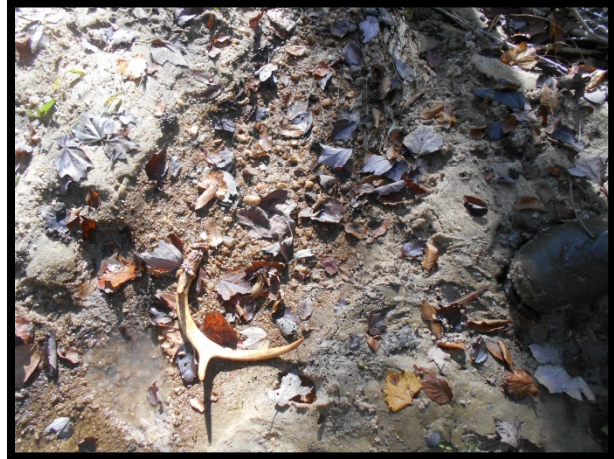
*Photo depicts floodplain deposition along lower R3 after Hurricane Matthew 2016.*

**Hurricane Matthew Observations:** On October 8<sup>th</sup>, 2016, Hurricane Matthew delivered over 10” of rain to the project site in less than 12 hours. Locally, the recurrence interval was estimated to be greater than a 500-year storm event (NOAA, NWS, 2016). After Hurricane Matthew and prior to subsequent rain events, WLS visited the site on October 20<sup>th</sup>, 2016 to measure sediment deposits in two distinct depositional areas or sinks, consisting of mostly fine sand material. The aggradational areas were measured towards the lower catchment (lower Reach R3) to quantify the approximate sediment deposited by the storm event. For better accuracy, depositional areas were delineated using existing conditions survey basemap and grid areas/cross-sections were measured and compared with a cloth tape and hand-augured borings. The cubic footage was then converted to cubic yards to estimate tonnage. The total sediment yields were estimated to be approximately 31 tons, indicating the size of the pulse of sediment was mobilized through the system as a result of Hurricane Matthew.

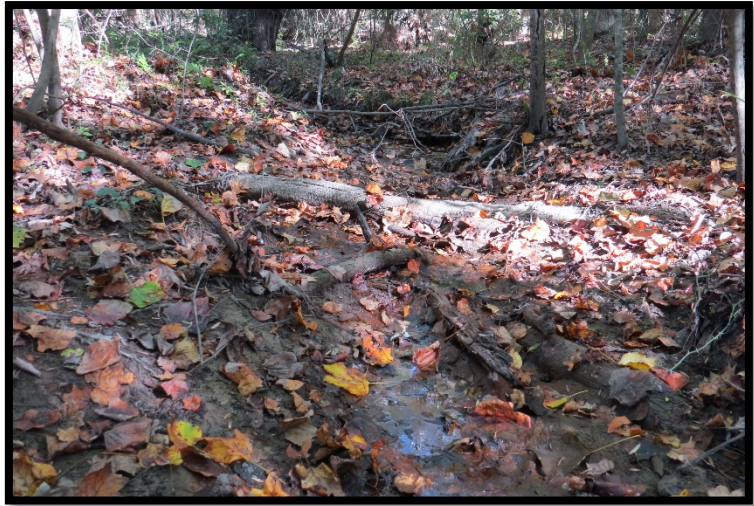
*Looking upstream at stable channel morphology and wood recruitment along R1 preservation area.*

R1 is a small intermittent headwater tributary that extends from the upstream terminus of the project site near Wendell Road at the northern parcel boundary to R2 downstream. R1 has a stream length of approximately 611 feet, valley slope of 1.1 percent, and drainage area of 96 acres. R1 originates at the outlet of a culverted pipe crossing that flows west from a small two-acre pond located immediately east of the Old Johnson Road 60-foot right-of-way. Based on preliminary site investigations, the existing pond in the upper catchment appears to intercept overland flows and partial road drainage, as well as to help attenuate storm events.

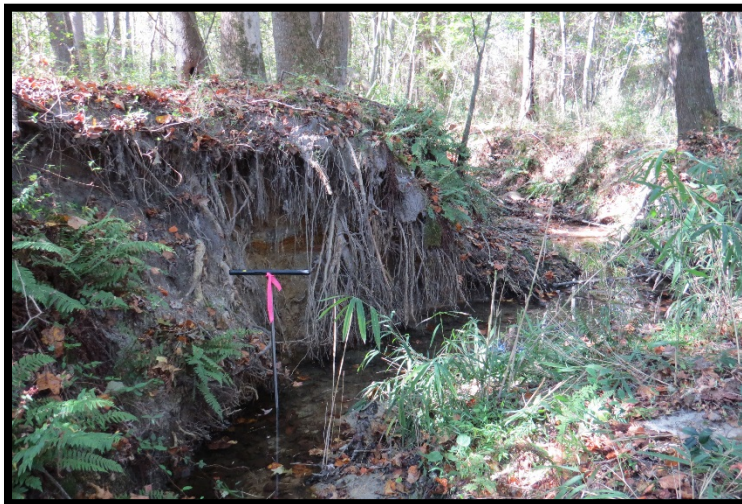
*Photo illustrates severe bank erosion and lateral instability along R2.*

R2 begins at a large headcut immediately downstream of R1 and flows southwest for approximately 1,020 feet towards the confluence with R4. The valley slope is approximately 1.4 percent and the drainage area is 120 acres. R2 appears to be vertically and laterally unstable, with active headcuts present and bank height ratios ranging from 1.5 to greater than 3.0. The active erosion is estimated on 30 to 40 percent of the streambanks. Most of the erosion is in the form of downcutting and bank

scour caused by high near bank stresses during storm flows and the lack of deep rooting vegetation or geologic grade control.

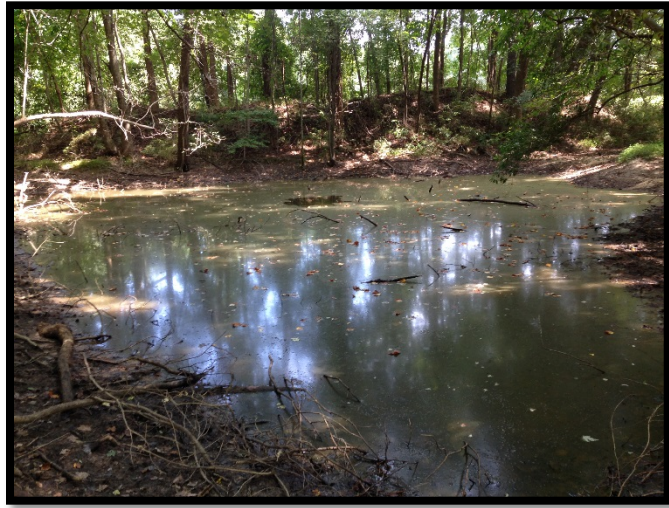
*Photo looking at existing impoundment and floodplain alterations along R4.*

There is an active headcut migrating towards the pond dam. Moderate to severe bank erosion was observed downstream of the impoundment and bank height ratios are greater than 2.0. The reach has experienced downcutting for approximately 50 percent of its length, although the riparian buffer vegetation is greater than 50 feet wide throughout the reach. R4 is classified as a Rosgen G5 stream type.

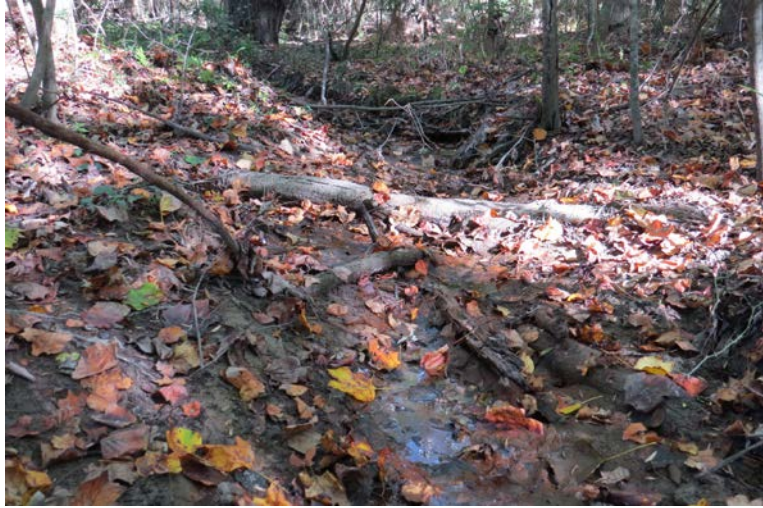
Reach R1- Typical stable conditions (10/21/15)

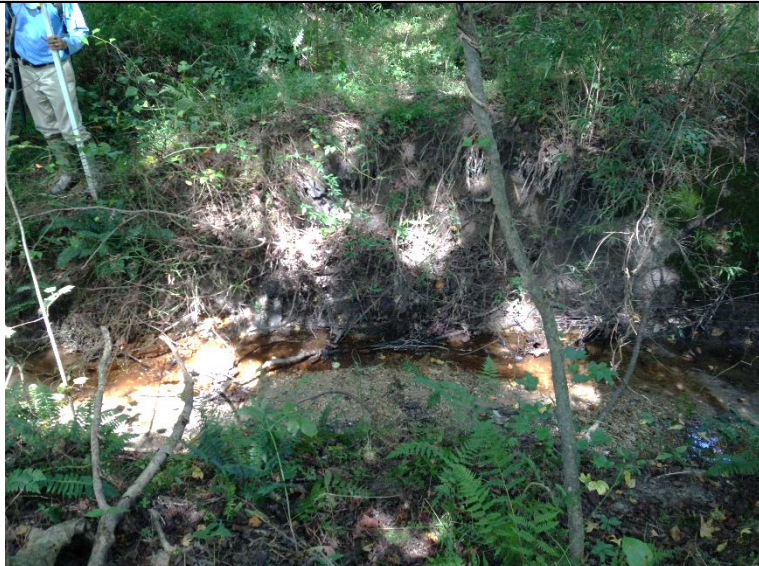
Reach R3-Typical unstable banks mid-reach (8/28/15)

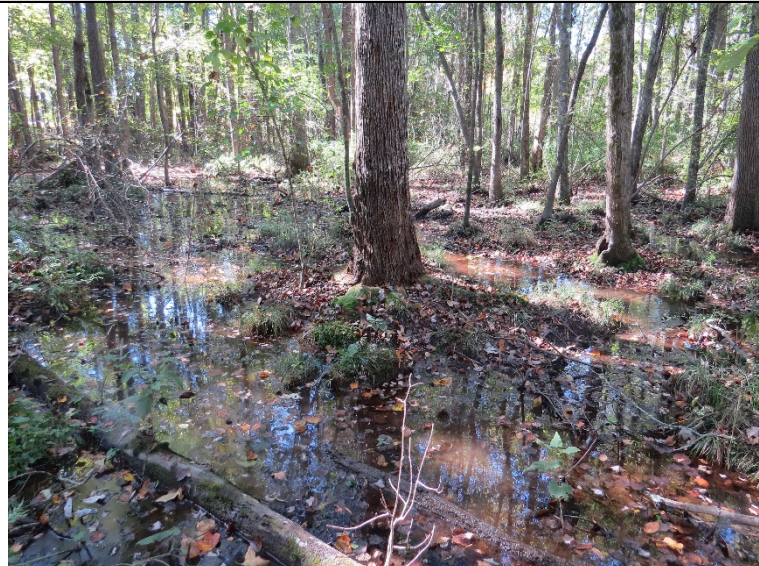
Reach R3- Downstream end after Hurricane Matthew (10/19/16)
