# Farrar Dairy Stream and Wetland Restoration Site

EEP Project #92552  
Contract # D06002

## Monitoring Year 05/Closeout Project Type: Stream and Wetland Restoration

Submitted: February 2014

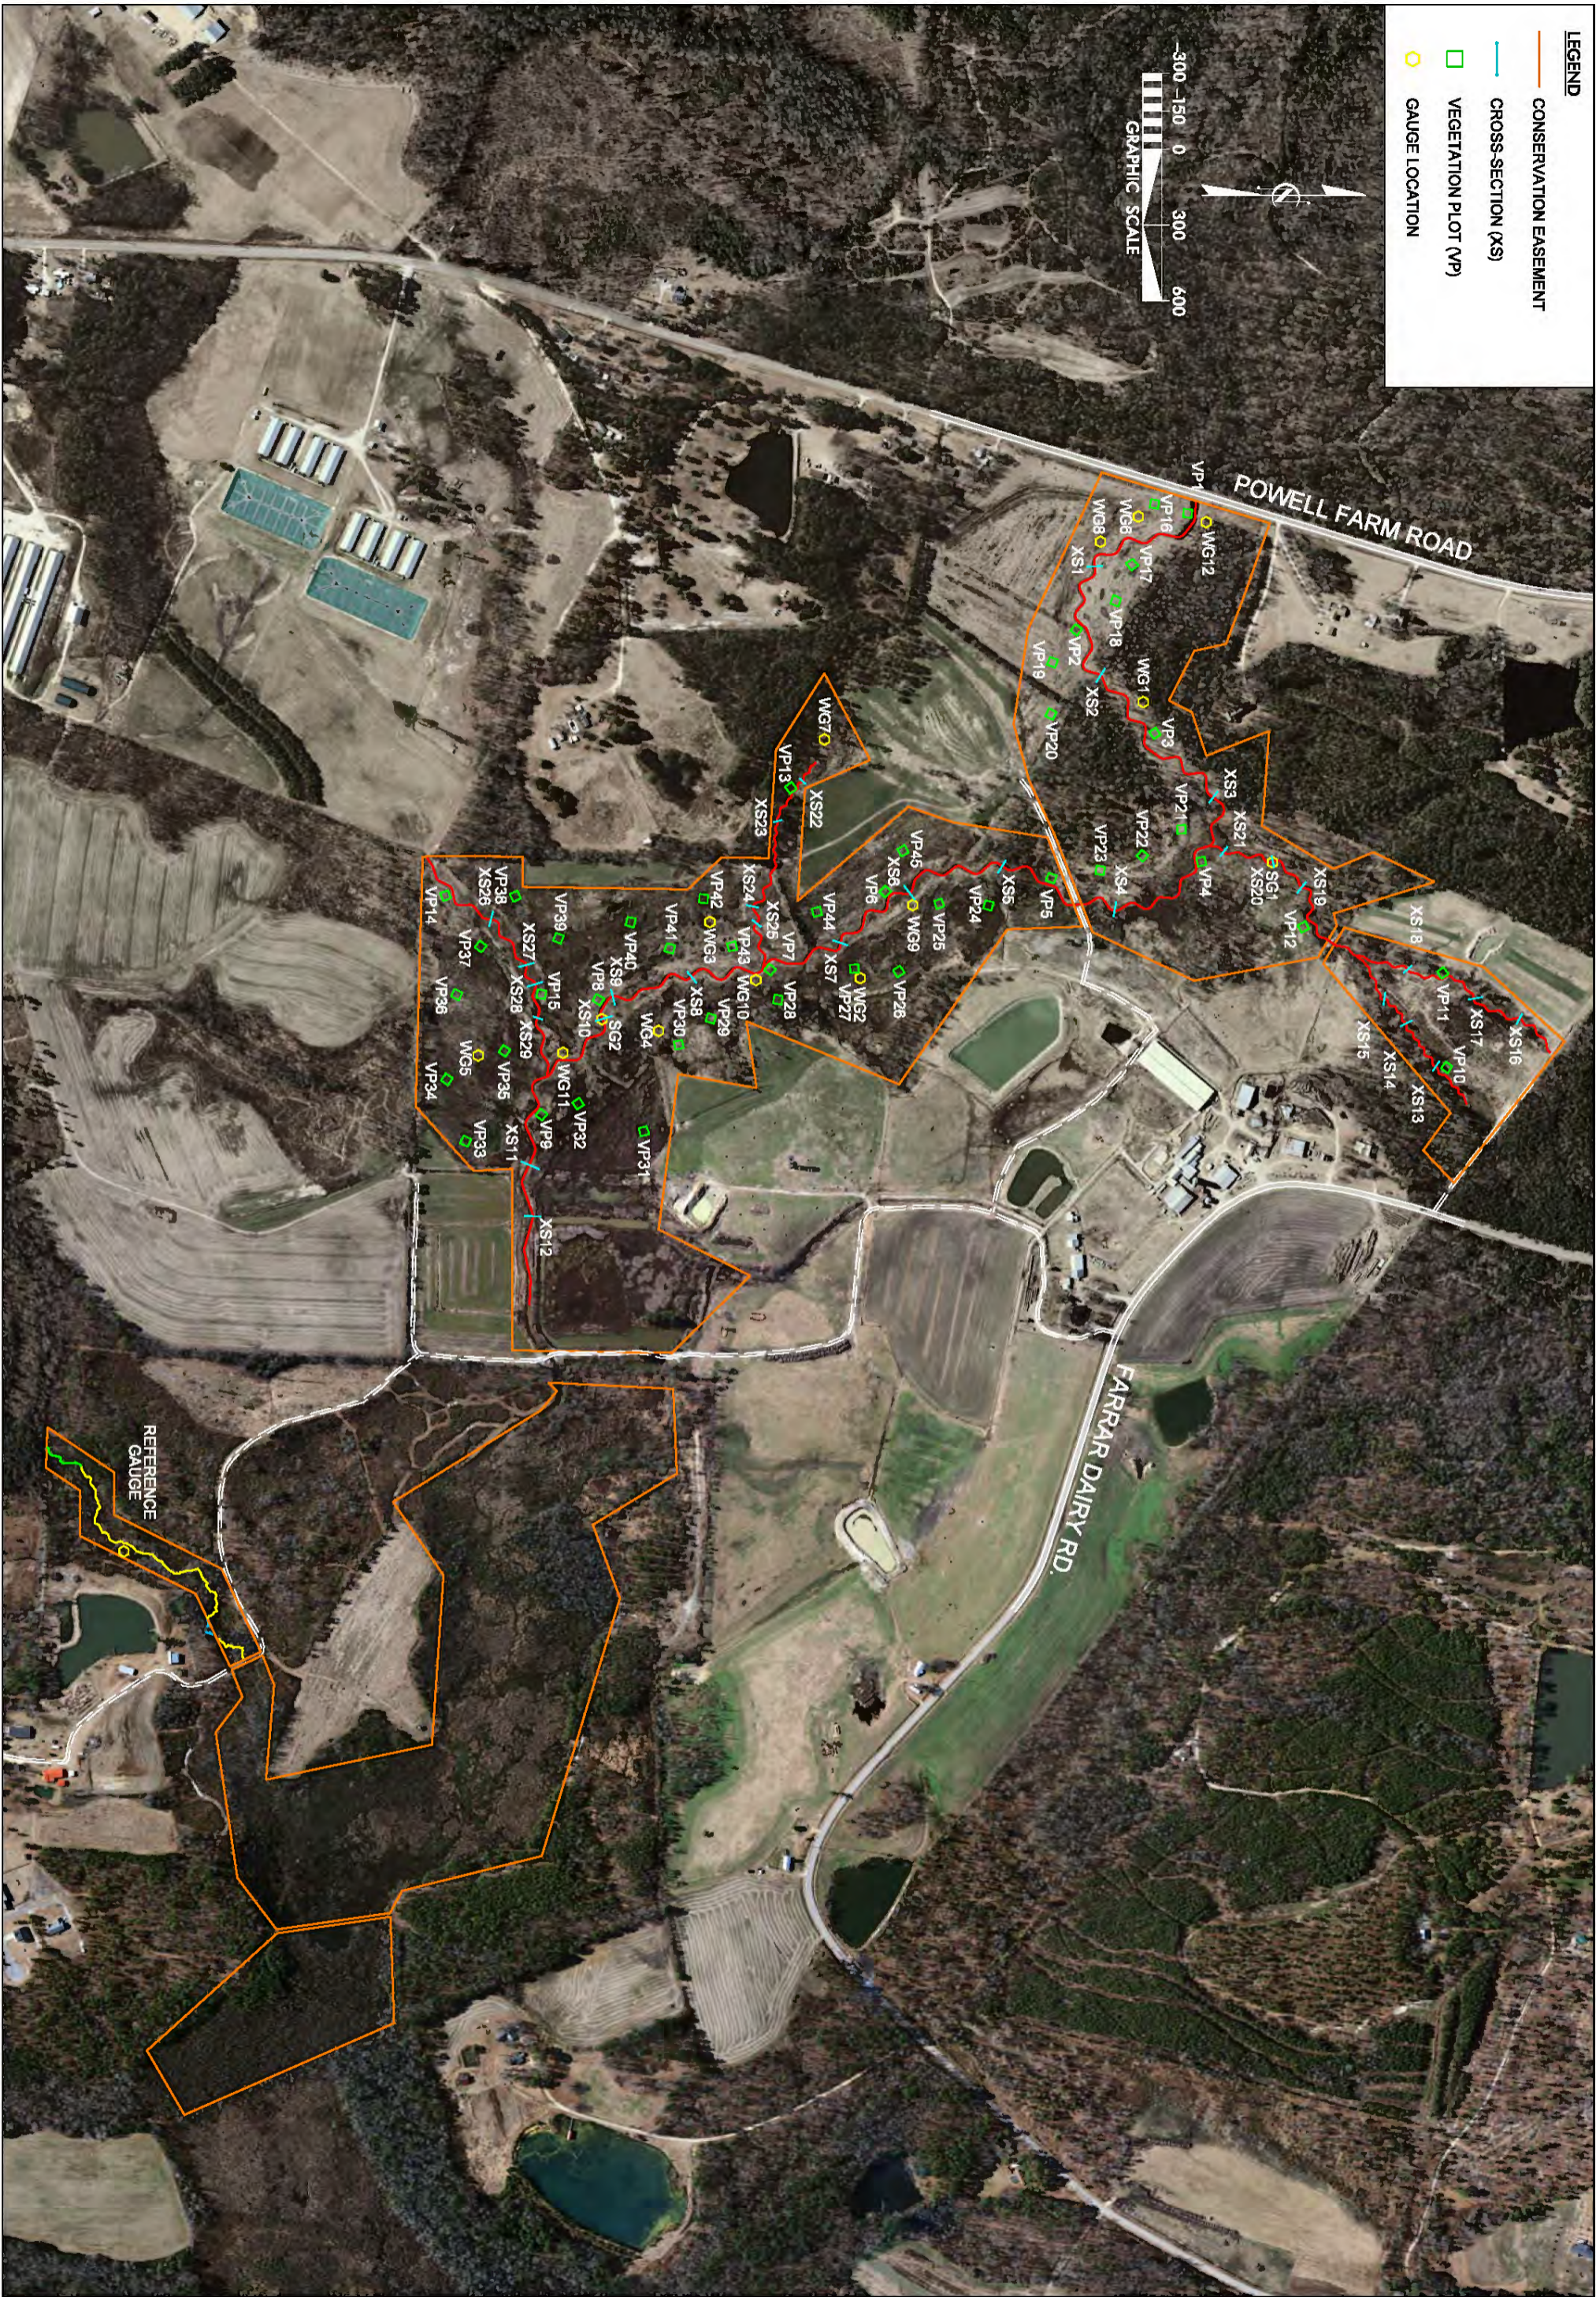
DATE: JAN 2014  
SCALE: GRAPHIC  
MONITORING FEATURES  
FIGURE 7

- CONSERVATION EASEMENT
- CROSS SECTION (XS)
- VEGETATION PLOT (VP)
- GAUGE LOCATION
