FLOOGIE STREAM AND WETLAND
MITIGATION PROJECT
BERTIE COUNTY, NORTH CAROLINA
DENR-EEP CONTRACT No. D06011
MITIGATION PLAN

September 2008

FLOOGIE STREAM AND WETLAND MITIGATION PLAN

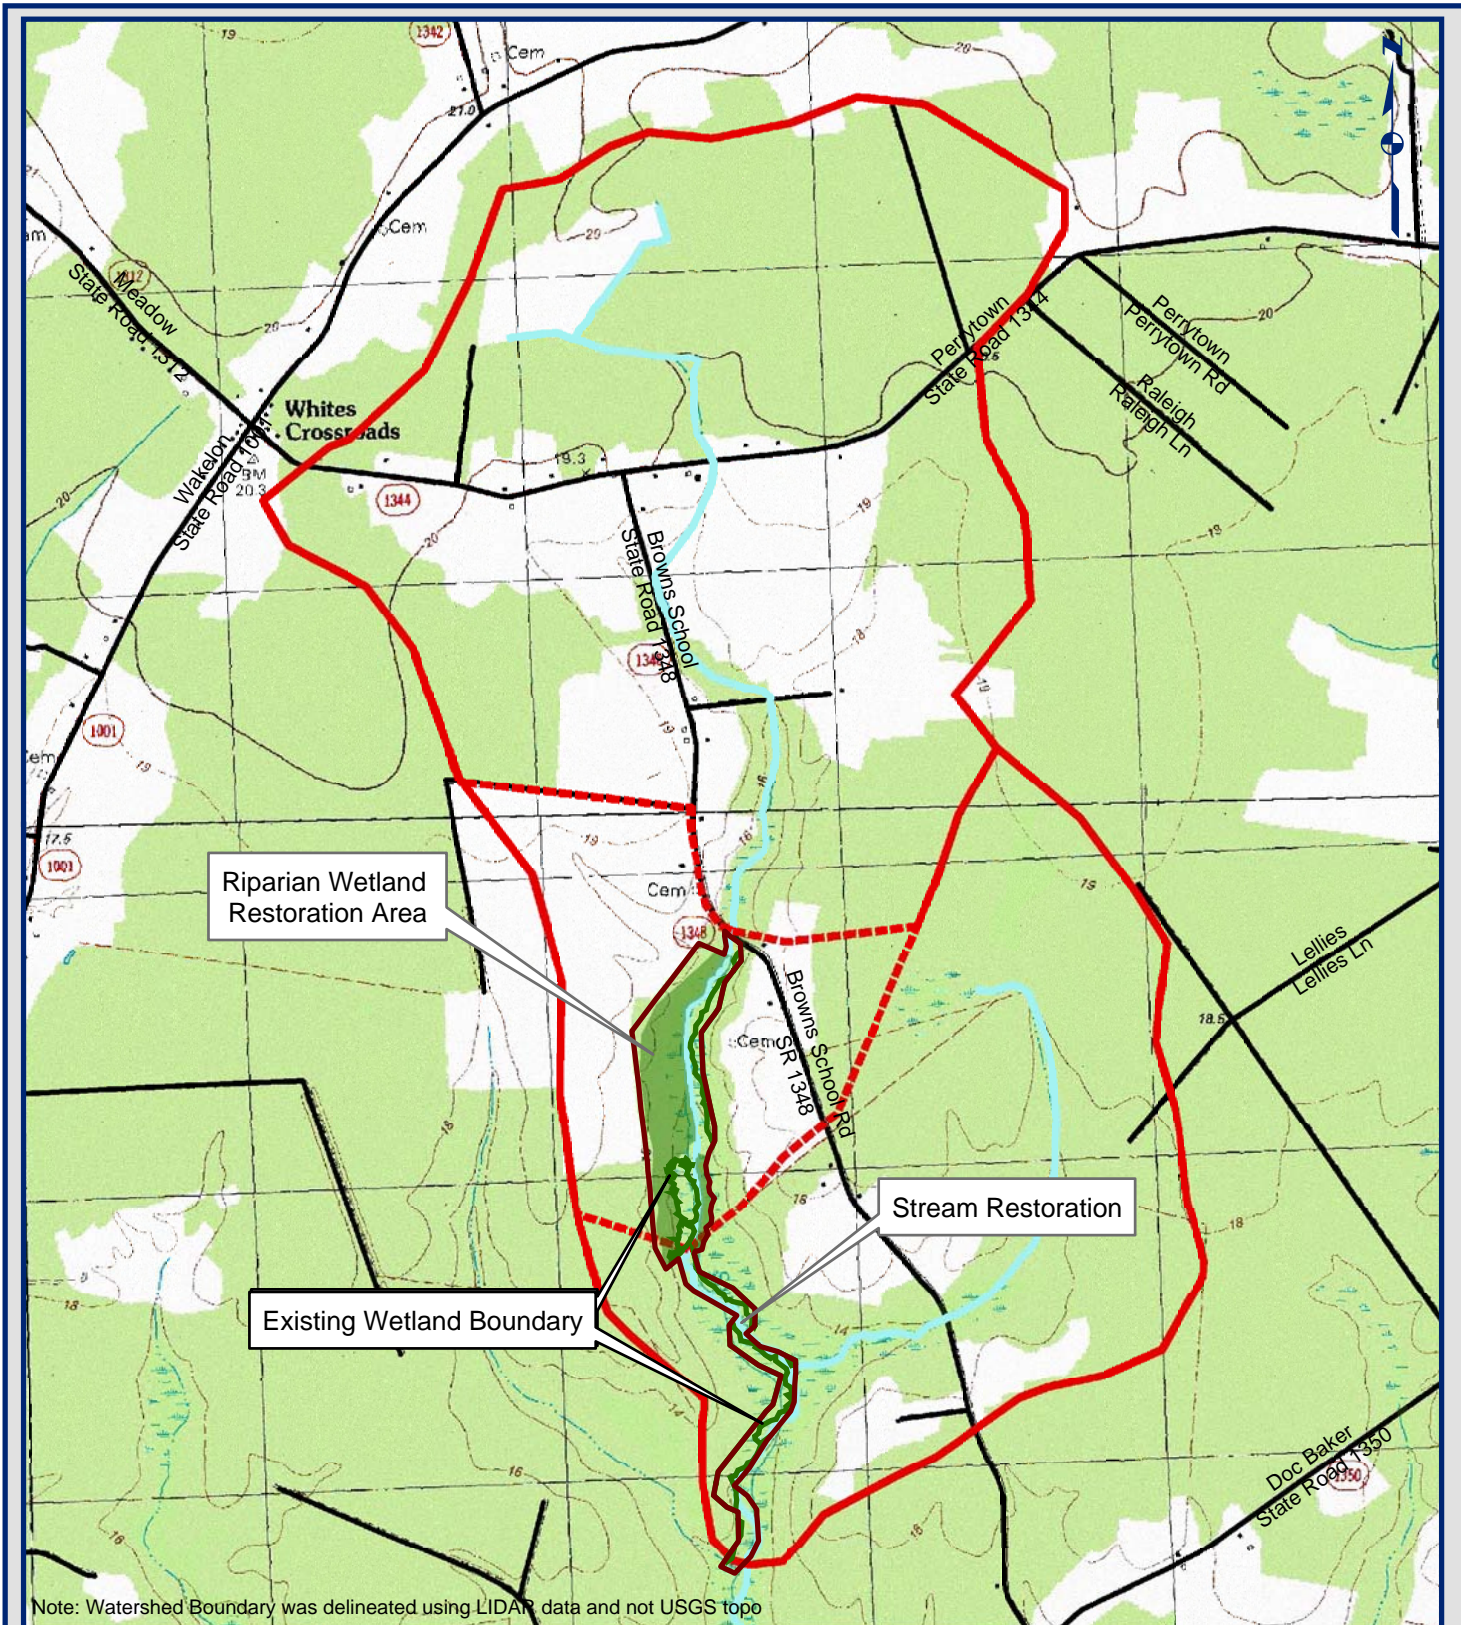
Figure 2.
USGS Quadrangle Map
Floodgic Site

Flat Swamp Creek has a drainage area of 1,168 acres (1.83 mi²) at the upstream end of the restoration project and 2,150 acres (3.36 mi²) at the downstream end (Figure 2). The wetland restoration area has a drainage area of 1,456 acres (2.28 mi²). The floodplain is mapped as Wehadkee loam, and the adjacent side slope drainages are mapped as Rains sandy loam. Wehadkee is an alluvial soil indicative of floodplains and valley features. Rains soils are nearly level and can occupy shallow depressions. As detailed in the Floogie Restoration Plan, soil borings confirmed hydric soils on the floodplain and adjacent side slope drainageways. The dominant historic land use was agricultural production of crops including cotton, soybeans, corn, and timber, although some areas were woodlands. Natural drainage patterns throughout the watershed had been historically altered to drain wetlands and promote agricultural production. Numerous agricultural ditches had been constructed on the project site, and streams had been channelized to route water off the site, draining areas that were once wetland. Decades of agricultural production and human manipulation altered the landforms and disturbed many of the indicators of headwater valleys adjacent to Flat Swamp Creek. Prior to restoration activities, the two headwater stream systems were conveyed down the valley and across the floodplain in agricultural drainage ditches. As detailed in the Floogie Restoration Plan, soil borings confirmed hydric soils on the floodplain and adjacent side slope drainageways. Both USGS topographic mapping and LiDAR imagery (Figure 3) clearly indicate valley features extending from the Flat Swamp Creek floodplain into the adjacent side slopes. At the conservation easement boundary

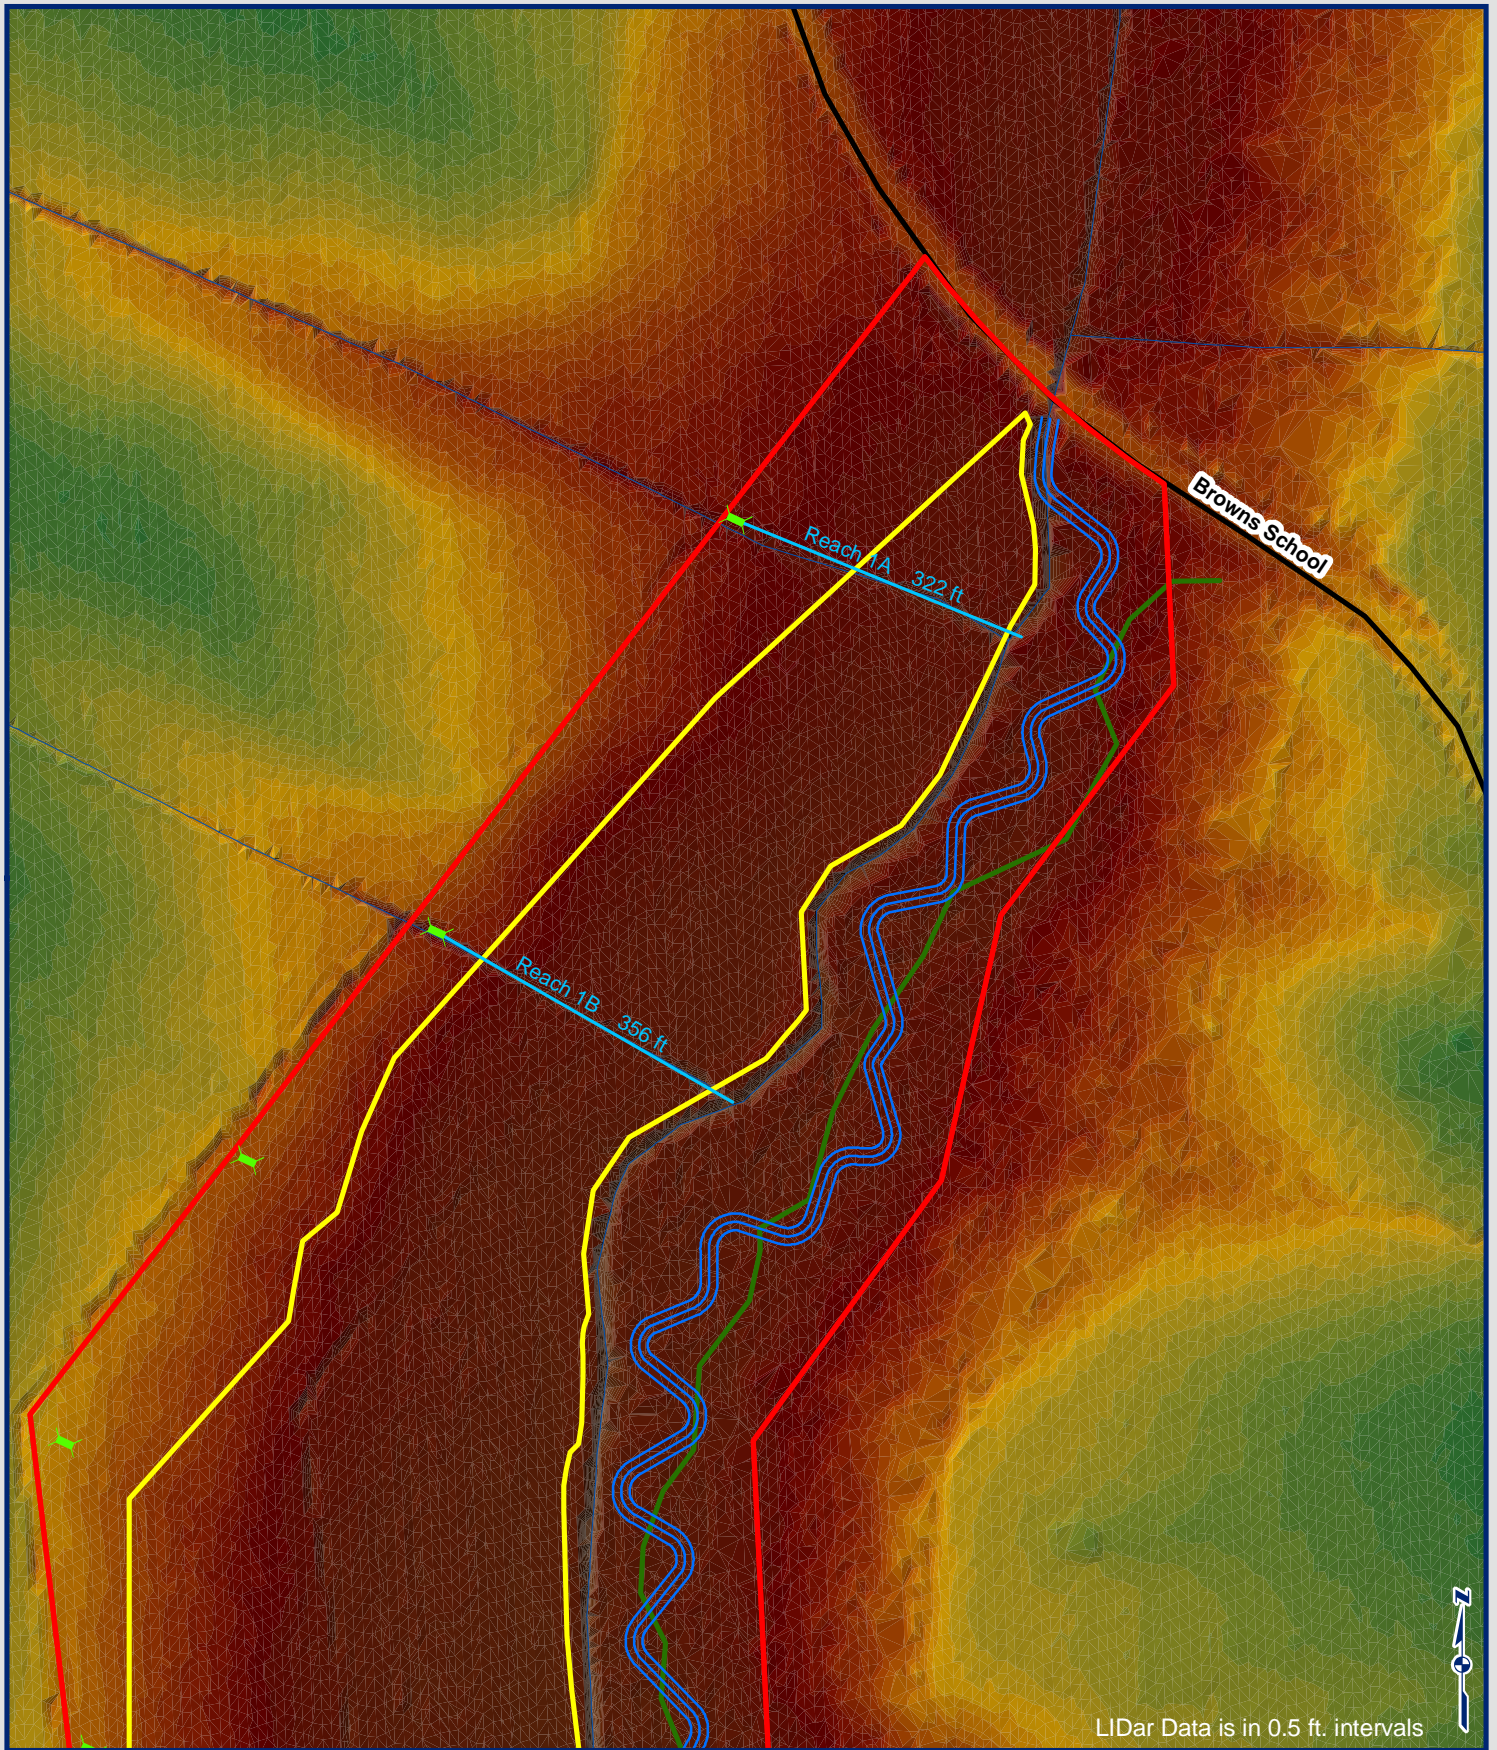
Figure 3
LIDAR Image
Flookie Site

LIDar Data is in 0.5 ft. intervals

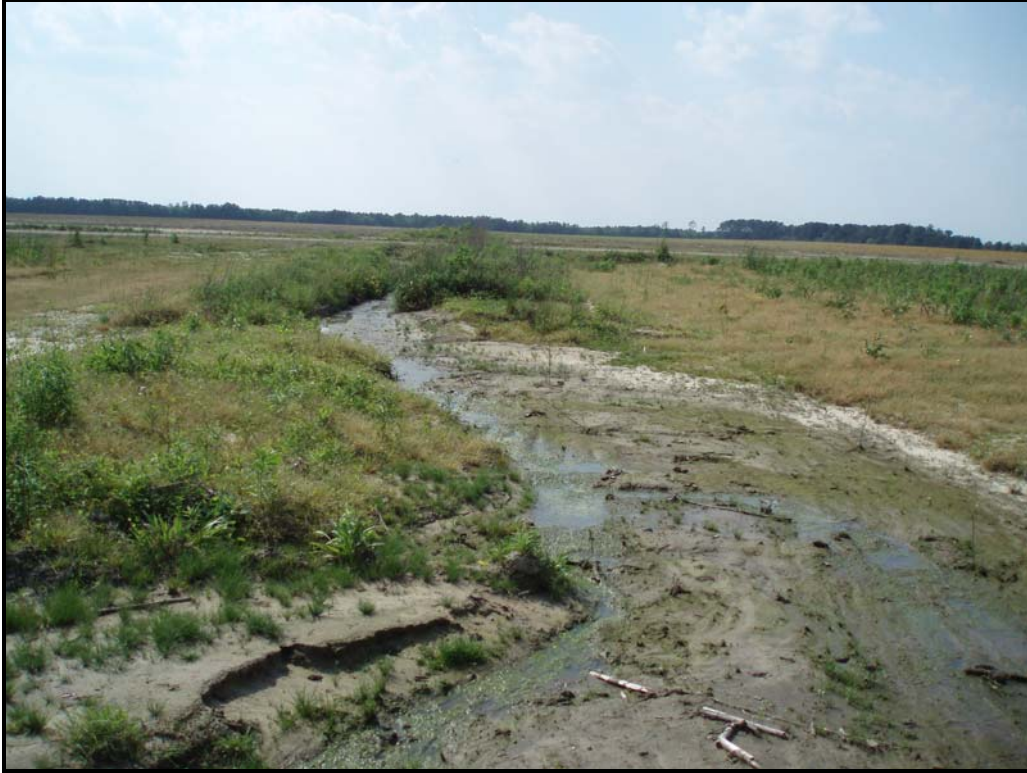
Restored headwater stream 1A.

Construction techniques pertaining to headwater stream restoration Reaches 1A and 1B included back-filling and plugging existing ditches, restoring microtopography, planting wetland species, and relocating an existing farm road outside of the easement. A typical ditch plug was 15 feet wide and extended approximately six inches above the ditch bank elevation. Plugs were constructed of compacted fill (clay or sandy clay) in 12 inch lifts with the upper 18 inches minimally compacted to facilitate plant growth. Plugs were spaced such that successive plugs are no more than 12 inches in elevation below the adjacent upslope plug. Specific to the headwater streams, culverts were placed beneath the new access road to convey surface flow into the wetland through the headwater valleys. The culverts were placed such that the agricultural ditches upgradient of the restoration area will remain open. Grading included microtopography on the floodplain to create hydrologic retention and to encourage species diversity. Locations of pertinent restoration features are given in the As-Built drawings Sheet 18A (attached).

The headwater stream restoration will be monitored using visual observations of surface flow, photographs of dye marking, and movement of deposited sand. Monthly site visits will be conducted during the growing season. At each site visit, a visual observation of each restored headwater stream will be made to document the presence of surface water. When surface water is present, a water soluble dye will be released in the water at a reference location, and time-sequenced photographs will be taken to document water movement. In addition to the visual observations, a small amount of white sand will be left at a reference location in each headwater stream. This sand will be observed monthly to determine if, and how much, the deposit has moved down the valley. Both photographs and qualitative observations will document this sand movement. Records of stream flow will be correlated with on-site rainfall data to document intermittent or seasonal flow. Success criteria will be met if the headwater streams exhibit intermittent or seasonal flow. Monitoring results will be presented in the annual monitoring report.

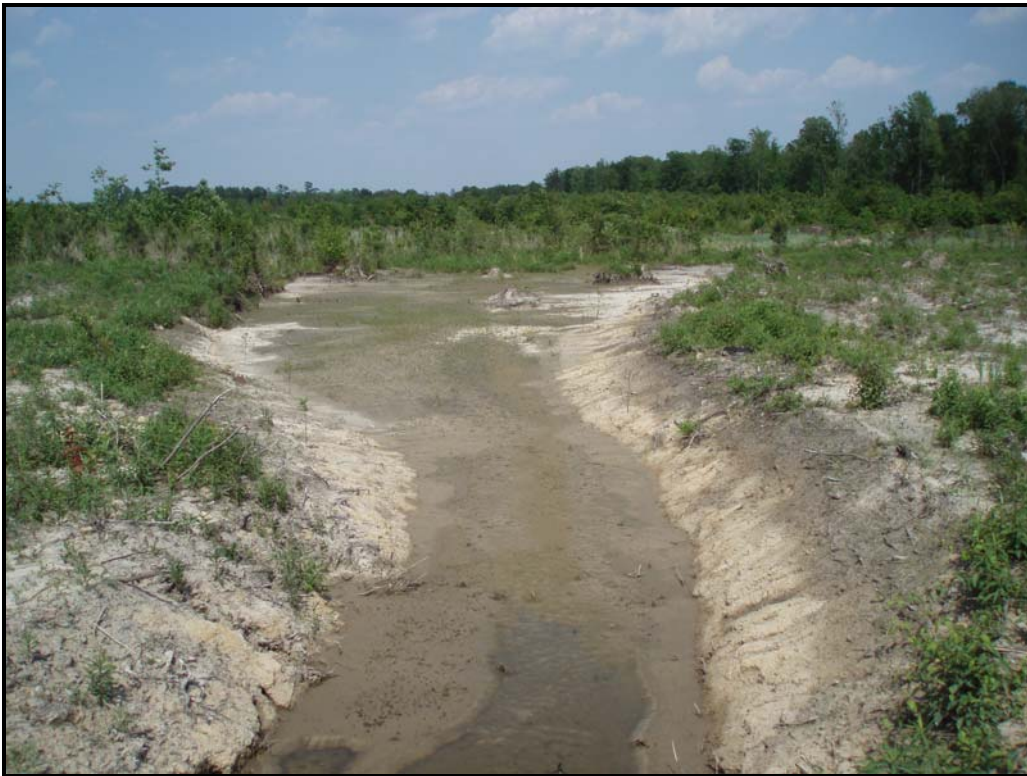
Surface flow in restored headwater stream.

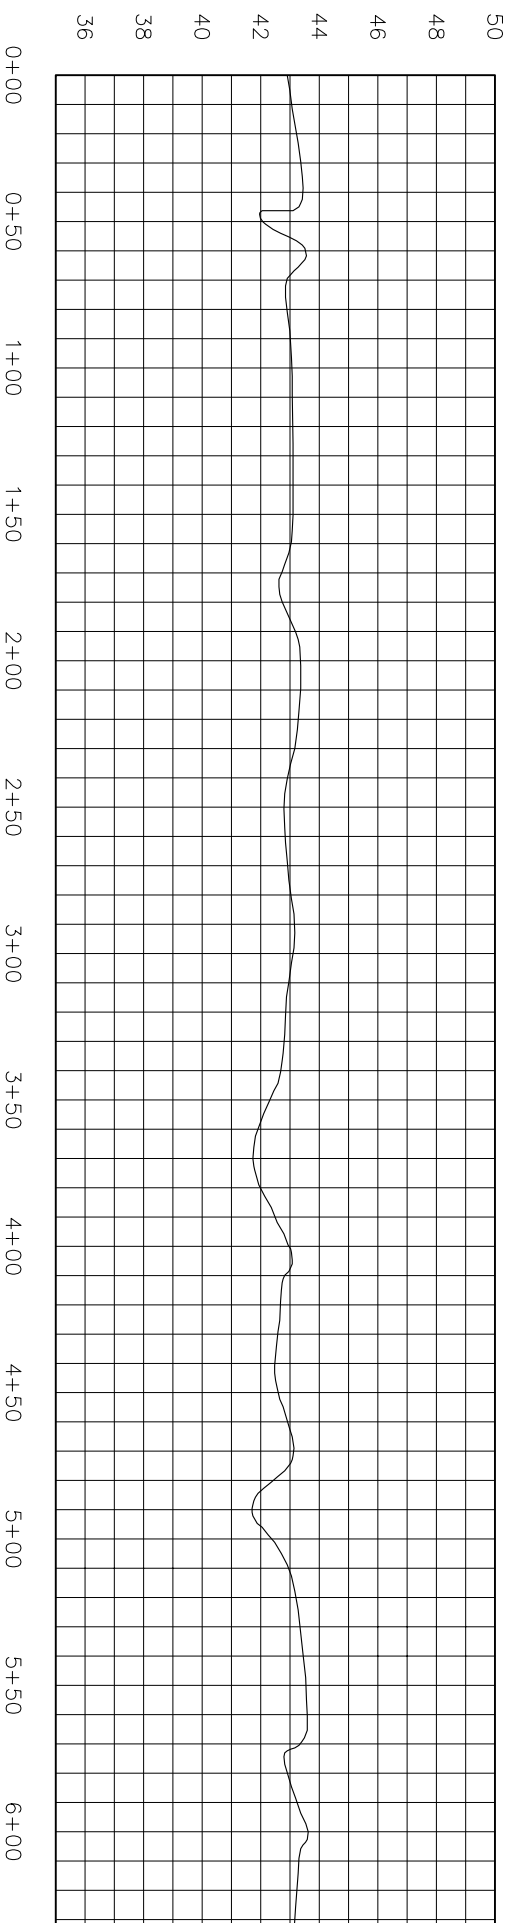
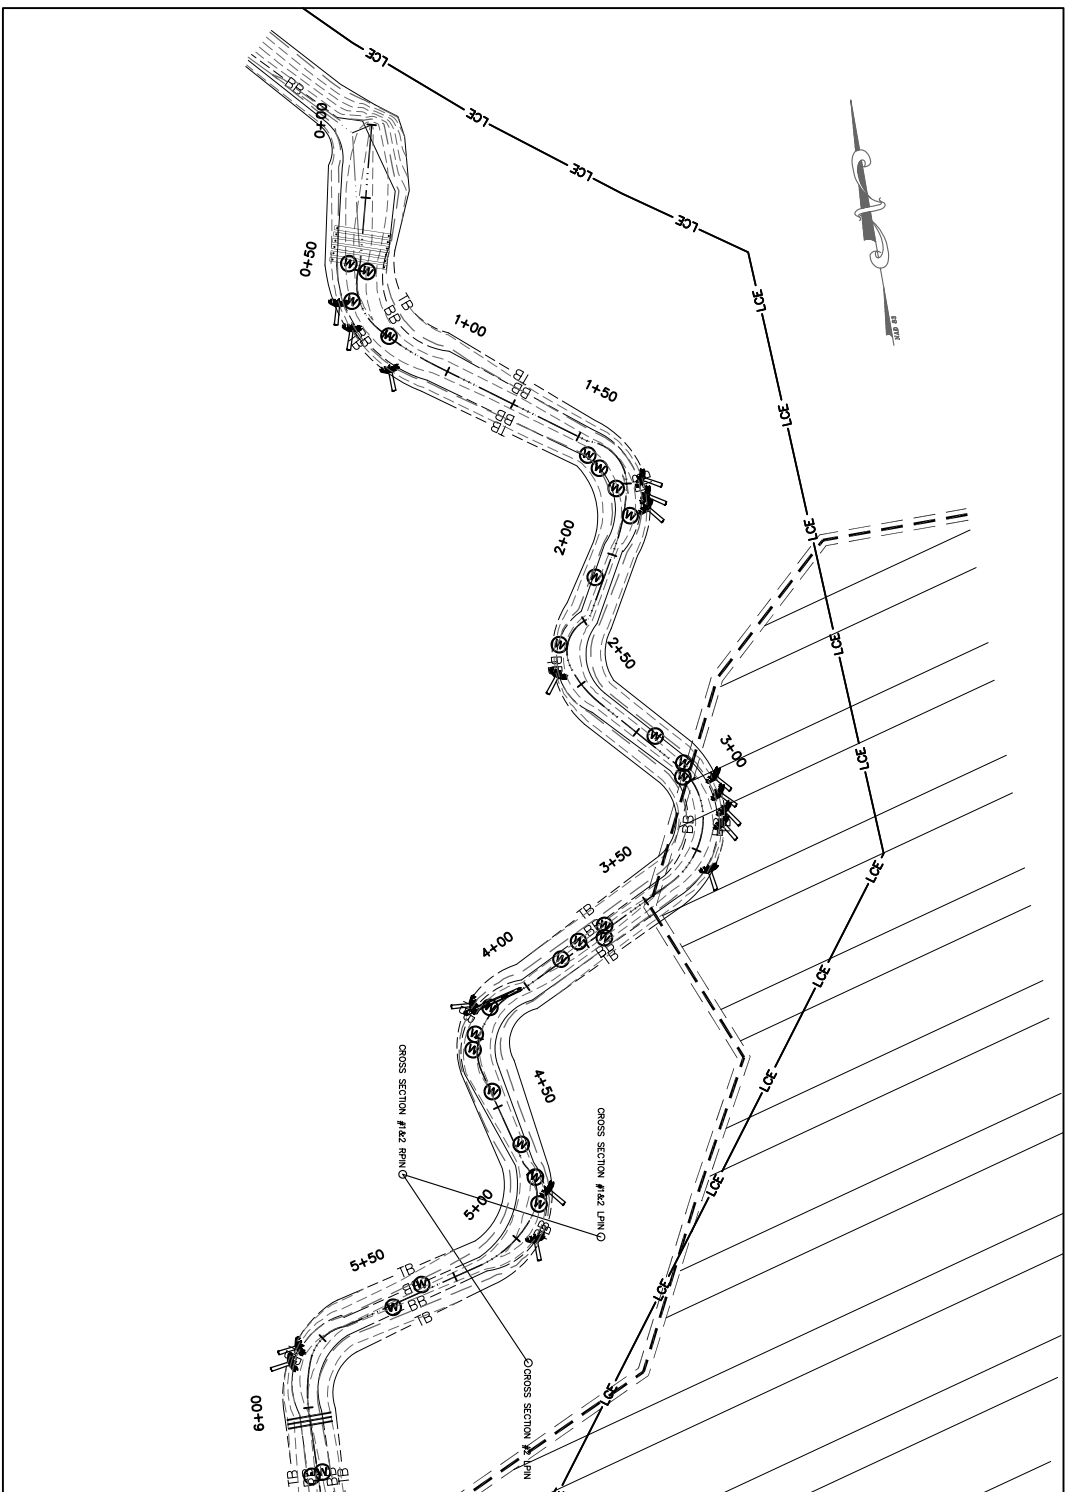
FLOODIE AS-BUILT PLANS
STA. 0+00 TO STA. 6+35

Horizontal Scale: 1 inch = 30ft.
Vertical Scale: 1 inch = 3ft.

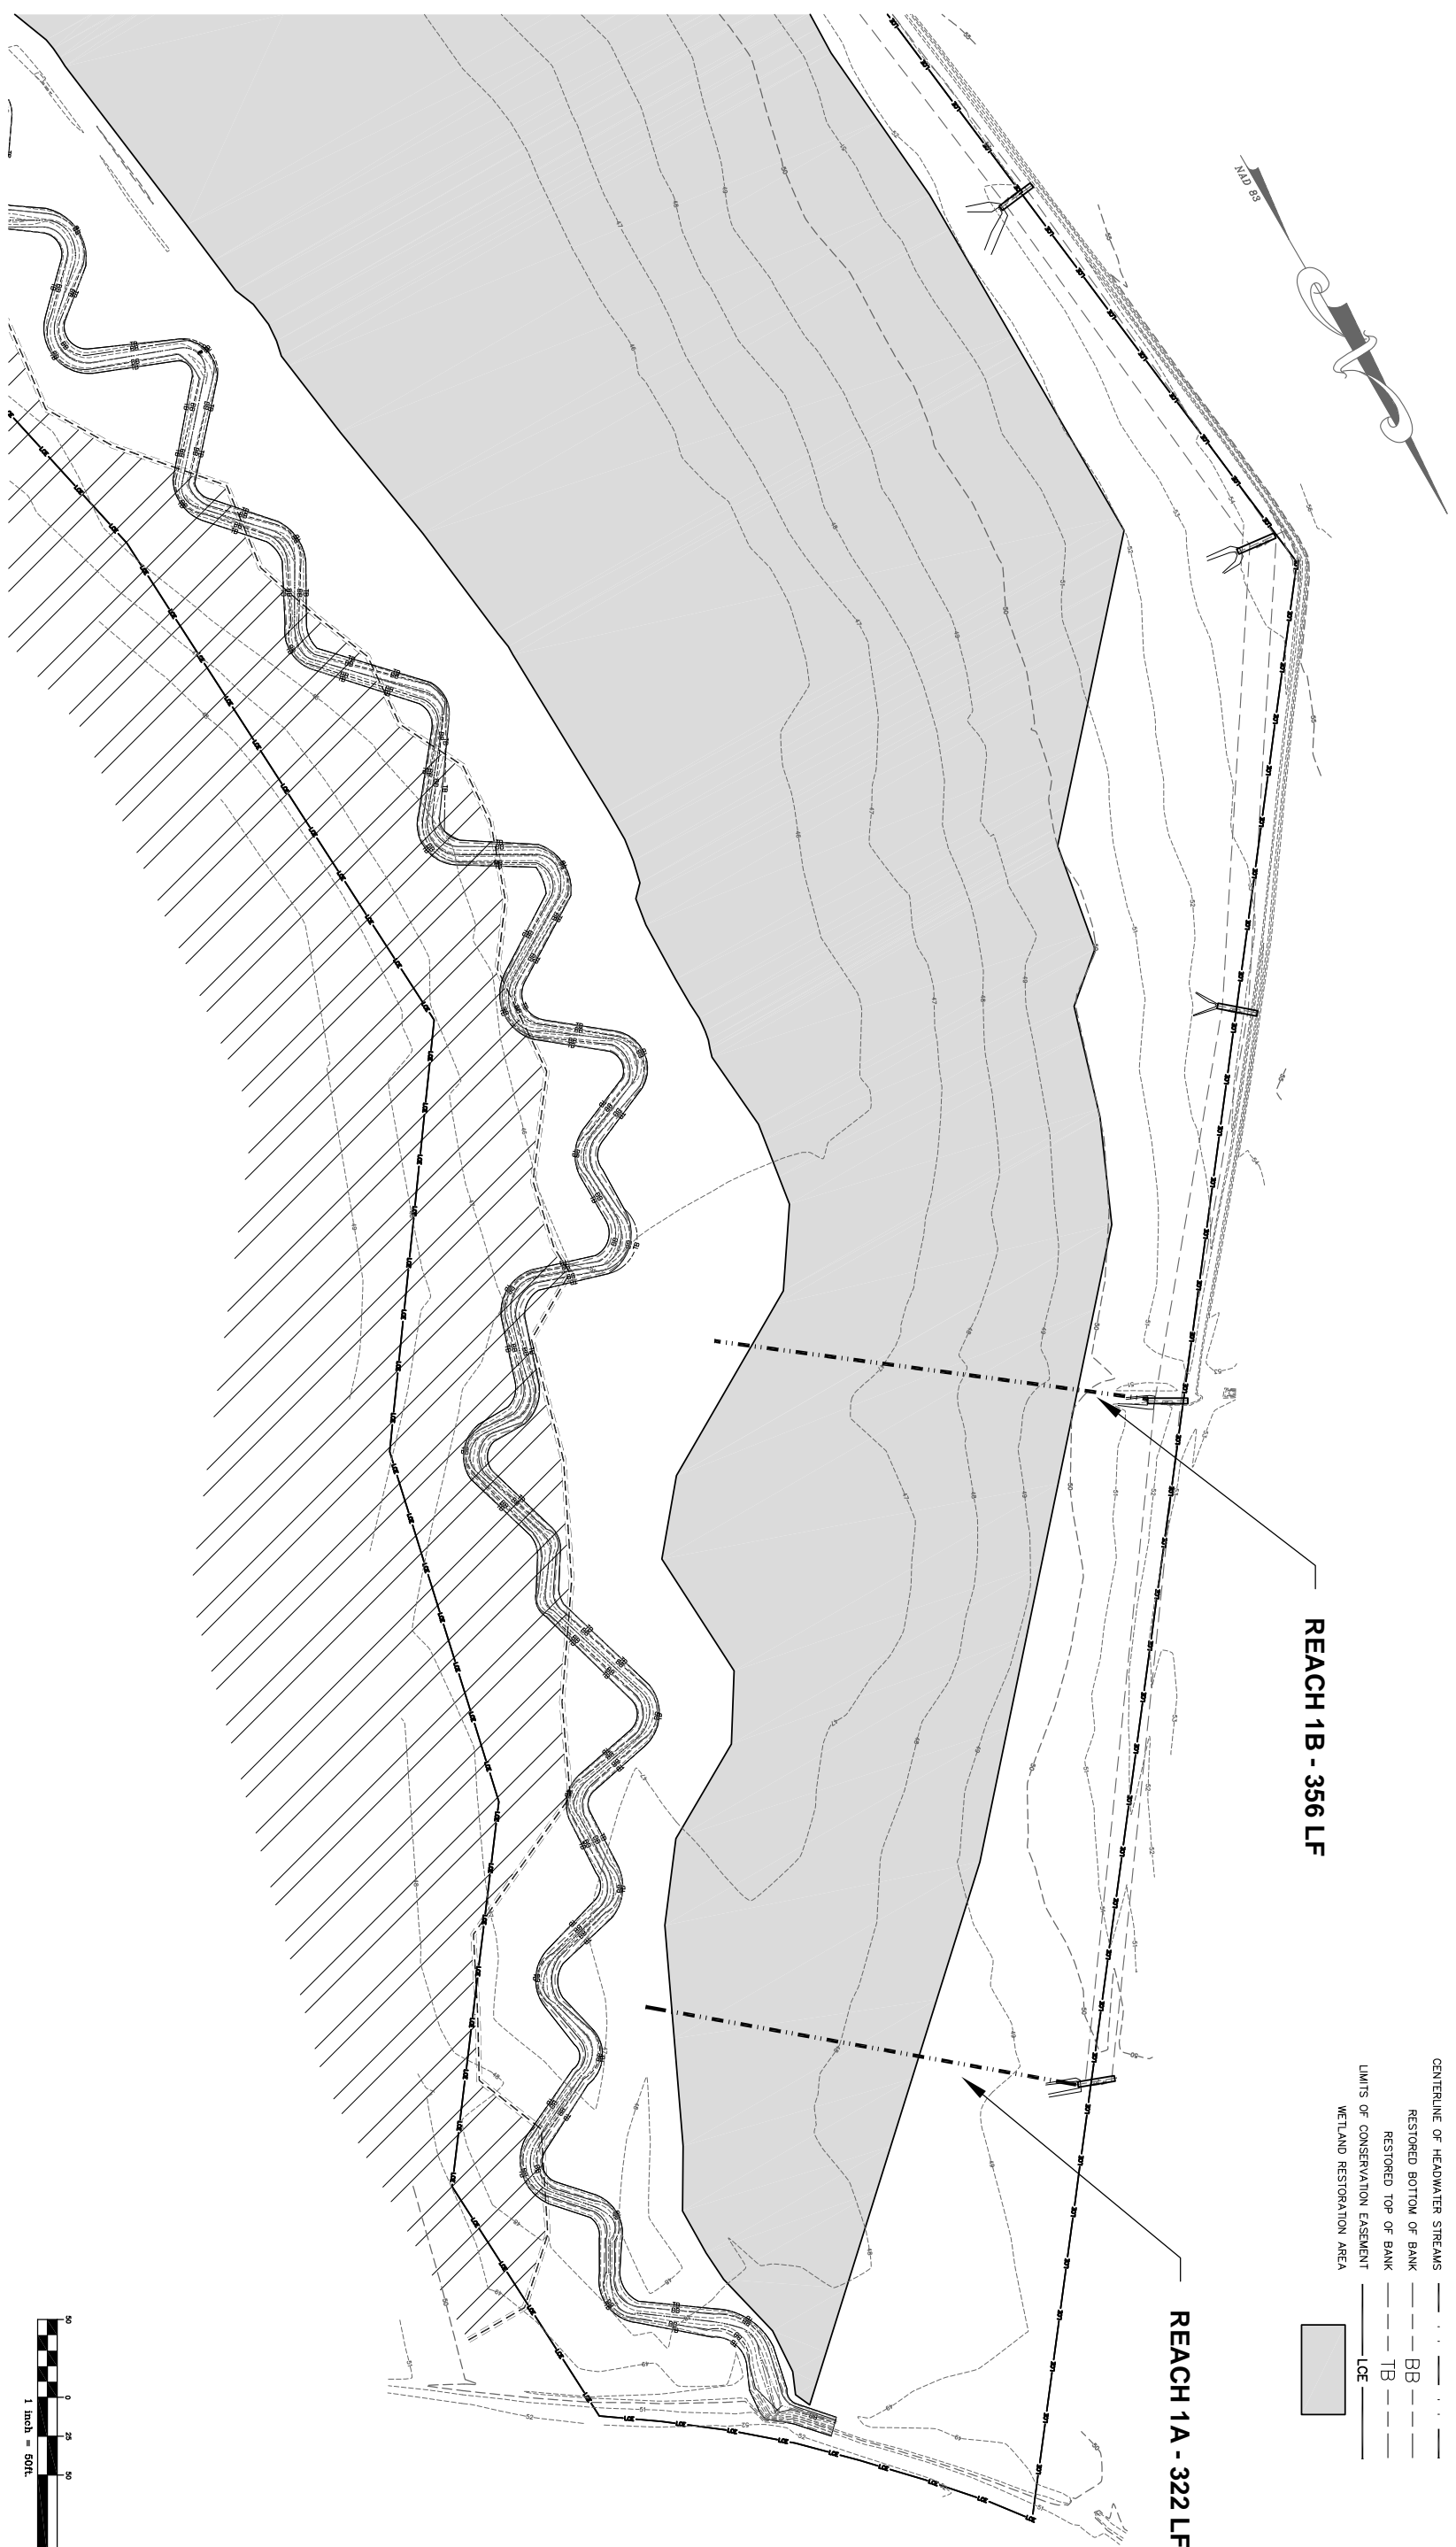
FLOODIE AS-BUILT PLANS
HEADWATER RESTORATION

- LEGEND**
- EXISTING CONTOURS
 - CENTERLINE OF HEADWATER STREAMS
 - RESTORED BOTTOM OF BANK
 - RESTORED TOP OF BANK
 - LIMITS OF CONSERVATION EASEMENT
 - WETLAND RESTORATION AREA
