MITIGATION PLAN
and AS-BUILT BASELINE REPORT
FOX RUN RIPARIAN BUFFER MITIGATION SITE
PITT COUNTY, NORTH CAROLINA
(EEP Contract No. 002281)

November 2010

SITE LOCATION
FOX RUN BUFFER RESTORATION SITE
 Pitt County, North Carolina

**MONITORING
PLAN VIEW**

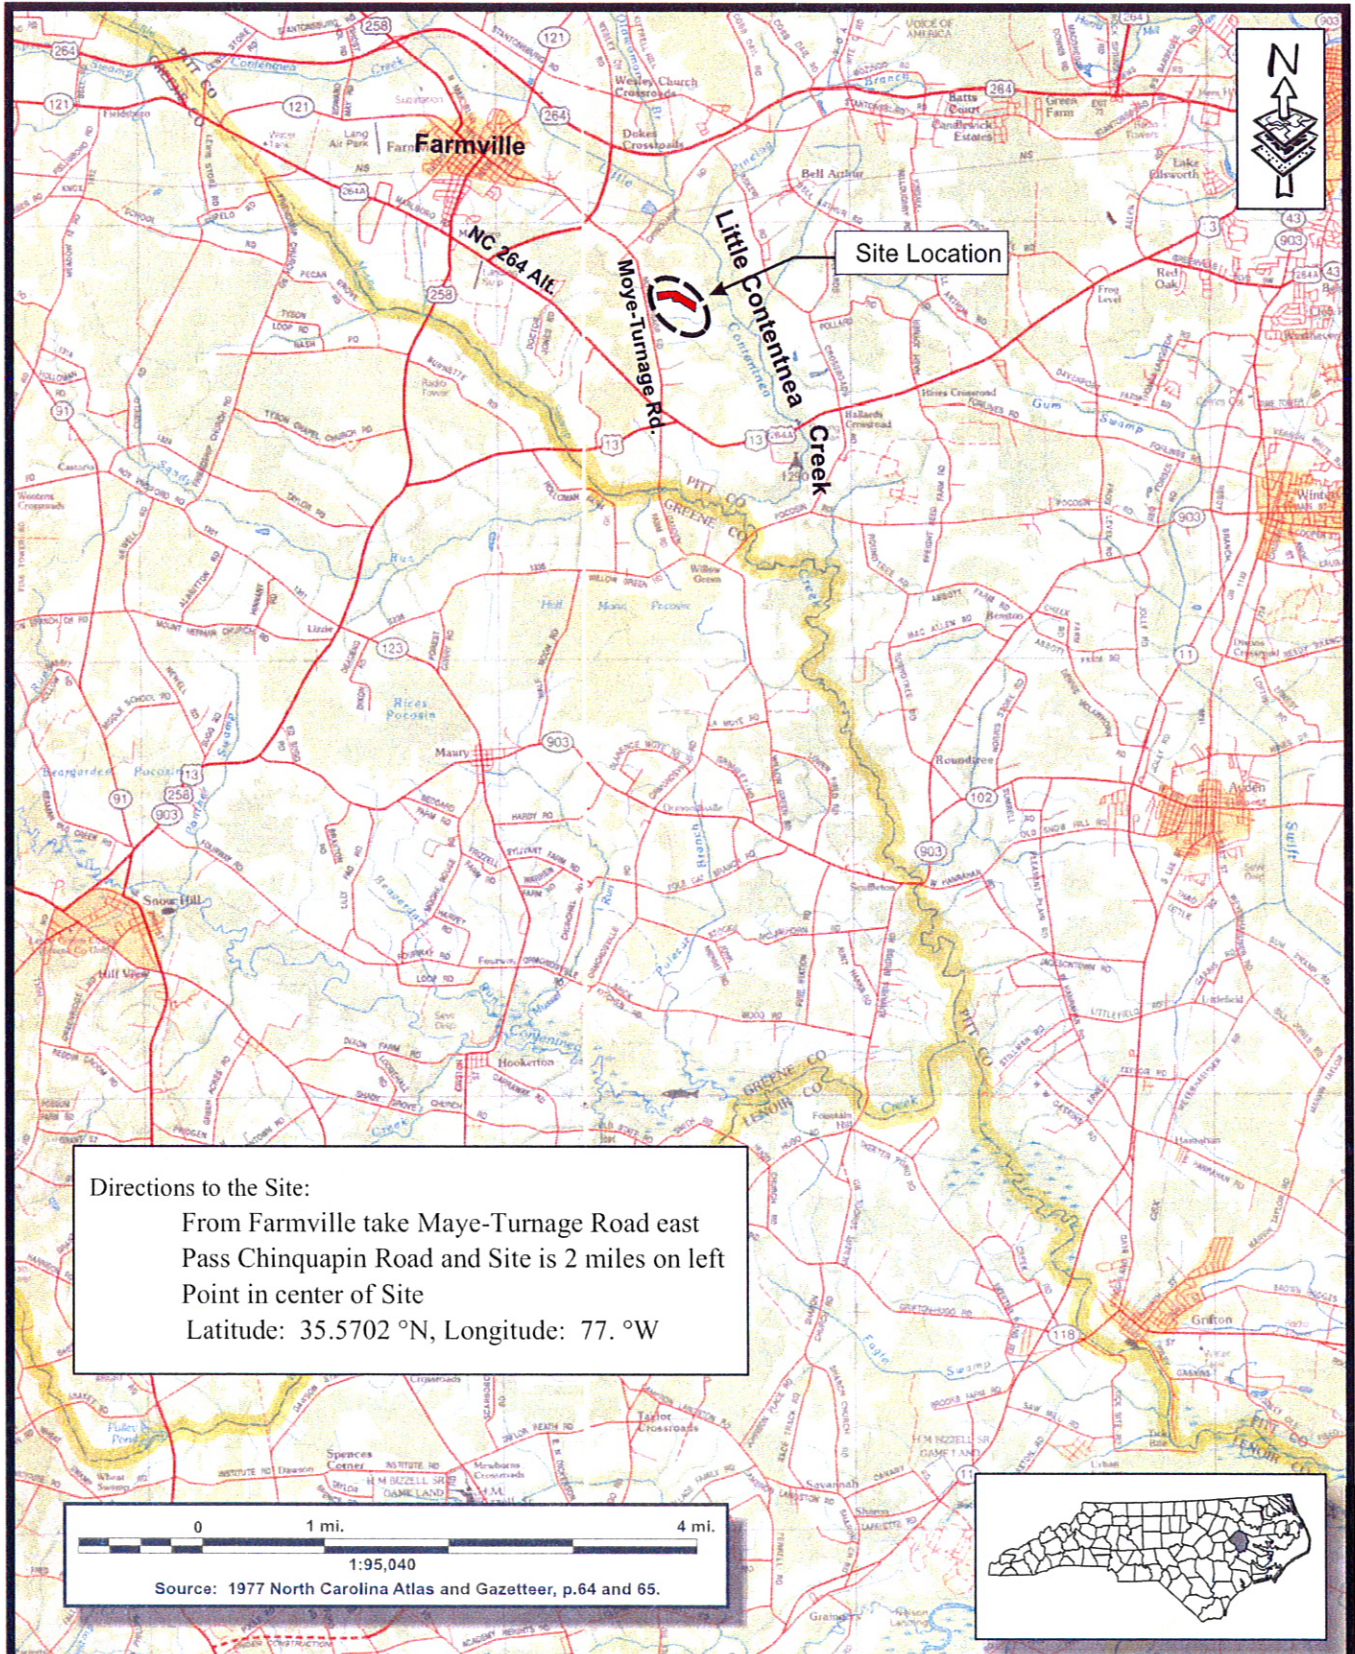
FIGURE
1

Directions to the Site:
 From Farmville take Moyer-Turnage Road east
 Pass Chinquapin Road and Site is 2 miles on left
 Point in center of Site
 Latitude: 35.5702 °N, Longitude: 77. °W

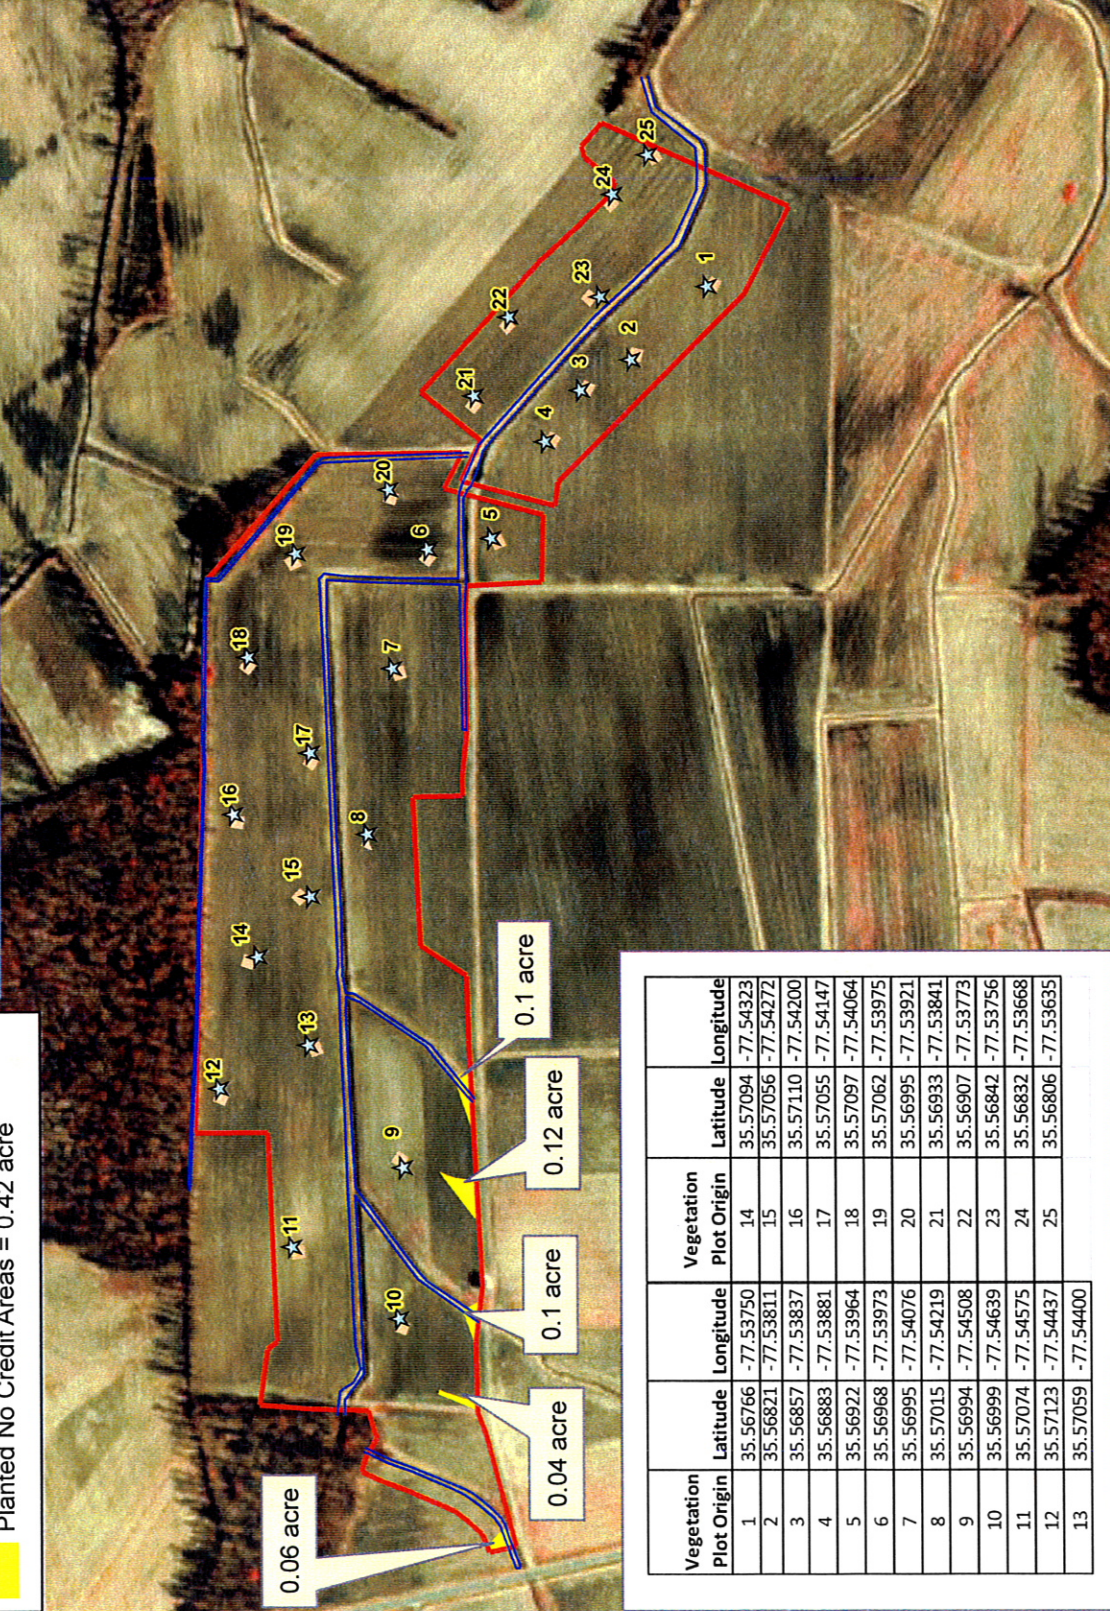
**FIGURE
2**

**BUFFER CREDIT AREA =
43.72 acres**

Note: The buffer credit area excludes planted no credit areas and surface water area within the easement.

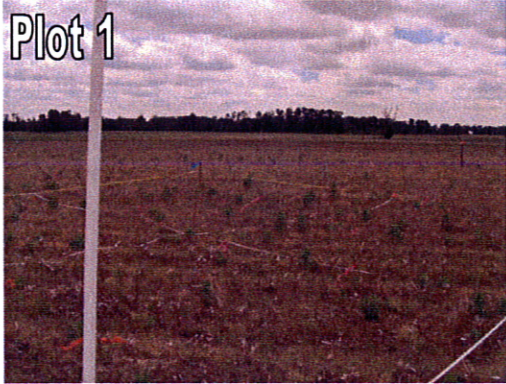
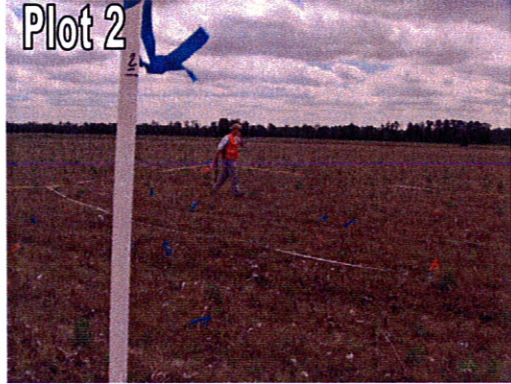
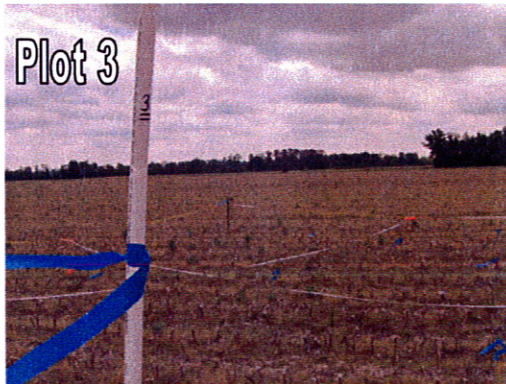
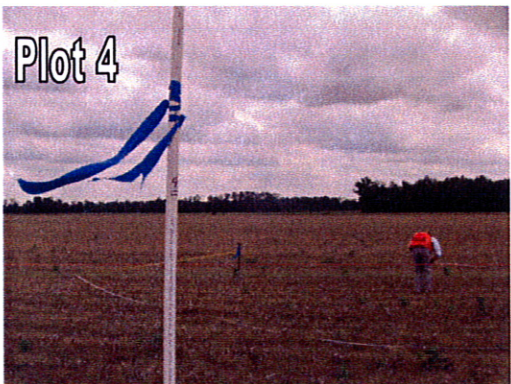
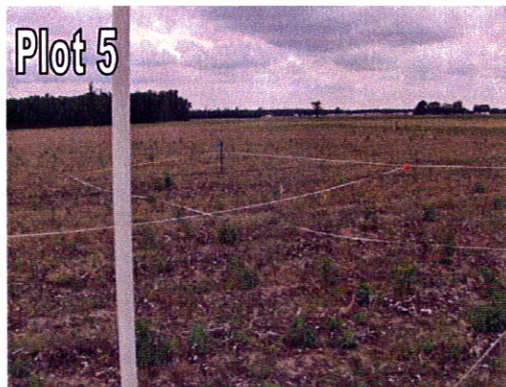
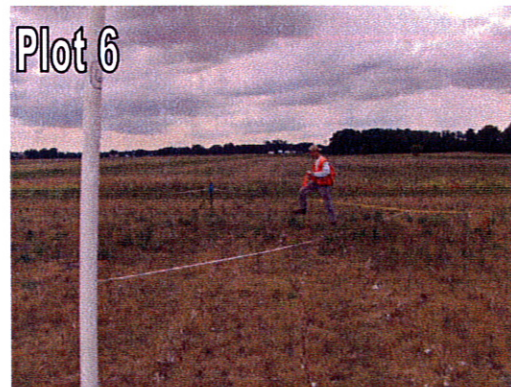
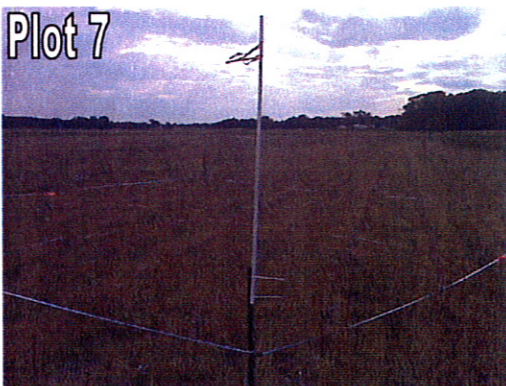
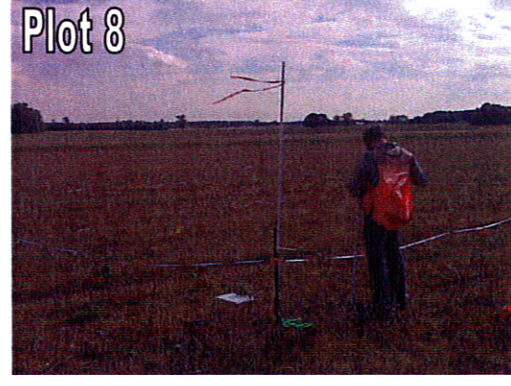
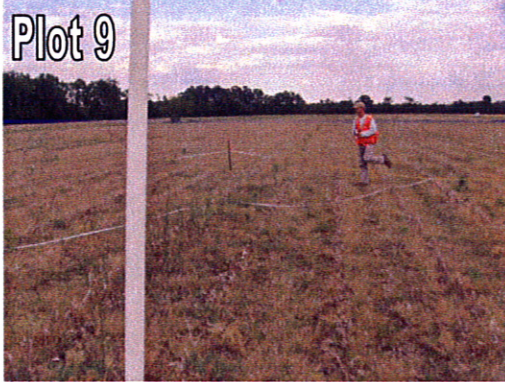
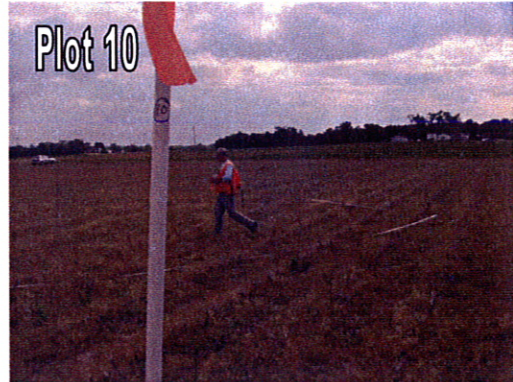
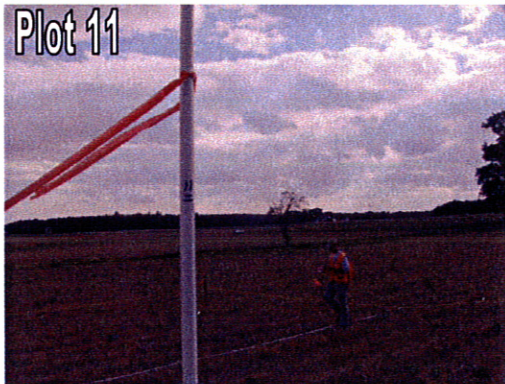
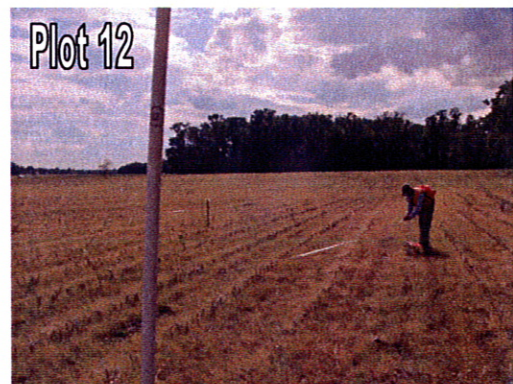
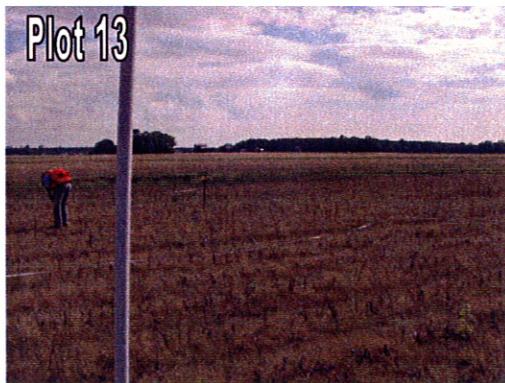
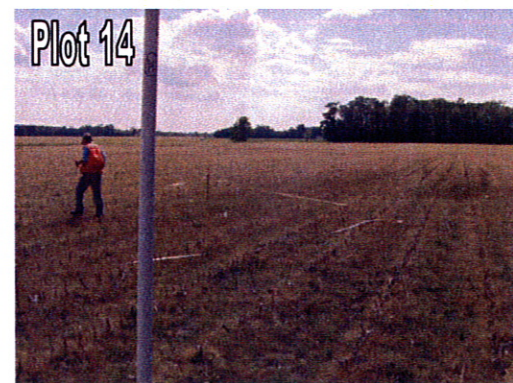
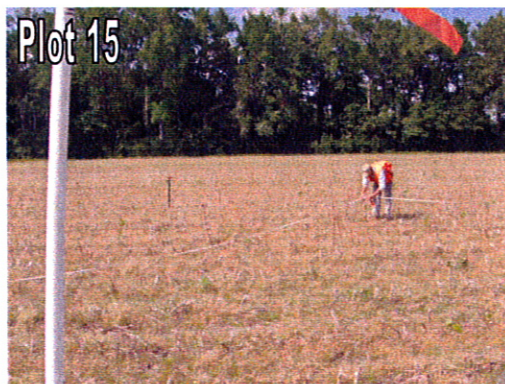
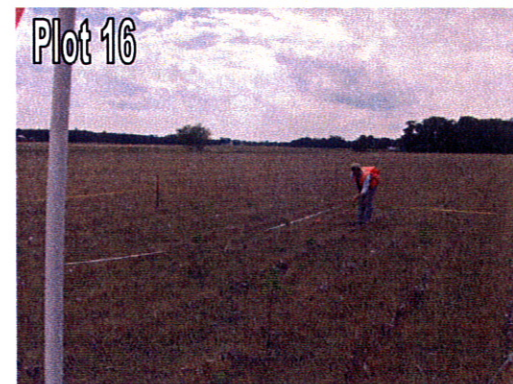
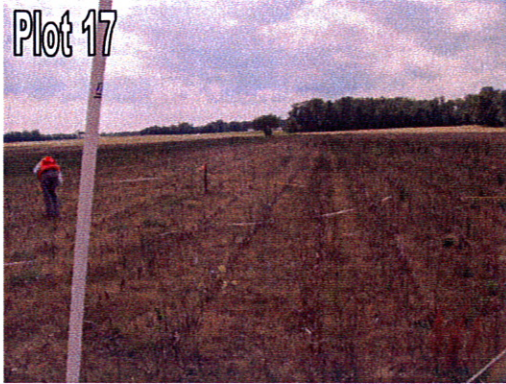
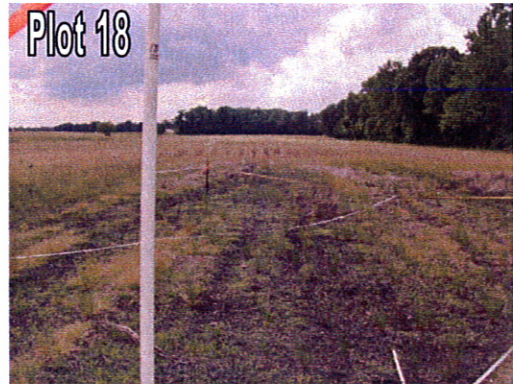
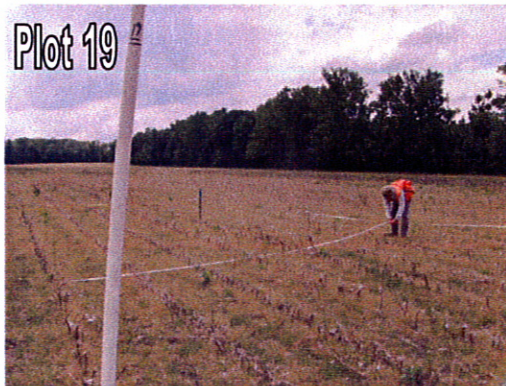
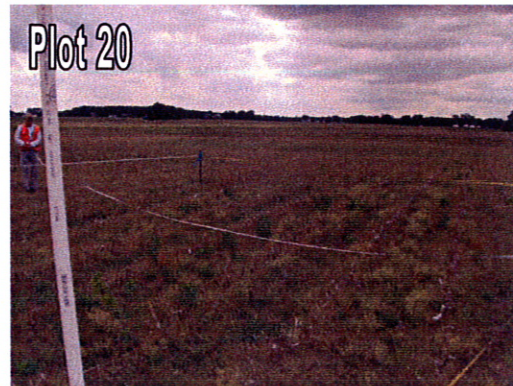
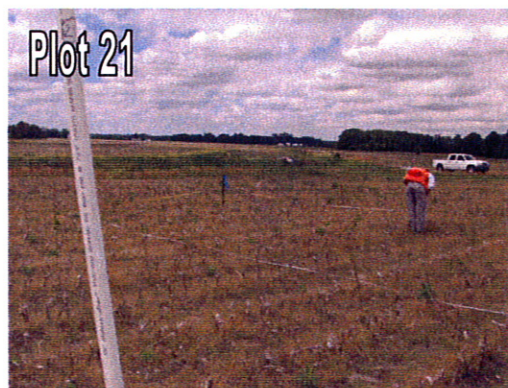
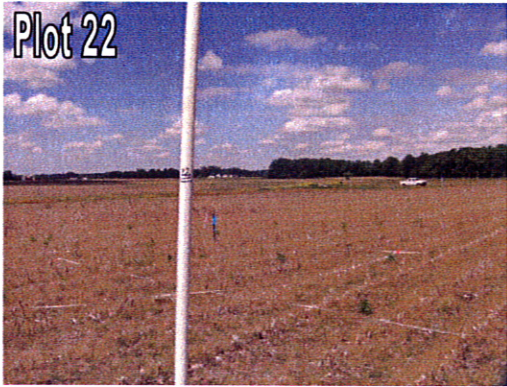
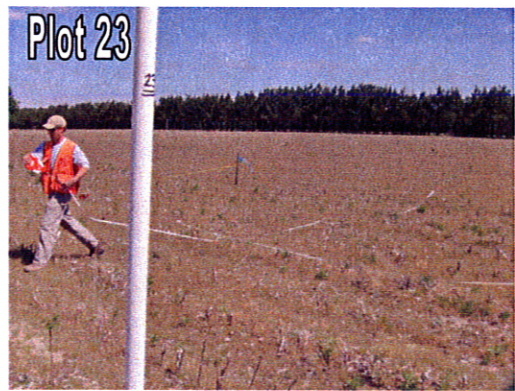
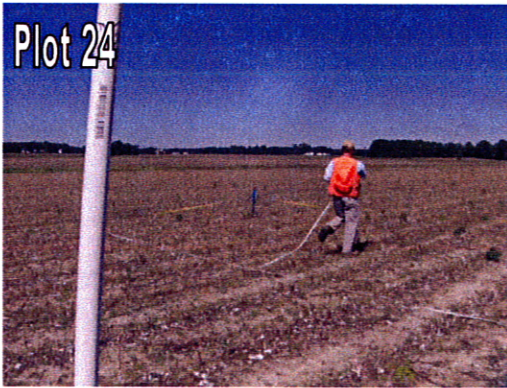
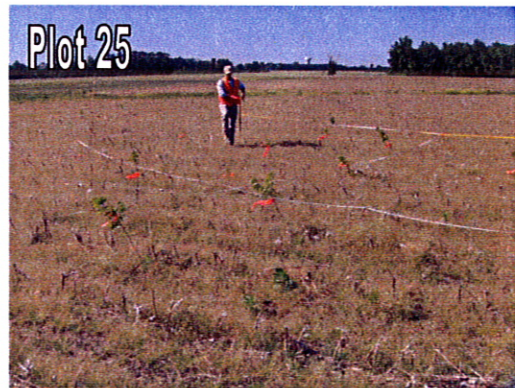
**Fox Run
Baseline
Vegetation Monitoring Plot Photos
Taken April 2010**

Quantitative sampling of vegetation was conducted in April, 2010. An average of 783 planted stems per acre was recorded within vegetation plots. In addition, stems counts within each individual plot were well-above the required 320 stems per acre and species diversity was good with 3-9 species per plot. Results are provided in Appendix C.
