ANNUAL WETLAND MONITORING REPORT YEAR 3 (2008)

**GATLIN SWAMP WETLAND RESTORATION SITE
MARTIN COUNTY, NORTH CAROLINA
(Contract # D05024-2)**

**GATLIN SWAMP WETLAND RESTORATION SITE
ANNUAL MONITORING REPORT
YEAR 3 (2008)
MARTIN COUNTY, NORTH CAROLINA**

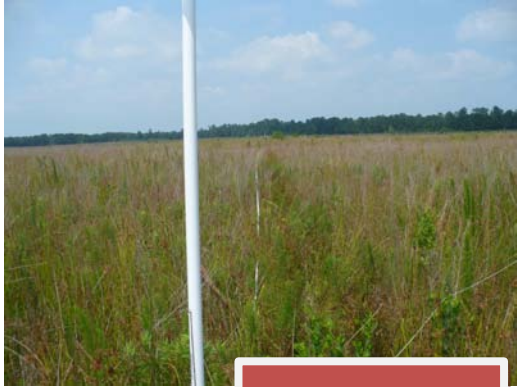
Veg Plot 1

TOTAL	171	145	254	203	138	911	1822	1822	1822	1822	1822	1822	1822	1822	1822
TOTAL STEMS/PLOT COUNTING TOWARDS SUCCESS CRITERIA	74	66	85	87	78										
TOTAL STEMS/ACRE COUNTING TOWARDS SUCCESS CRITERIA	744	664	854	874	784
