ANNUAL WETLAND MONITORING REPORT YEAR 4 (2009)

GATLIN SWAMP WETLAND RESTORATION SITE
MARTIN COUNTY, NORTH CAROLINA
(Contract # D05024-2)

**GATLIN SWAMP WETLAND RESTORATION SITE
ANNUAL MONITORING REPORT
YEAR 4 (2009)
MARTIN COUNTY, NORTH CAROLINA**

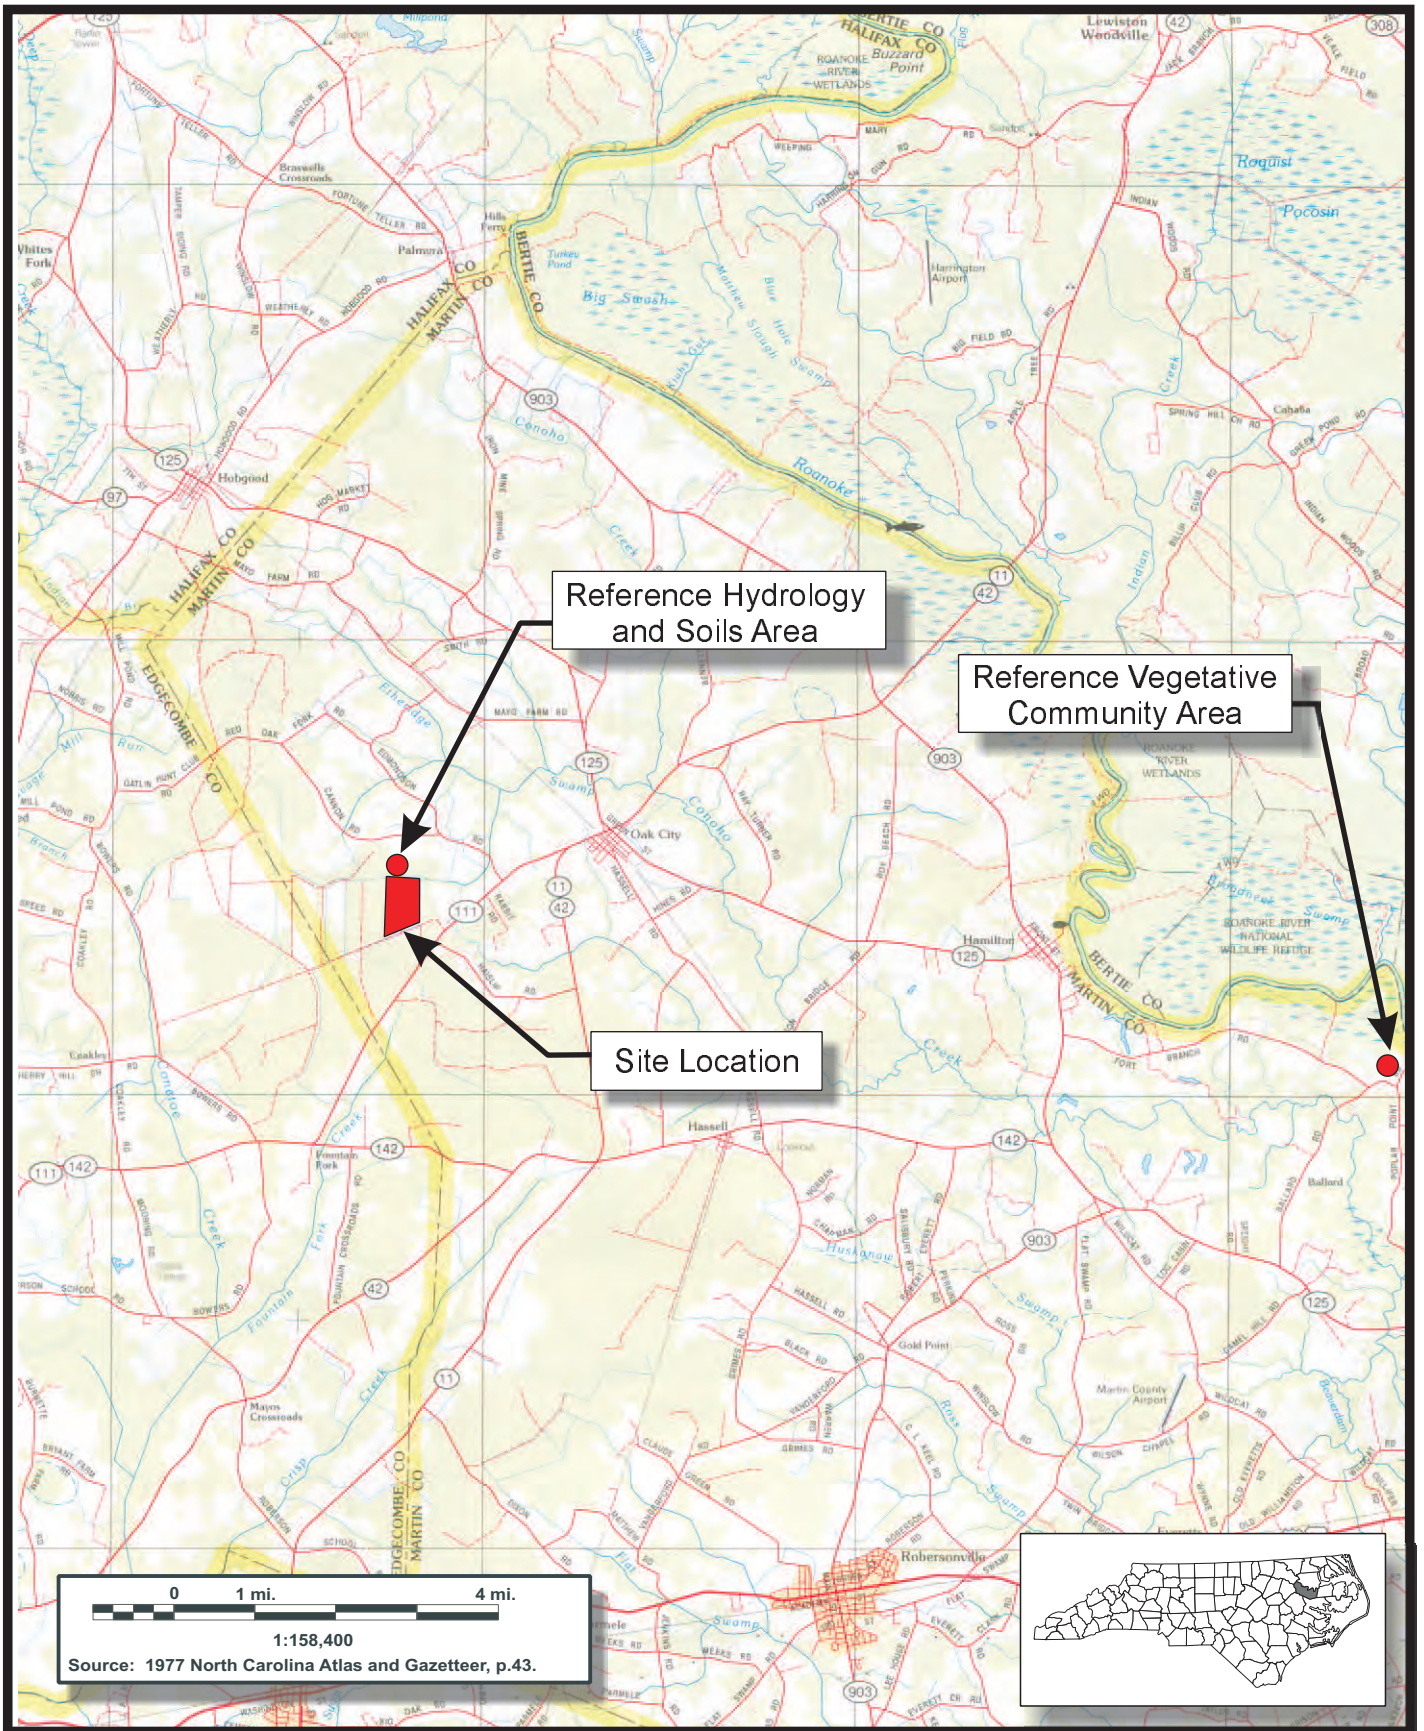
FIGURE

Restoration Systems established the Gatlin Swamp Wetland Restoration Site (Site) in the Coastal Plain region of the Roanoke River Basin (14-digit HU 03010107120020). The Site is located approximately 1.5 miles southwest of Oak City, in Martin County (Figure 1). The Site encompasses approximately 150.2 acres of land situated in an expansive interstream flat characterized primarily by timber production and agriculture. The project offers 138.7 acres of nonriverine wetland restoration, with benefits to water quality and wildlife in a watershed that is highly dissected for agriculture and timber production.

SITE LOCATION
GATLIN SWAMP WETLAND RESTORATION SITE
Martin County, North Carolina

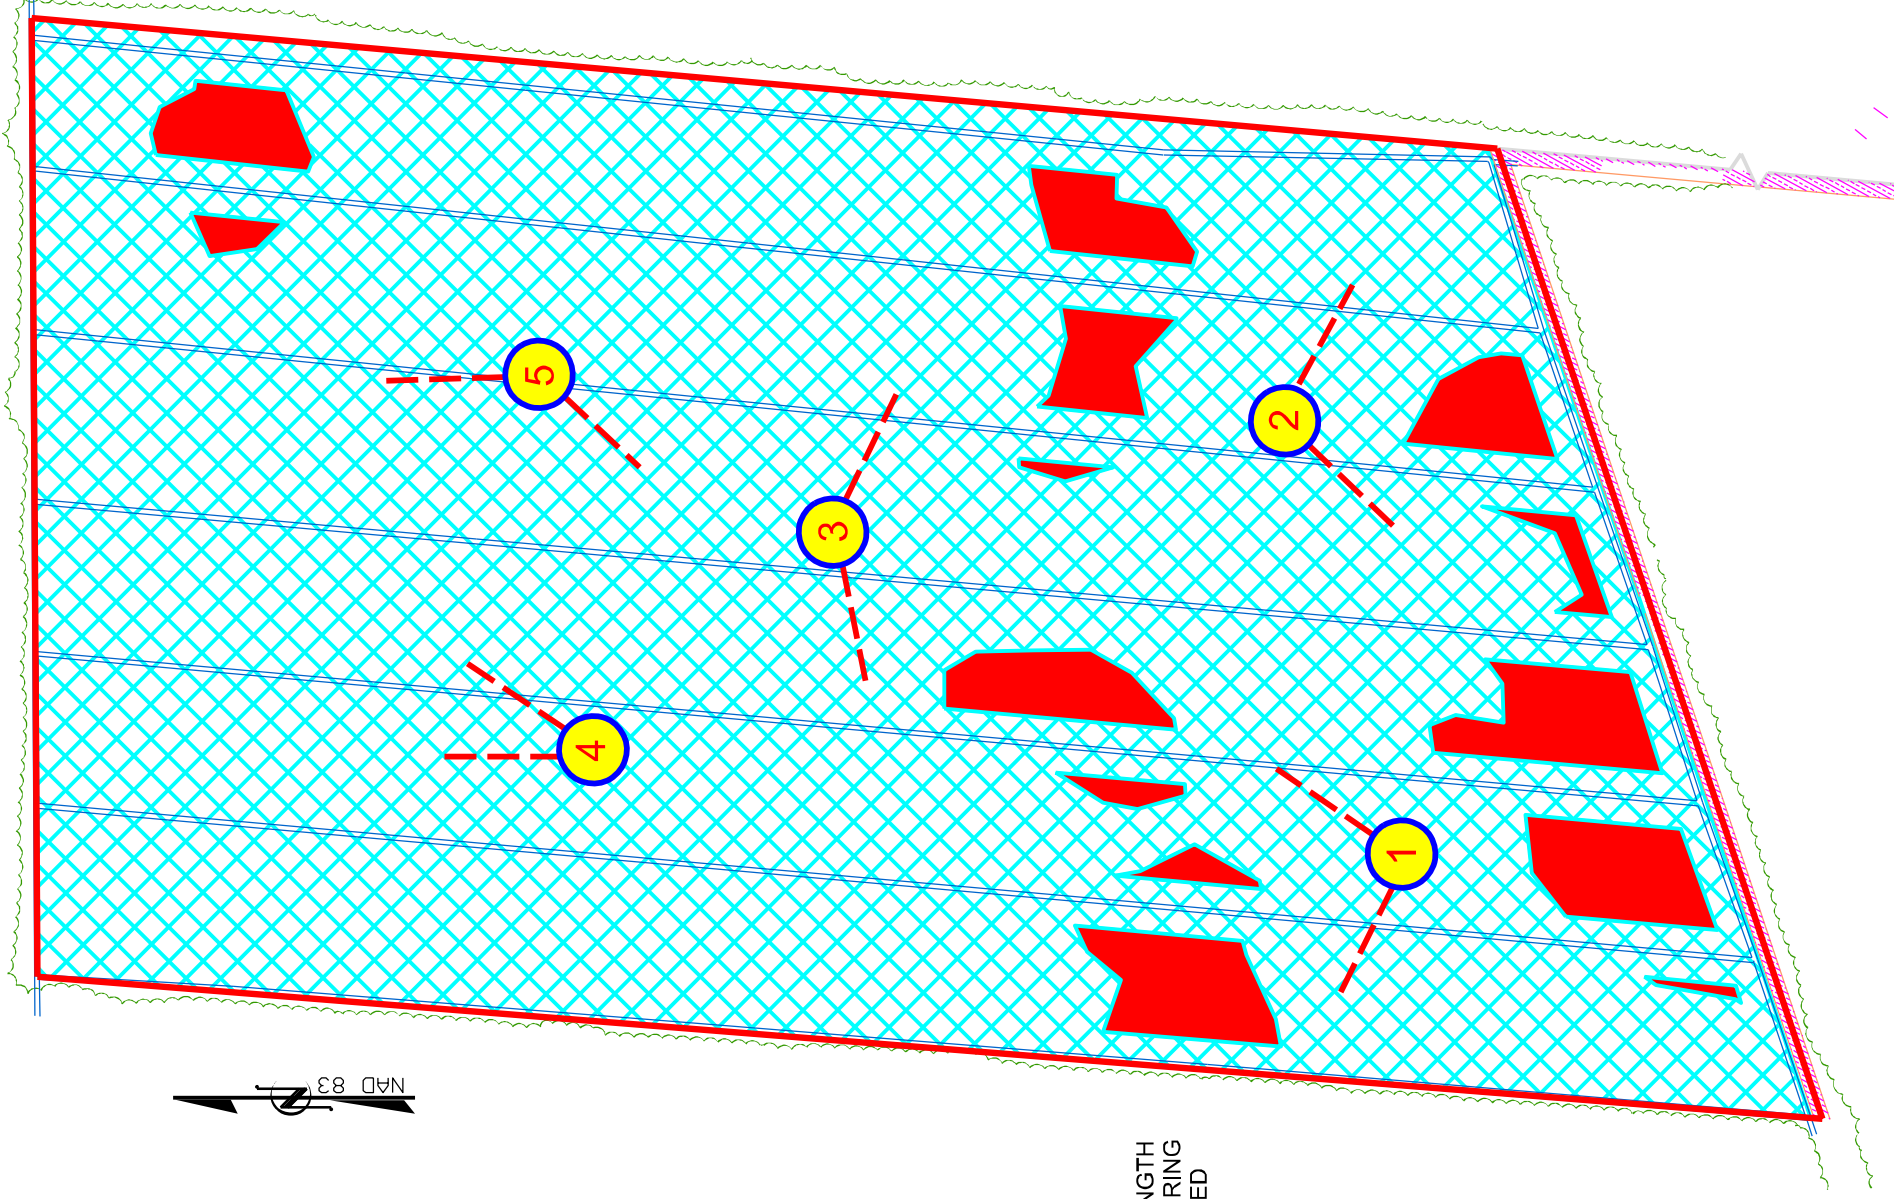
FIGURE NO.

MONITORING
PLAN

INFINITY CONTINUOUS MONITORING GAUGES INSTALLED IN ACCORDANCE WITH SPECIFICATIONS OUTLINED IN U.S. ARMY CORPS OF ENGINEERS, INSTALLING MONITORING WELLS/PIEZOMETERS IN WETLANDS (WRP TECHNICAL NOTE HY-IA-3.1, AUGUST 1993). SCREENS ARE SET TO A DEPTH OF APPROXIMATELY 18 INCHES. GAUGES ARE PROGRAMMED TO RECORD AT 24-HOUR INTERVALS. DAILY RAINFALL IS CORRELATED FROM DATA OBTAINED AT A NATIONAL WEATHER SERVICE STATION LOCATED IN TARBORO (STATION 318500 - COOP).

VEGETATION MONITORING PLOTS ARE COMPRISED OF TRANSECTS, 600 FEET IN LENGTH AND 7.25 FEET IN WIDTH CENTERED ON EACH OF THE FIVE GROUNDWATER MONITORING GAUGES. IN EACH MONITORING PLOT, VEGETATION PARAMETERS TO BE MONITORED INCLUDE SPECIES COMPOSITION AND DENSITY.

Five monitoring gauges were installed in wetland restoration areas to provide representative coverage of the Site (Figure 2). Two gauges were also placed in a reference area in similar landscape positions to use as comparison with onsite conditions (Figure 1). Hydrological sampling will be performed in restoration and reference areas during the growing season (March

Five sample transects were installed within planted areas of the Site to equally represent the various hydrologic regimes (Figure 2). Each transect is 600 feet in length and 7.25 feet in width (0.1 acre). Transects were centered on the five groundwater monitoring gauges and are defined by the corresponding gauge number. In each sample plot, vegetation parameters monitored include species composition and species density. Photographs of the five vegetation plots are included in Appendix B.

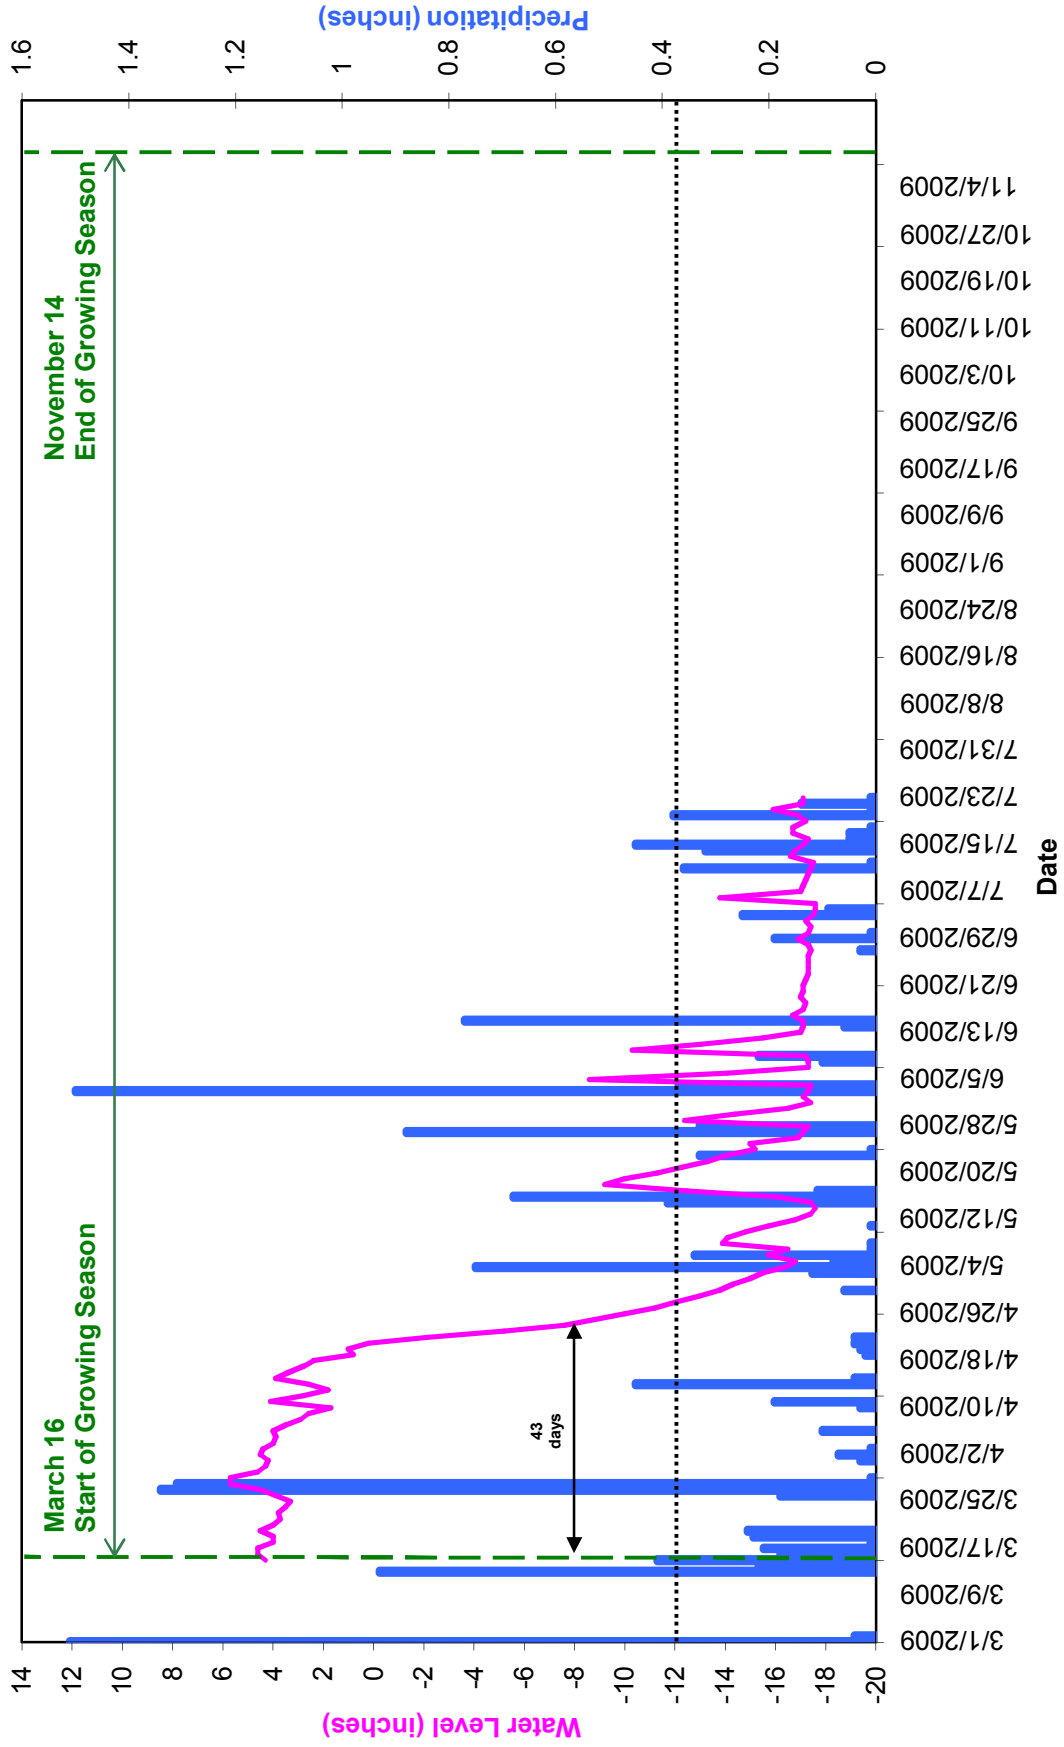
Gatlin Swamp Ground Water Gauge 1 Year 4 (2009 Data)

Gauge	Max Consecutive Days Saturated During Growing Season (Percentage) *	Defined (or Targeted) Success Criteria Achieved
1	43 days (17.6 %)	Yes
2	43 days (17.6 %)	Yes
3	46 days (18.9 %)	Yes
4	44 days (18.0 %)	Yes
5	45 days (18.4 %)	Yes
Ref 1	43 days (17.6 %)	Yes
Ref 2	48 days (19.7 %)	Yes

Hydrographs for each monitoring location are provided in Appendix A along with daily rainfall totals for 2009. Groundwater data presented in Table 1 were collected through July 23, 2009 for reference and restoration area gauges. Data will continue to be downloaded monthly until the end of the 2009 growing season (November 14, 2009) and will be available upon request.
